**Re: RI-SCE Addendum, Former Mar Com Site (South)  
2007 PGE Transformers Removal and Cleanup  
DEQ ECSI ID Number: 2350**

This is an addendum to the May 2010 Remedial Investigation and Source Control Evaluation (RI-SCE) report to document the July 2007 removal and cleanup of transformers from the former Mar Com Site (South) completed by Portland General Electric (PGE). The former Mar Com Site (South) is located at 8970 North Bradford Street in Portland, Oregon (Site).

RI-SCE Addendum, 2007 PGE Transformer Removal Former Mar Com Site (South) Portland, Oregon
PHOTOGRAPHS	Job No: 108.00242.00001

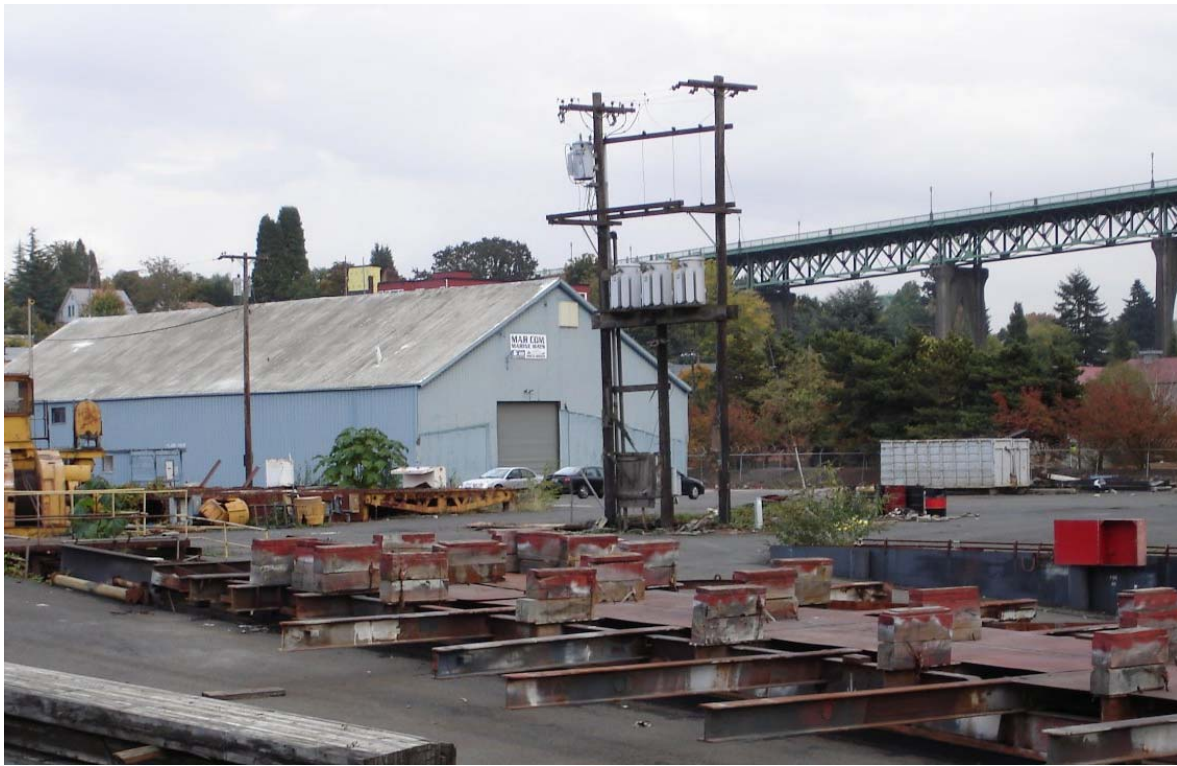
**Photo 1:** Site Photograph from June 2006 showing the three PGE transformers

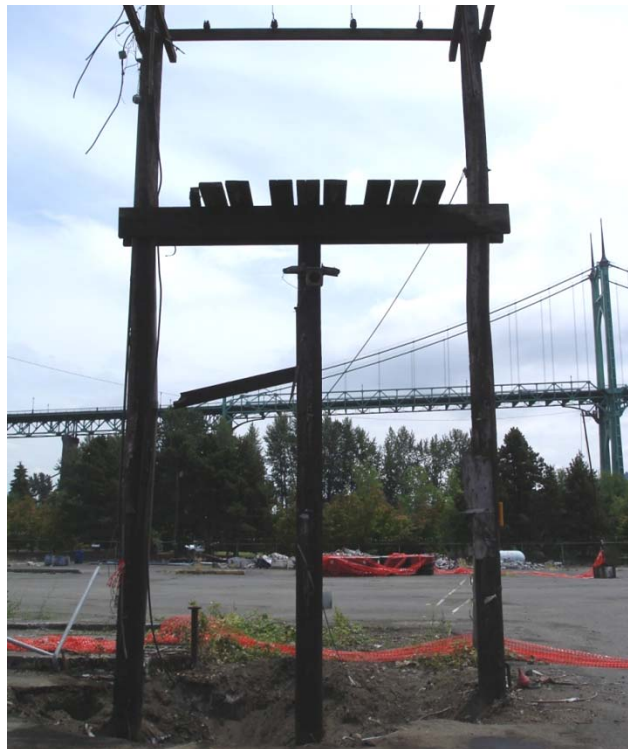
**Photo 2:** Transformer area following transformer removal and soil removal

Records and photographs show that the PGE transformers were removed and soil was removed below the areas of the transformers. As presented in the PGE Spill/Release Report (Attachment 2) and as discussed in a paragraph above, the source of transformer oil has been removed and it is assumed that the residual impacts from the spill of transformer oil has also been removed to below the referenced screening level values. The area of soil removal by PGE was later filled with on-site fill material and covered with landscaping bark. This area has remained relatively unchanged since 2007. Soil remaining in the former transformer area following excavation by PGE is not in an area of stormwater runoff nor available to direct exposure. Information from the 2007 PGE transformers removal and cleanup does not change the conclusion for the May 2010 RI-SCE report that no potentially complete exposure pathways for contaminant migration to the Willamette River were identified in connection with residual surface or subsurface soil impacts.
