Operation and Maintenance Report January 2012 to December 2012 McCormick and Baxter Superfund Site Portland, Oregon

Prepared for Oregon Department of Environmental Quality

May 6, 2013 15670-06/Task 5

Prepared by **GSI Water Solutions, Inc.**

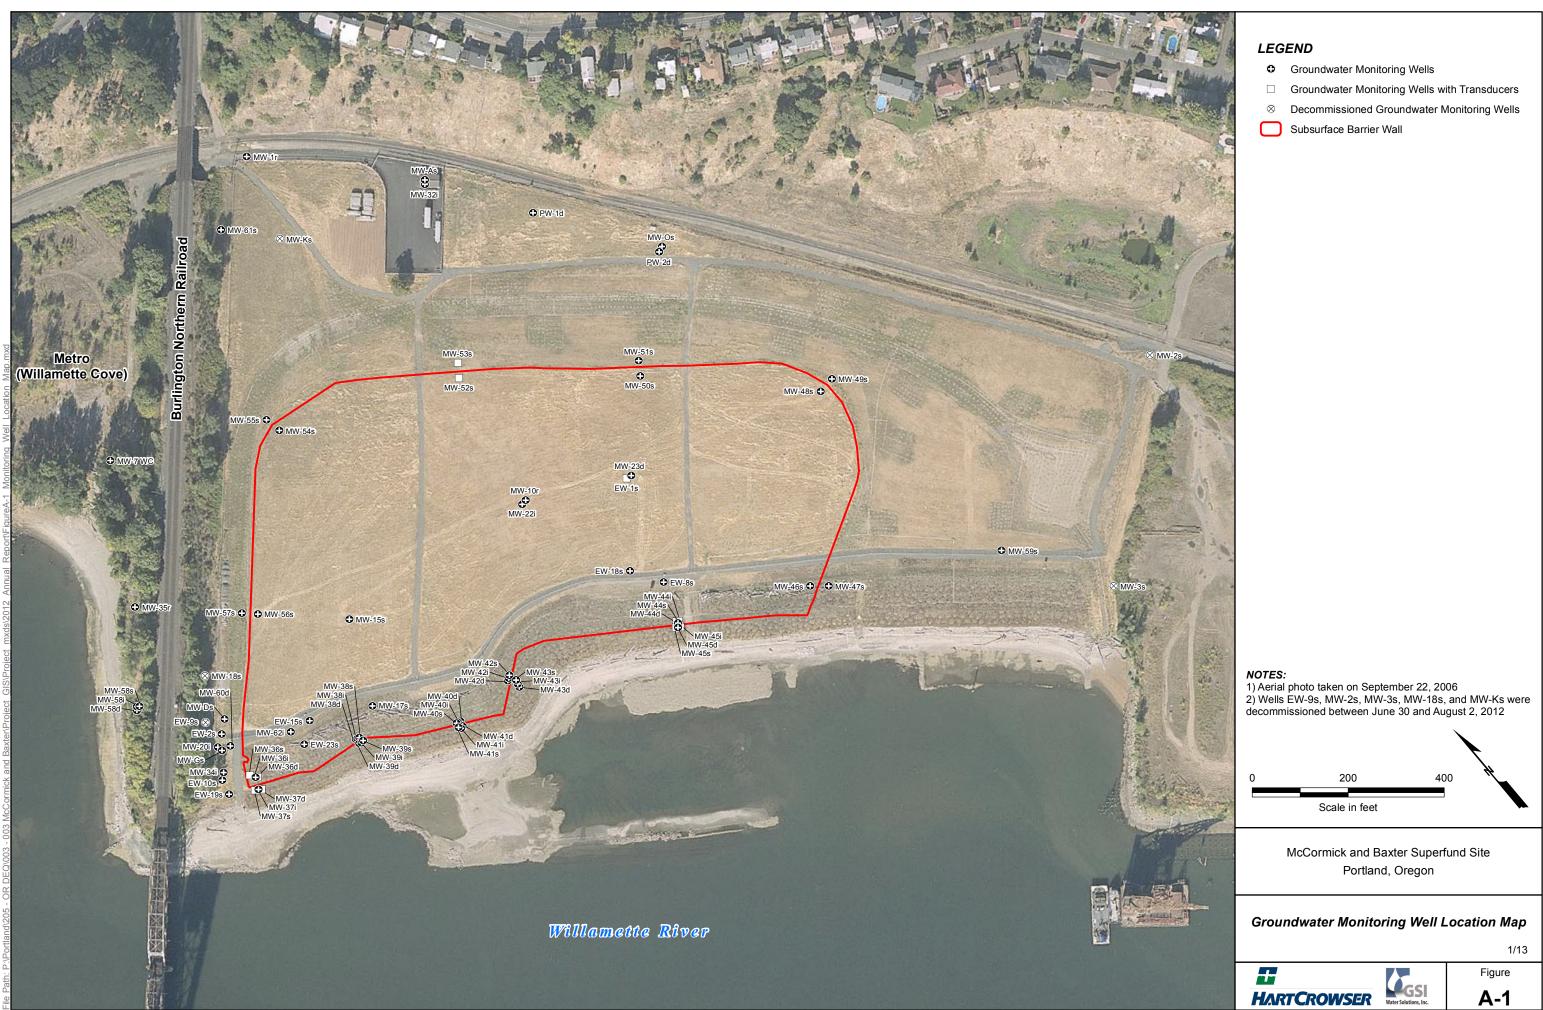
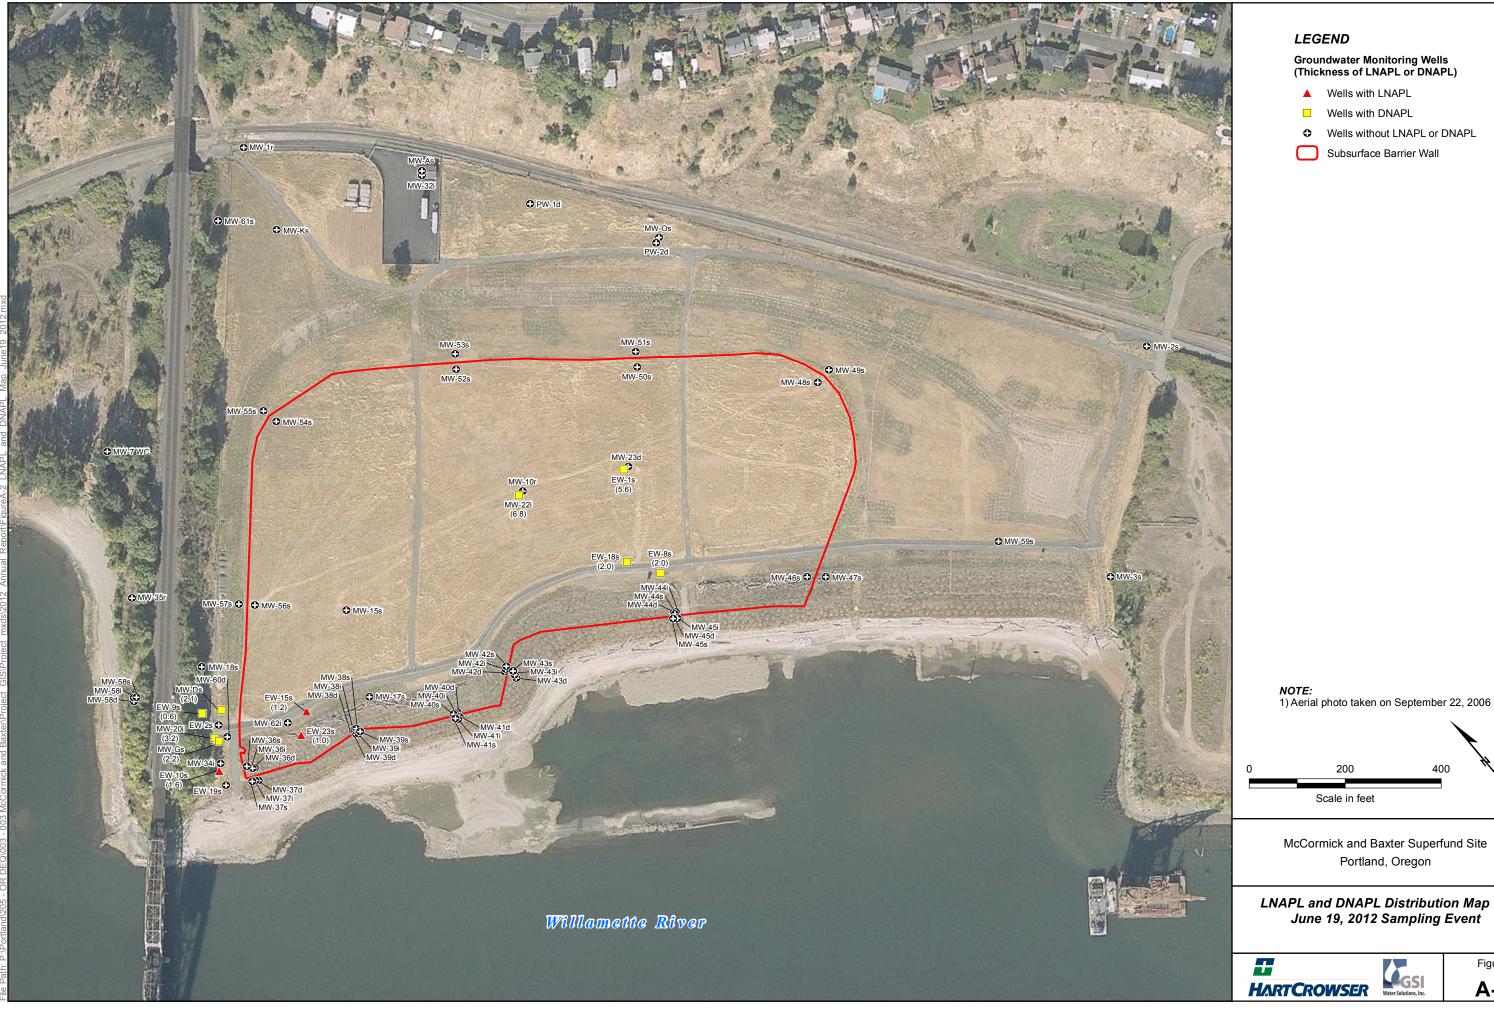
Groundwater Monitoring Wells (Thickness of LNAPL or DNAPL)

- Wells with LNAPL
- Wells with DNAPL

In 2012, NAPL was found in 13 wells (EW-1s, EW-2s, EW-8s, EW-9s, EW-10s, EW-15s, EW-18s, MW-10r, MW-20i, MW-22i, MW-56s, MW-Ds, and MW-Gs). The locations and thicknesses of NAPL remain consistent with previous year's monitoring since remedy construction completion in September 2005.

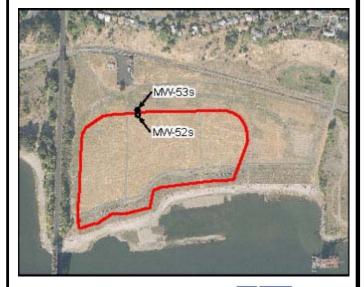
Top of Barrier wall (not shown) is about 31 ft NÁVD.

Breaks in transducer data are the result of removal for calibration, removal for well modification, or a transducer was not collecting accurate pressure readings.

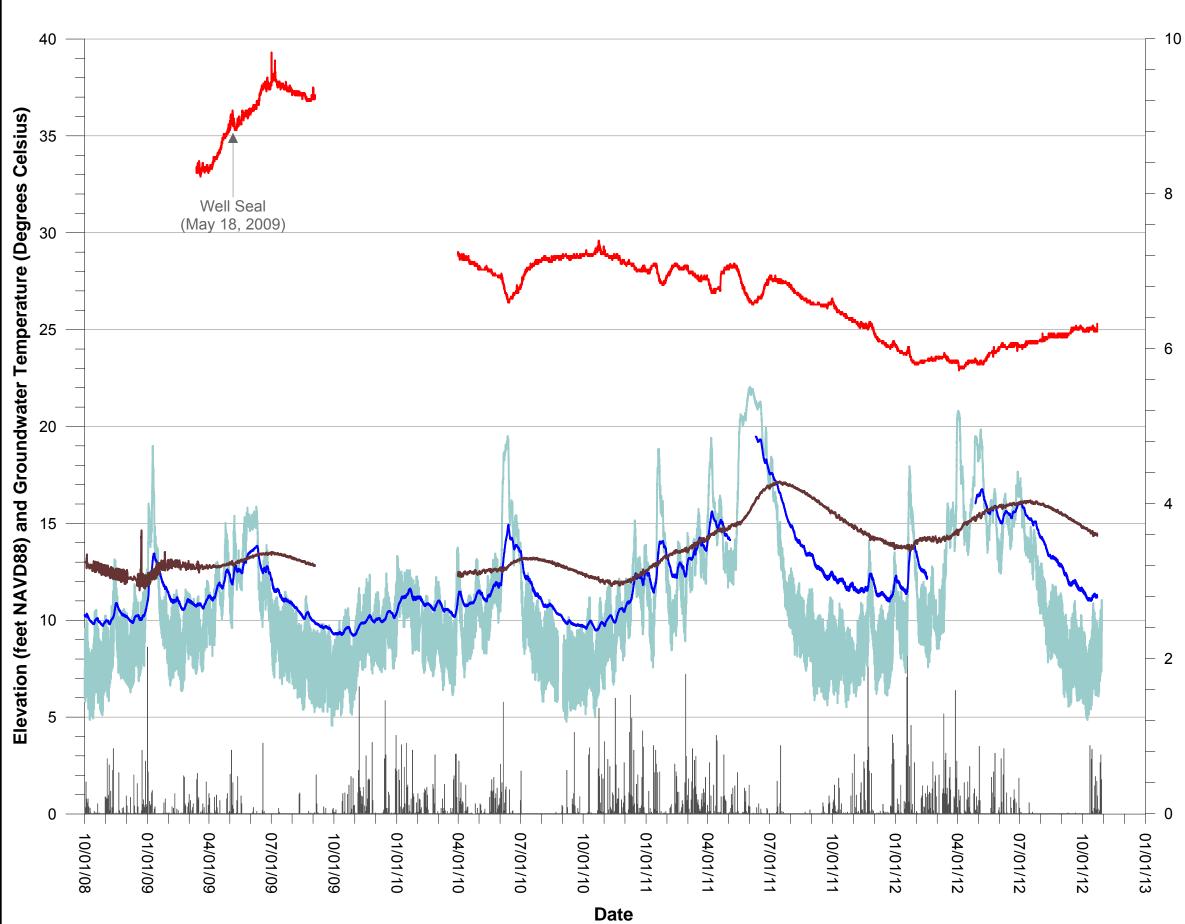
Figure A-20:

The frequent fluctuations (~1-foot oscillations) observed in 2008 and 2009 in well EW-1s, shown in Figure A-20, were caused by gas produced from the degradation of the wood debris buried at the Site escaping through this well. The elevated shallow groundwater temperatures in EW-1s reflect aerobic oxidation of wood and creosote constituents observed in this area. The oxidation process was initiated via the introduction of oxygen through the well screen in the unsaturated zone of EW-1s when water levels within the barrier wall dropped after construction of the RCRA cap. To slow biodegradation and

reduce temperatures, an airtight seal was installed in the well on May 18, 2009. As shown on Figure A-20, temperatures peaked at 38.8°C on July 6, 2009, and steadily declined to between 23°C and 25°C in 2012. A reduction in oscillations indicating a reduction in gas production was noted after well EW-1s was sealed, preventing oxygen from reaching the subsurface. As discussed in Appendix B of this report, the subsidence has been insignificant since EW-1s was sealed.

2008 to 2012 Groundwater **Temperature in Montoring Well EW-1s** and Groundwater Elevations in Monitoring Wells EW-1s and MW-36s **McCormick and Baxter Superfund Site** Portland, OR

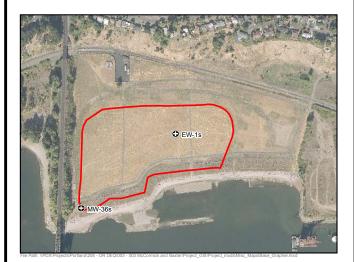
Breaks in transducer data are the result of removal for calibration, removal for well modification, or a transducer was not collecting accurate pressure readings.

Groundwater elevation manually adjusted 0.25 ft up between 17:00 on May 6, 2010 and 14:00 on June 15, 2010 due to apparent displacement from field activities.

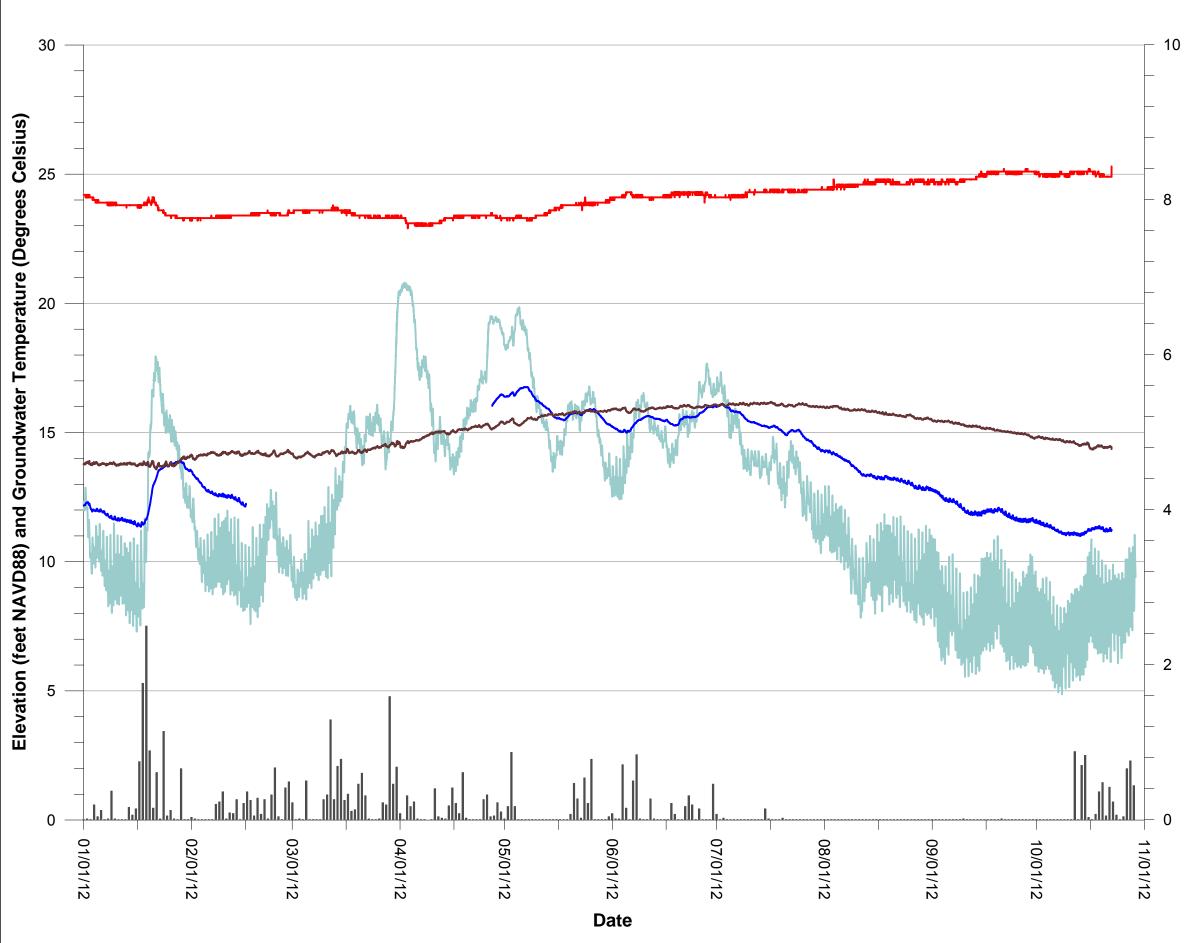
Figure A-21:

2012 Groundwater Temperature in Montoring Well EW-1s and Groundwater Elevations in Monitoring Wells EW-1s and MW-36s McCormick and Baxter Superfund Site Portland, OR

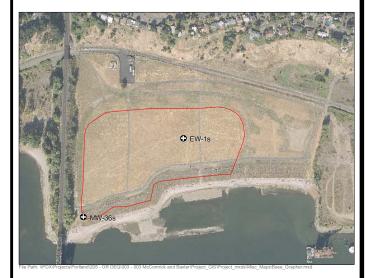
Monitoring wells EW-1s and MW-36s are located inside the barrier wall.

Breaks in transducer data are the result of removal for calibration, removal for well modification, or a transducer was not collecting accurate pressure readings.

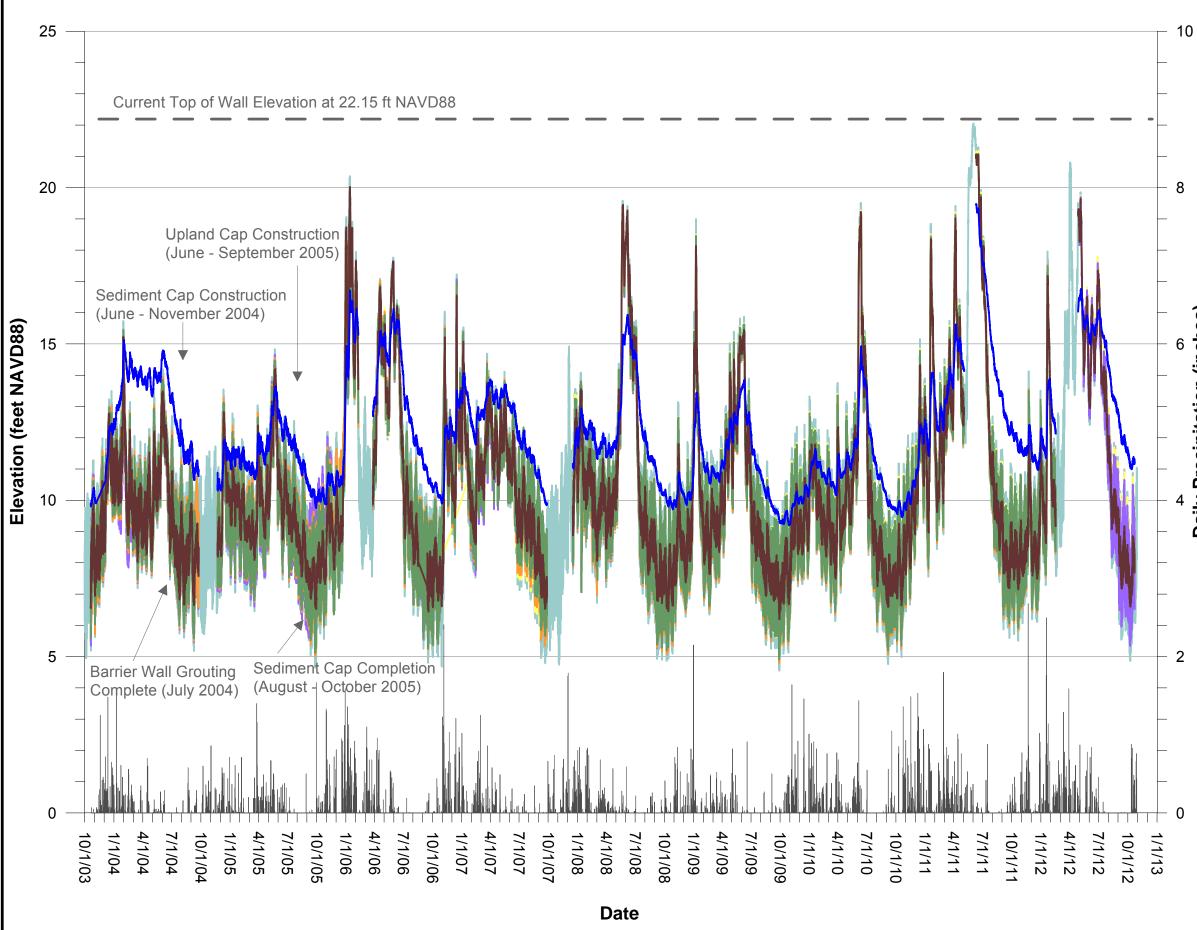
Figure A-22:

Vertical gradients inside and outside the barrier wall along the Willamette River were observed in monitoring well clusters MW-36/MW-37 and MW-44/MW-45. The hydrographs for these wells (Figures A-22 through A-25) indicate that the deep groundwater zone is in direct hydraulic connection with the river. The deep zone both inside and outside of the barrier wall closely mimics the river stage both in elevation and timing with a small vertical gradient that varies between upward and downward with the tidal changes. The exterior shallow wells, also in hydraulic connection with the river, show about a quarter cycle delay from river fluctuations and have dampened amplitude in comparison with the deeper wells.

Post-Barrier Wall Groundwater Elevations in Monitoring Wells MW-36 and MW-37 McCormick and Baxter Superfund Site Portland, OR

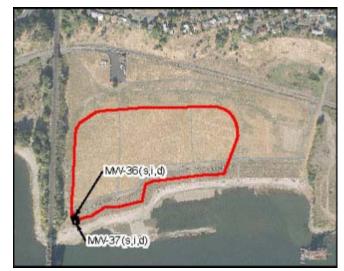
MW-36 wells are located inside the barrier wall and MW-37 wells are located outside the barrier wall.

Breaks in transducer data are the result of removal for calibration, removal for well modification, or a transducer that was not collecting accurate pressure readings. Transducers in MW-36i and MW-37i were removed on February 16, 2012.

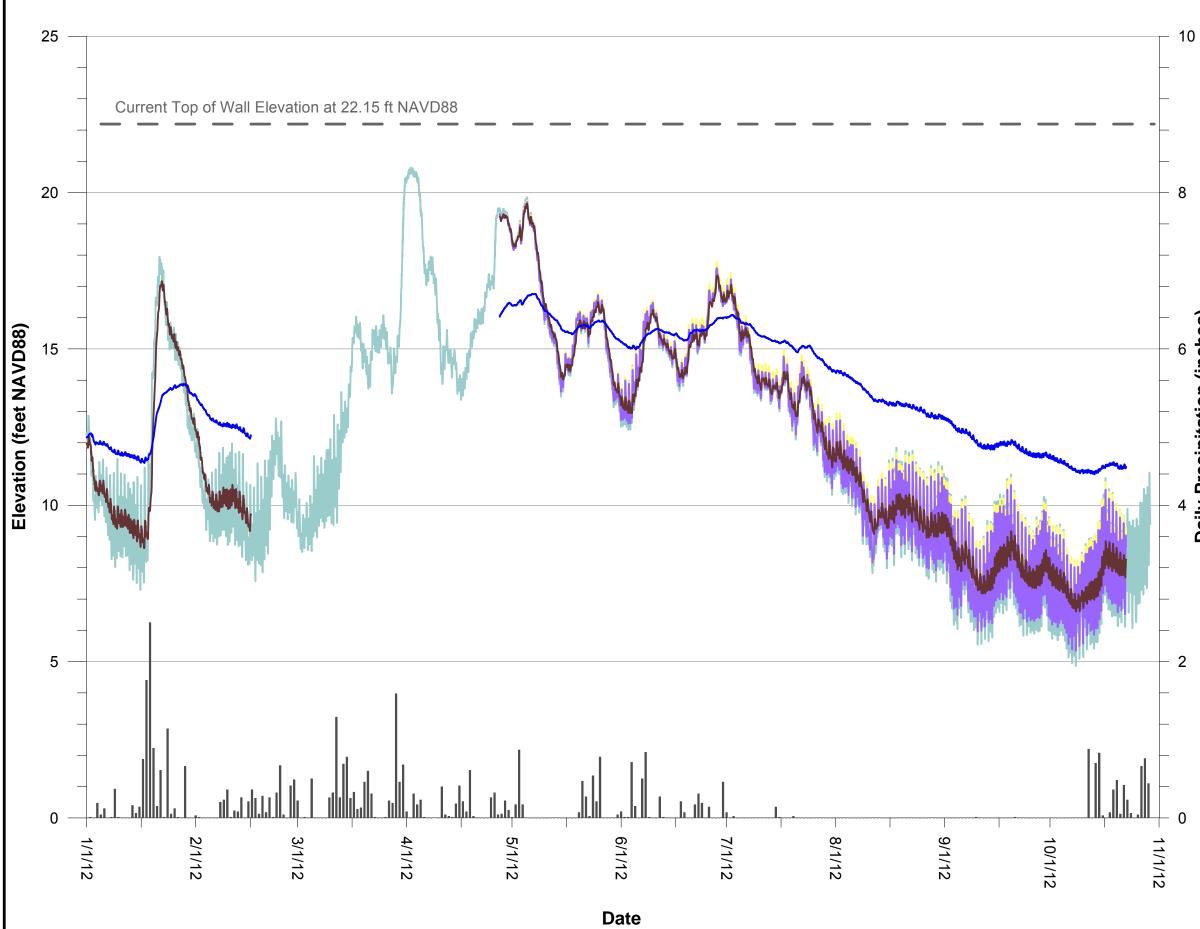
Figure A-23:

2012 Groundwater Elevations in Monitoring Wells MW-36 and MW-37 McCormick and Baxter Superfund Site Portland, OR

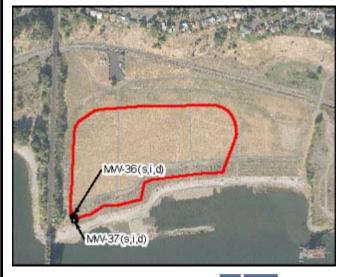
MW-36 wells are located inside the barrier wall and MW-37 wells are located outside the barrier wall.

Breaks in transducer data are the result of removal for calibration, removal for well modification, or a transducer was not collecting accurate pressure readings.

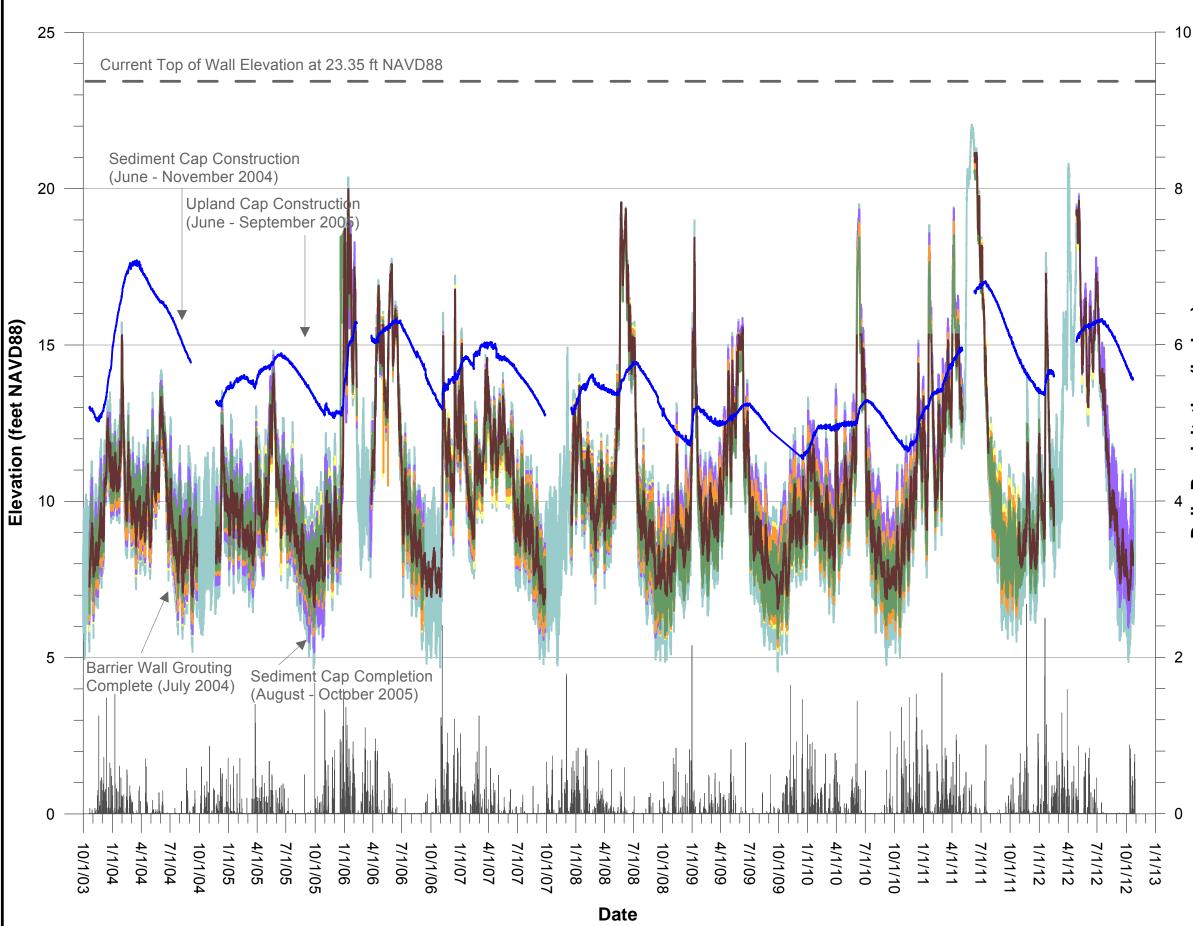
Figure A-24:

Post-Barrier Wall Groundwater Elevations in Monitoring Wells MW-44 and MW-45 **McCormick and Baxter Superfund Site** Portland, OR

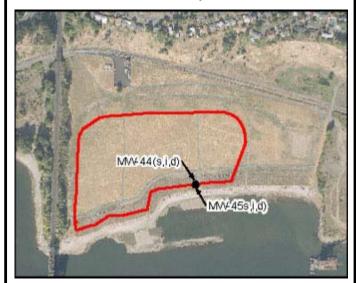
MW-44 well cluster is located inside the barrier wall and MW-45 well cluster is located outside the barrier wall.

Breaks in transducer data are the result of removal for calibration, removal for well modification, or a transducer was not collecting accurate pressure readings. Transducers were removed from MW-44i and MW-45i on February 16, 2012.

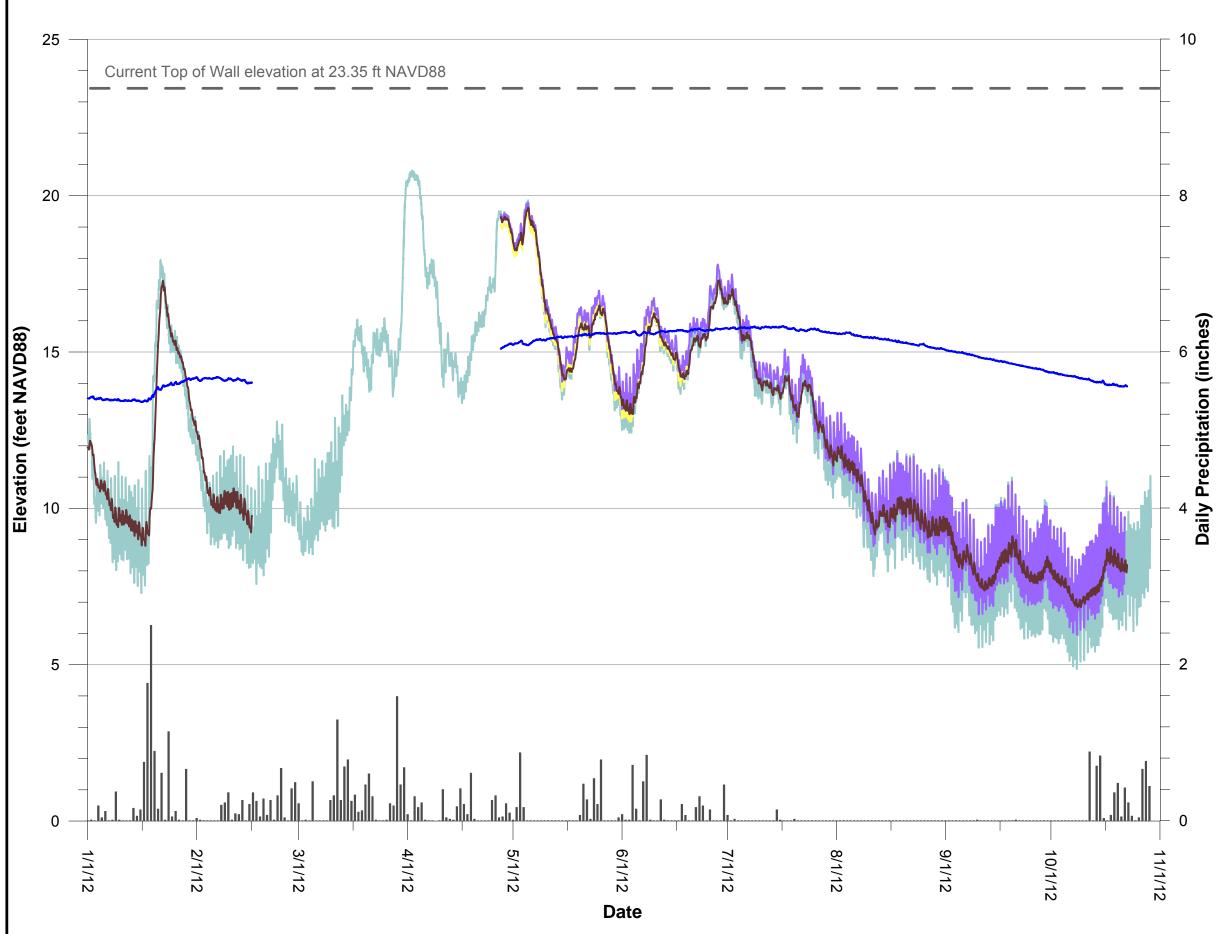
Figure A-25: 2012 Groundwater Elevations

in Monitoring Wells MW-44 and MW-45 McCormick and Baxter Superfund Site Portland, OR

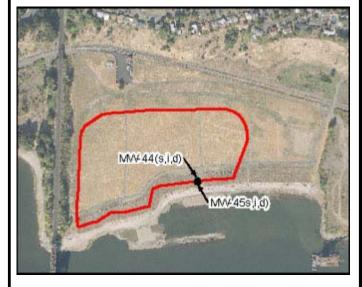
MW-44 well cluster is located inside the barrier wall and MW-45 well cluster is located outside the barrier wall.

Breaks in transducer data are the result of removal for calibration, removal for well modification, or a transducer was not collecting accurate pressure readings.

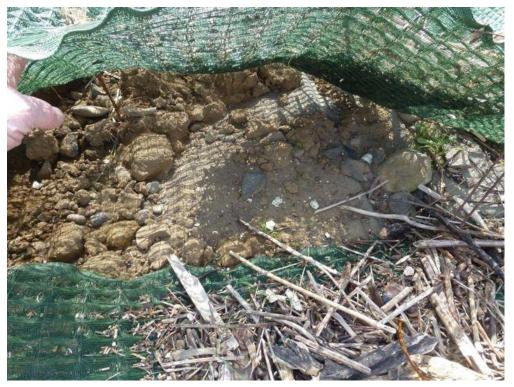
Photograph 1 - Eroded soil observed under the TRM.

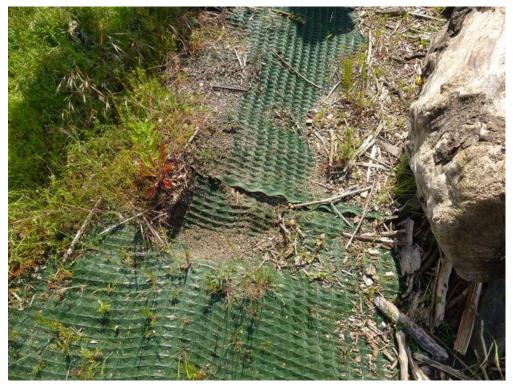
Photograph 2 - Soil erosion and damage to the TRM.

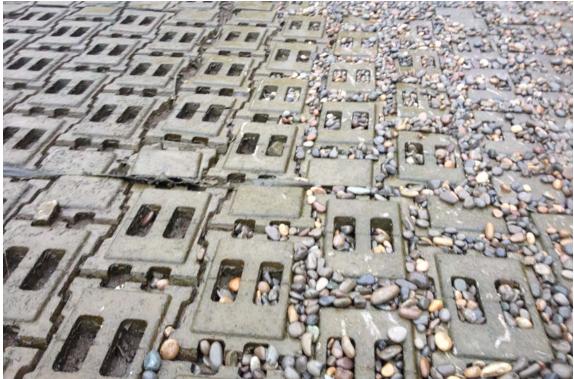
Photograph 1 – Comparison of ACB with and without habitat gravel to fill voids. Photograph taken facing northeast in Willamette Cove.

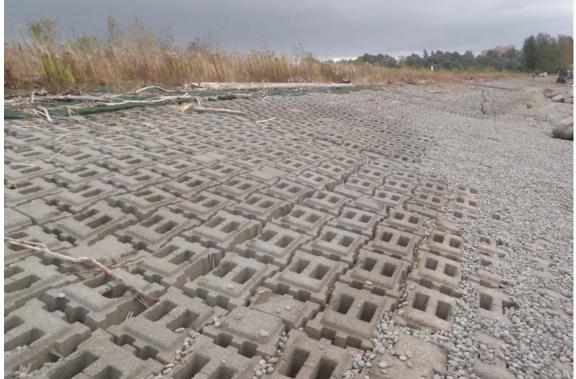
Photograph 2 – Comparison of ACB with and without habitat gravel to fill voids. Photograph taken facing east.

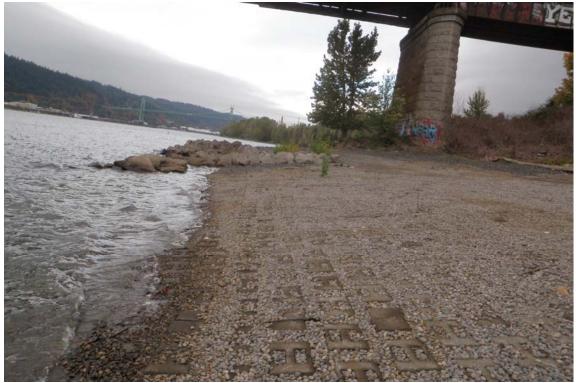
Photograph 3 – Habitat gravel along the beachfront in the foreground. Rip rap armoring along shoreline in background. Photograph taken facing northwest.

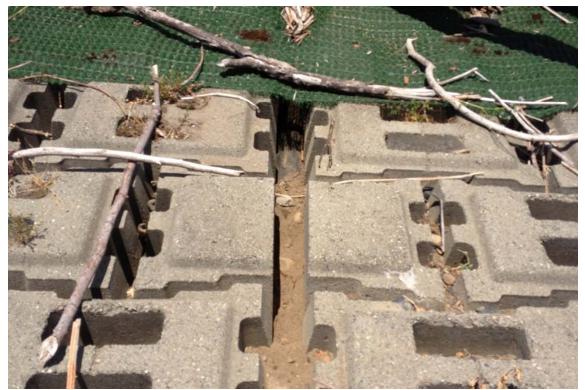
Photograph 4 – Soil can be observed eroding from under the TRM into ACB. Photograph taken facing northwest.

No sheens were observed along the shoreline during the three Site inspection visits in 2012. Moderate erosion of soil mulch and vegetation cover on the green turf reinforced matting (TRM) was observed in October 2011 along the lower riparian area where the TRM is attached to the ACB. This erosion was the result of high Willamette River levels (up to 22 feet NAVD88) in June 2011. In October 2012, Cherokee Construction Services (Cherokee) of Vancouver, Washington, filled areas of erosion under the TRM with crushed gravel and re-secured the TRM to the ACB using concrete anchor nails. During the same field effort, Cherokee also filled void spaces within the ACB along the shoreline using rounded-1½ inch-minus gravel. The general public uses the shoreline for recreation, most commonly for walking dogs. The gravel overlay creates a more stable substrate for wildlife and for a consistent and safer walking surface for public use.

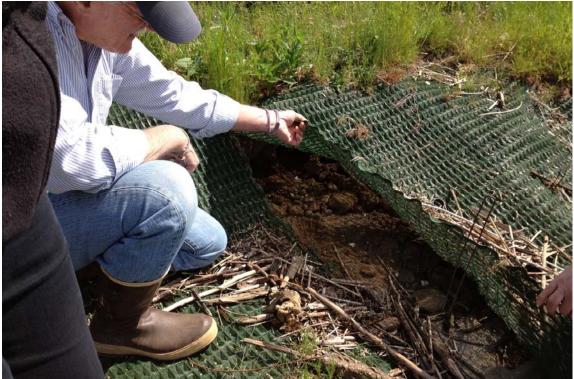
Photograph 5 – Void space under the TRM where soil has eroded away. Photograph taken facing east.

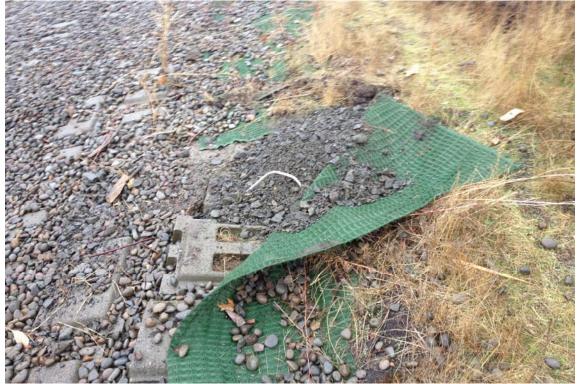
Photograph 6 – Void space under TRM filled in with crushed rock before TRM was re-secured to ACB. Photograph taken facing north.

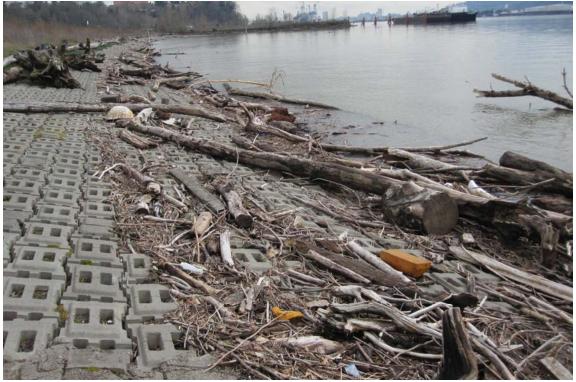
Photograph 7 – Shoreline with accumulated woody debris. Photograph taken facing southwest.

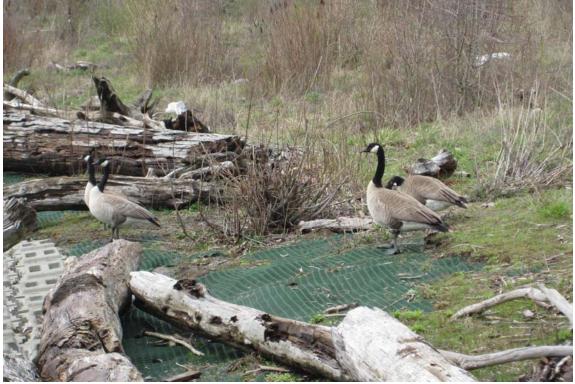
Photograph 8 – Geese within riparian area. Photograph taken facing north.

Boulder clusters placed during the sediment cap construction remain in place. Numerous wildlife species continue to be observed at the Site; most frequently observed are various birds, including Canada geese, gulls, pigeons, blue herons, and ospreys (Photograph 8). Juvenile fish, clams, and crayfish were observed in the Willamette River at lower river levels.

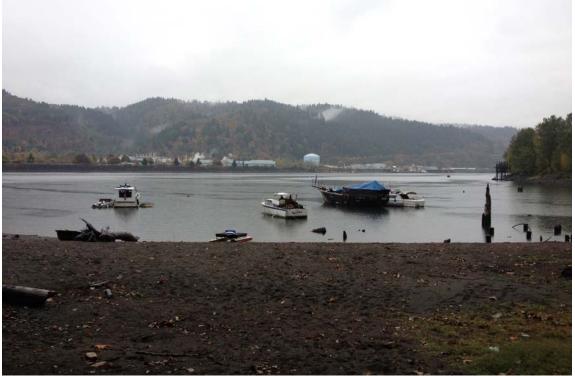
Photograph 9 – Transient boats within Willamette Cove. Photograph taken facing west.

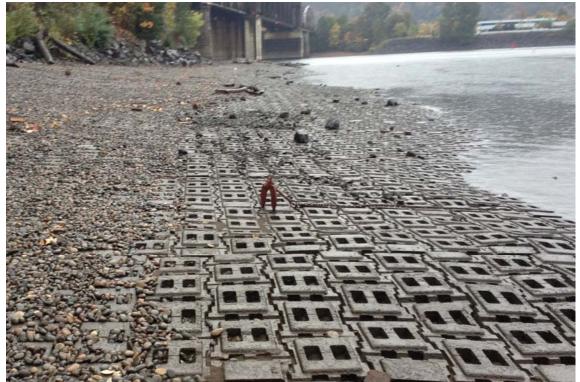
Photograph 10 – Transient boat anchor on ACB in Willamette Cove. Photograph taken facing southwest.

Four dilapidated boats were seen beached in Willamette Cove during the October 2012 Site inspection. During low tide, boat anchors could be seen resting on the sediment cap portion of the cove. No visible effects to the sediment cap were observed from the resting anchors. Although an existing Oregon Marine Board rule prohibits any anchoring on the sediment cap, damage to the ACB armoring was not observed or expected, and therefore no action was taken to enforce the anchoring prohibition. DEQ did notify Metro, which has taken action in the past to respond to transient boaters and encampments in the Willamette Cove.

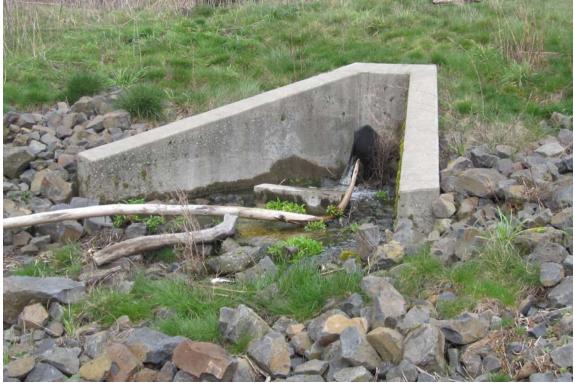
Photograph 11 – Stormwater discharge functioning correctly. Photograph taken facing north.

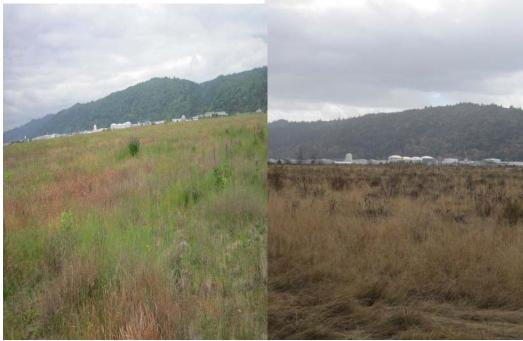
Photograph 1 – Earthen cap and drainage swale in the foreground with the impermeable cap in the background. Photograph taken from Photo Station 1 looking south (Left - June 2011 [baseline]; right - October 2012 [current]).

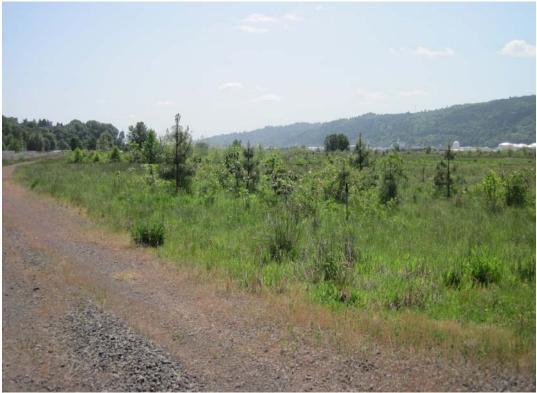
Photograph 2 – Tree and shrub plantings on the earthen cap are healthy and spreading. Photograph taken from Photo Station 2 looking south (October 2012).

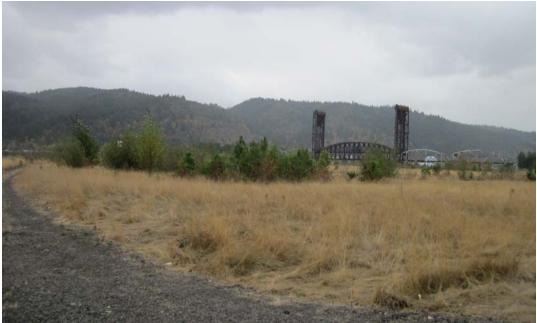
Photograph 3 – Eastern edge of the earthen cap with perimeter road in foreground. Photograph taken from Photo Station 3 looking west (October 2012).

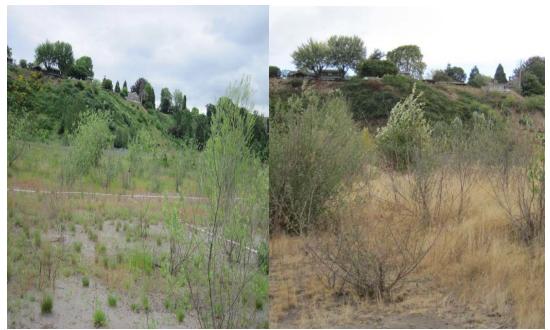
Photograph 4 – Stormwater pond dominated by willow and alder. Photograph taken from Photo Station 4 looking northeast (Left - June 2011 [baseline]; right - October 2012 [current]).

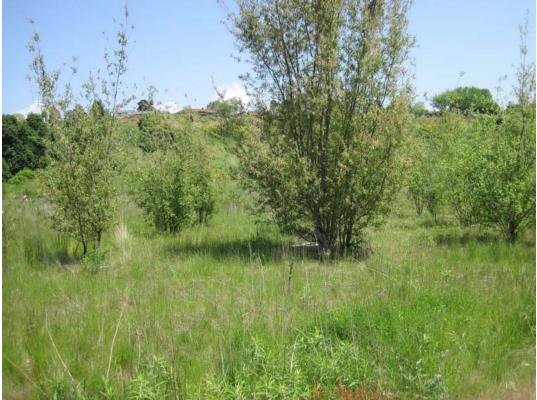
Photograph 5 – Willow plantings on the earthen cap. Photograph taken from Photo Station 5 looking northeast (October 2012).

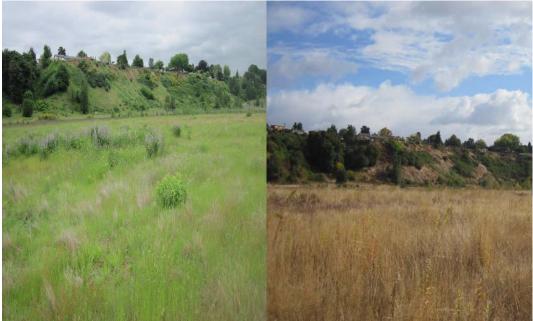
Photograph 6 – Impermeable cap dominated by grasses and herbaceous vegetation in the early summer (left) and fall (right). Photograph taken from Photo Station 6 looking east (Left - June 2011 [baseline]; right - October 2012 [current]).

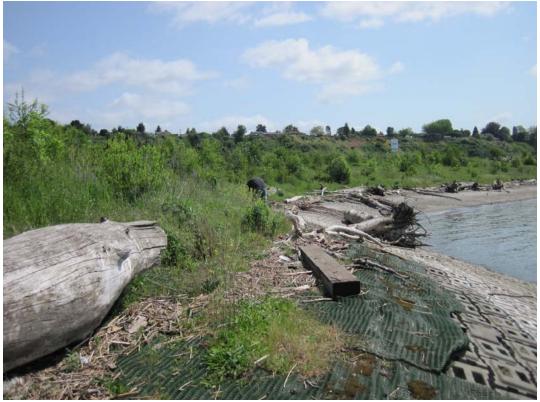
Photograph 7 – Vegetation growth within the lower riparian component. Photograph taken from Photo Station 7 looking south (May 2012).

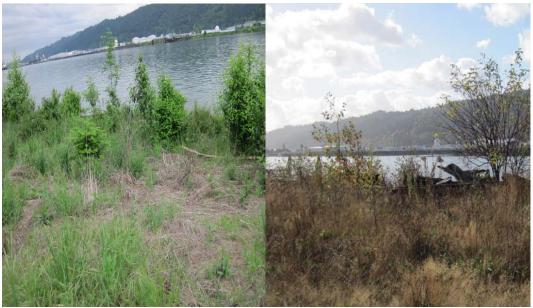
Photograph 8 – Upper riparian component with trees, shrubs, and herbaceous plants. Photograph taken from Photo Station 8 looking southwest (Left – June 2011 [baseline]; right - October 2012 [current]).

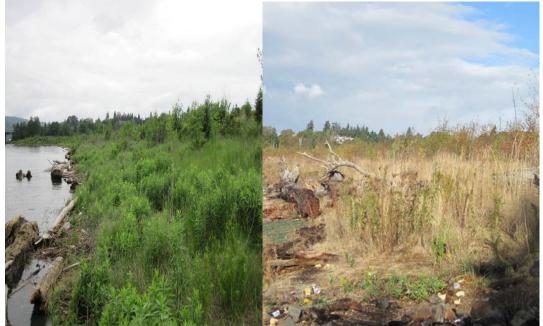
Photograph 9 – Lower riparian component with large wood along the edge. Photograph taken from Photo Station 9 looking northwest (Left – June 2011 [baseline]; right - October 2012 [current]).
