**FIFTH FIVE-YEAR REVIEW REPORT FOR
NORTHSIDE LANDFILL SUPERFUND SITE
SPOKANE COUNTY, WASHINGTON**

**U.S. Environmental Protection Agency
Region 10
Spokane, Washington**

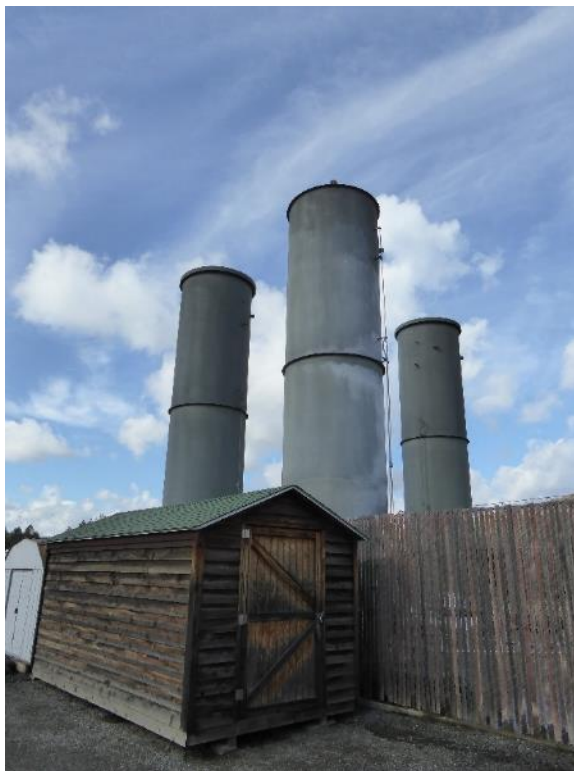
Three landfill gas flares on site; only one operates due to low gas volumes.

The O&M personnel also monitor landfill gas data to analyze the effectiveness of the landfill cover. The O&M personnel monitor the gas generation data for system contributions of methane, carbon dioxide and oxygen as the collected gas is burned in the flares. Oxygen concentration data also serve to determine potential leakage through the landfill cap liner. The gas collection system is regularly monitored and repaired as needed. Currently, only one of the three flares are operating based on gas volume produced.

E. Gas Collection and Treatment <input checked="" type="checkbox"/> Applicable <input type="checkbox"/> N/A	
1.	Gas Treatment Facilities <input checked="" type="checkbox"/> Flaring <input type="checkbox"/> Thermal destruction <input type="checkbox"/> Collection for reuse <input type="checkbox"/> Good condition <input type="checkbox"/> Needs maintenance Remarks: <u>One of three flares is functional. There is not enough gas to run the other flares.</u>

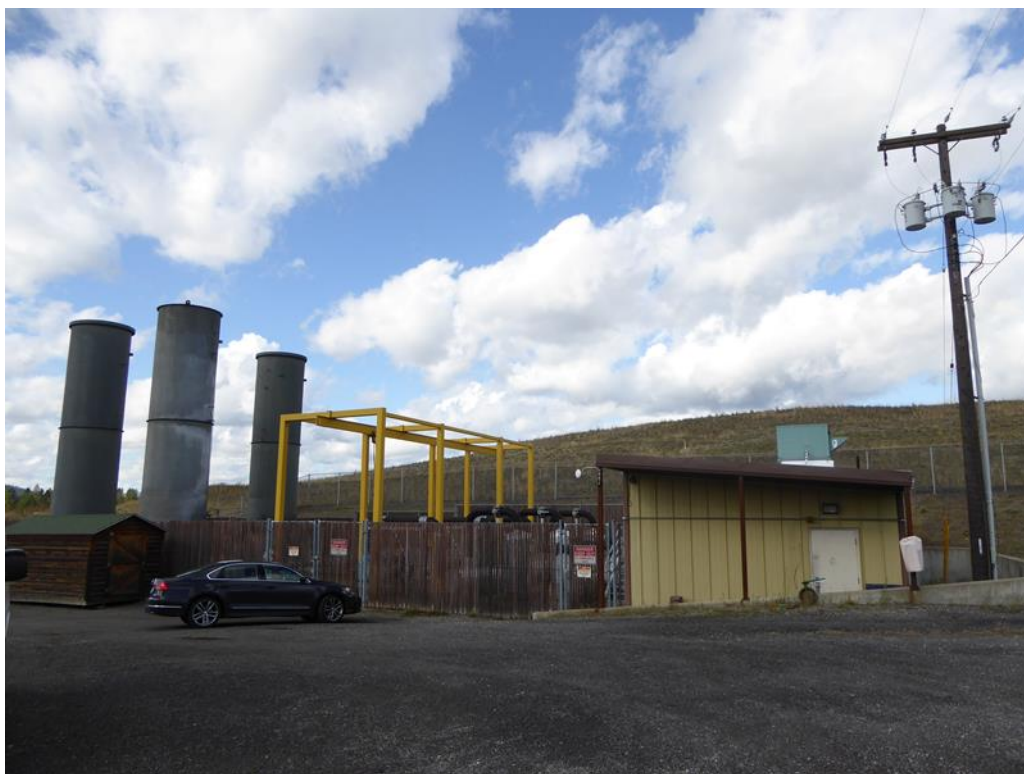
View of the on-site office for maintenance of the landfill, with gas flares in the background.

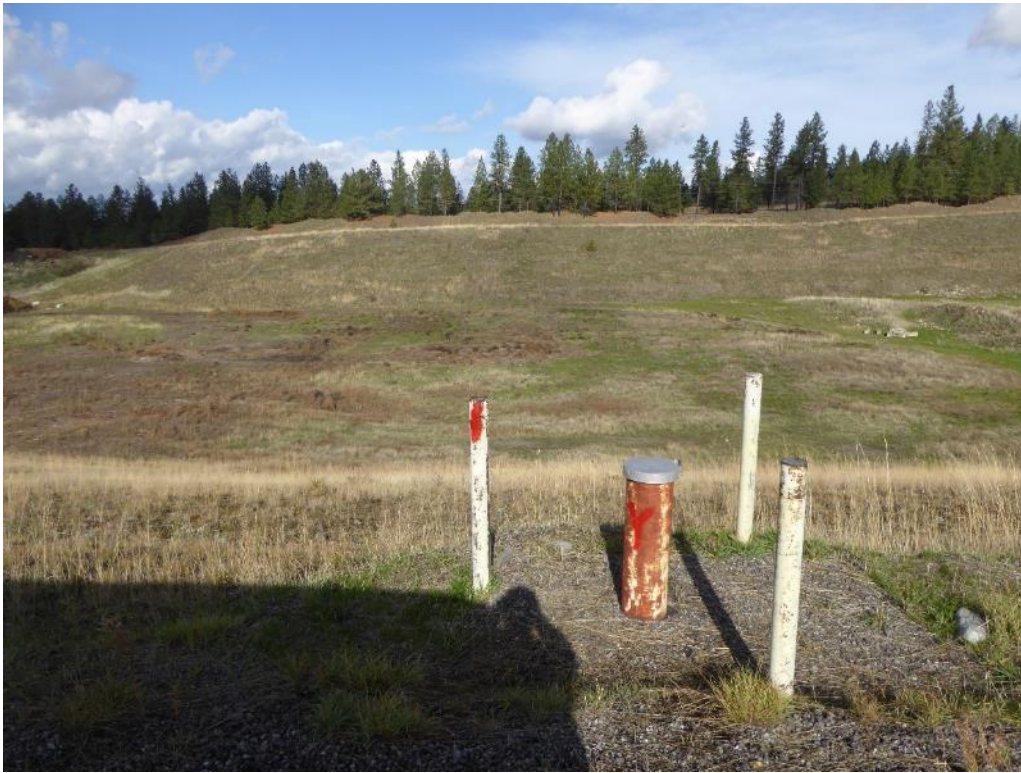
Monitoring well with capped landfill visible in background.

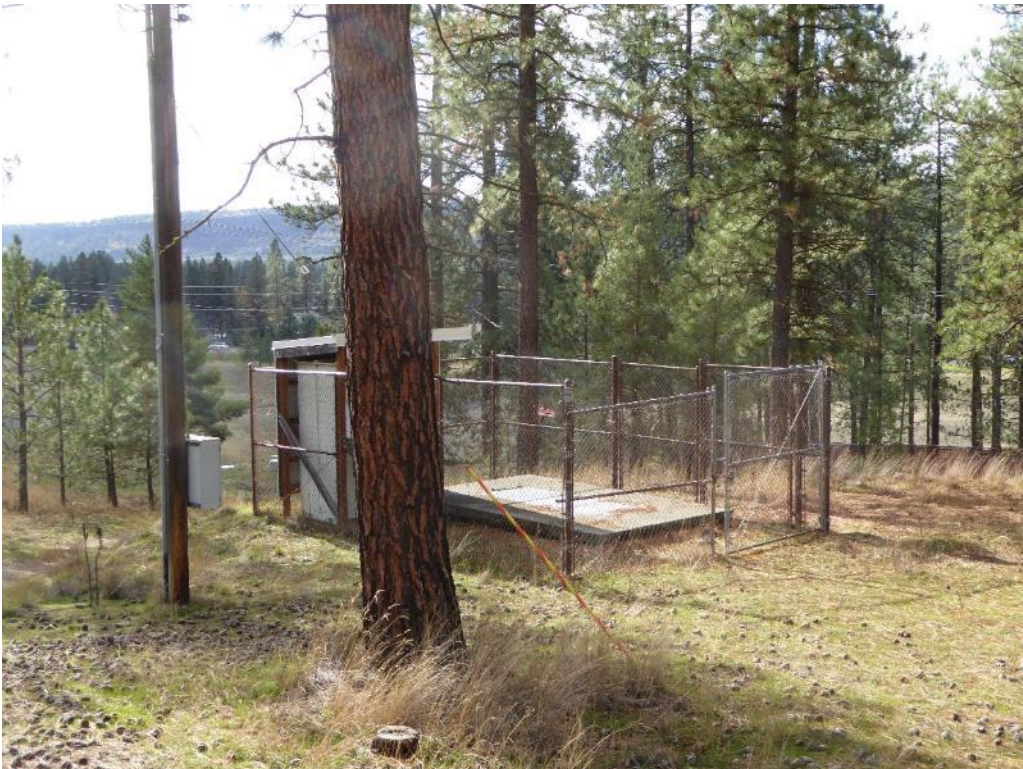
View of PEW, which has been shut down and is in operational standby mode since December 2012.

After achieving two years where groundwater COC concentrations remained below the cleanup levels (Quarter 1 2009 to 2012), Ecology and EPA authorized the start of the PEW shutdown period on December 15, 2012. The authorization indicated that the PEW shutdown period would last for two years to determine whether the COC concentrations remained below cleanup levels without active treatment. Groundwater monitoring has continued quarterly and, following repairs in September 2012, the PEW system has been maintained in operational standby mode such that it could be re-started, if needed. The PEW shutdown authorization letter stipulated that the PEW system should be maintained in operational standby mode for a period of five years after the shutdown, or until December 15, 2017.

A. Groundwater Extraction Wells, Pumps and Pipelines		<input type="checkbox"/> Applicable	<input type="checkbox"/> N/A
1.	Pumps, Wellhead Plumbing and Electrical		
<input checked="" type="checkbox"/> Good condition <input checked="" type="checkbox"/> All required wells properly operating <input type="checkbox"/> Needs maintenance <input type="checkbox"/> N/A			
Remarks: <u>PEW is operational but not currently operating per the PEW shutdown authorized in December 2012.</u>

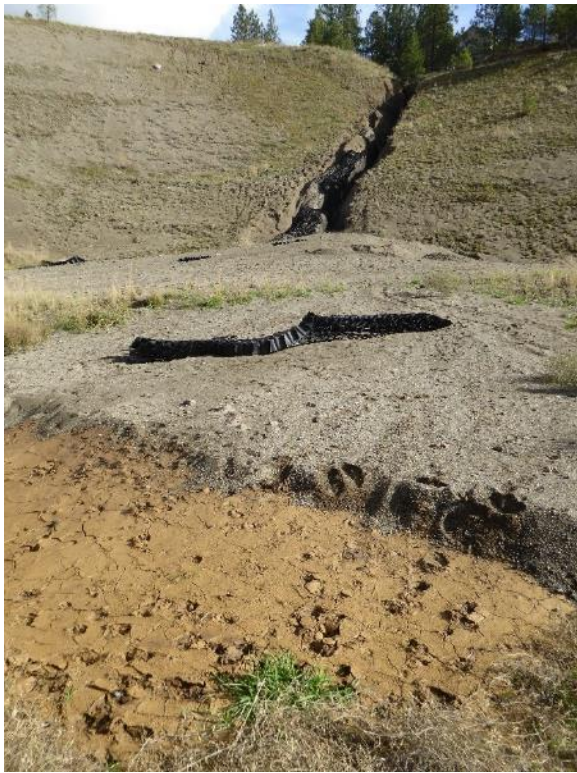
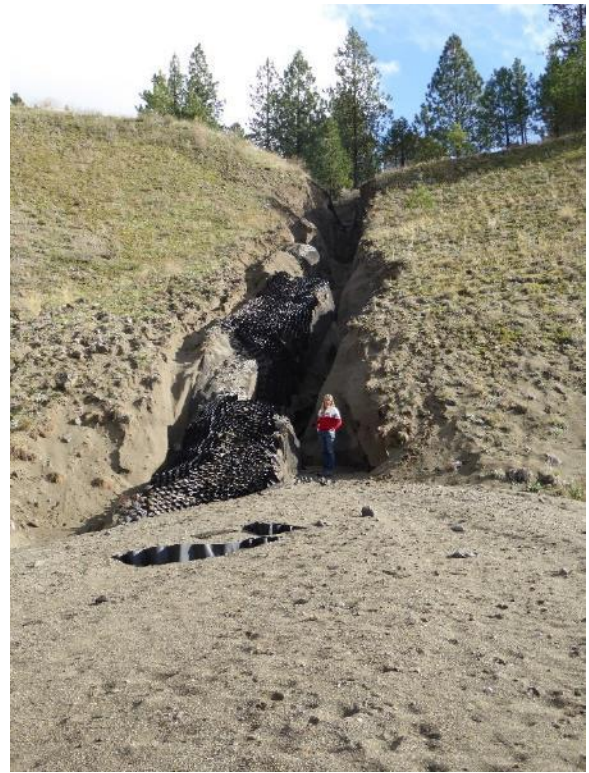
B. Other Site Conditions			
Remarks: <u>The Site is well-maintained. A 10-year storm event in May 2016 caused erosion in a section of the outer edge of the landfill buffer area. Photos are included in Appendix F.</u>			
VII. LANDFILL COVERS <input checked="" type="checkbox"/> Applicable <input type="checkbox"/> N/A

Two views of the washout area in the outer edge of the landfill buffer zone. Left image shows material and geowebbing carried to the bottom by the water flow. Right image shows site RPM standing in washout for scale.

Site inspection participants discussed several maintenance needs during the October 2016 site inspection. These included repairs to areas of the cap that had ponding of water, as well as repairs to the washout area in the buffer zone resulting from the May 2016 10-year storm event. The PRP is currently working to address these needs.

OU(s): Sitewide	Issue Category: Operations and Maintenance			
	Issue: Erosion from a 100-year storm in May 2016 damaged portions of the elevated, outer edge buffer area and may have impacted the landfill gas collection piping.			
	Recommendation: Complete an assessment of damages and make repairs and modifications to better fortify against future storm events, as needed.			
Affect Current Protectiveness	Affect Future Protectiveness	Party Responsible	Oversight Party	Milestone Date
No	Yes	PRP	EPA/State	3/1/2018

2.	Gas Collection Wells, Manifolds and Piping <input checked="" type="checkbox"/> Good condition <input type="checkbox"/> Needs maintenance Remarks: <u>At the time of writing this FYR, the PRP is performing an engineering assessment of the washout area, which will include a determination of whether the gas collection piping incurred any damage during the May 2016 washout event.</u>

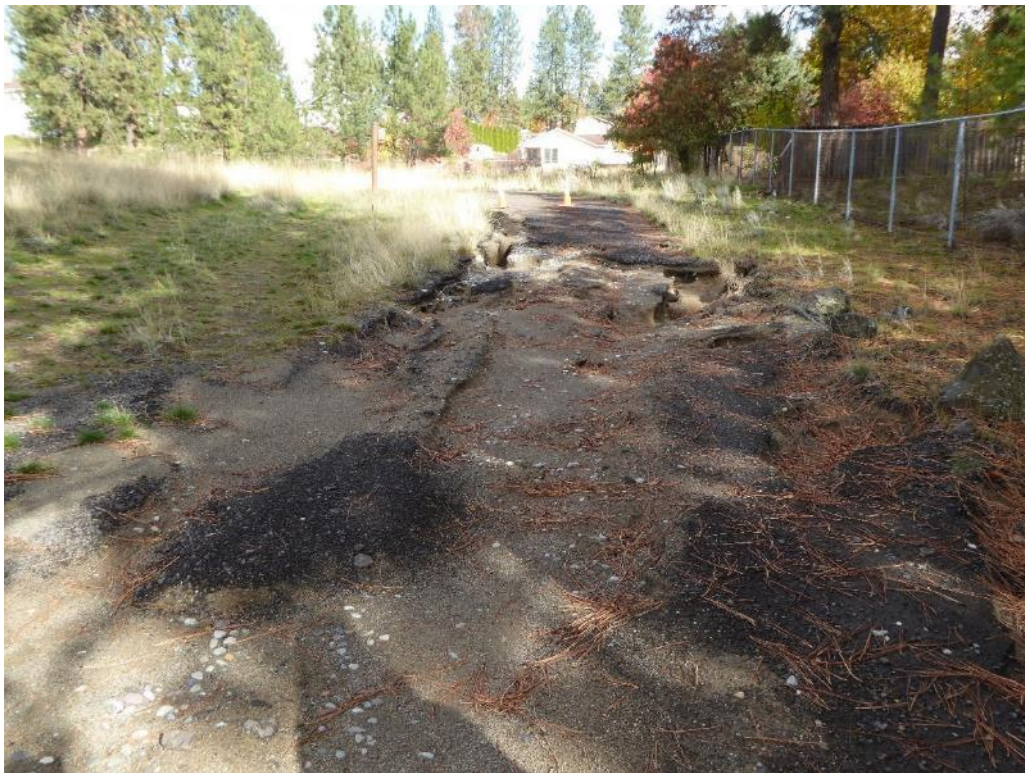
A. Roads <input checked="" type="checkbox"/> Applicable <input type="checkbox"/> N/A			
1. Roads Damaged <input type="checkbox"/> Location shown on site map <input checked="" type="checkbox"/> Roads adequate <input type="checkbox"/> N/A Remarks: <u>Road at the area of the washout in the outer edge of the buffer area needs repair.</u>

Damage to the access road at the top of the washout area.

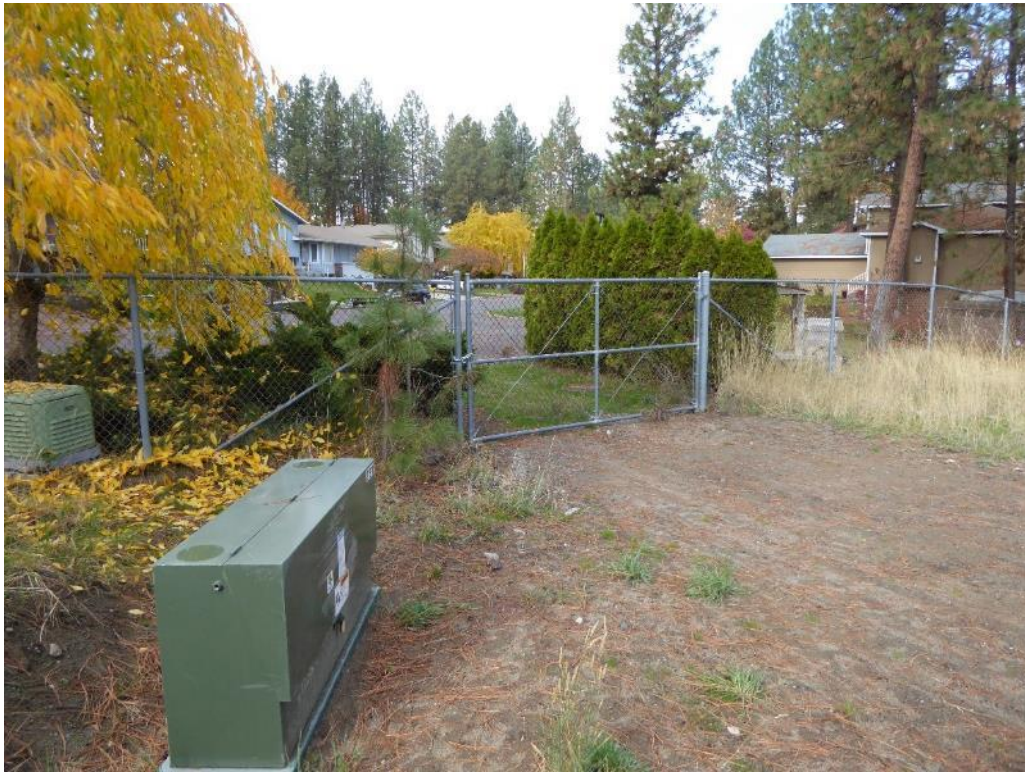
Secured site access gates.

D. General			
1. Vandalism/Trespassing <input type="checkbox"/> Location shown on site map <input type="checkbox"/> No vandalism evident Remarks: <u>Section of fencing damaged by an adjacent homeowner has since been repaired.</u>

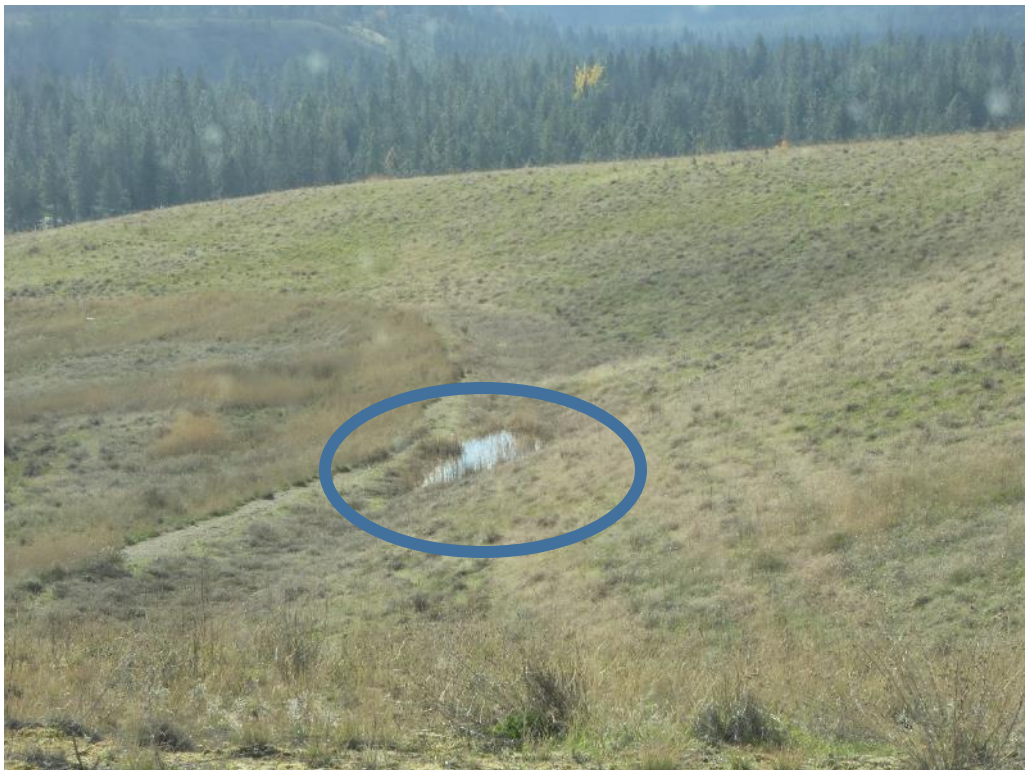
8.	Wet Areas/Water Damage <input type="checkbox"/> Wet areas/water damage not evident <div style="display: flex; justify-content: space-between;"> <div style="width: 30%;"> <input type="checkbox"/> Wet areas <input checked="" type="checkbox"/> Ponding <input type="checkbox"/> Seeps <input type="checkbox"/> Soft subgrade </div> <div style="width: 30%;"> <input type="checkbox"/> Location shown on site map <input checked="" type="checkbox"/> Location shown on site map <input type="checkbox"/> Location shown on site map <input type="checkbox"/> Location shown on site map </div> <div style="width: 30%;"> Arial extent: _____ Arial extent: _____ Arial extent: _____ Arial extent: _____ </div> </div> Remarks: <u>One small area of ponding was visible. The City is repairing.</u>

Ponding on the capped landfill.

OU(s): Sitewide	Issue Category: Operations and Maintenance			
	Issue: Site inspection participants noted areas of ponding on the capped landfill.			
	Recommendation: Implement maintenance activities to ensure the continued integrity of the landfill cap.			
Affect Current Protectiveness	Affect Future Protectiveness	Party Responsible	Oversight Party	Milestone Date
No	Yes	PRP	EPA/State	3/1/2018

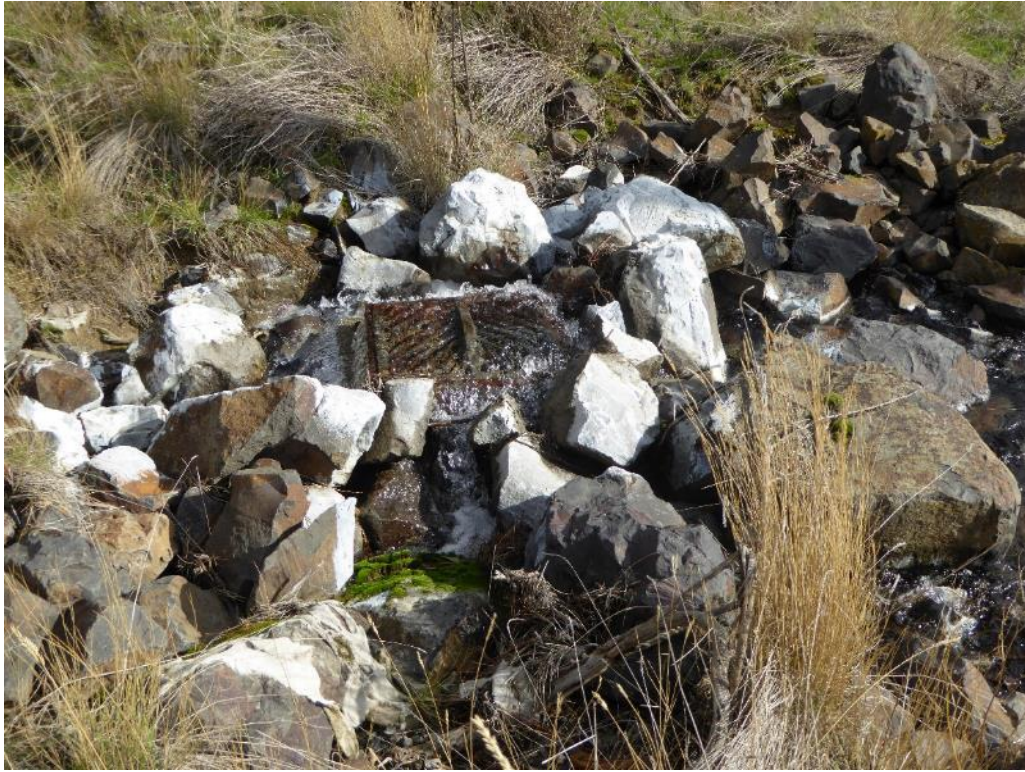
During the October 2016 FYR site inspection, the City turned on the PEW system temporarily to show it is operational. This image shows pumped water discharging to the infiltration gallery.
