## Henry's Knob Site Case Study

### *Revitalizing Mine Tailings in Clover, South Carolina*

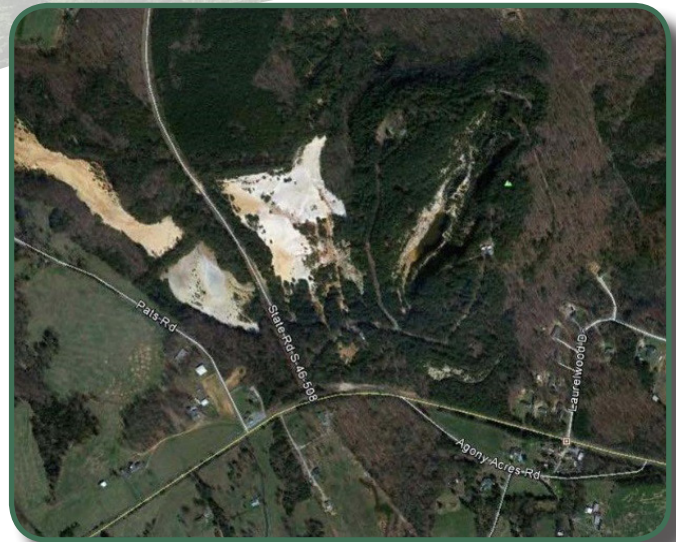
Figure 2. Aerial photo of Henry's Knob in 2012 prior to revegetation (Source: ABB Inc.)

In 2004, EPA and ABB signed an Administrative Order on Consent for the site's remedial investigation and feasibility study (RI/FS). The RI/FS identifies the extent and location of contamination and cleanup options. EPA and SCDHEC provide oversight for ABB's activities. Figure 2 shows an aerial photo of the Site in 2012.

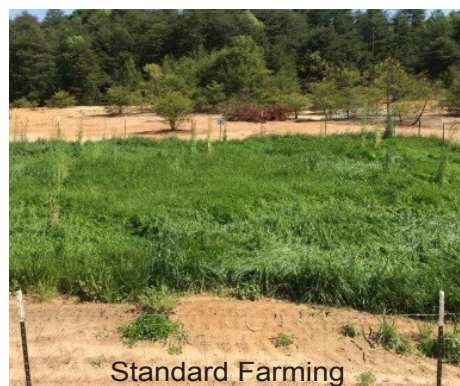
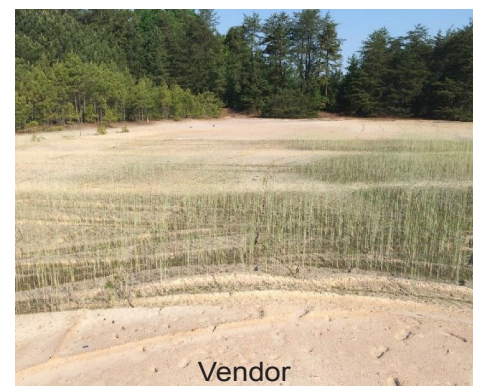
Figure 4. Differences in vegetation growth across the Ridge and Furrow test plot (left), the Standard Farming test plot (middle) and the vendor test plot (right) in April 2015. (Source: ABB Inc.)

Following approval from EPA and SCDHEC, ABB consulted with local farmers as well as companies and experts that specialize in revegetation for guidance and recommendations. The responsible party also led several studies to create a soil profile with a sufficient organic content and pH that could support plant growth across the site's mine tailing areas. These studies included three test plots within AOC 1 – the Ridge and Furrow test plot, the Standard Farming test plot, and a test plot that tested some specific vendor provided amendments. The Standard Farming test plot was based on basic farming practices that incorporates organic materials and fertilizer into the upper portion of the mine tailings to create a soil material suitable for the establishment and sustainable growth of vegetation. Figure 4 shows differences in growth among the three test plots. They demonstrate that the addition of organic material increases vegetation success.

During the two-year study (from 2013 until 2015), substantial growth was observed on the Standard Farming test plot. The community welcomed the study findings. Some community members stopped in the field office to compliment the appearance of the vegetated tailing.

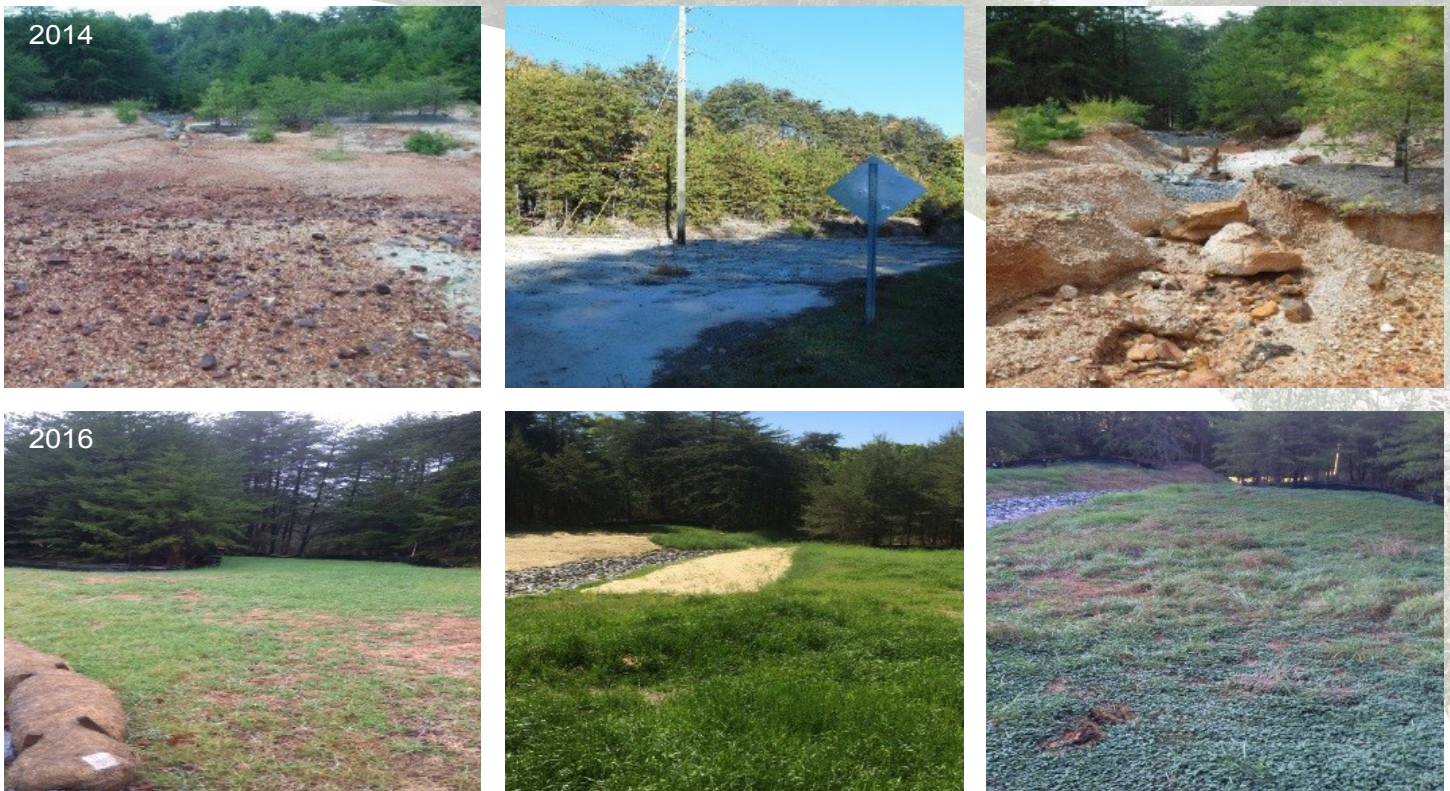
Figure 5. AOC 3 Vegetative Cover before construction (top row, 2014) and after construction (bottom row, 2016). (Source: ABB Inc.)

The local cooperative extension, EPA and SCDHEC also helped the responsible party add a pollinator seed mix to the original pilot study mix that would both establish native plants and support pollinators for all plantings. Native vegetation and pollinator habitat are now well established on the tailings areas of the site; all of the tailing areas will be vegetated by the mid-2018. Figure 5 shows before and after photos of revegetation on AOC 3.
