HRS DOCUMENTATION RECORD COVER SHEET

Name of Site: Northwest Odessa Groundwater

HRS DOCUMENTATION RECORD

Name of Site: Northwest Odessa Groundwater Date Prepared: September 2020

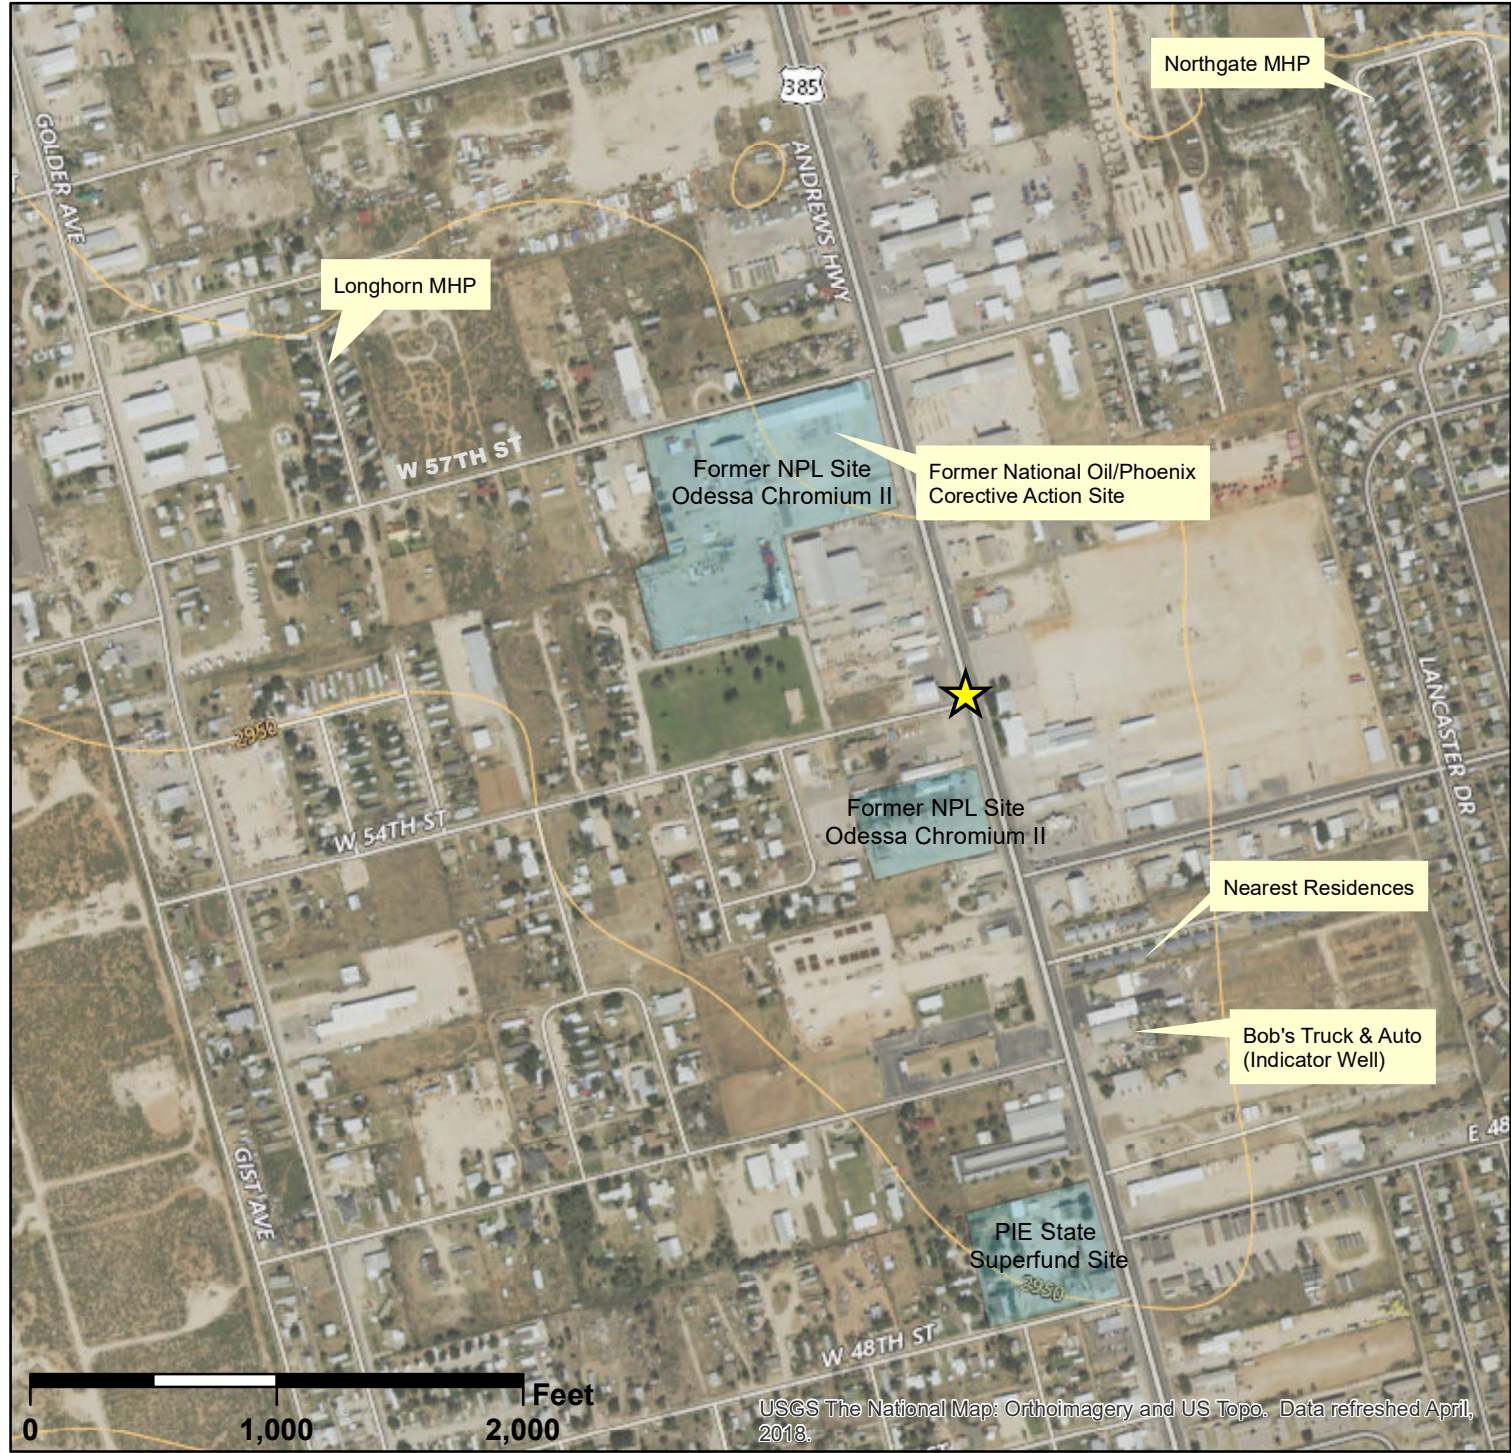
Figure 3.
Groundwater Plume Map

- Background Wells
 - Observed Release Wells
 - Approximate Plume Location
 - ★ Approximate Plume Center
- *All concentrations are in units of µg/L

*Map annotated by TCEQ on 8 January 2020 to depict background well and observed release well locations (Table 8; Table 10; Ref. 32, pp. 15-18; Ref. 33, pp. 16-18, 24-25).

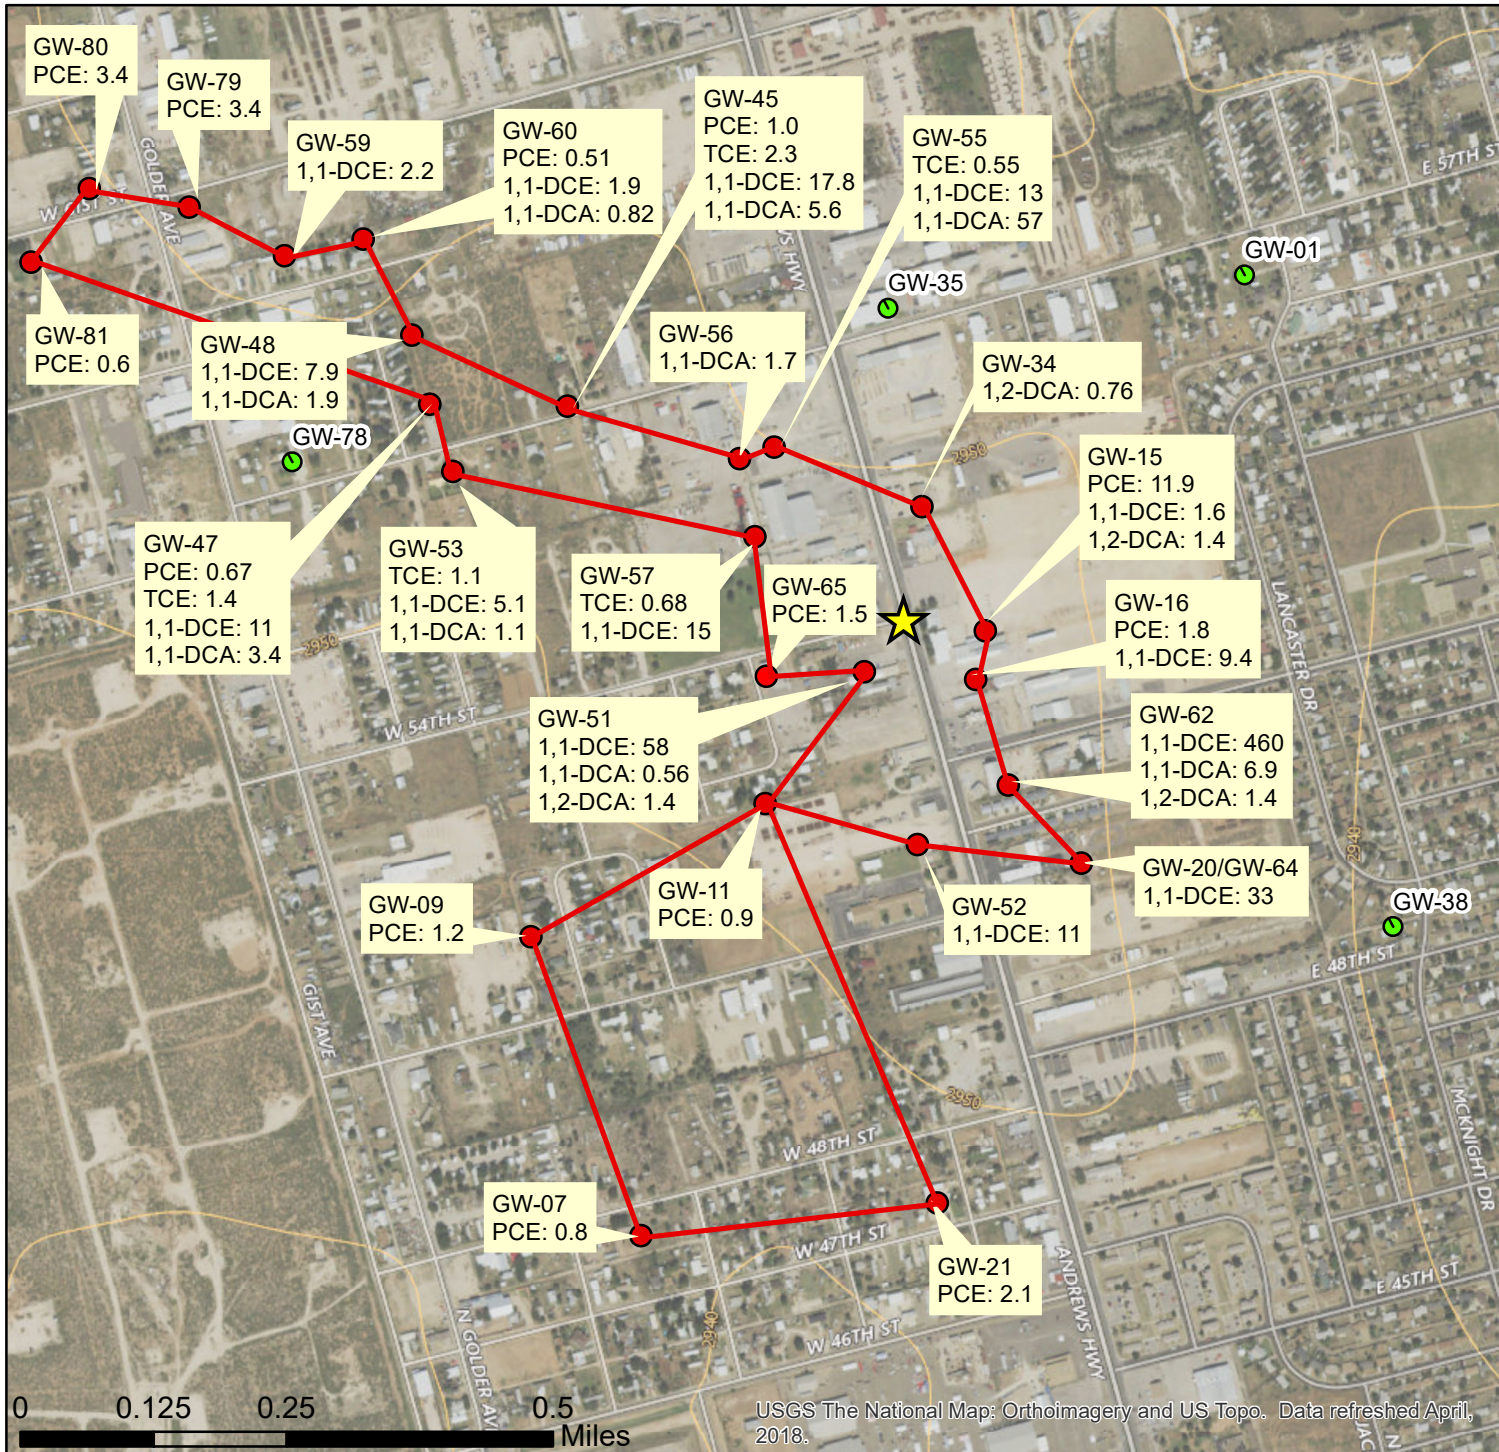
Figure 4. 4-Mile TDL Map

- Approximate Plume Center
- Canyon Dam Mobile Home Park PWS
- Depot Water Store PWS
- Dollar Genral Yukon Rd. PWS
- Huber Garden Estates PWS
- Judy K S Kountry Kitchen PWS
- Northgate Mobile Home Park 1 PWS
- Sunset Country Club PWS
- Weatherford Artificial Lift System PWS
- Weatherford International NW Loop PWS
- Colorado River Municipal Water (Inactive)
- Private Water Wells (TWDB)
