HAZARD RANKING SYSTEM (HRS) DOCUMENTATION RECORD COVER SHEET

Name of Site: Lower Neponset River

HAZARD RANKING SYSTEM (HRS) DOCUMENTATION RECORD

Name of Site: Lower Neponset River Date Prepared: September 2021

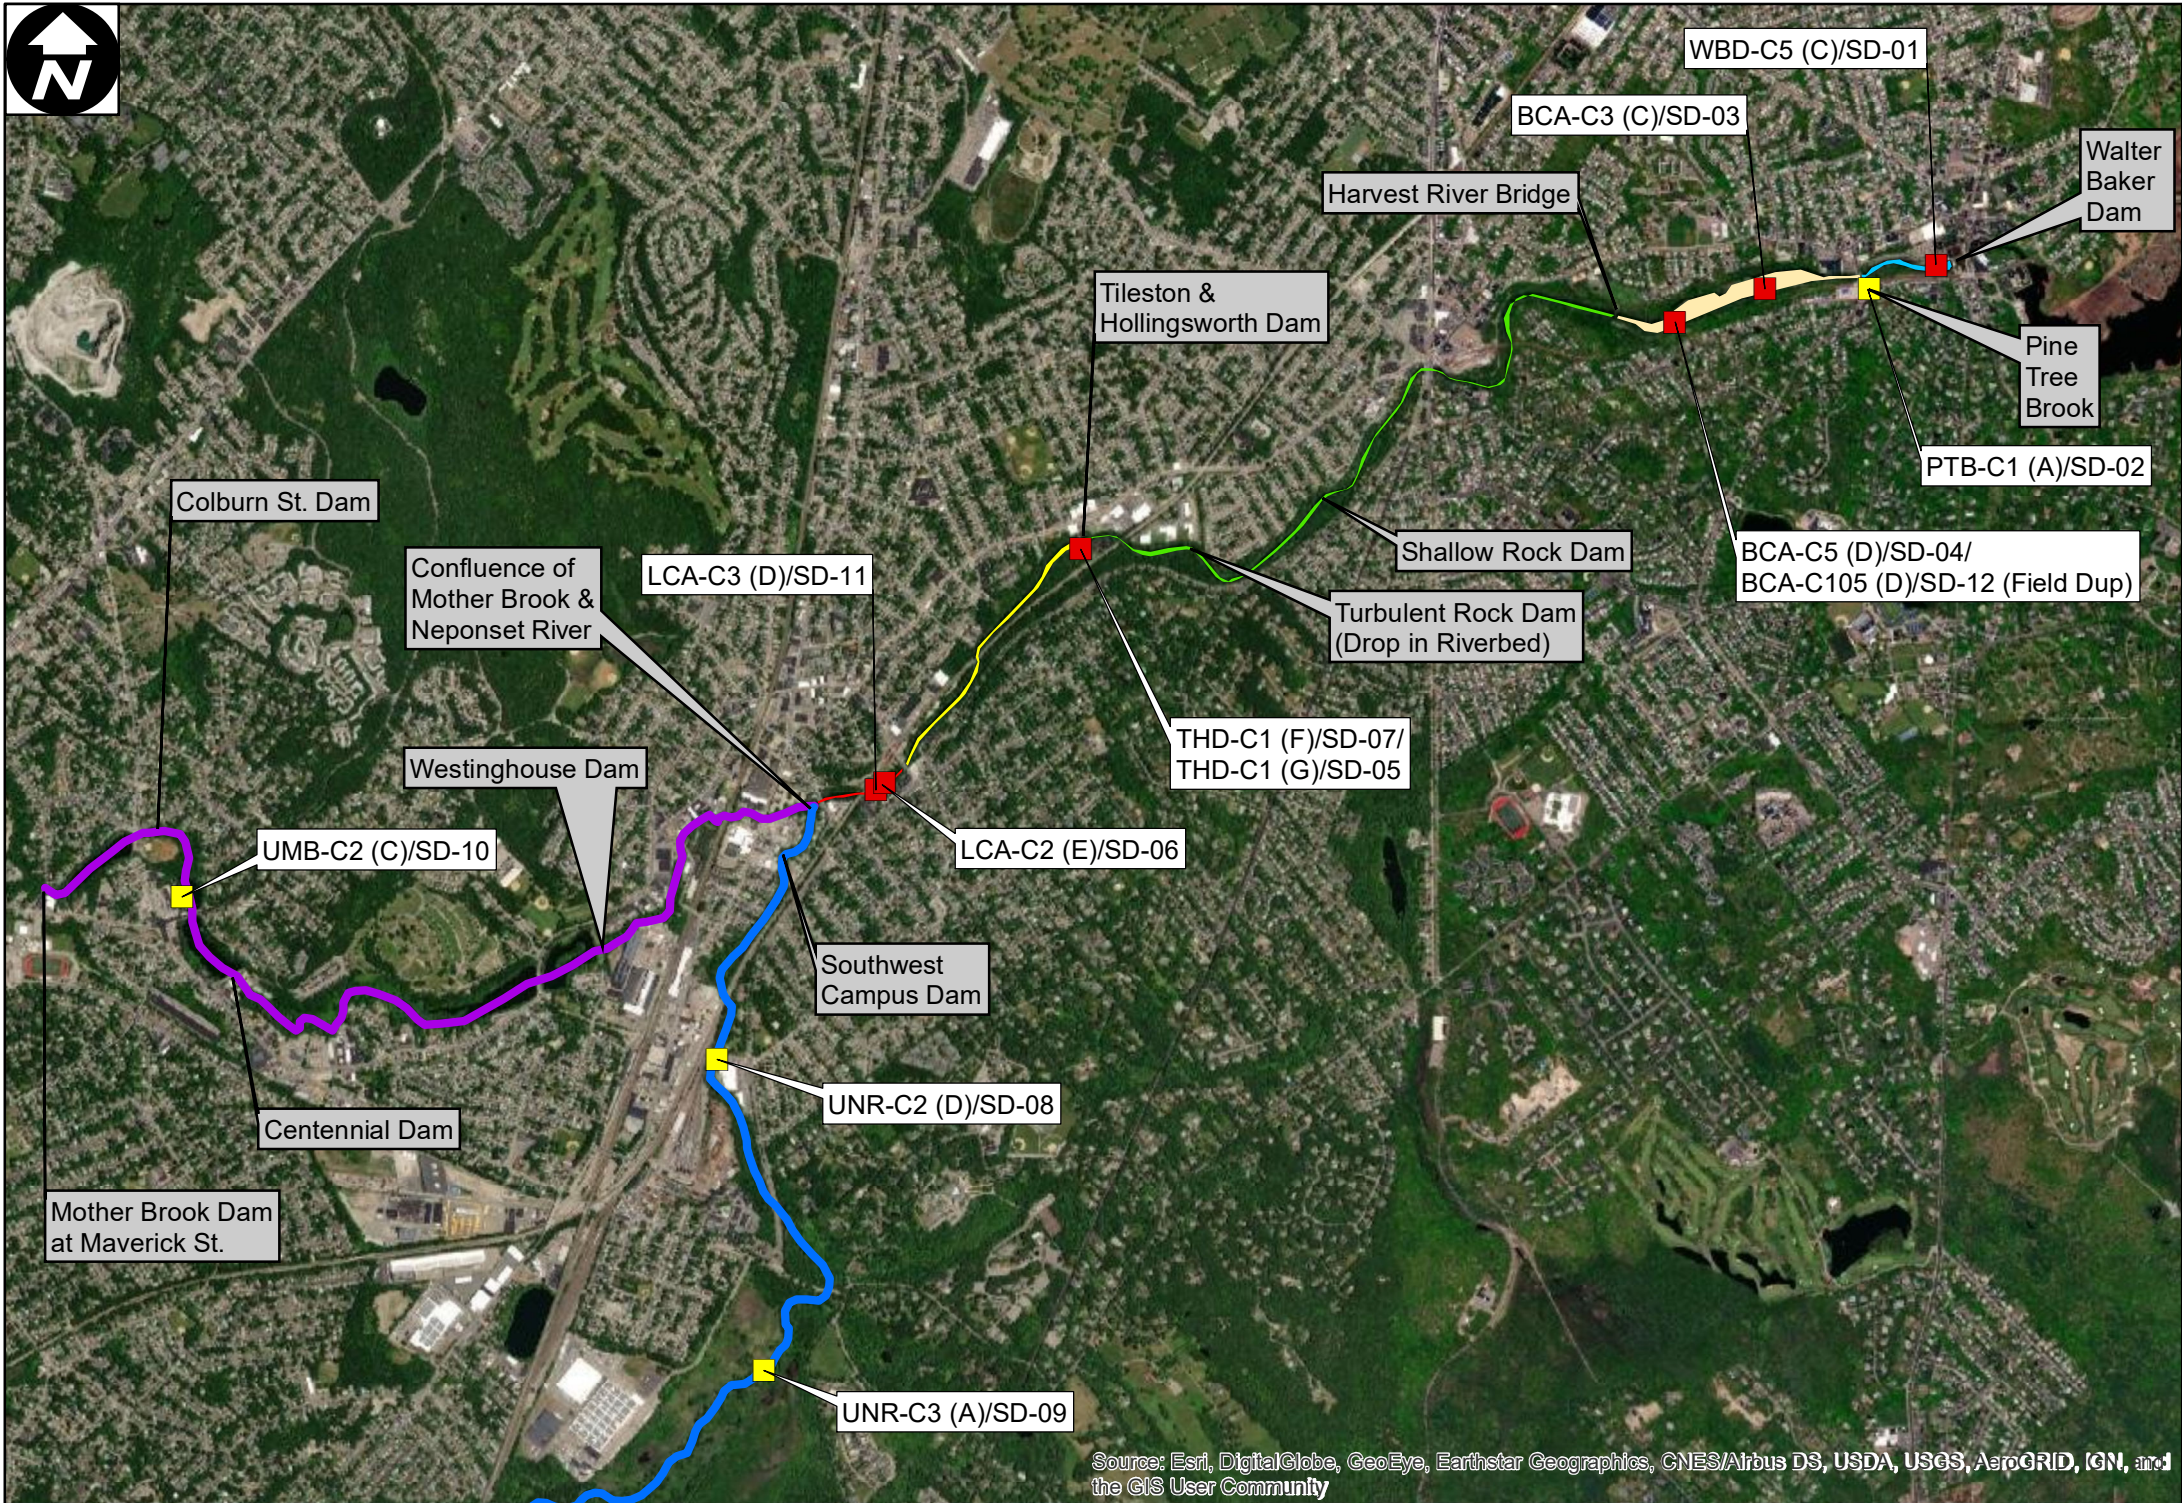
Figure 2

Site and Sediment Sample Location Map

Water also enters the site via Pine Tree Brook, a small tributary which discharges to the site (riverbed) near the Baker Dam Impoundment; overland flow directly into the river; and various discharge pipes along the river banks (Figure 2). Several former facility discharge pipes and City of Boston and Town of Milton storm drain pipes have been observed along the site and presumably have discharged to the site riverbed at various points in the past [7, pp. 154; 18, p. 9].

Walter Baker Chocolate Dam (Baker Dam) area (upstream of Adams Street, Dorchester, MA) and the location of EPA sediment sample WBD-C5 (C)/SD-01 (Figure 2) [16, pp. 1-2]. This sample is located within the surface water impoundment for the Baker Dam, approximately 210 feet upstream of the dam [16, pp. 1-2]. Sediment sample WBD-C5/SD-01 is the most distal downstream documented observed release sample (Figures 2 and 3) [16, pp. 1-2]. The SWP continues from sediment sample WBD-C5/SD-01 4.22 miles to the east, past the Baker Dam, under Adam Street to the Lower Mills Dam, and continues downstream along the Neponset River and Estuary to Dorchester Bay at Commercial Point in southern Dorchester, located 7.71 miles downstream of sediment sample location LCA-C3/SD-11 (Figure 4) [3; 16, pp. 1-2; 17, pp 10; 54, p. 2]. The SWP continues into Dorchester Bay and the Boston Harbor to the SWP Terminus, which is formed by a 7.29-mile arc extending from the mouth of the Neponset River at Dorchester Bay to Crescent Beach in Revere to the north and to Stony Beach in Hull to the south [16, pp. 1-2, 4]. The total length of the SWP is 15 miles [16, pp.1-2]. The Neponset River and Estuary, Dorchester Bay, and Boston Harbor are all tidally influenced downstream of the Baker Dam [16, pp. 1-2; 17, pp. 10-11].
