**Final
Third Five-Year Review Report**

Former Naval Air Station South Weymouth
Weymouth, Massachusetts

July 2019

FINAL
THIRD FIVE-YEAR REVIEW REPORT
FOR
FORMER NAVAL AIR STATION SOUTH WEYMOUTH
WEYMOUTH, MASSACHUSETTS
COMPREHENSIVE LONG-TERM
ENVIRONMENTAL ACTION NAVY (CLEAN) CONTRACT

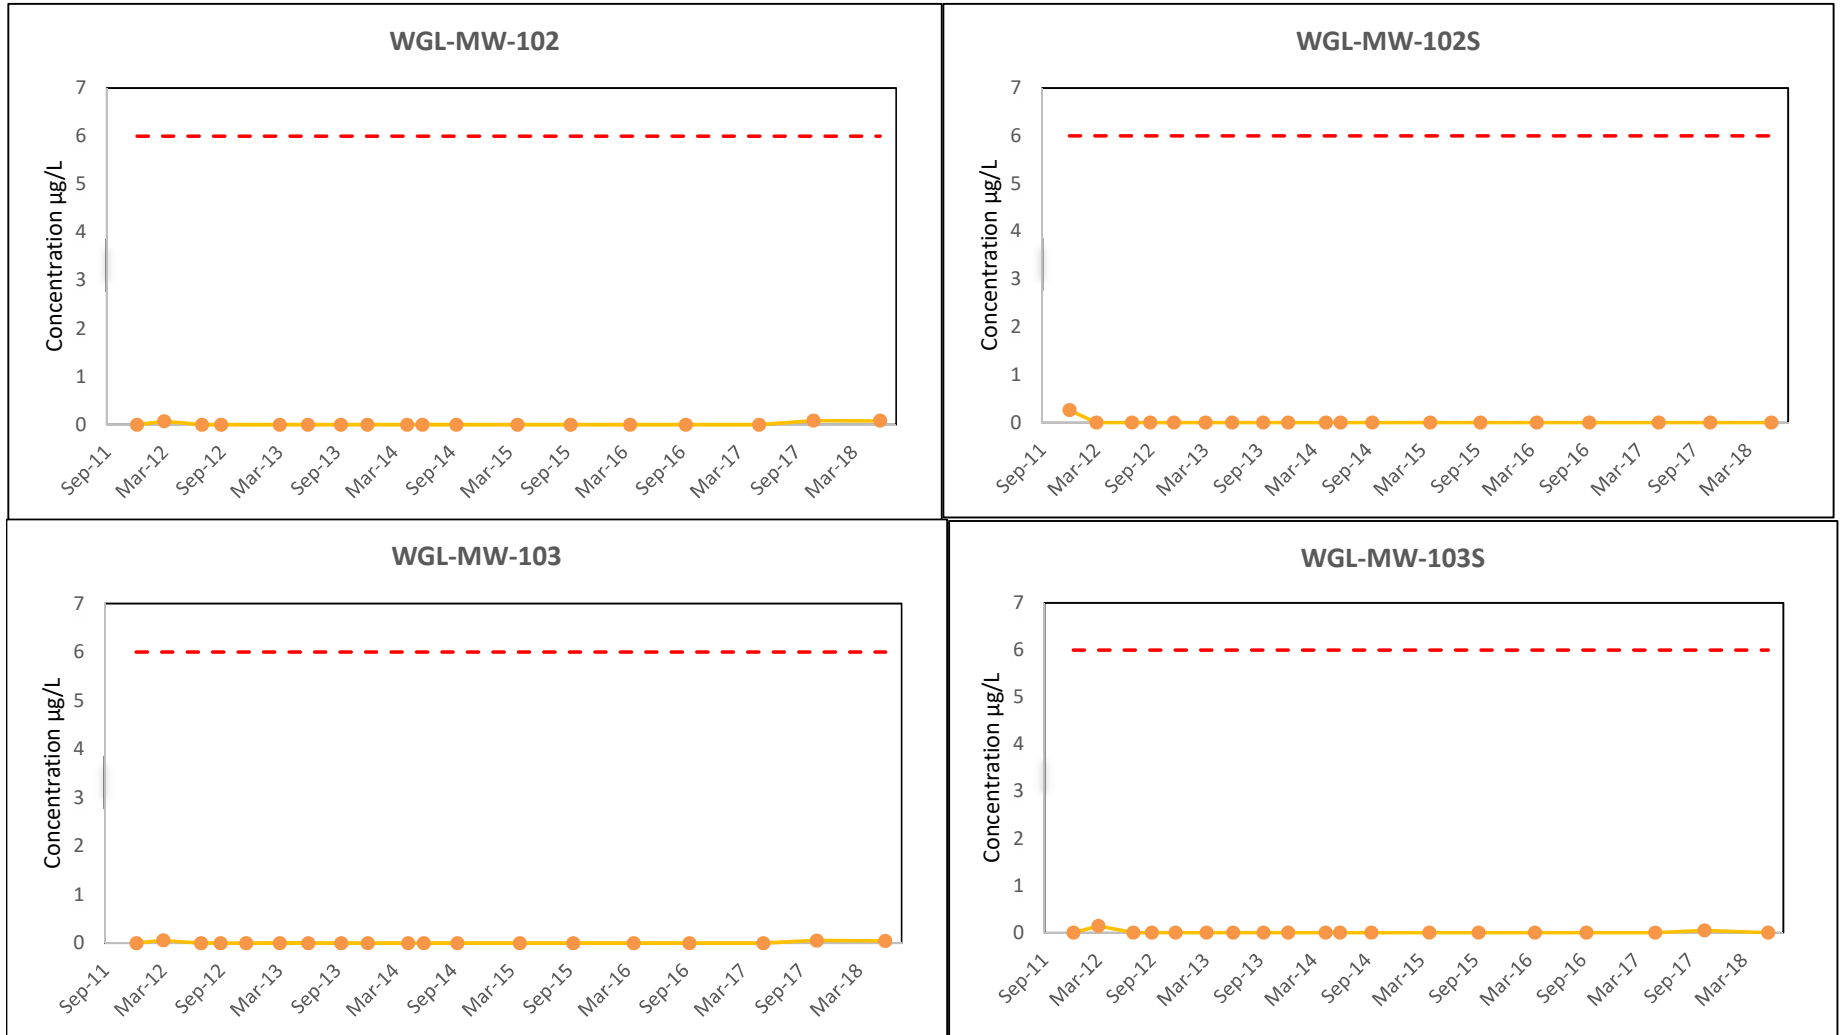
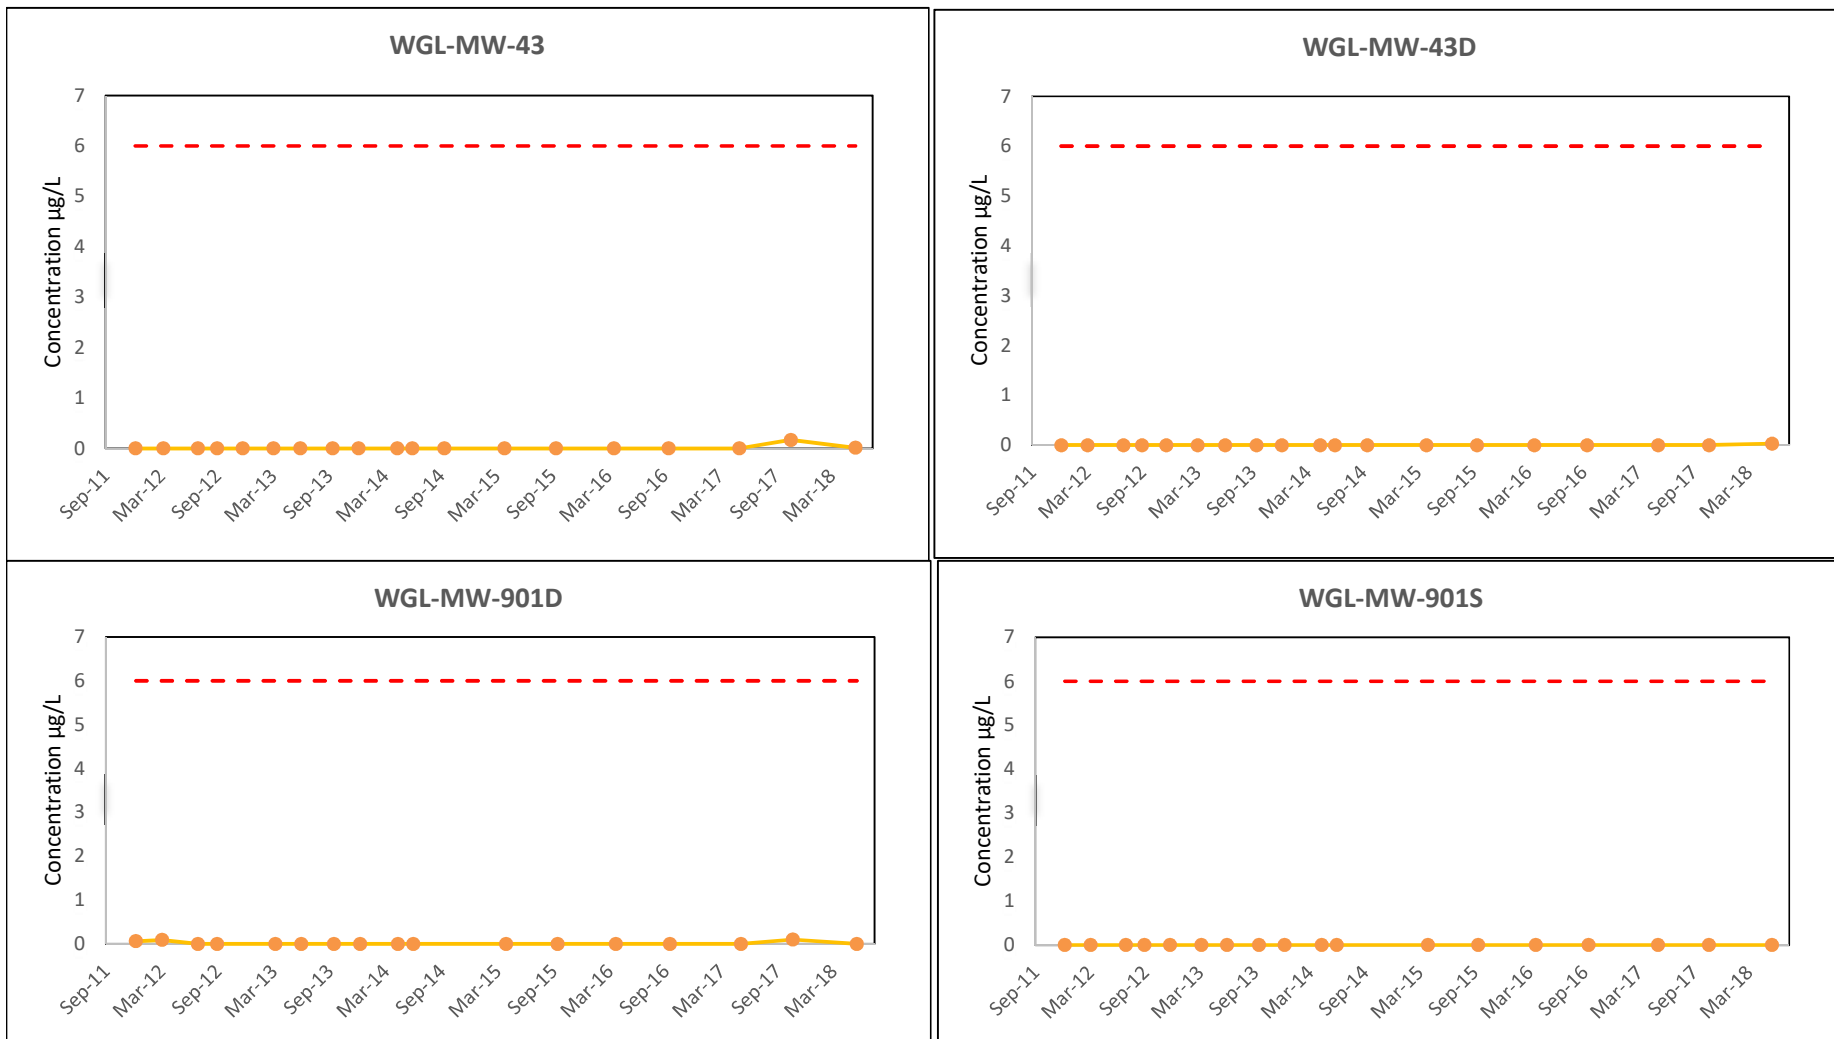
Exhibit 2-1
1,4-Dioxane Trends in Groundwater - 2011 - 2018
West Gate Landfill
NAS South Weymouth

Notes: ●—● 1,4-Dioxane Concentration - - - Project Action Limit = 6 µg/L
 A value of zero was used as a surrogate for a non-detect result for graphing purposes. Field duplicate results were averaged.

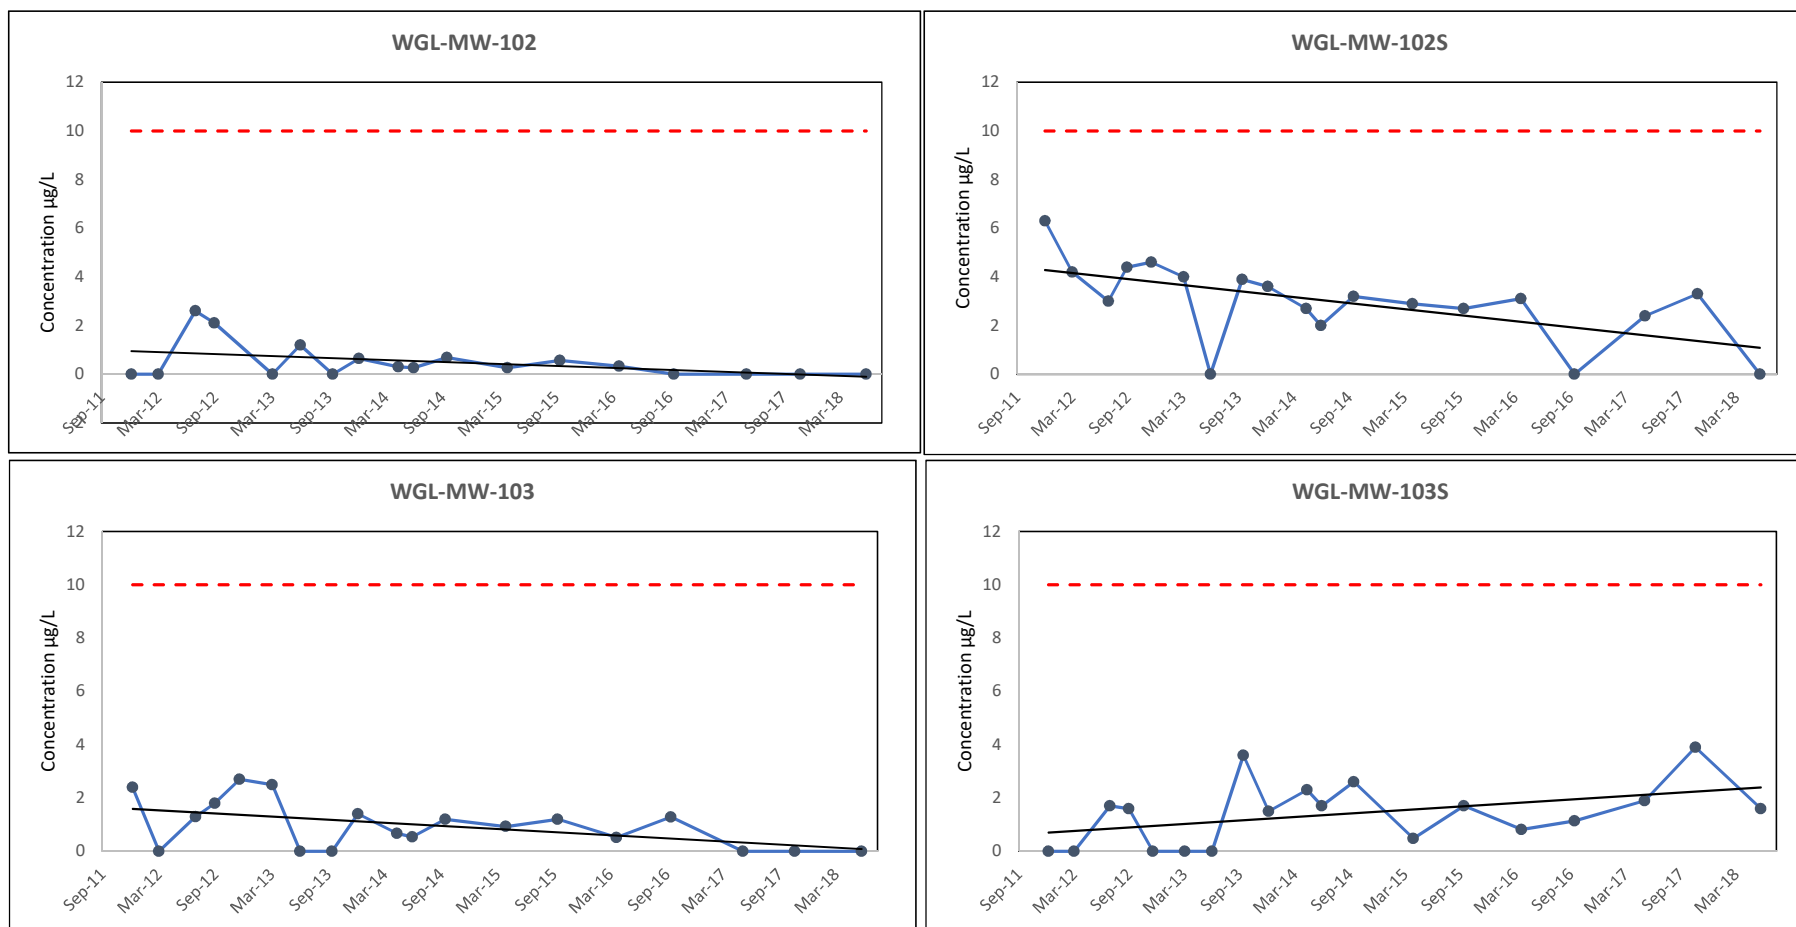
Exhibit 2-2
Arsenic Trend in Groundwater - 2011 - 2018
West Gate Landfill
NAS South Weymouth

Notes: ●—● Arsenic Concentration - - - Project Action Limit = 10 µg/L
 A value of zero was used as a surrogate for a non-detect result for graphing purposes. Field duplicate results were averaged.

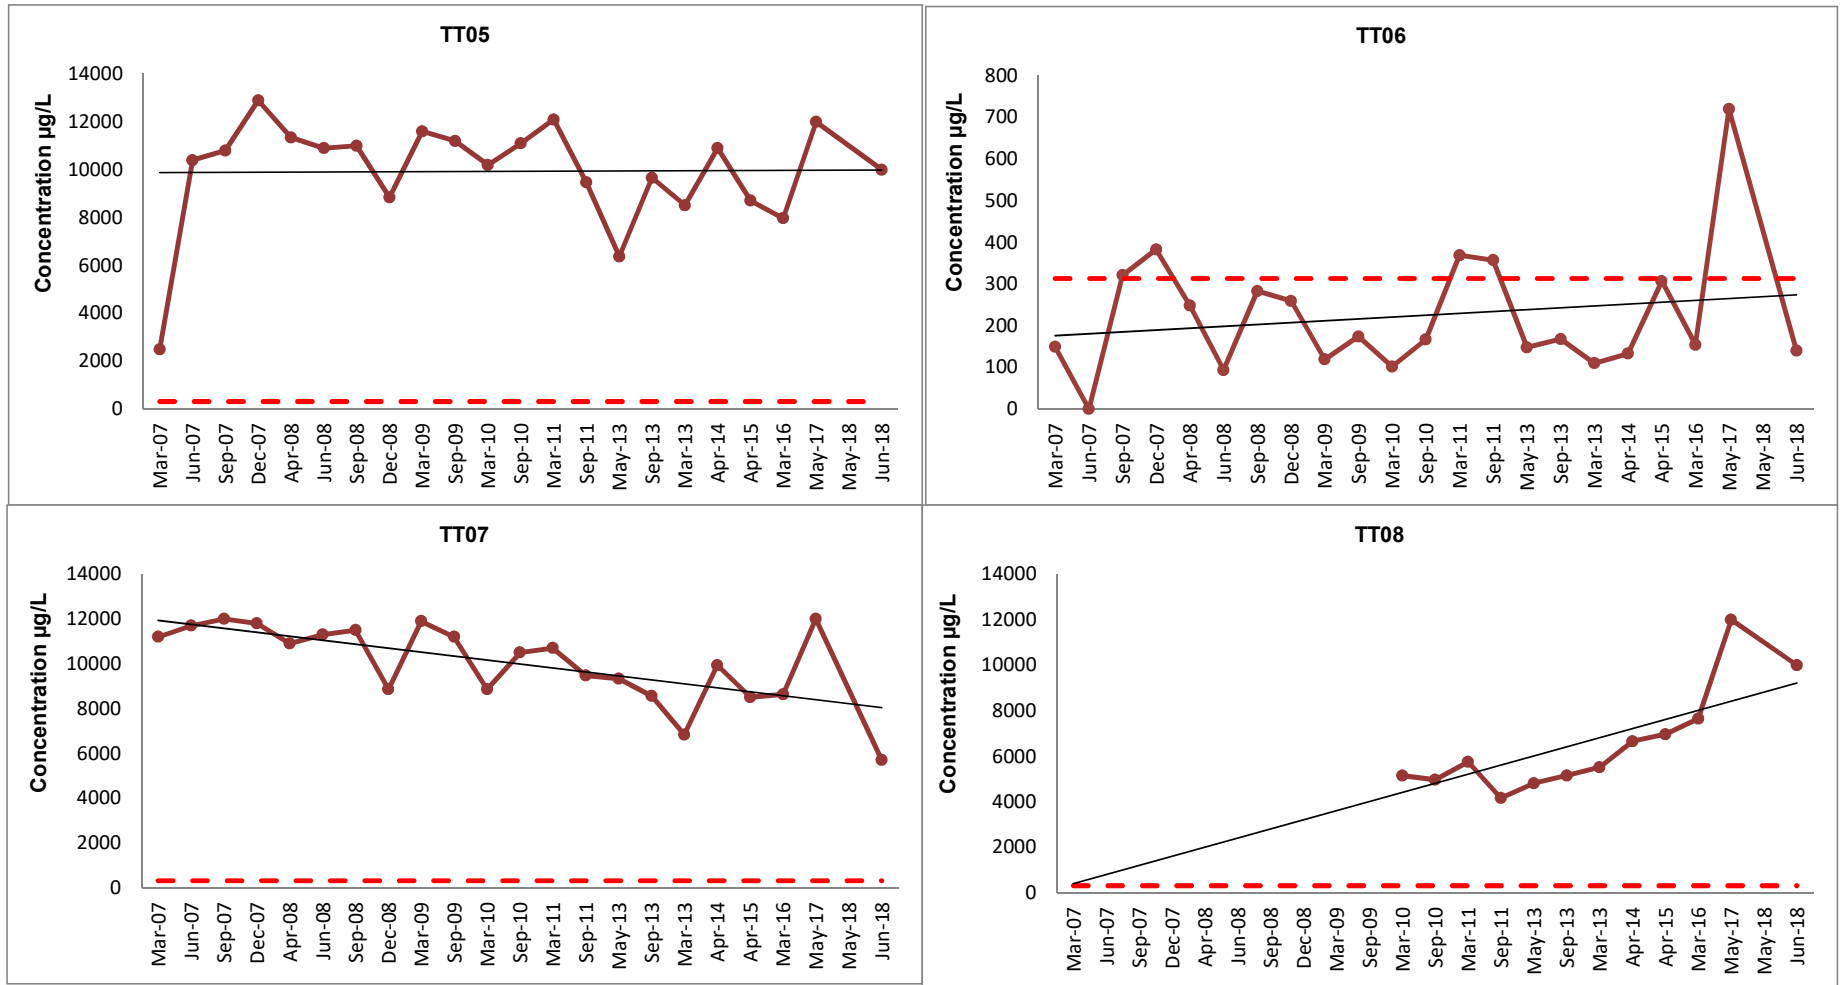
Exhibit 3-5
 Total Manganese Trends In Groundwater: 2007 - 2018
 Rubble Disposal Area
 NAS South Weymouth

Notes: —●— Manganese Concentration - - - - - PAL = 313 µg/l — Regression line
 A value of zero was used as a surrogate for a non-detect result for graphing purposes.
 Field duplicate results were averaged. As of March 2013, analysis of metals was reduced to an annual frequency during the spring event.

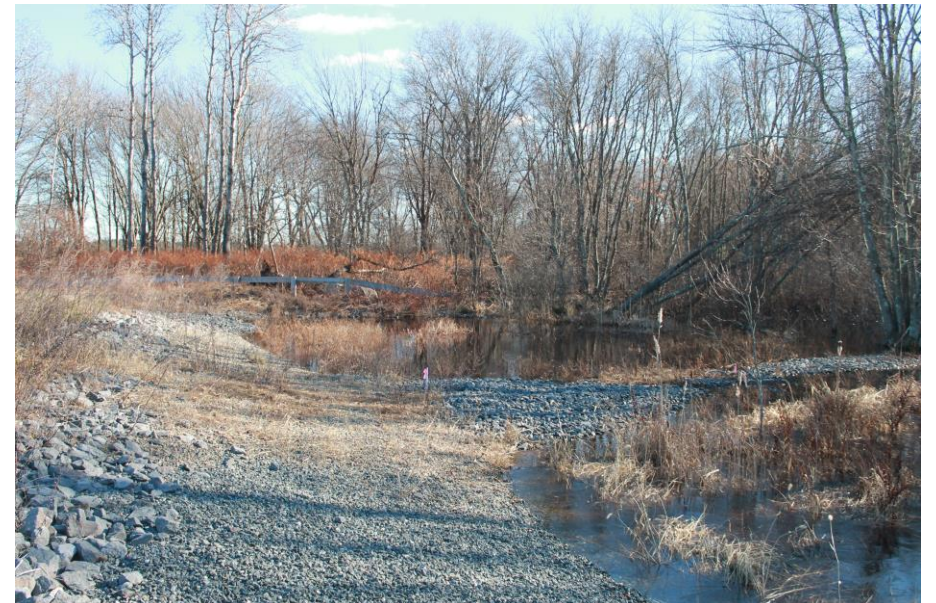
Date: 12/4/2018 Picture No. 15 Location: WGL
Comment: Some ponding of surface water observed along access road in southeast corner of perimeter
