Phase II Environmental Site Assessment

**Lavoie Property
Hillside Avenue
Lots 127-13, 127-14, and 127-15
Berlin, New Hampshire 03570**

**NHDES Site No. 200402064
Project No. 38138**

**March 26, 2019
Nobis File No. 70705.00**

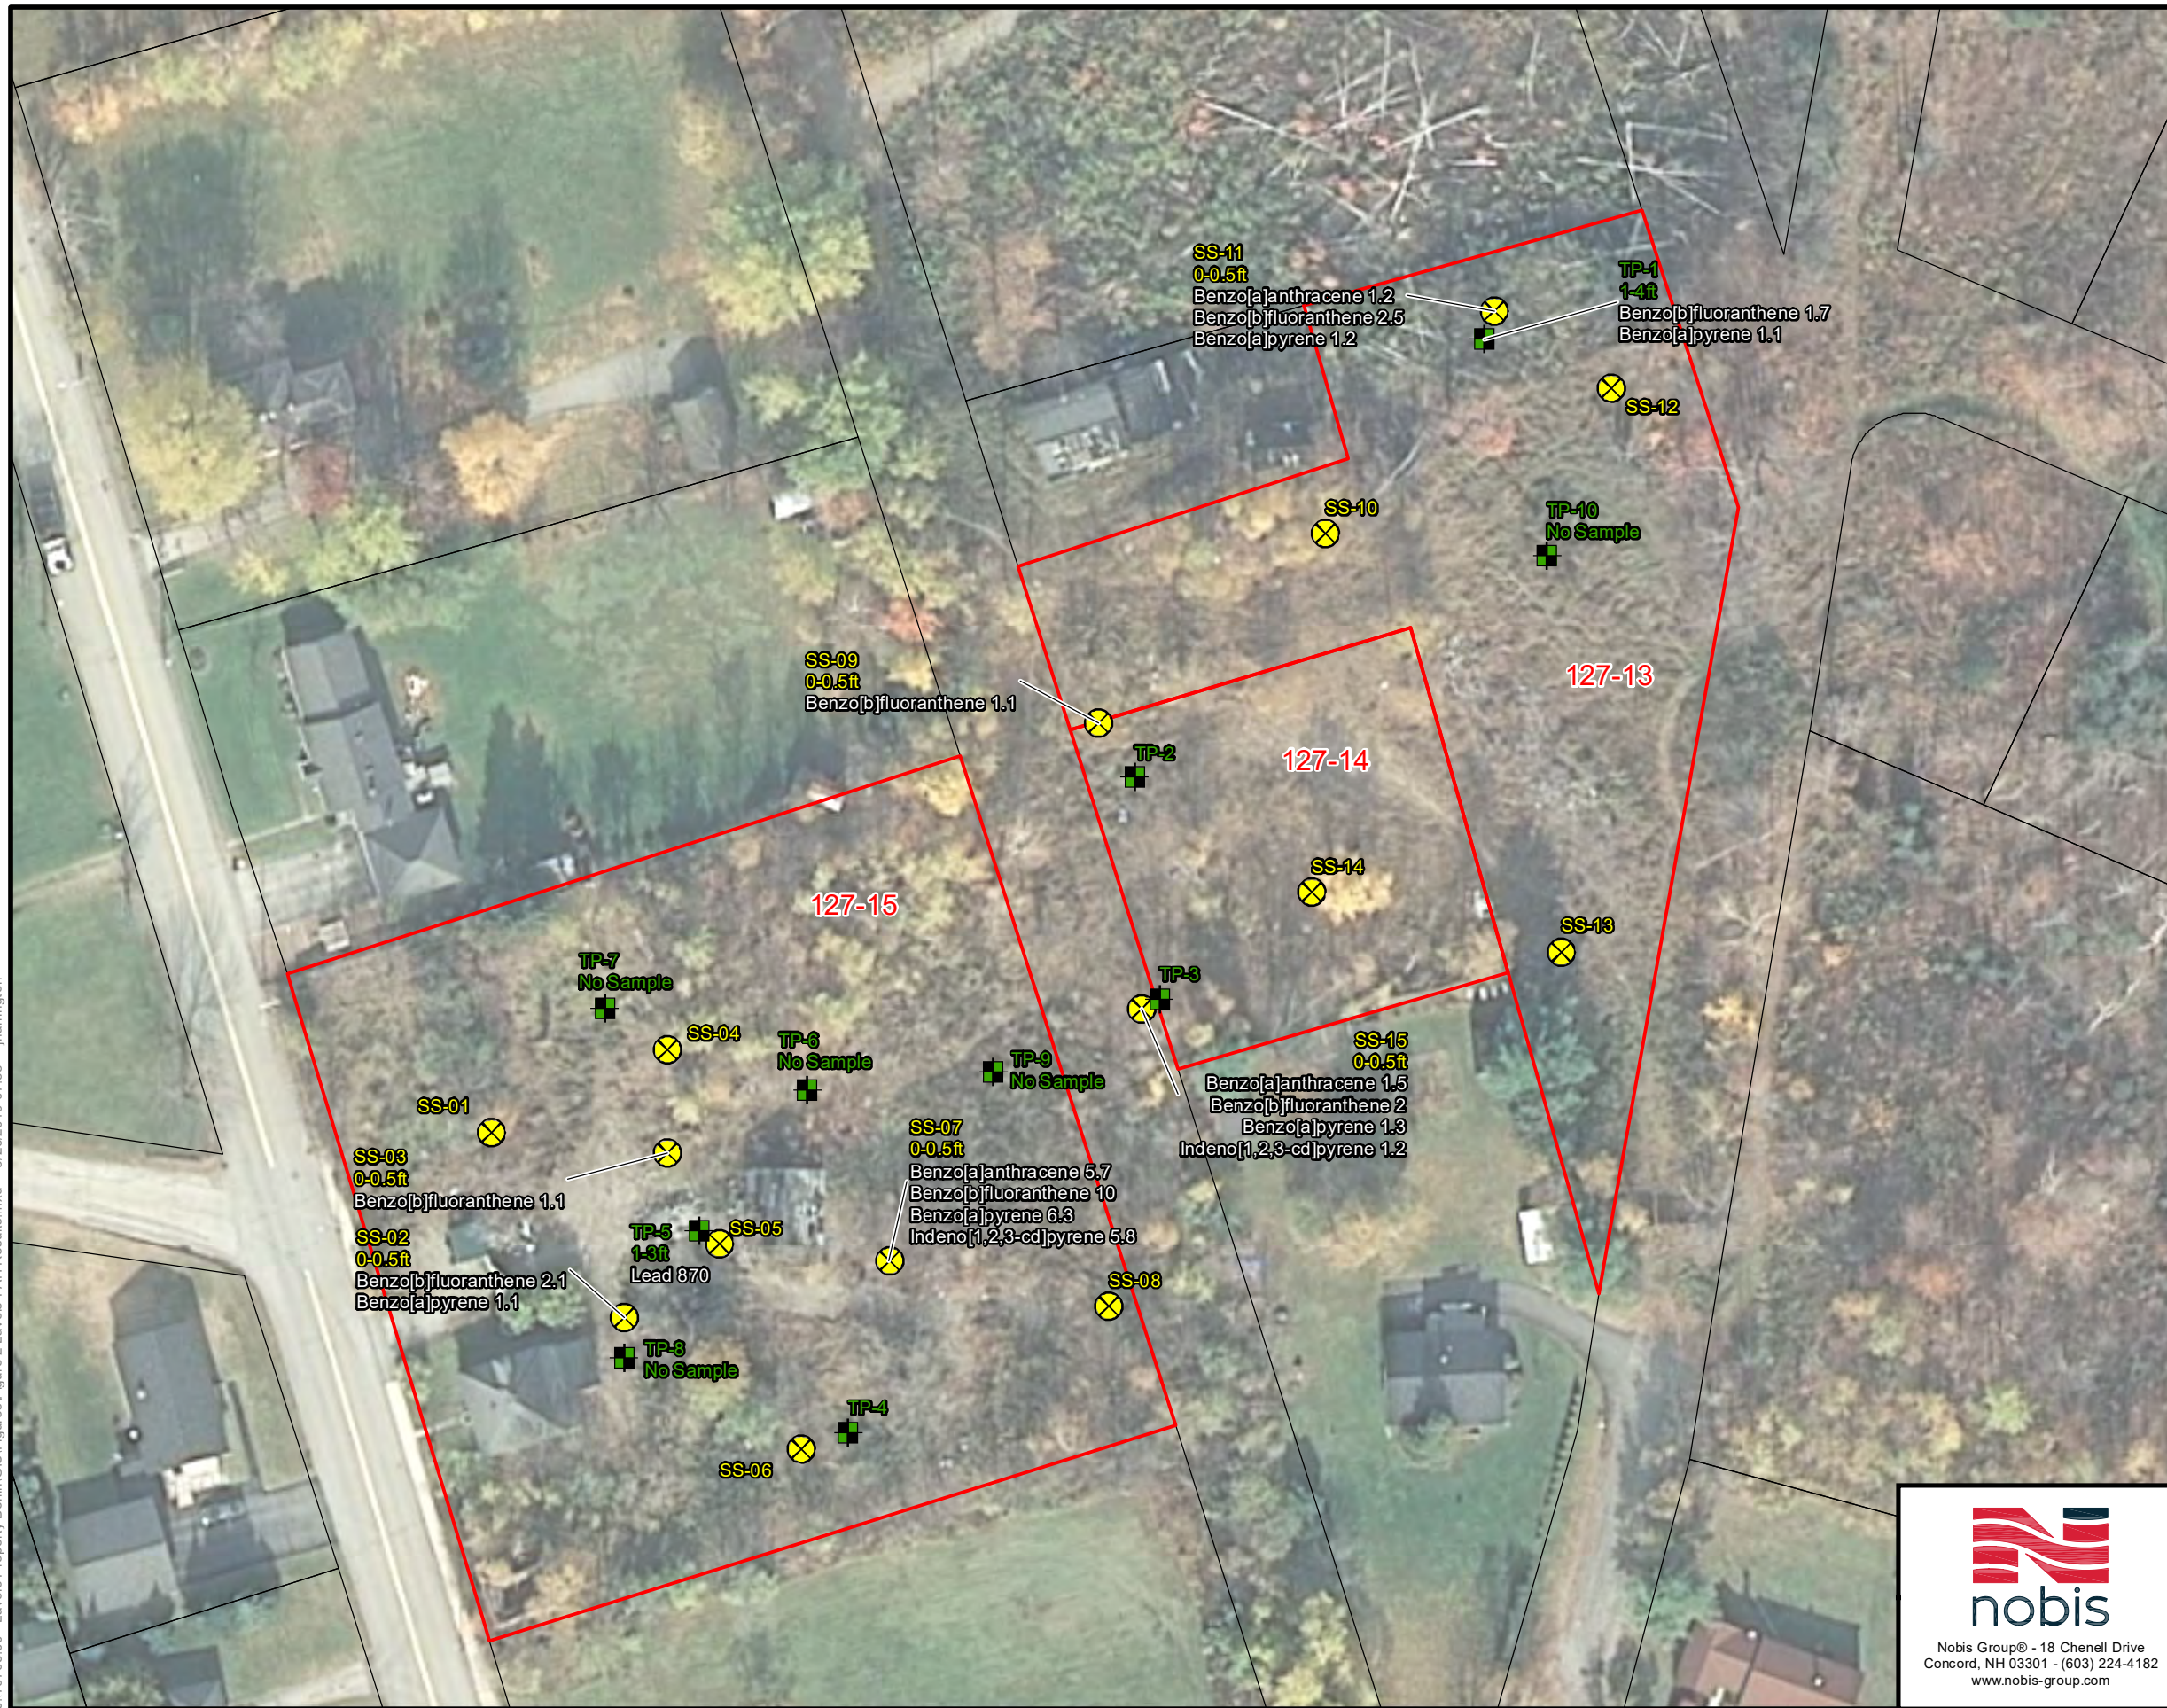
FIGURE 2	
PAH SAMPLE RESULTS LAVOIE PROPERTY 640 HILLSIDE AVE BERLIN, NEW HAMPSHIRE	
PREPARED BY: JRS	CHECKED BY: TA
PROJECT NO. 70705.00	DATE: MARCH 2019

1. Parcels are from NH GRANIT, revised February 2017. Aerial photo from NH GRANIT, 2010-2011.
2. All results are reported in mg/kg, only concentrations exceeding applicable Soil Remediation Standards (SRS) are shown.
3. Locations of site features depicted hereon are approximate and given for illustrative purposes only.

PAHs were present in several samples collected at the site at concentrations exceeding applicable SRS. The source of PAH contamination at the site can likely be attributed to historical uses at the property, additionally, some ash material was observed in TP-08. PAHs are not considered to be

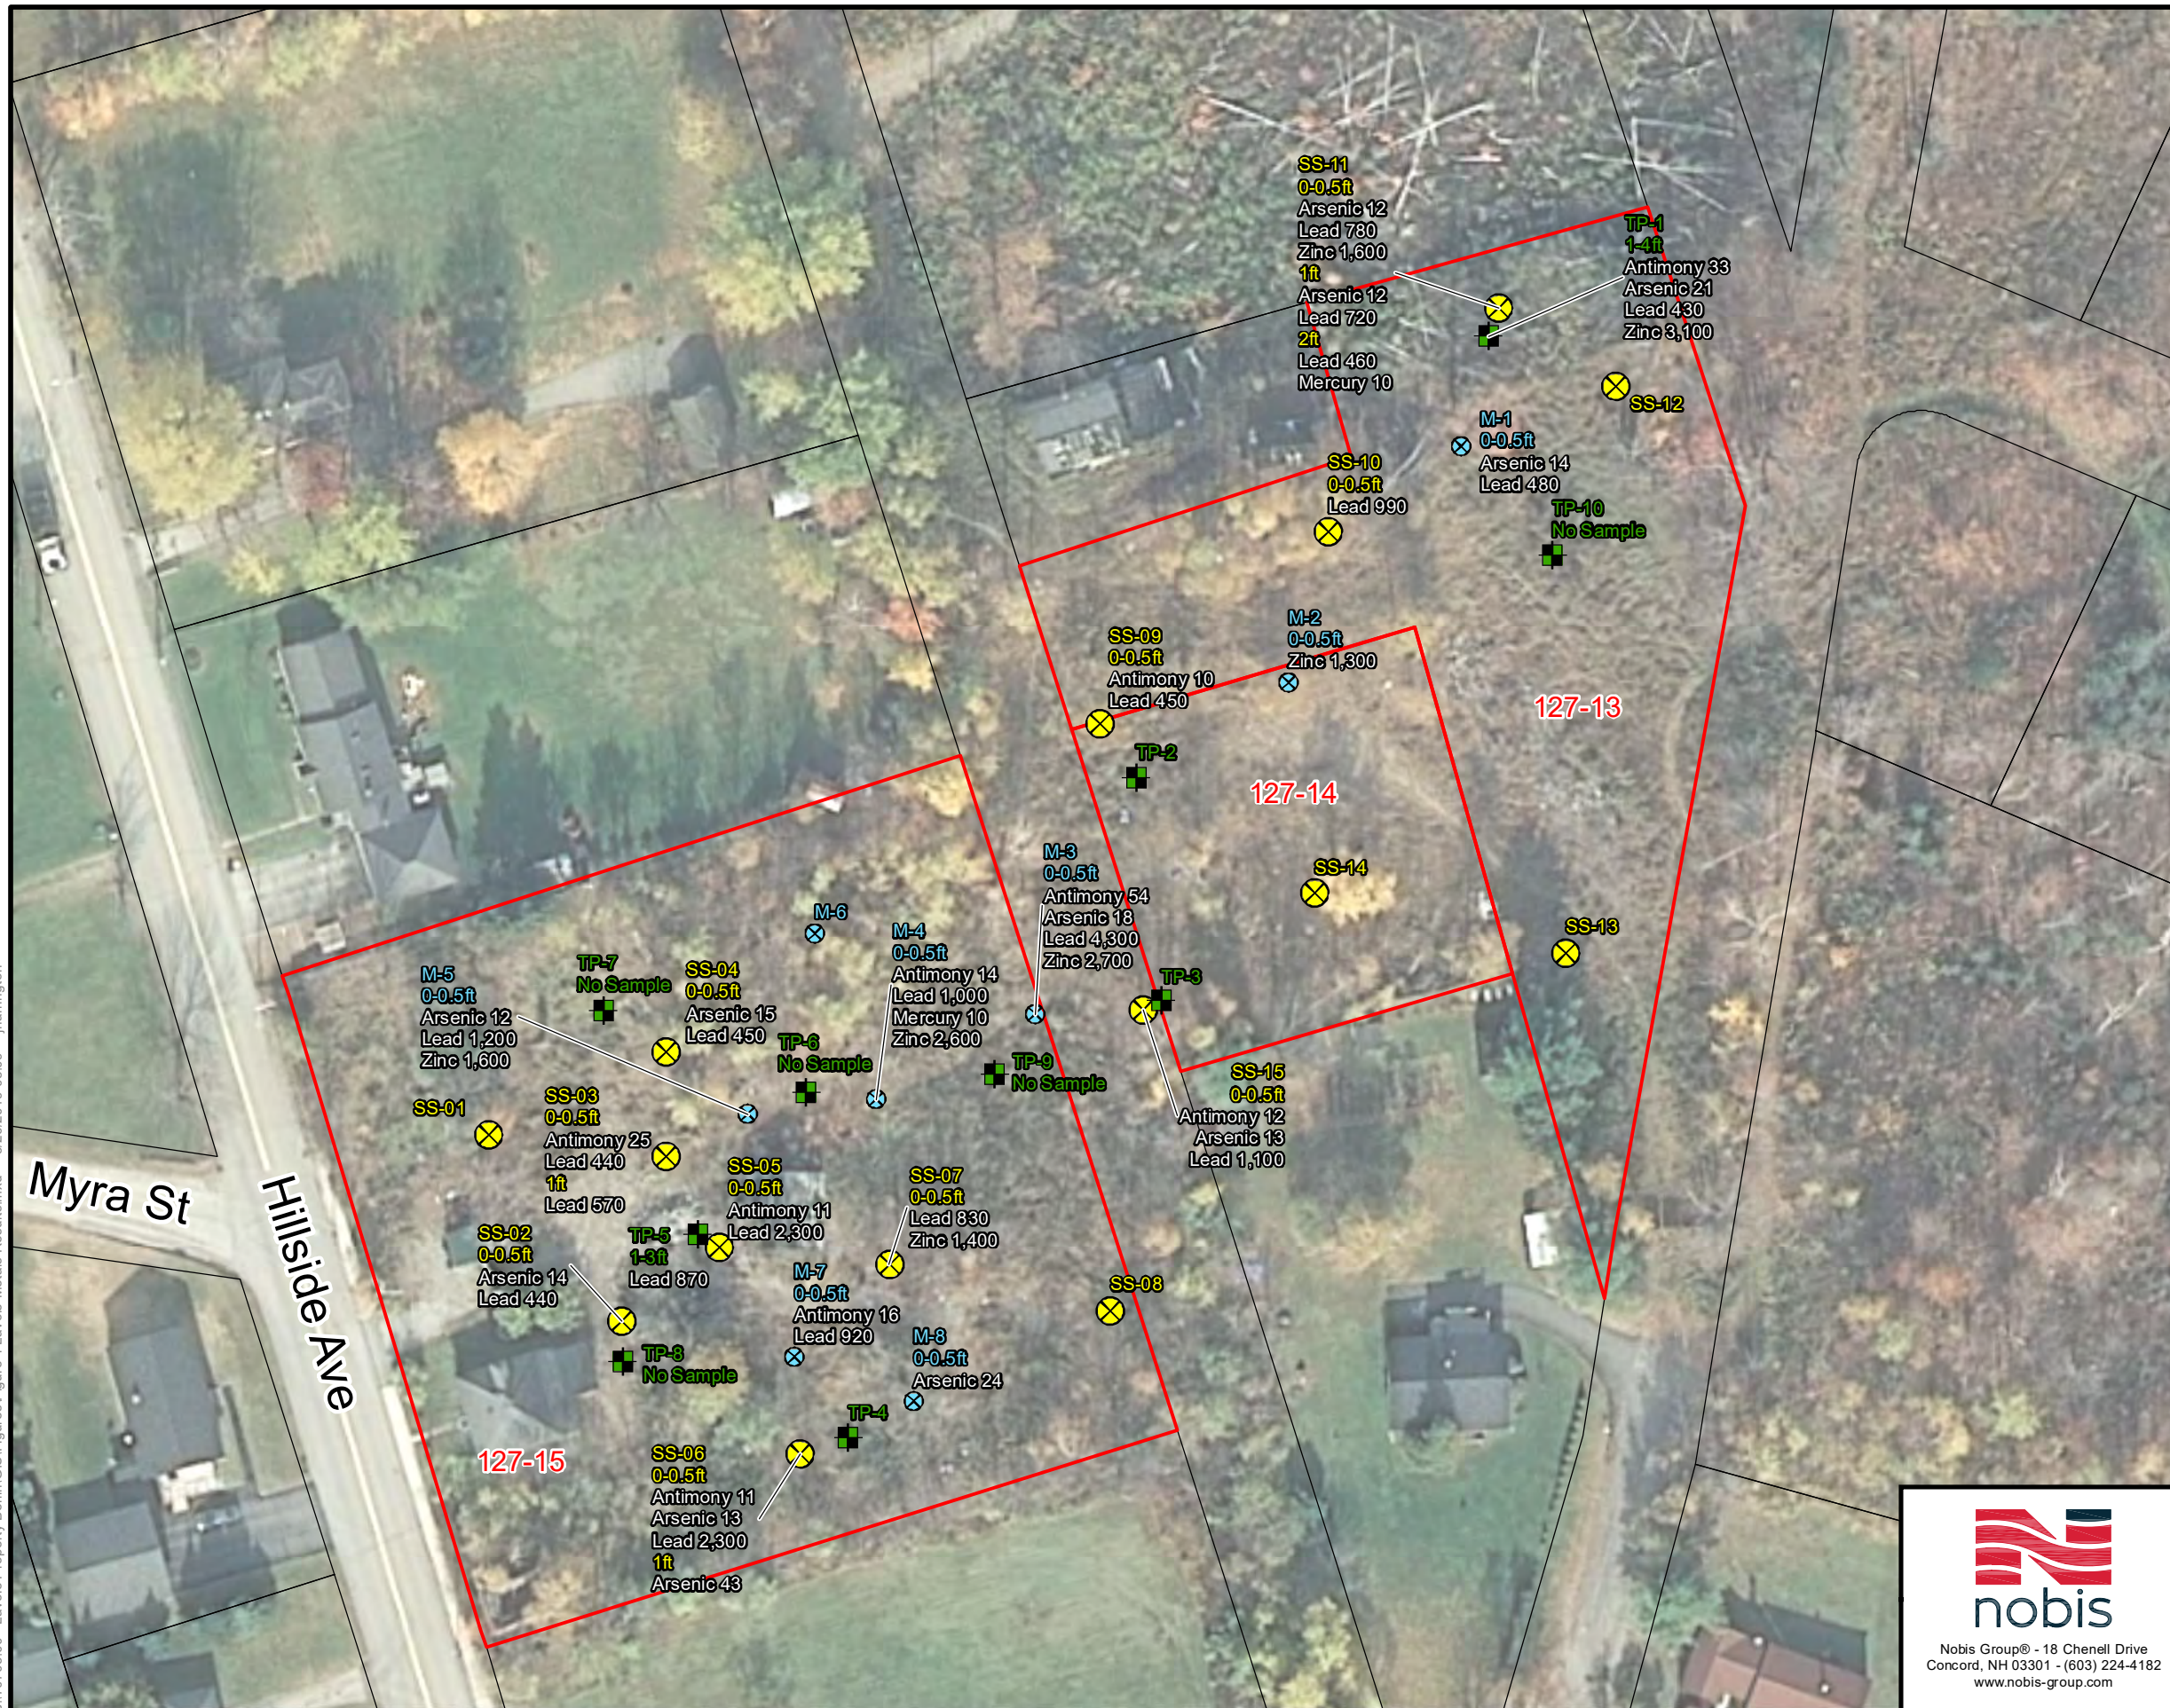
FIGURE 4	
METALS SAMPLE RESULTS LAVOIE PROPERTY 640 HILLSIDE AVE BERLIN, NEW HAMPSHIRE	
PREPARED BY: JRS	CHECKED BY: TA
PROJECT NO. 70705.00	DATE: MARCH 2019

1. Parcels are from NH GRANIT, revised February 2017. Aerial photo from NH GRANIT, 2010-2011.
2. All results are reported in mg/kg, only concentrations exceeding applicable Soil Remediation Standards (SRS) are shown.
3. Locations of site features depicted hereon are approximate and given for illustrative purposes only.
