# Coakley Landfill Community Update

March 3, 2021

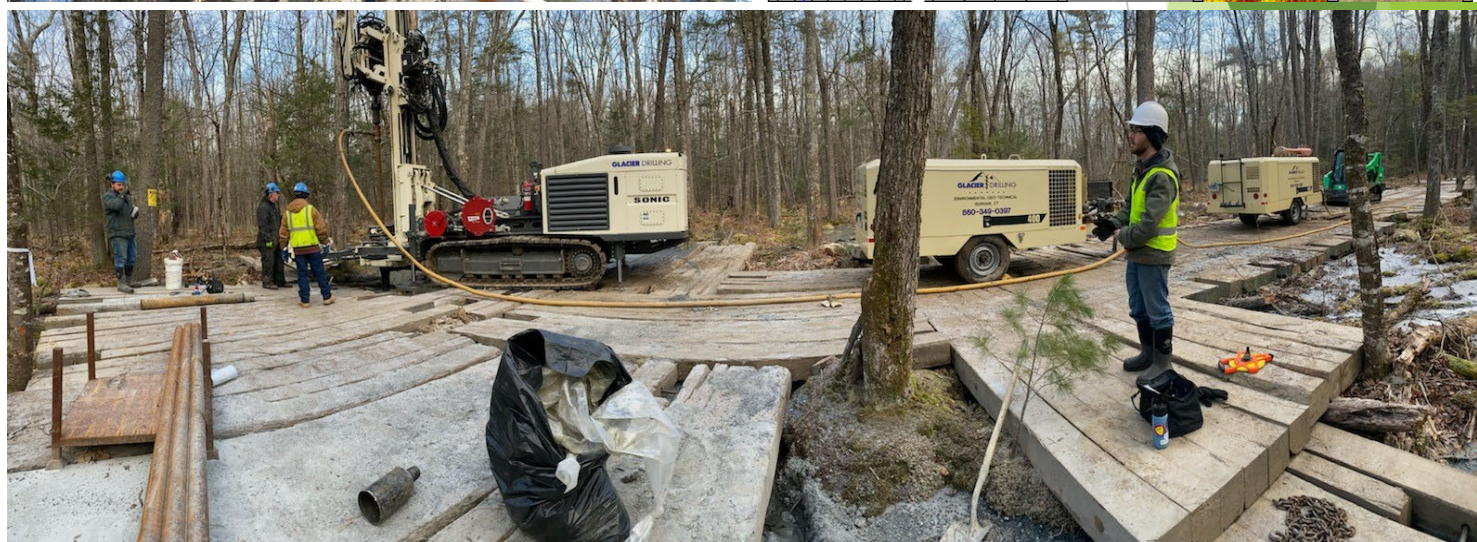
# Direct Push Investigation

- Data Gap
  - Overburden Groundwater
- 11 Locations Completed
- 10 Total GW Samples
- Definition of GMZ Western Boundary

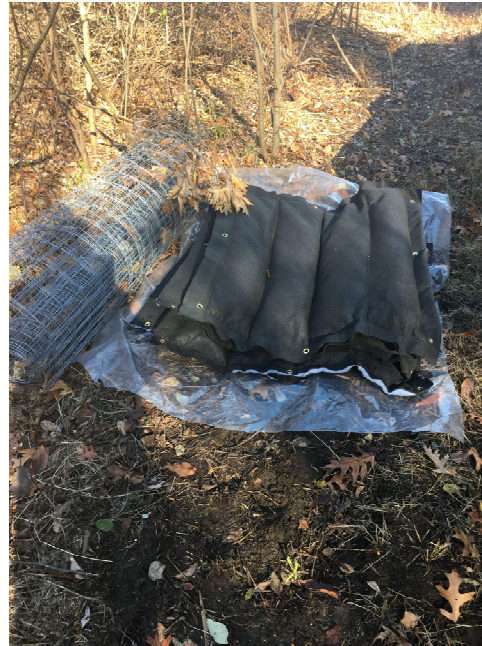
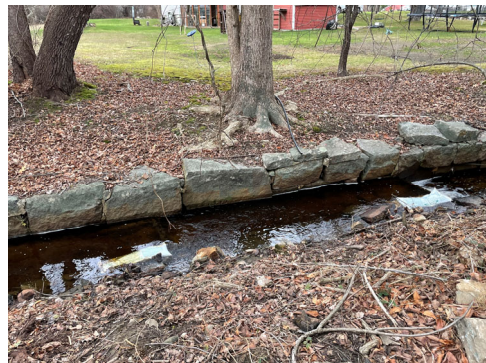
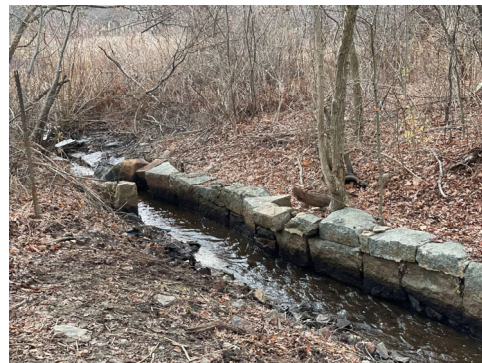
## Surface Water Treatment

- House Bill 494
- Remedy Evaluation
- Learning Process
- Ongoing Pilot Studies

- Remedy Options
  - Modifications
- Site Preparation
  - Flow Restoration
  - Channel
- Inter-agency Effort
  - USEPA
  - NHDES
  - NHDOT
  - USDA
- Deployment/Sampling
- Evaluation
