FOURTH FIVE-YEAR REVIEW REPORT FOR
PINE STREET CANAL SUPERFUND SITE
BURLINGTON
CHITTENDEN COUNTY, VERMONT

U.S. Environmental Protection Agency
Region 1
Boston, MA

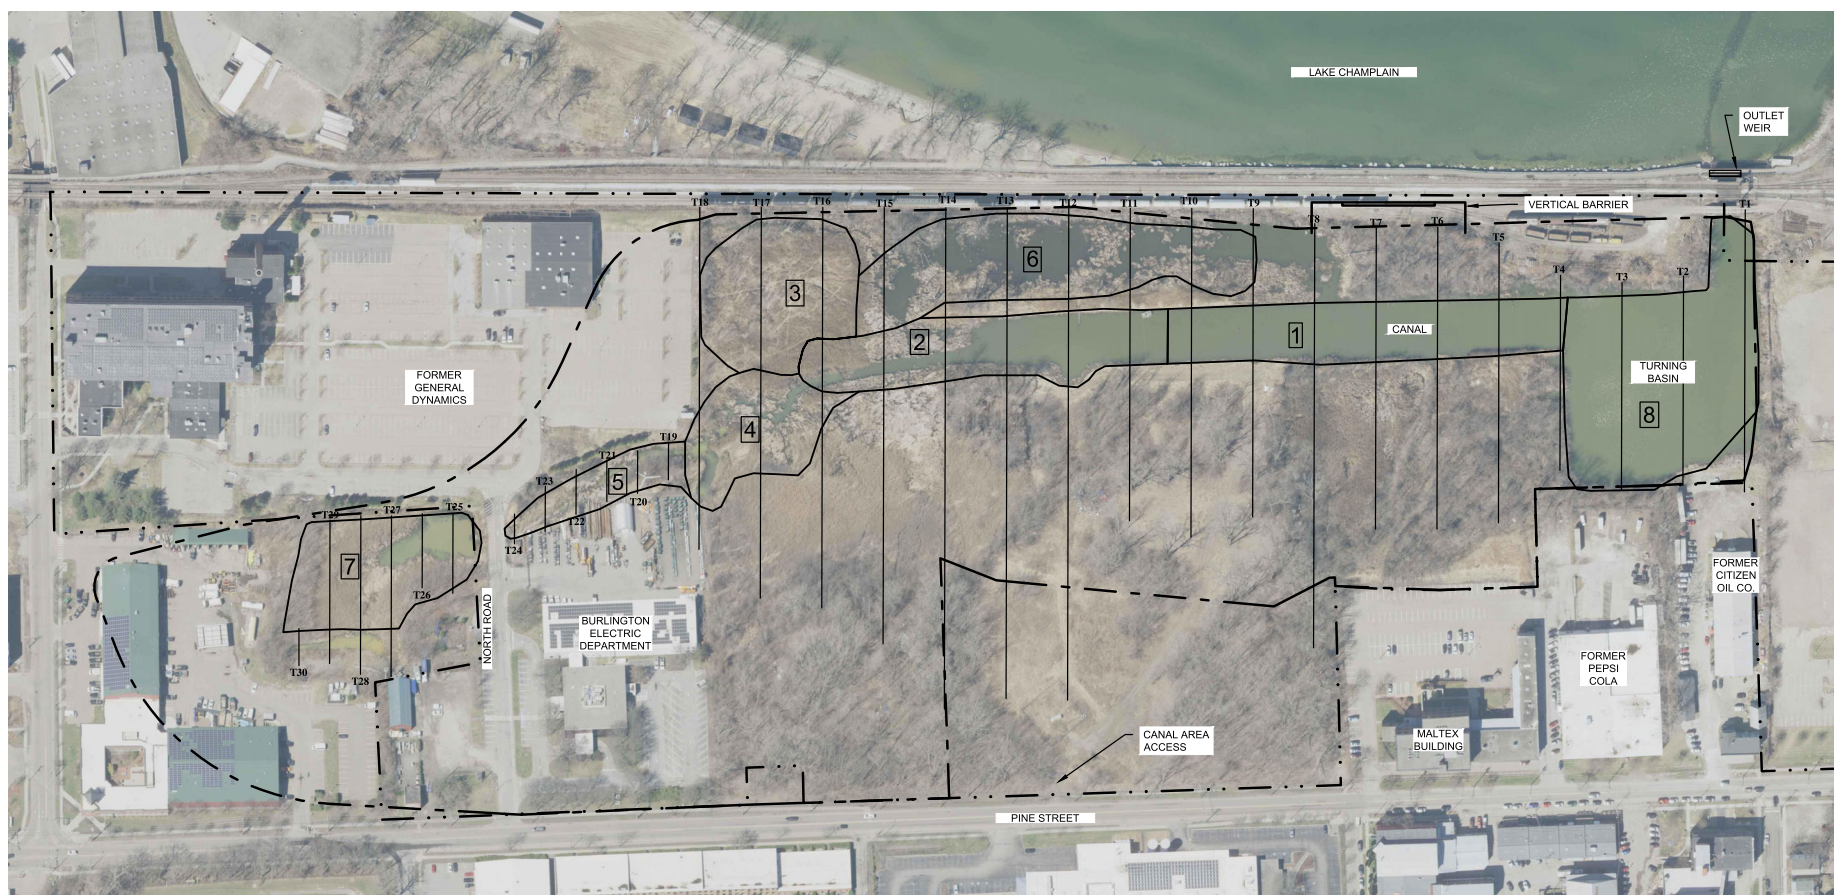
FIGURE 4:
GENERAL SITE PLAN
PINE STREET CANAL SITE
BURLINGTON, VERMONT

In the spring of 2003, following completion of the cap in Areas 1, 2, 3, 7, and 8 (Figure 4), pools of free-phase coal tar were observed outside the cap footprint on the west bank of the canal and on the surface of the subaqueous cap in the canal. Oily sheens and globules of NAPL were also observed on the surface of the water in the canal. During the fall of 2003, a response strategy was developed that recommended extending the sand cap over the affected portion of the west bank of the canal and removal of NAPL that had accumulated on the surface of the cap in the canal. The west bank cap construction and NAPL removal were implemented in the summer of 2004 (JCO, 2004c).

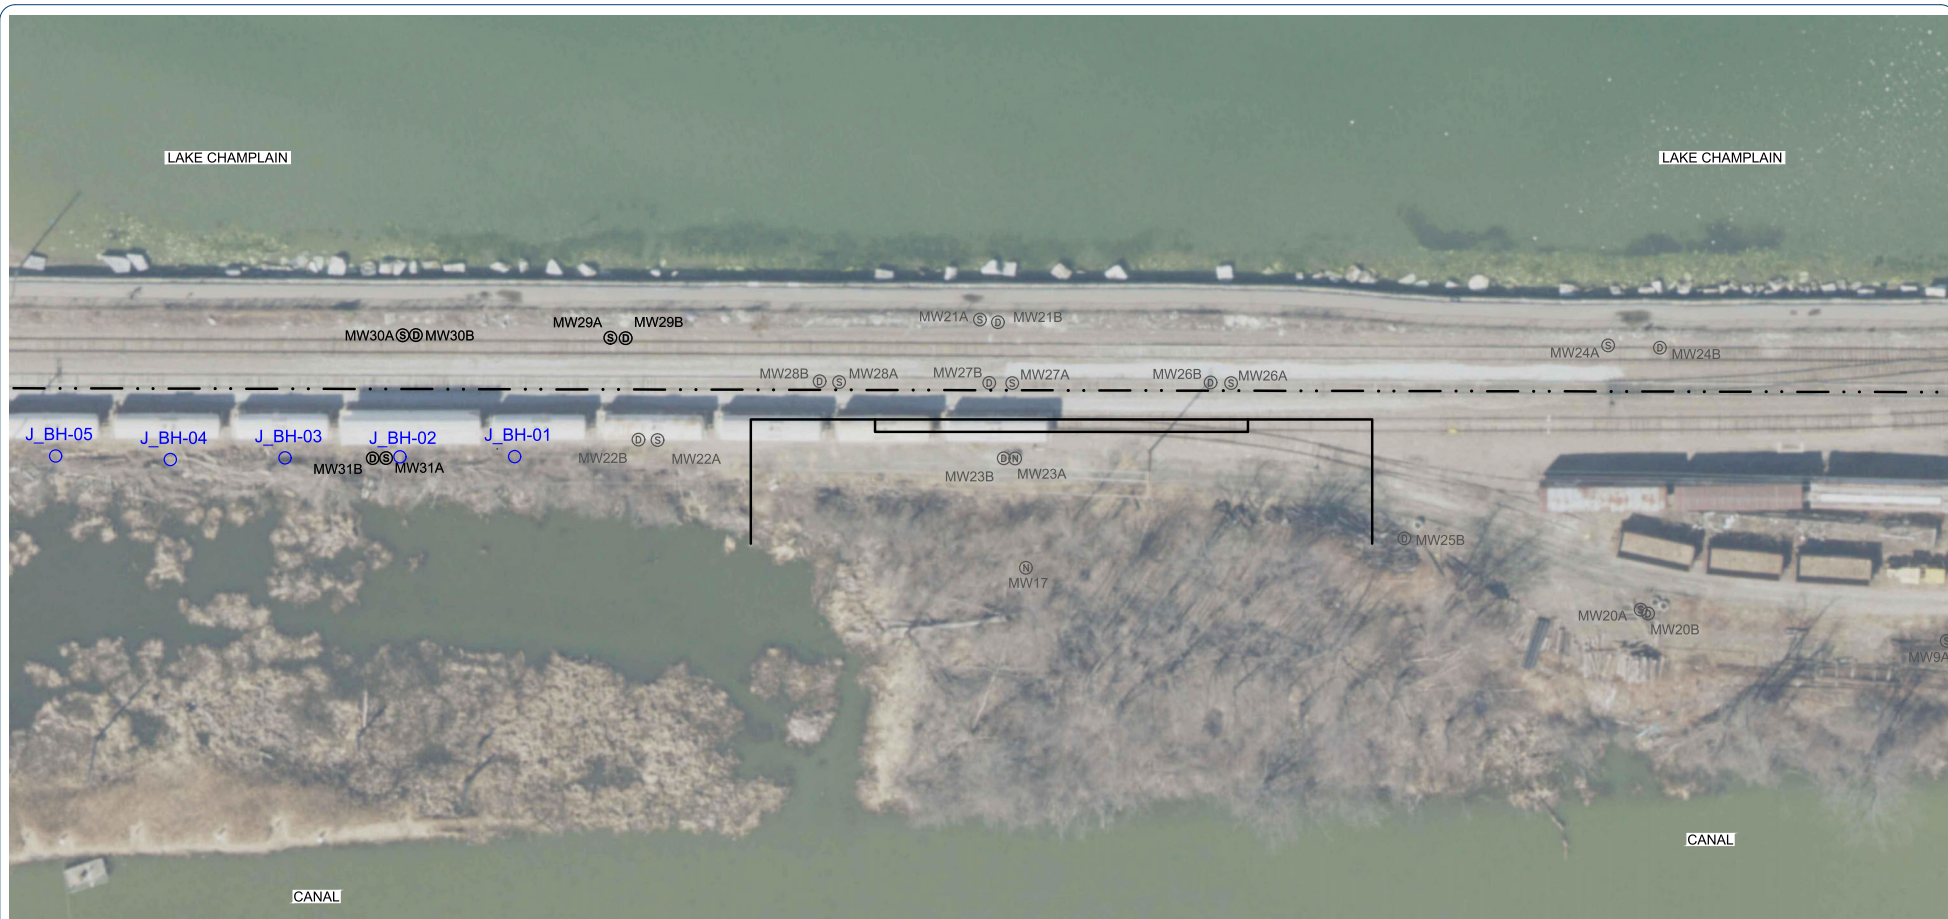
FIGURE 5: SOUTHERN EXTENT
FOCUSED INVESTIGATION LOCATIONS
PINE STREET CANAL SITE
BURLINGTON, VERMONT

In response to this comment, two investigations were conducted to assess the groundwater conditions near the Vertical Barrier. The first was conducted in September 2017 and results were reported in the November 15, 2017, Well Installation and Boring Report, Vertical Barrier – Southern Extent Focused Investigation Technical Memorandum (JCO, 2017c). This focused field investigation included the advancement of five investigative boreholes south of the Vertical Barrier to delineate the southern extent of Site-related contamination and the installation of three pairs of monitoring wells (MW-29A&B, MW-30A&B, and MW-31A&B) for long-term monitoring of the southern extent of contamination (Figure 5). Of the newly installed wells, only MW-29B has had concentrations that exceed the MCL/VGES, and those were limited to benzene and naphthalene.

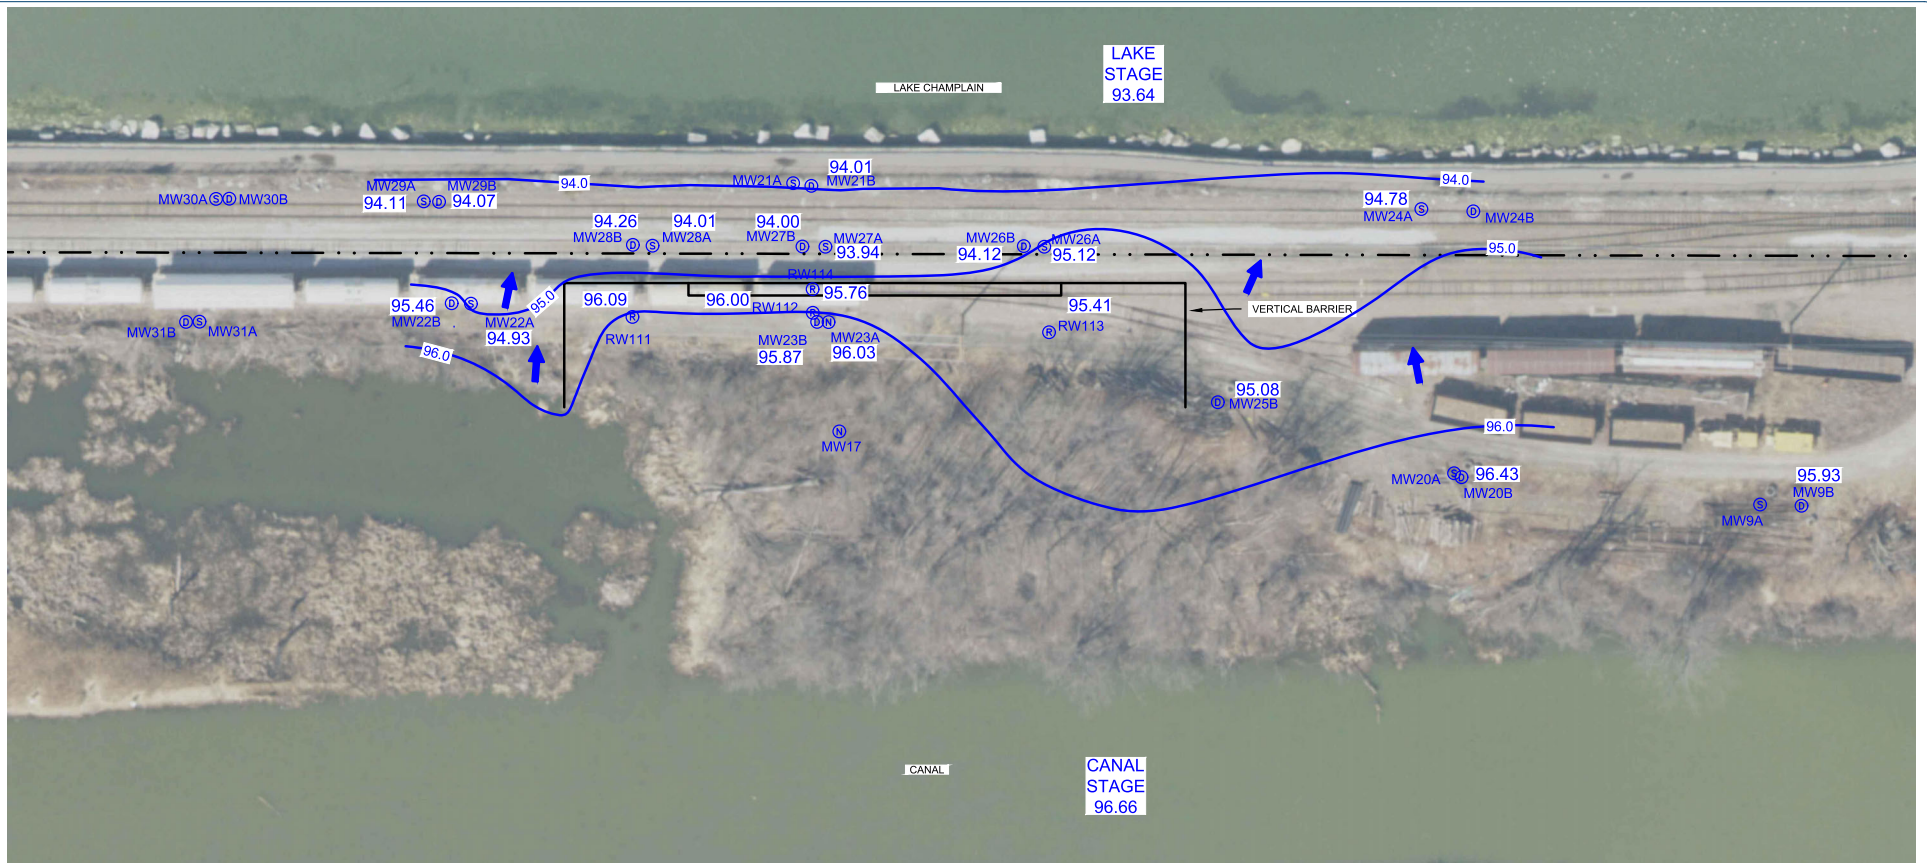
FIGURE 9: ZONE B GROUNDWATER ELEVATIONS
VERTICAL BARRIER AREA - OCTOBER 26, 2020
PINE STREET CANAL SITE
BURLINGTON, VERMONT

Typically, the greatest hydraulic gradients and groundwater flow rates are observed in August or early September when the Lake is at its lowest level. Figure 9 presents groundwater elevations near the Vertical Barrier on October 26, 2020, which is consistent with typical fall data as recorded during the last five years. Groundwater measurements recorded during the fall semi-annual monitoring events over the last five years indicate that the Vertical Barrier is halting groundwater flow to the east of it, which indicates that groundwater is being directed upward into the peat, as designed. Water levels in wells on the west (Lake) side of the Vertical Barrier are lower, near the center of the Vertical Barrier, similar to that of the Lake level. Water levels near the south edge of the Vertical Barrier (MW-22A & B), however, are slightly lower than the mounded groundwater behind (upgradient of) the Vertical Barrier and higher than the area on the west side of the Vertical Barrier. This suggests that a portion of the groundwater flows south and around the Vertical Barrier. The potentiometric depression on the downgradient (west) side of the Vertical Barrier apparently draws the groundwater that flows around the southern end of the Vertical Barrier and northwest toward location MW-28.

The potentiometric data observed during the last five years are consistent with data collected prior to 2016 and indicates that the direction of groundwater flow is from the south, southeast towards the Site and into the Class IV groundwater boundary. As discussed above, the exception is the vicinity of the Vertical Barrier, where seasonal variations in the Lake level result in groundwater flow from the canal toward the Lake.
