**SITE SAMPLING CHRONOLOGICAL SUMMARY
FOR
STAMINA MILLS SITE
NORTH SMITHFIELD, RHODE ISLAND**

**U.S. Environmental Protection Agency
Region I
60 Westview Street
Lexington, MA 02173**

**ROY F. WESTON, INC.
Technical Assistance Team
Region I**

July 1990

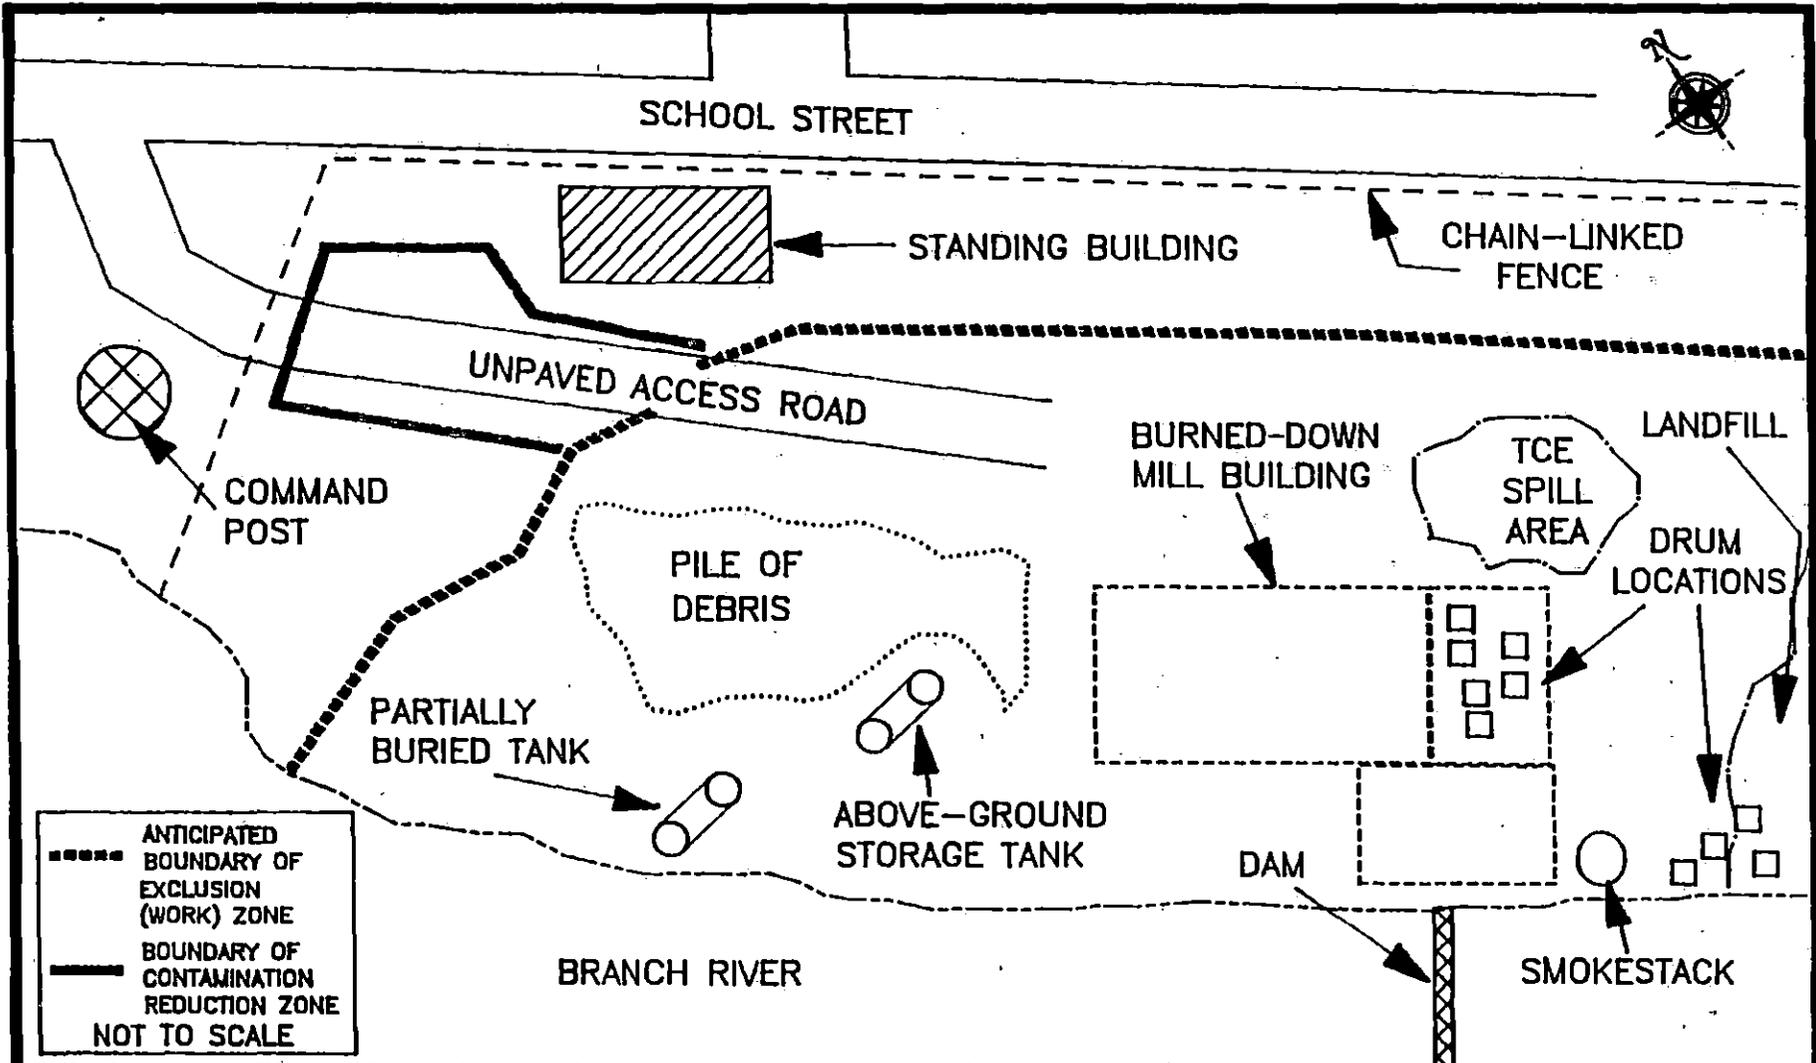
FIGURE 2

SITE DIAGRAM
STAMINA MILLS SITE
NORTH SMITHFIELD, RHODE ISLAND

- 0945 hrs: TAT members Fahle, Smart and Saccoccio proceeded to the aboveground tank location (Figure 2). The Rhode Island Times Magazine photographer exited the premises.

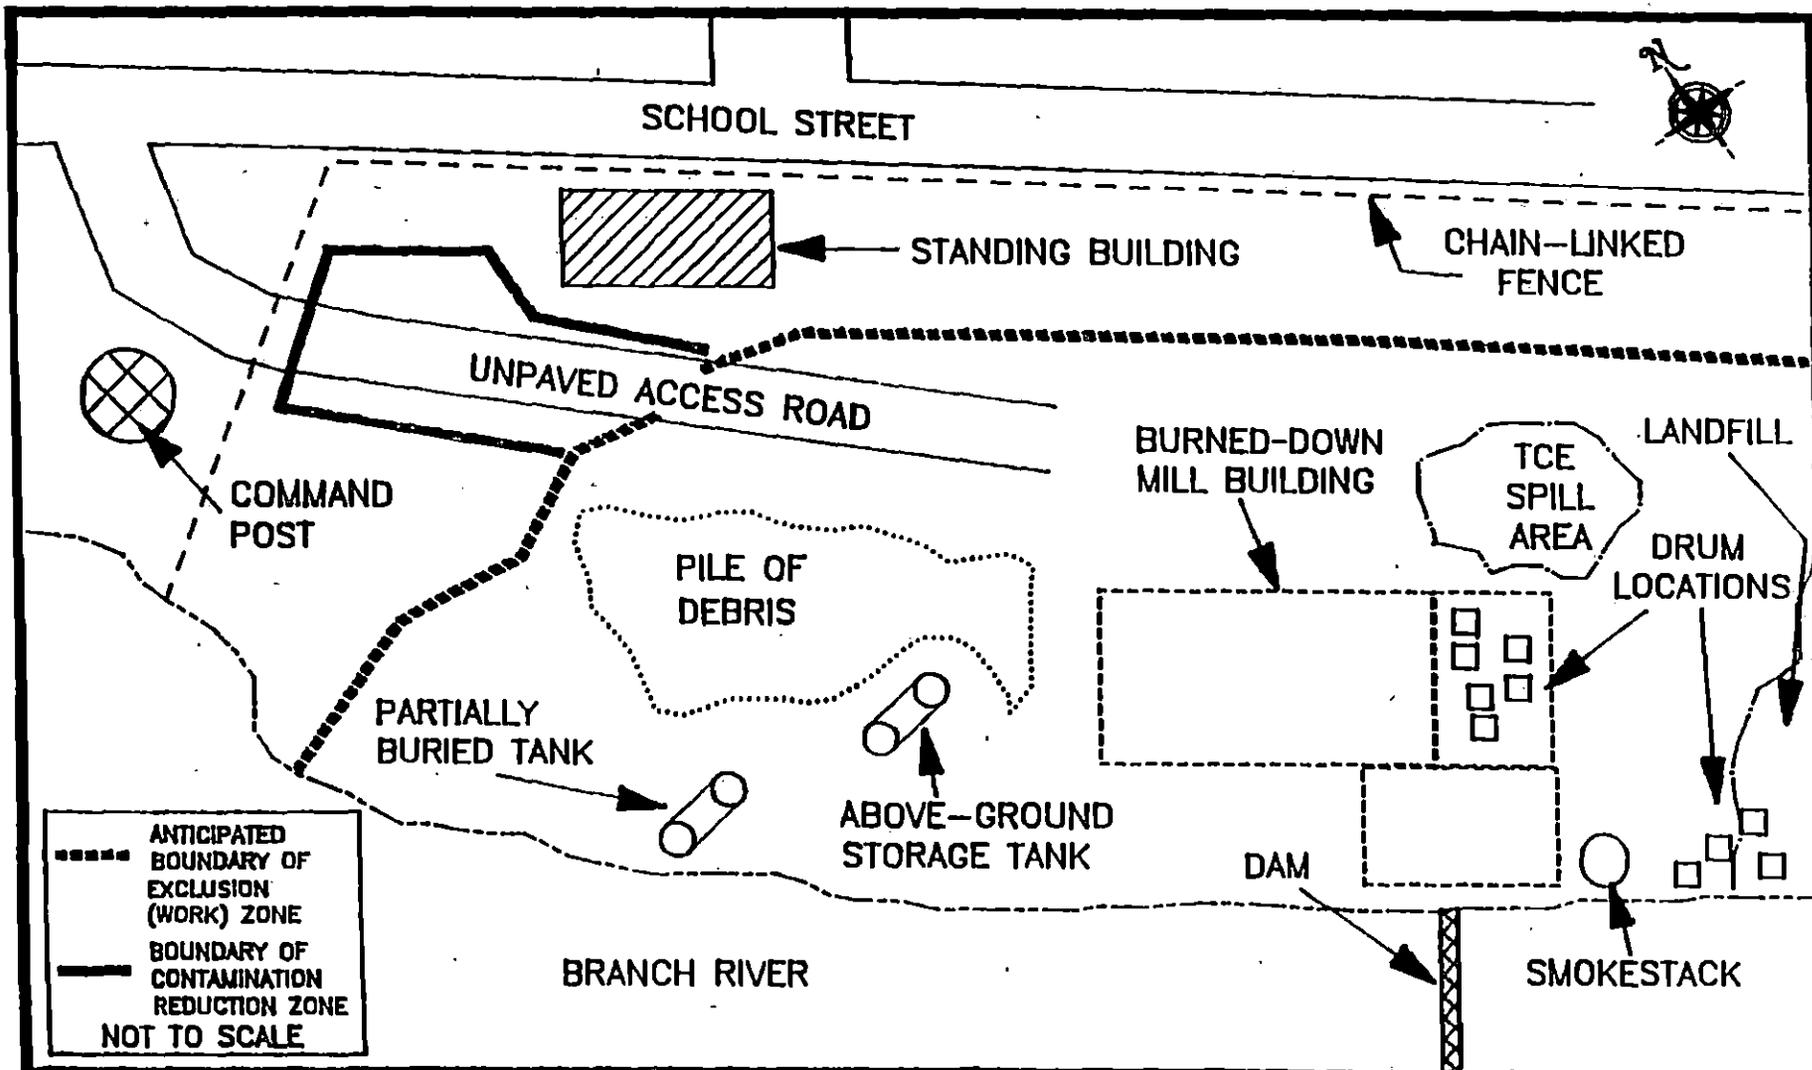
FIGURE 2

SITE DIAGRAM
 STAMINA MILLS SITE
 NORTH SMITHFIELD, RHODE ISLAND
