Subject.: USACE CONTRACT NO. DACW33-94-D-0002  
TOTAL ENVIRONMENTAL RESTORATION CONTRACT (TERC)  
TASK ORDER No. 0024 – NEW BEDFORD  
Final North of Wood St. After Action Report

**FIGURE 1-1**  
 NEW BEDFORD HARBOR SUPERFUND SITE  
 NEW BEDFORD, MASSACHUSETTS

**NEW BEDFORD HARBOR SUPERFUND SITE  
 NEW BEDFORD, MASSACHUSETTS  
 CONSTRUCTION SEQUENCE  
 AND STAGING AREAS PLAN**

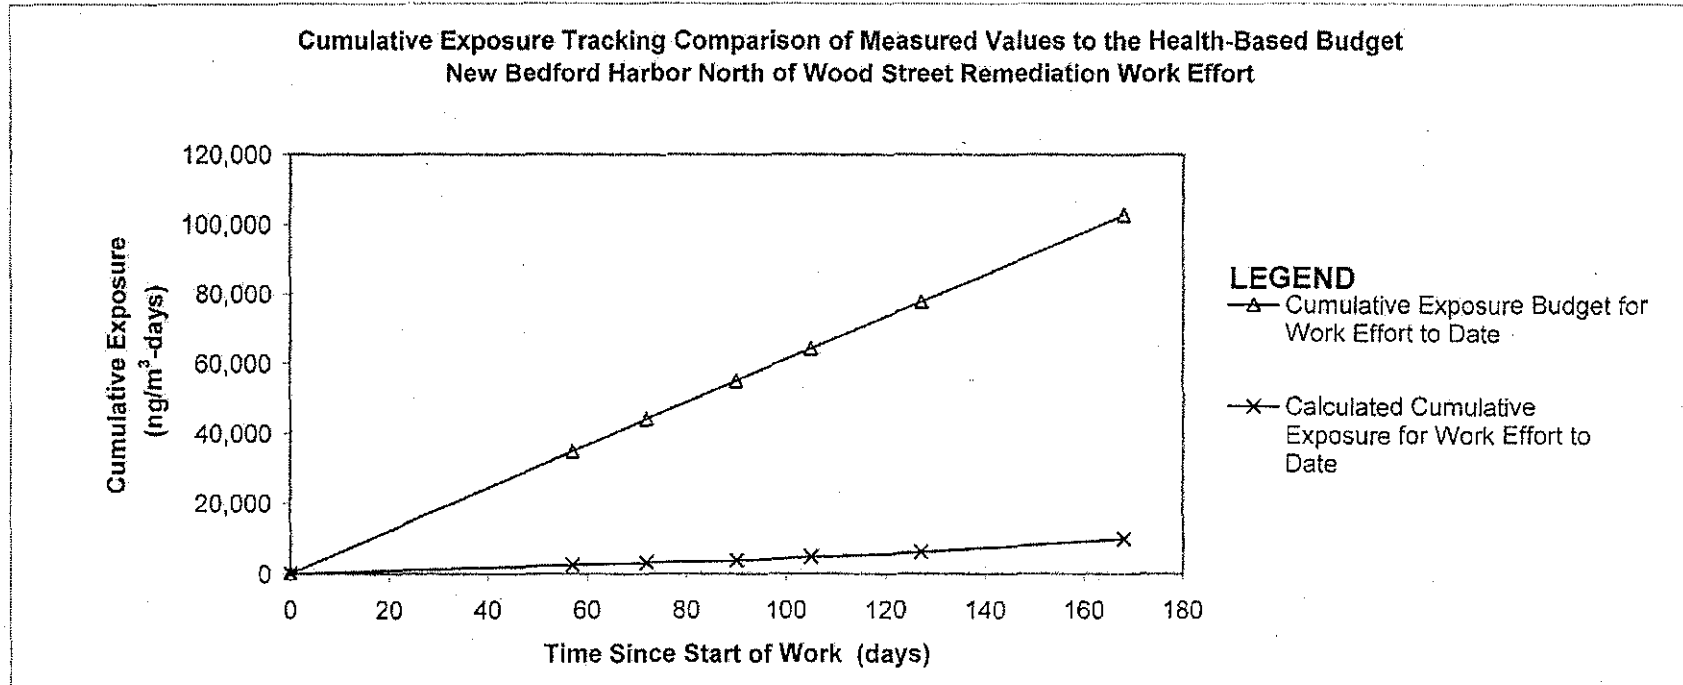
Sample Station :	AQ Site 02 - E Side of CDF
Collection Date:	4/29/03
Measured PCB Concentration (ng/m <sup>3</sup> ):	160
Exposure Budget Expended During This Period:	15.1%
Cumulative Exposure Budget Expended to Date:	9.6%
Response Level:	LOW
Response:	Evaluate the Cause and Significance of the Triggering Conditions

Trigger C5 and Trigger C7: C5: Measured Concentration Exceeds the Annual Average Background Concentration by more than 200%; C7: Measured Concentration has Doubled Since the Last Monitoring Period

## Sample Results, Calculated Budget and Exposure Values

C5 and C5&C7 concentration triggers were identified during this sampling period. These triggering conditions were of comparison type and the values for comparison were low. The higher total PCB concentration observed at the sampling station during this period was probably caused by a combination of the higher ambient temperature, calm winds directed toward the station, and more active site activities (transferring dredged material to the CDF and/or DDA). Since the expenditure of the cumulative exposure budget to date was still at a low level at this point in the project, no change in field procedures is warranted.

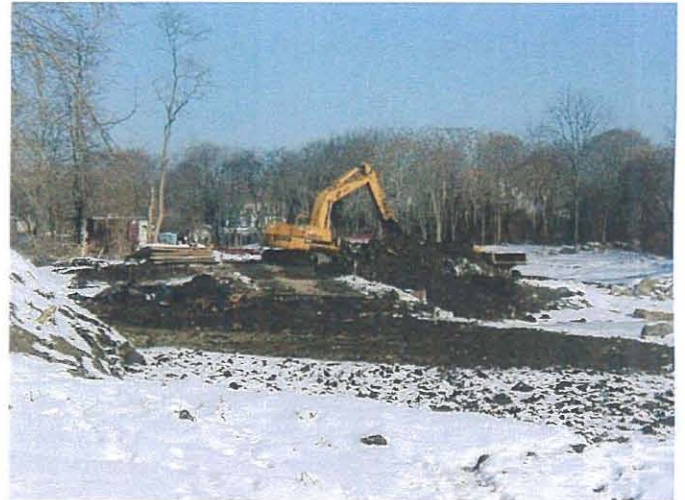
**Excavation/removal of the West haul road**  
Photo # WS21306  
2/13/03  
JPK

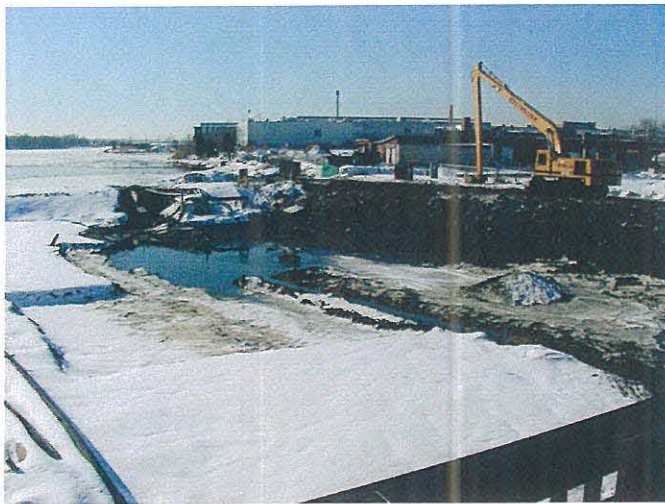
**Post-excavation conditions at the south zone**  
Photo # WS22104  
2/21/03  
JPK

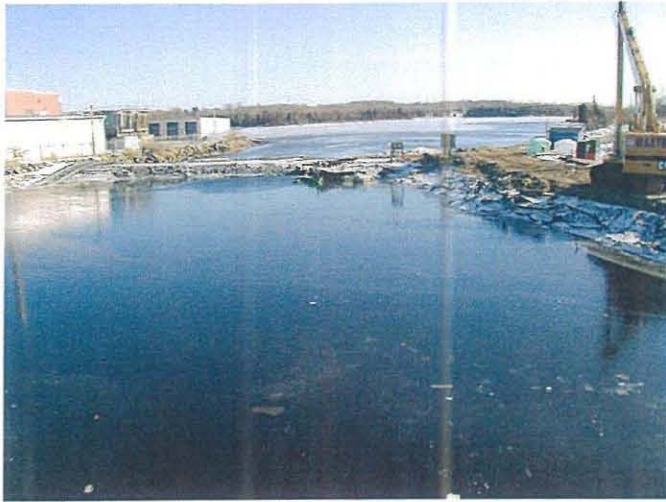
**Conditions after berms opened due to heavy rain**

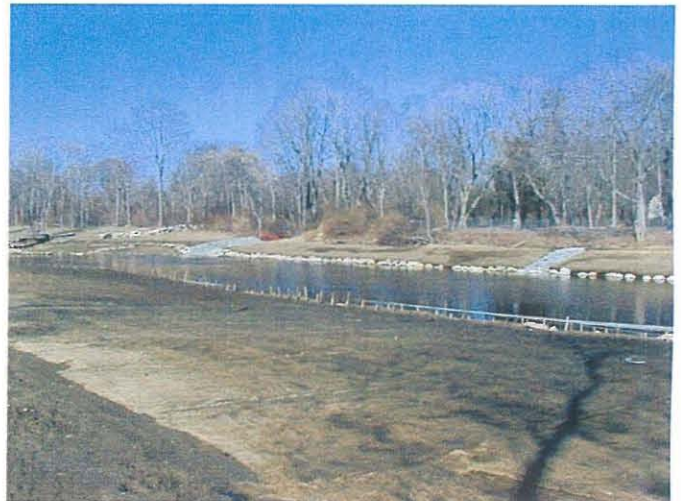
**Restored condition. Note: Water elevation = -0.5ft**  
Photo # WS31903  
3/19/03  
JPK

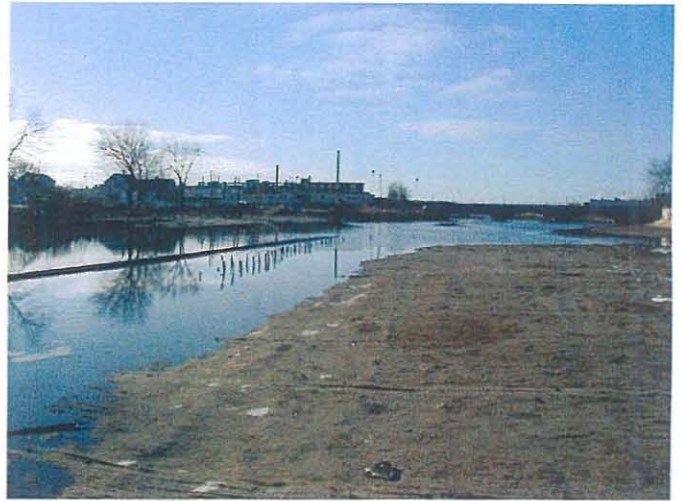
**Restored condition. Note: Water elevation = 1.7 ft**  
Photo # WS32001  
3/20/03  
JPK

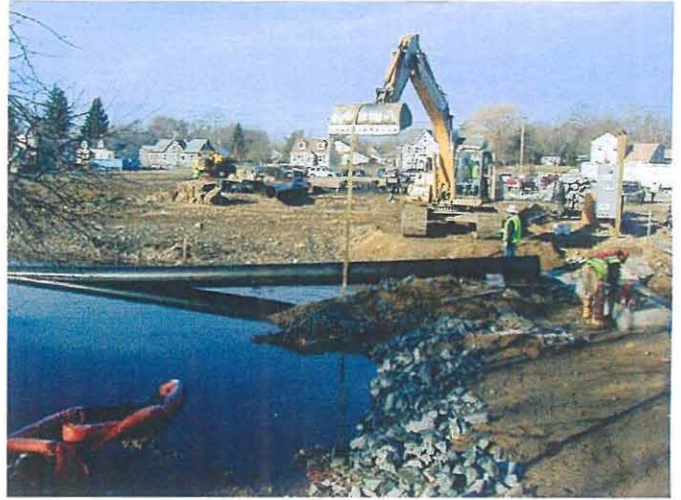
**Removal of the by-pass piping from river**  
Photo # WS32005  
3/20/03  
JPK

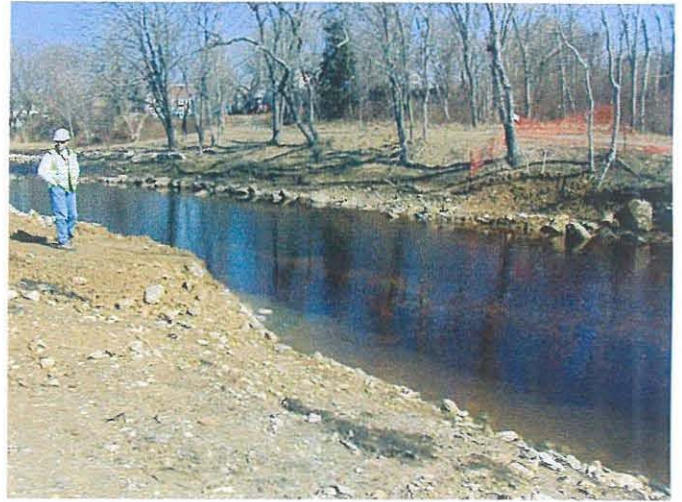
**Site conditions following removal of the north berm**  
Photo # WS32401  
3/24/03  
JPK

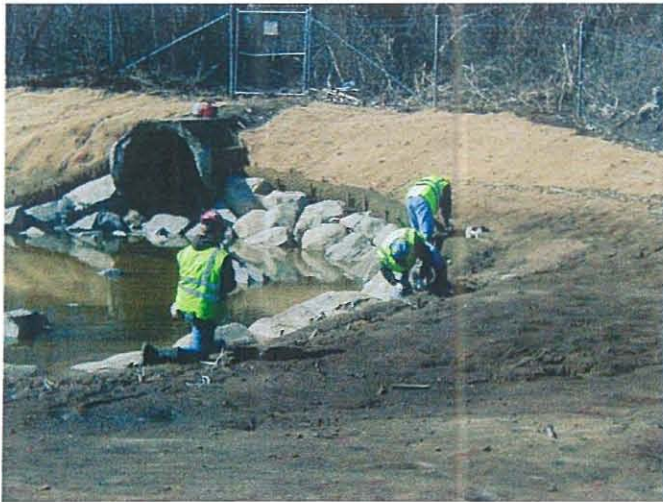
**MT employees securing the coir logs**  
Photo # WS32402  
3/24/03  
JPK

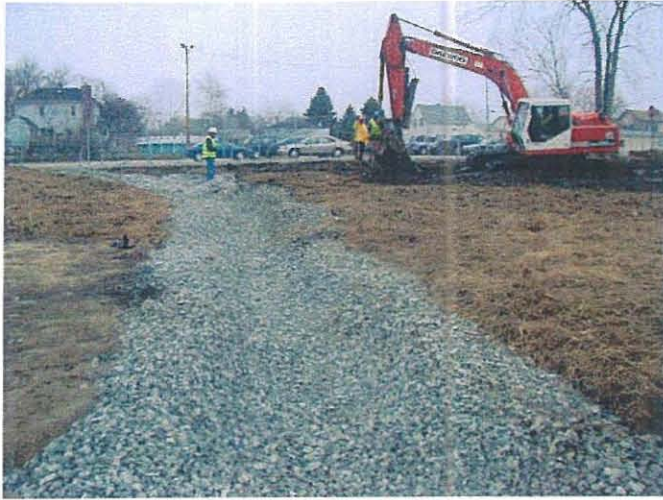
**Construction of drainage swale north of Tieleist lot**  
Photo # WS40701  
4/07/03  
JPK
