**PINE STREET CANAL SUPERFUND SITE  
BURLINGTON, CHITTENDEN COUNTY, VERMONT**

**HISTORIC RESOURCES STUDY**

2001  
(Revised May 23, 2001)

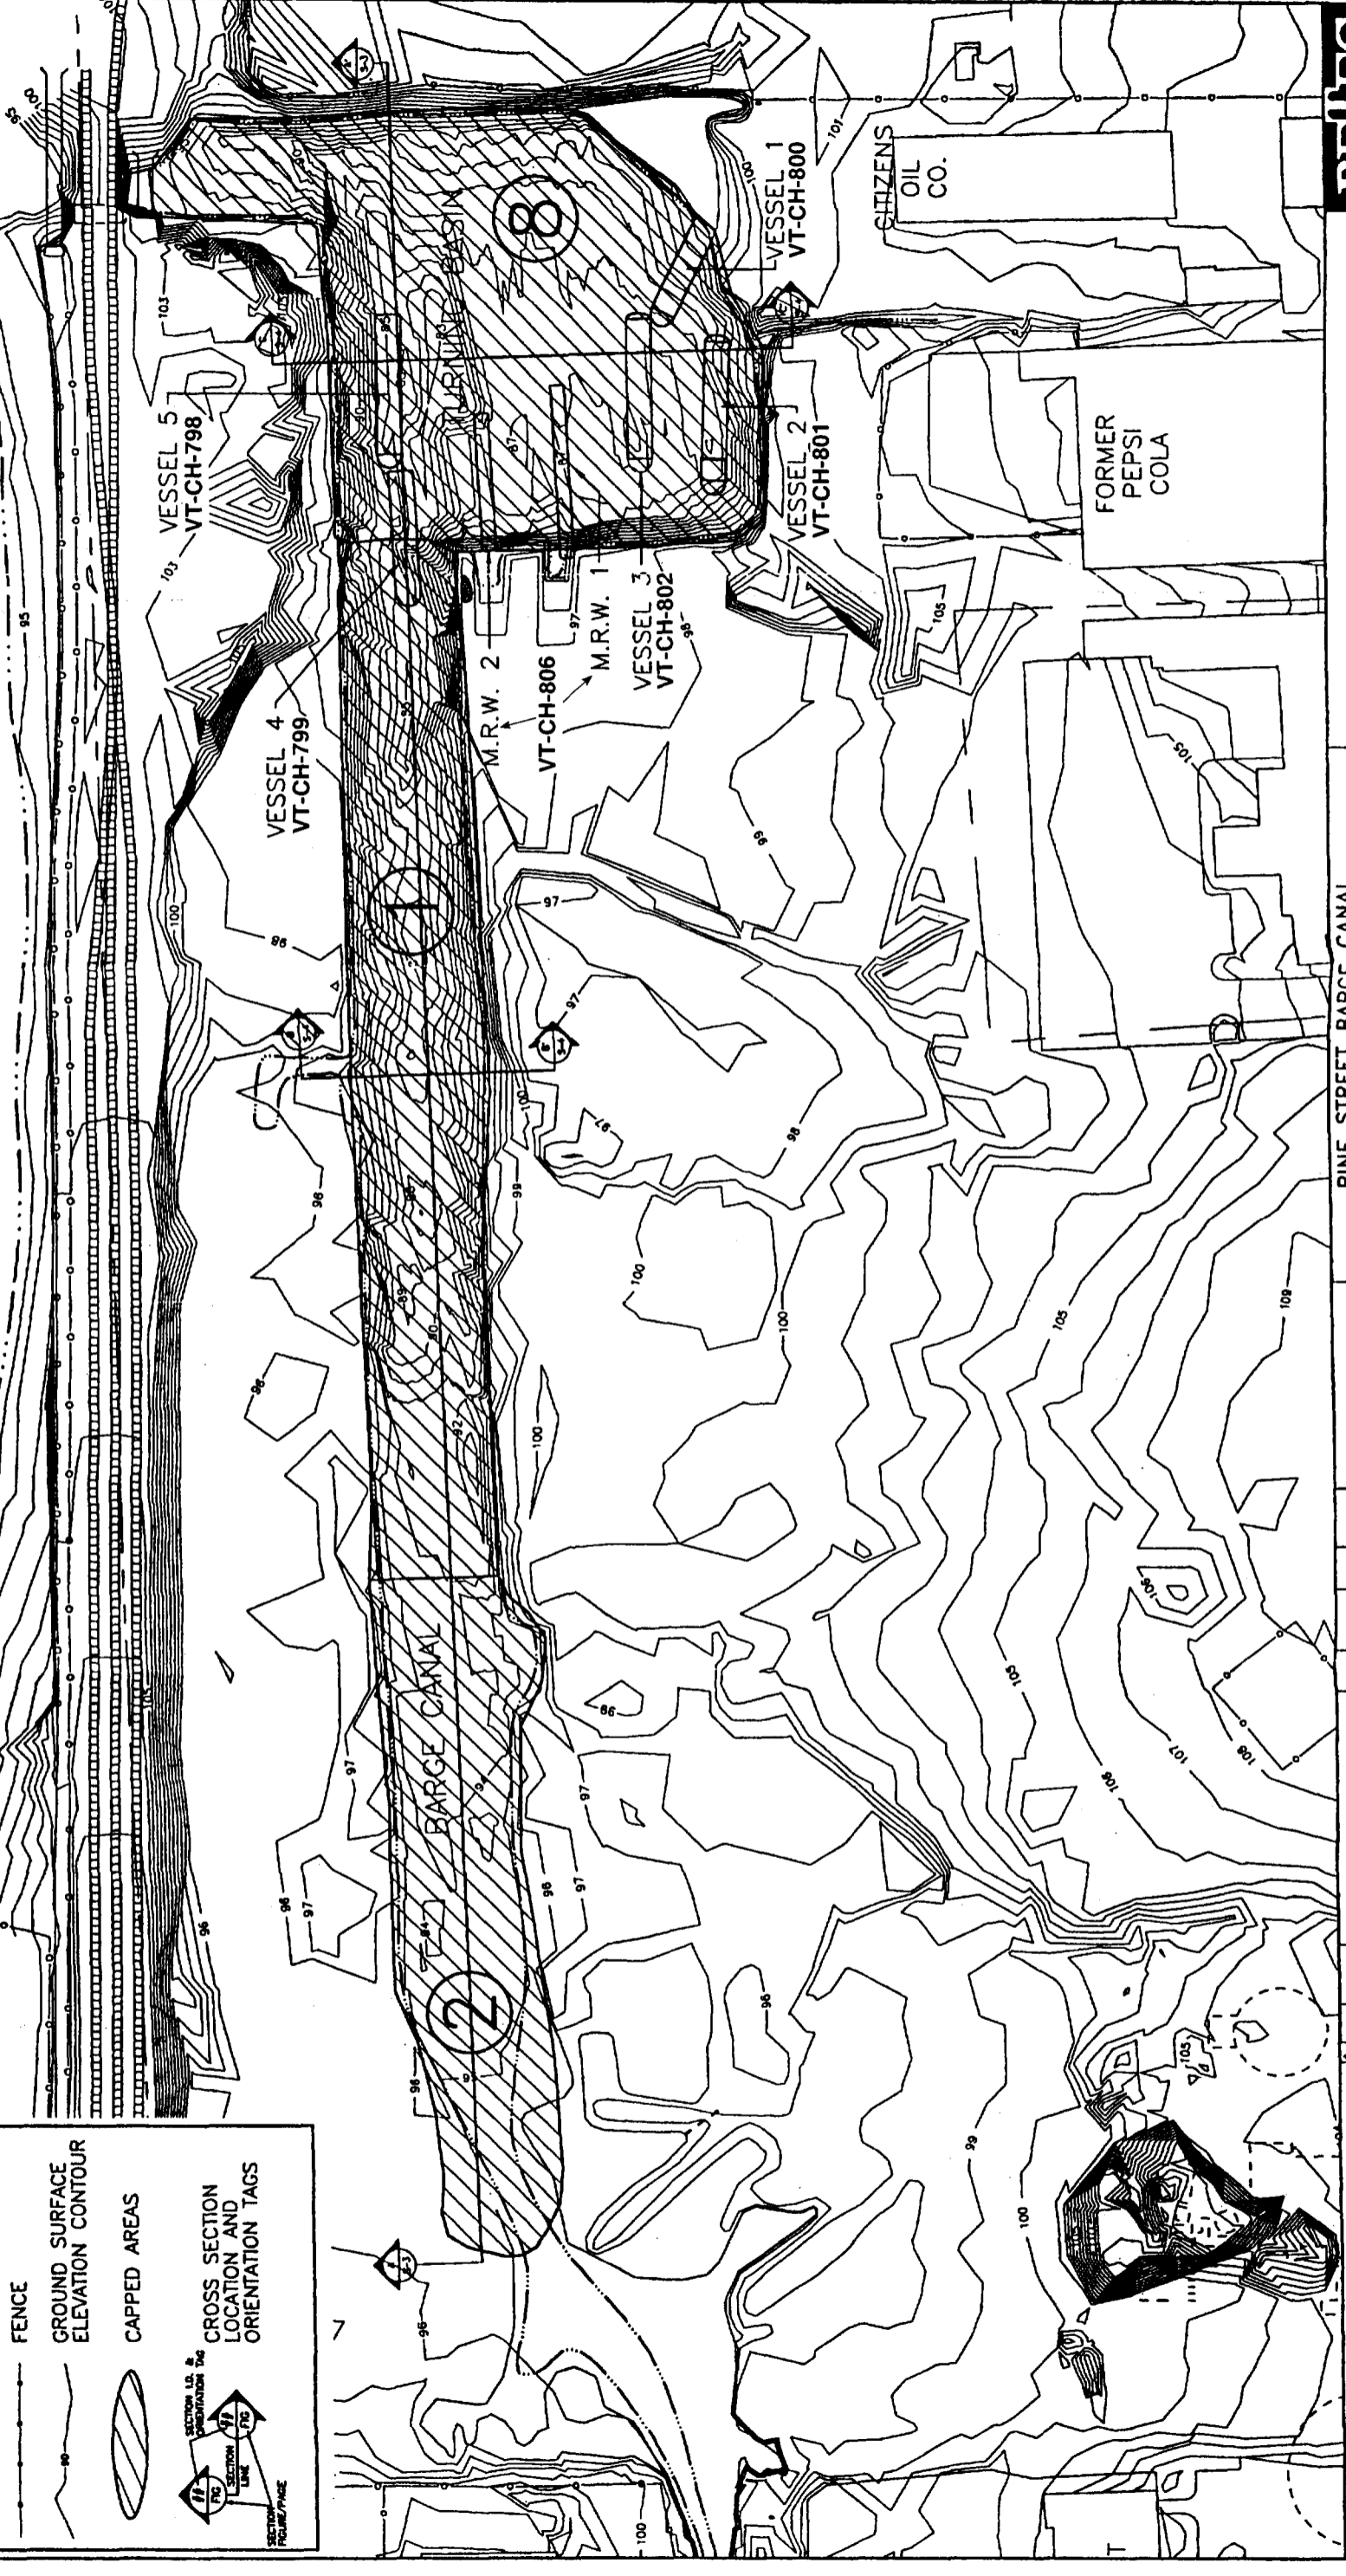
Figure 5. Pine Street Barge Canal subaqueous cap plan.

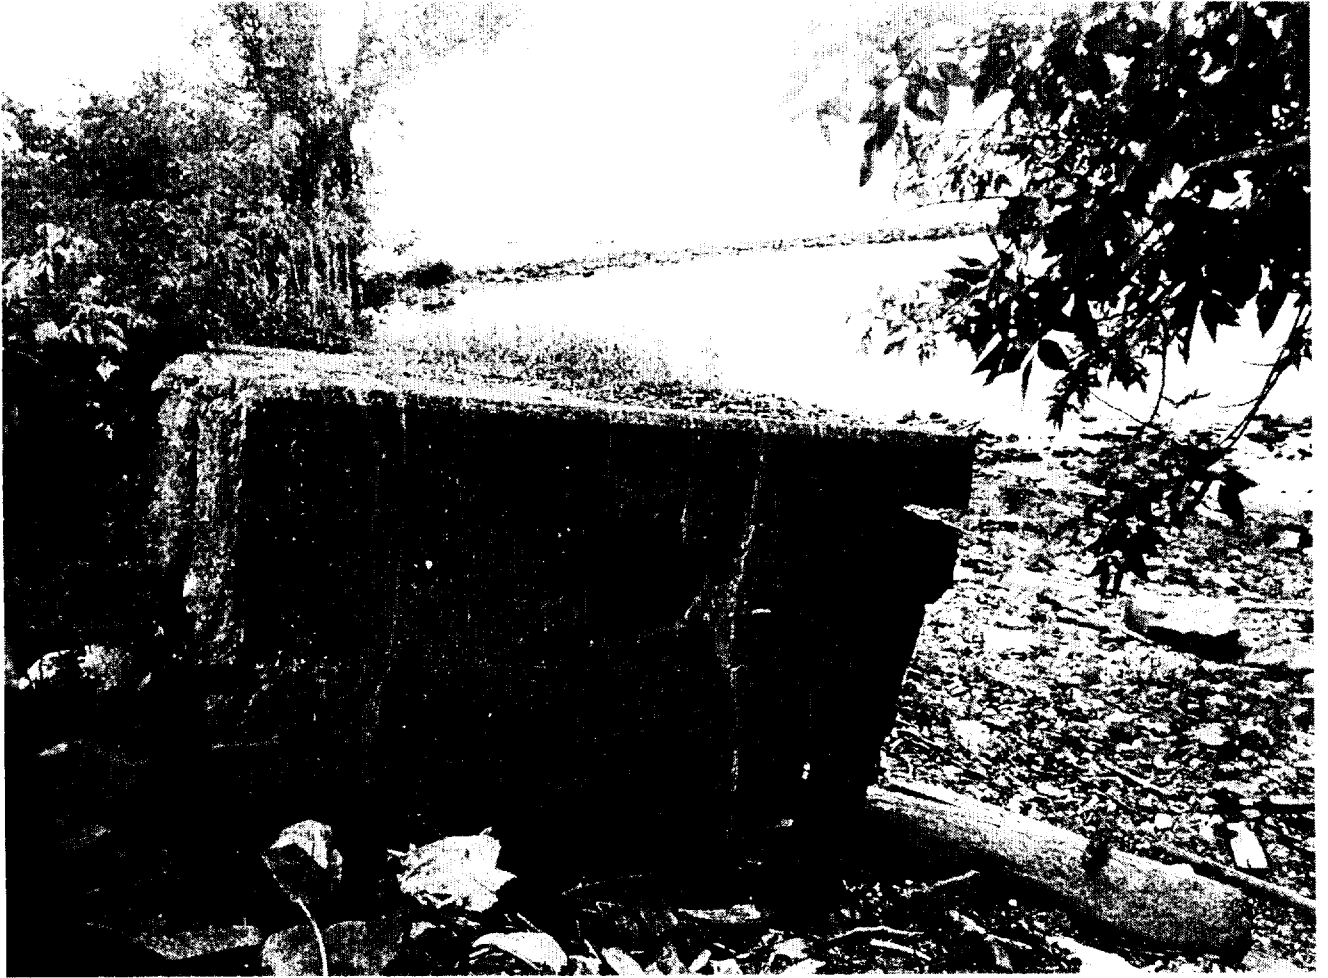
Plate 13. Portion of concrete bridge counterweight lying on ground next to bicycle path bridge. View to southwest. Note breakwater in background.
