# Sloop Island Canal Boat Study

SDMS DocID 454657

# Vessel Description

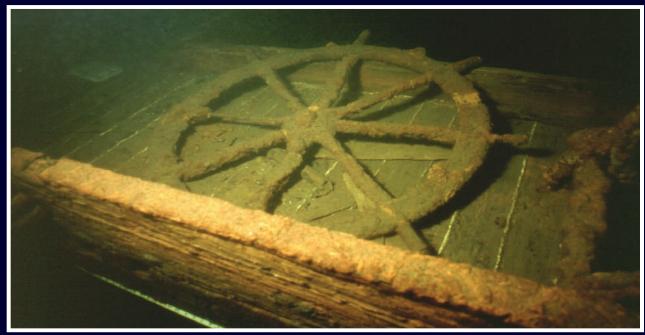
Steering wheel onboard the Sloop Island Canal Boat

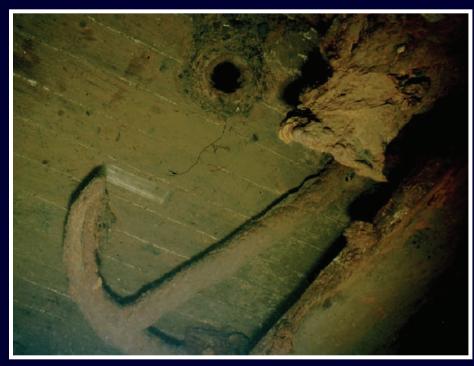
Anchor on the deck of the vessel

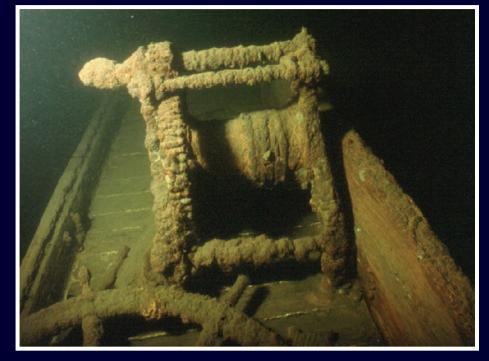
Steering mechanism located near the steering wheel

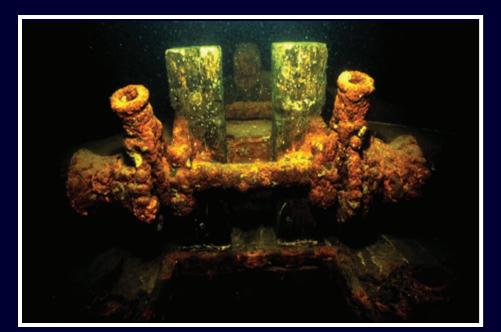
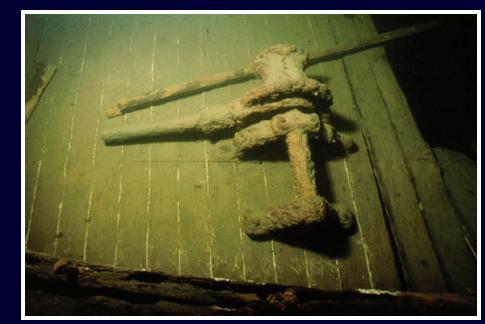
Bow Windlass Stern Windlass

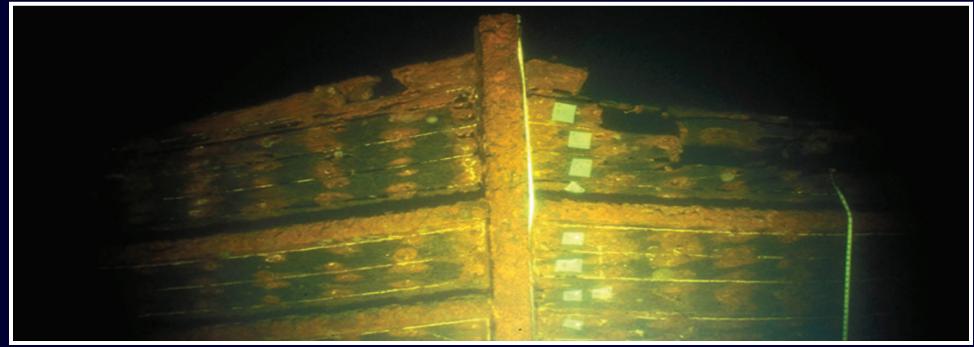
Bow and Stem of the vessel

The Sloop Island Canal Boat rests below 85 feet of cold water and is in excellent condition. Its hull, with one single, large open cargo hatch, rises about 10 feet off the bottom, presenting an impressive structure. The vessel's hull, like that of nearly all canal boats, is box-shaped with vertical sides, a flat bottom and blunt ends - a shape designed to carry as much cargo as possible within the confines of the size allowed by the canal locks. The boat is 97 feet  $3\frac{1}{2}$  inches long, 17 feet 10 inches wide, and is approximately 9 feet 10 inches high.

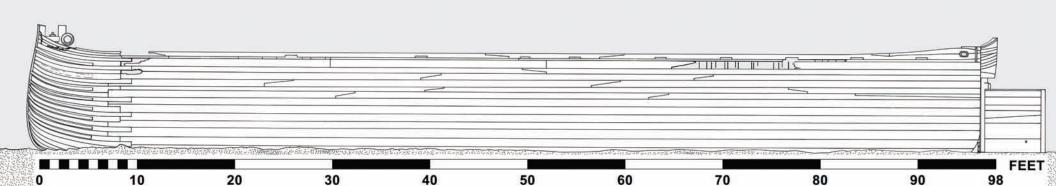
Above left: Artifacts jumbled in the vessel interior. Above Right: LCMM archaeologist records artifacts on the vessel's deck. Below: Drawing of the Sloop Island Canal boat based on archaeological documentation.

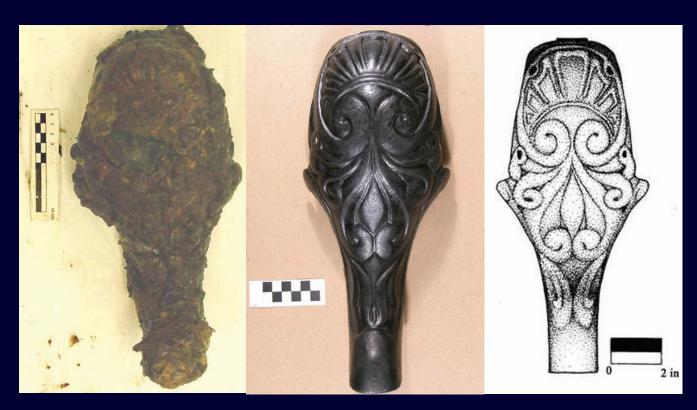
Above: LCMM archaeologist drafting an image of the wreck. Left to Right: Pretreatment, post-treatment and inking images of a cast iron stove leg recovered from the wreck and conserved by LCMM.

The process of artifact conservation begins with pre-treatment photographs, drawings, measurements and an assessment of each artifact. The artifacts are then stabilized using a procedure appropriate for its material type. For example, iron would be treated by removing any surficial rust, then sealing the artifact with tannic acid and wax. Wood, however, would be treated with either pine rosin or polyethylene glycol (PEG), a process that can either take months or even years depending on the size of the artifact.

A detailed record is kept of every treatment employed to conserve each artifact. Once an artifact is stable, post-treatment drawings, photographs and measurement are taken and the artifact is either archivally packaged for storage or put on display in an exhibit.
