***Aquatic Invertebrate, Sediment, and Surface Water Sampling in Unnamed Stream  
Commerce Street Plume Superfund Site  
Williston, VT  
Final Technical Memo***

TDF No. 2559A,B,C  
Task Order No. 86  
Task No. 04

ESAT - Region I

October 4, 2012

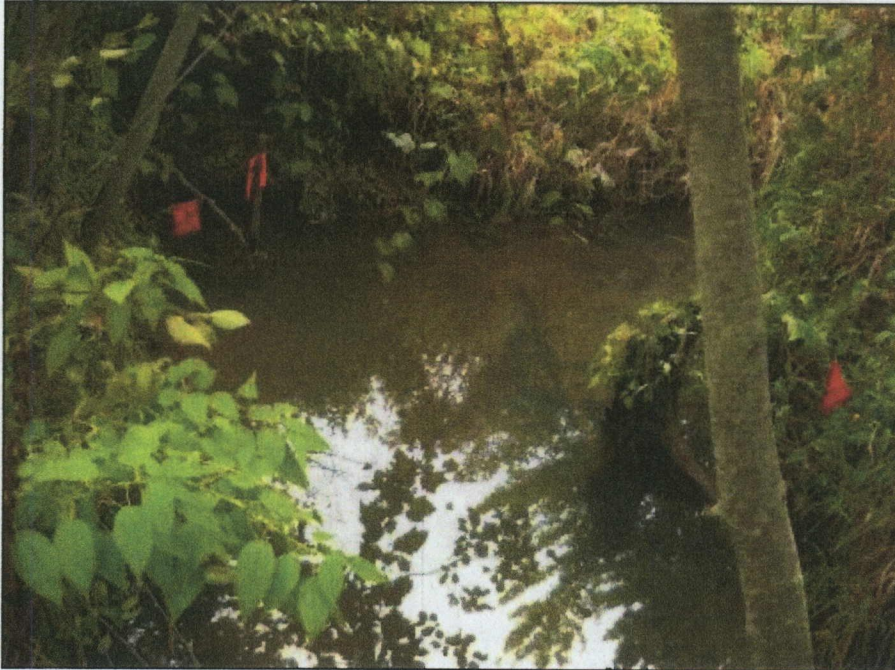
**Figure 1. PW-20 (facing east)**

Sampling stations PW-20 and PW-17 were sampled on Tuesday September 11, 2012 (see **Figure 1** and **Figure 2** for lotic habitat pictures).

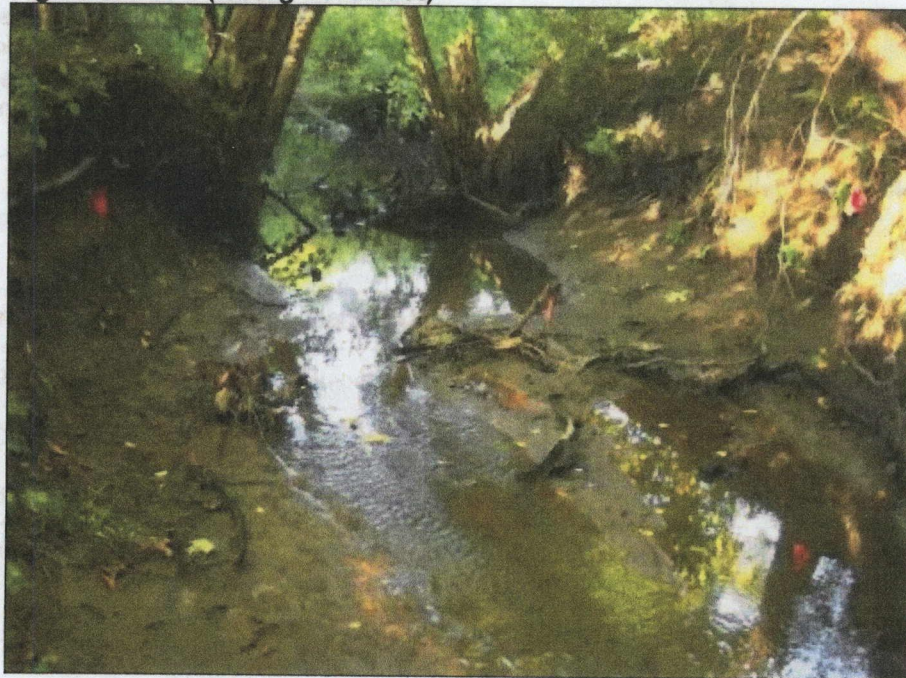
**Figure 5. PW-1 (facing northeast)**

Rick Sugatt (EPA) and Michael Ferrier (ESAT) decided not to sample PW-1, the on-site reference, as originally planned. PW-1 could not be properly sampled because the stream at this location was only a couple of inches deep and quite narrow, which made it difficult to collect a surface water sample without disturbing the sediment. In addition, the substrate consisted mostly of fine sediment (as seen in **Figure 5**).

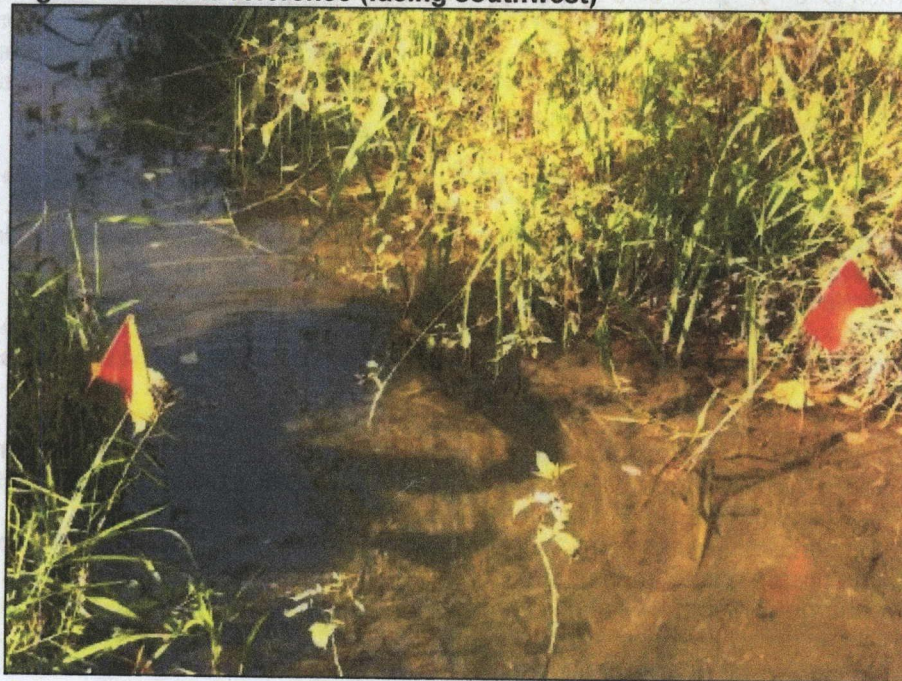
**Figure 6. off-site reference (facing southwest)**

The off-site reference location was sampled on Thursday September 13, 2012, (See **Figure 6**). The sampling team received permission from Rich Watson to park in the Vermont Plastic Specialists, Inc. parking lot at 209 Blair Park Road. The stream was accessed via the Western side of the Vermont Plastics building near the loading dock. This area of the stream consisted of a small wetland fed by urban runoff. The sampling team had difficulty finding a more suitable reference location upstream of the groundwater plume without getting into more industrialized areas.
