PRELIMINARY SITE ASSESSMENT

SURFACE COATINGS, INC.

100 Eames Street
Wilmington, Massachusetts

Date Submitted:
August 6, 1980

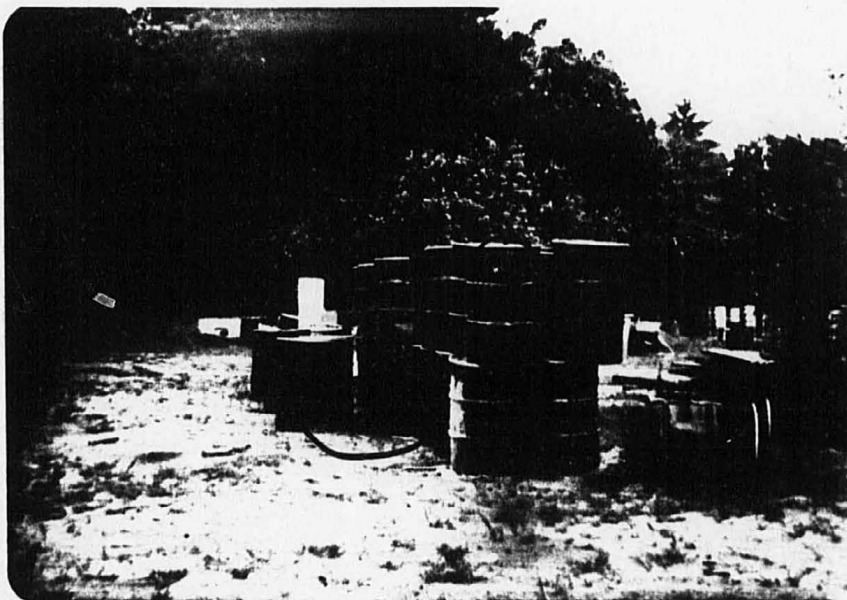
FIGURE 1

- A. Scene: *STACKED DRUMS AT REAR OF R/S PROPERTY TAKEN
THROUGH WEST FENCE; NOTE "DIRTY WASH" LABEL, POSSIBLE spill*
- B. Photo by: *PAUL CLAY, EET/FIT*
- C. Date/Time: *2/22/80 1510 HRS*
- D. Sky Cond.: *CLEAR*
- E. Camera/Lens: *WERLISA/1.75 FIXED FOCUS*
- F. Setting: *SUN*
- G. Type of Film: *Fujichrome ASA 100*
- H. Witness(es): *DAVID COOK, EET/FIT*

The group of barrels containing off-spec solvents near the tank farm should be emptied and/or removed, eliminating the spill potential that presently exists there.

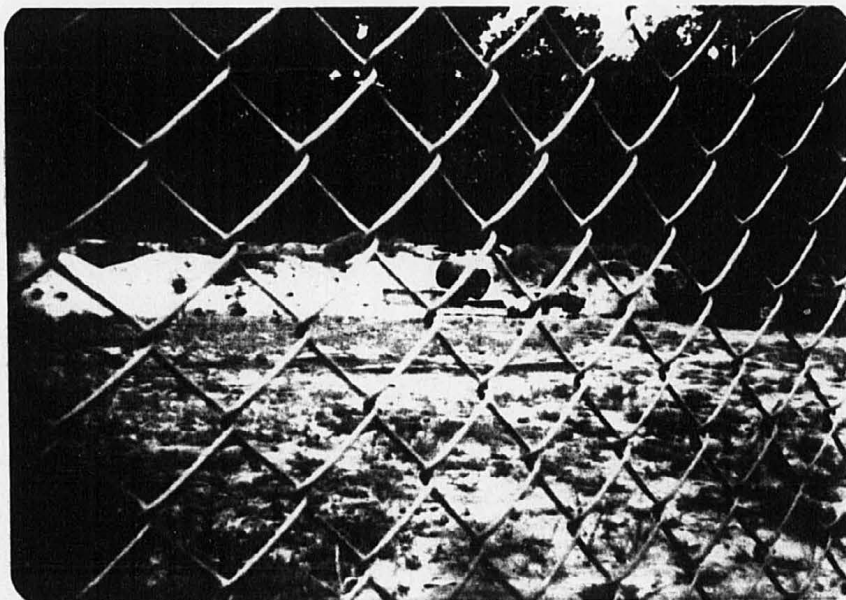
FIGURE 2

- A. Scene: *DISTURBED FILL AREA AT REAR OF RAFFI & SWANSON
TAKEN THROUGH FENCE ON WEST BOUNDARY OF PROPERTY*
- B. Photo by: *PAUL CLAY, EEI/FIT*
- C. Date/Time: *7/22/80 1510 HRS*
- D. Sky Cond.: *CLEAR*
- E. Camera/Lens: *WERLISA/1.75 FIXED FOCUS SUN SETTING*
- F. Setting: *SUN*
- G. Type of Film: *FUTICROME ASA 100*
- H. Witness(es): *DAVID COOK, EEI/FIT*

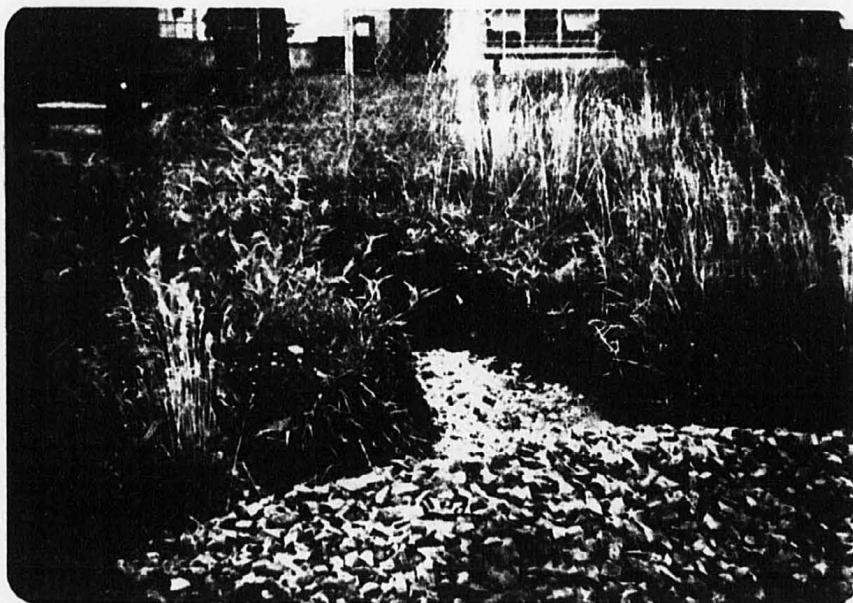
FIGURE 3

A. Scene: *VIEW OF PARTIALLY FILLED DRAINAGE CUT AT
WESTERN SIDE OF R&S PROPERTY (TAKEN FROM B&M TRACKS)*
