# Immediate Response Action Status Report

**Willis Avenue Apartments  
Congress and Exchange Aves.  
Medford, Massachusetts**

**RTN 3-31839**

**IMMEDIATE RESPONSE ACTION STATUS REPORT**

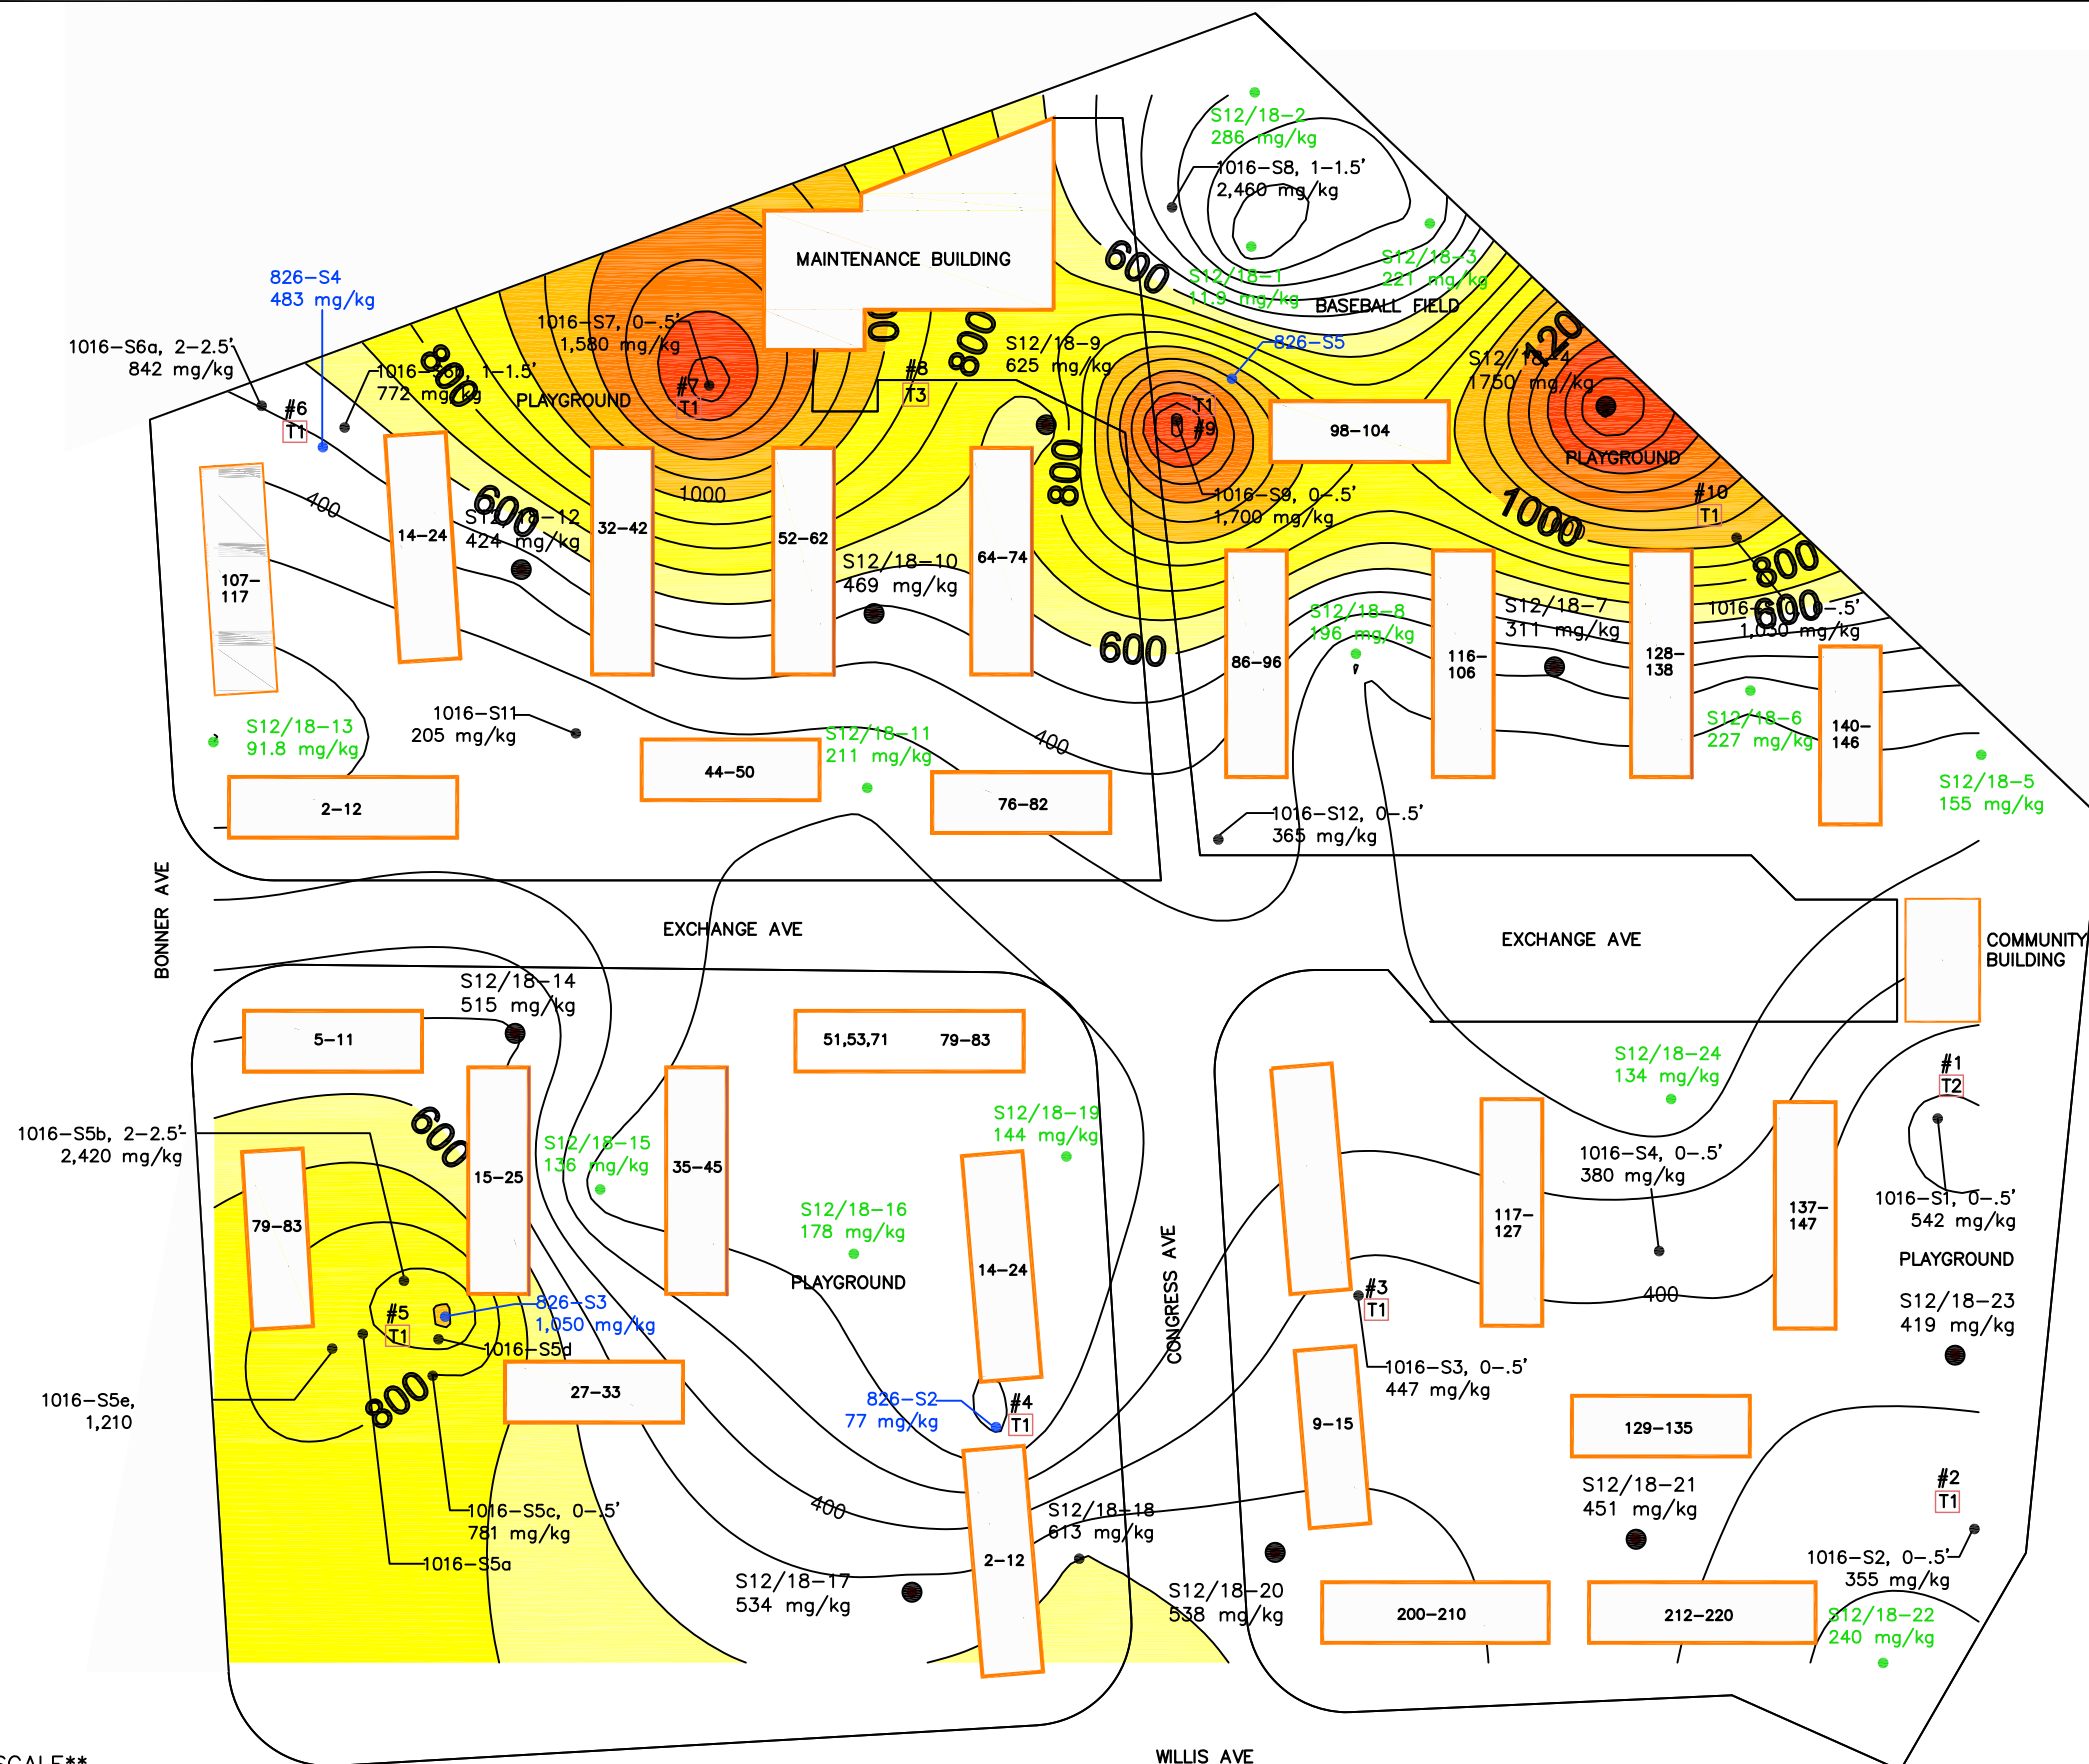
- LEGEND**
- SOIL SAMPLE LOCATIONS 8/26/2013
  - SOIL SAMPLE LOCATIONS 10/16/13
  - SOIL SAMPLE LOCATIONS BELOW RCS1 12/18/2013
  - SOIL SAMPLE LEAD CONCENTRATIONS ABOVE RC-S1

The December 2013 data has been incorporated into the site-wide data set. The resultant data revealed lead concentrations ranging from 11.9 mg/kg to 1,750 mg/kg. Following receipt of the data, GREEN contacted the MassDEP to discuss the proposed IRA activities, including additional IH mitigation in this area which included the relocation of fencing from areas of lower lead contamination to expand and encompass the areas where higher concentrations of lead were observed.

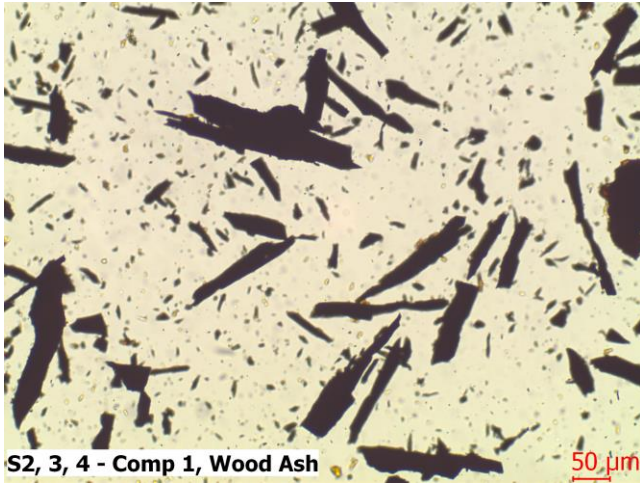
Particle type 3 consisted of four (4) friable, black grains approximately 1mm-3mm in length. The PLM examination indicated this particle type to be consistent with wood ash. The PLM and SEM photos show the cellular structure typical of wood still present in these grains.
