**Re: GE-Pittsfield/Housatonic River Site
Groundwater Management Area 5 (GECD420)
Post-Certification Inspection Report for 2016**

MONITORING WELL INTEGRITY ASSESSMENT

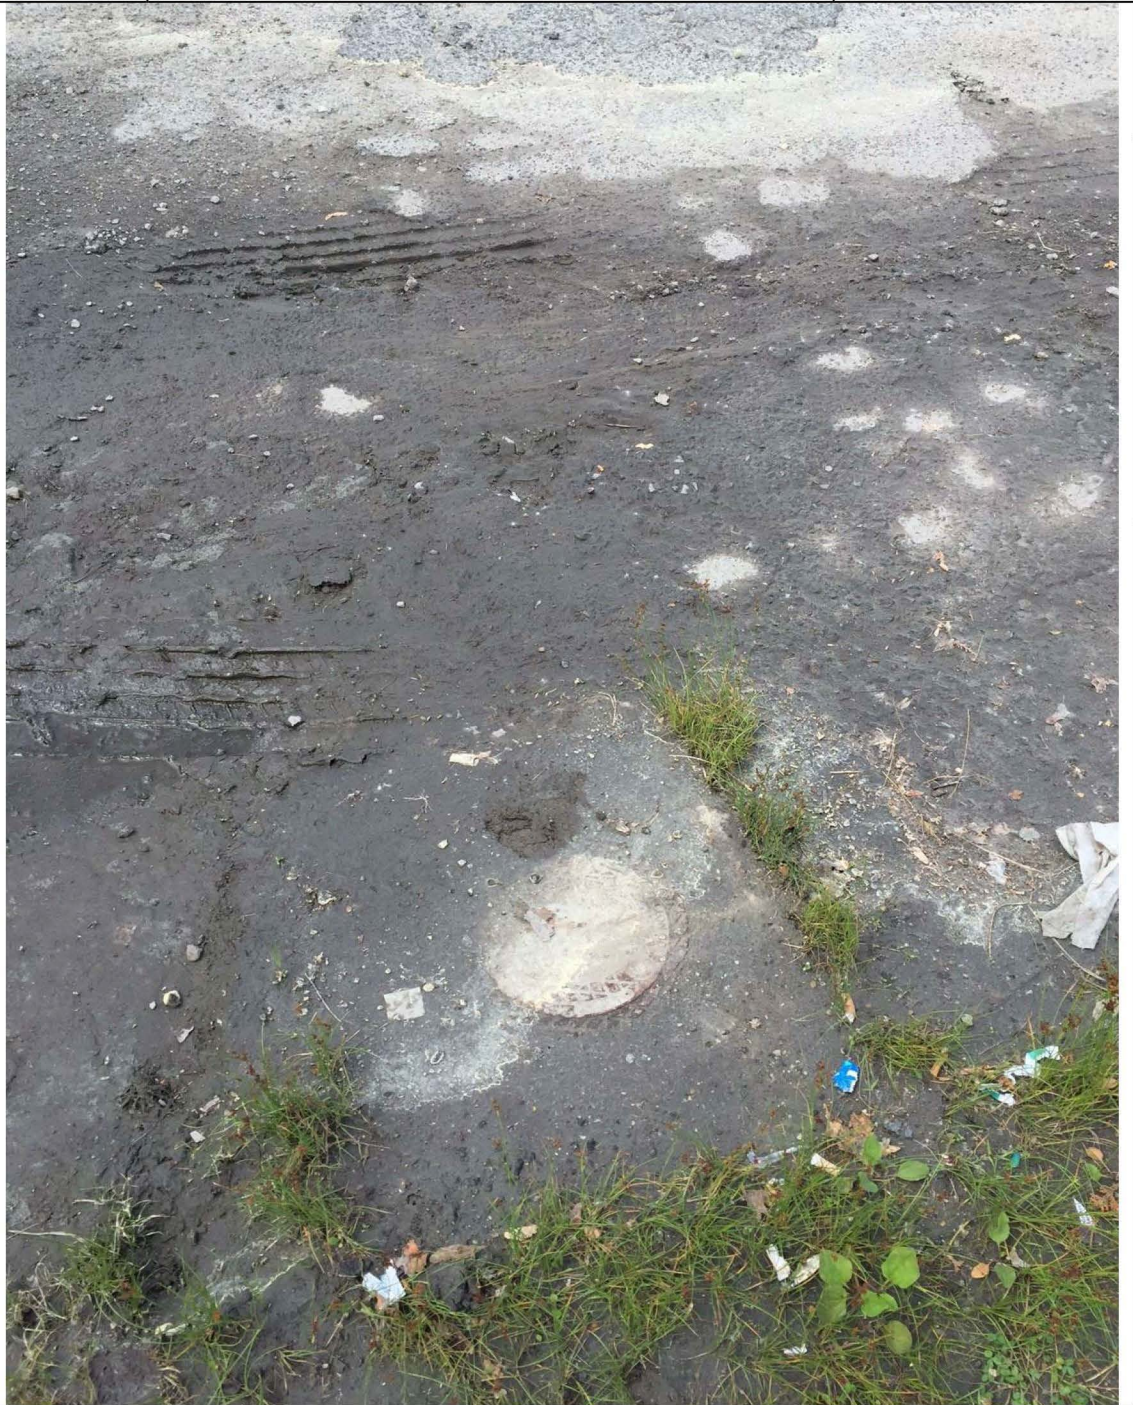
GMA5-1

The June 2016 inspection indicated that all of the seven monitoring wells inspected were in usable condition. Only two minor maintenance issues were identified. Specifically, as noted in Table 1 and Attachment A, well identification markings had faded at one monitoring well (GMA5-1) and another flushmount monitoring well (GMA5-6) was difficult to locate in the grass.

Well I.D. Clearly Marked: YES NO
Well Completion: FLUSH MOUNT ABOVE-GRADE STANDPIPE
Lockable Cover: YES NO DAMAGED (Describe below)
Lock Present: YES NO ADDED Key Brand/Number: 2537 Master
Measuring Point Marked: YES NO ADDED
Well Riser Diameter (inches): 2"
Well Riser Type: PVC Stainless Steel Other (Describe)

Repair Concrete/Surface Completion: YES NO
Re-Survey Well: YES NO If yes, list date performed:
Remove Sediment and Re-Measure Depth: YES NO If yes, list date performed:
Replace Well Cap: YES NO If yes, list date performed:
Replace Bolts: YES NO If yes, list date performed:
Other/Miscellaneous Observations: Voc Vapor not detected

As noted above, well identification markings were faded on well GMA5-1. The faded well identification marking on the lid of that well was enhanced during the June 2016 inspection, as shown in Table 1. Additionally, the flushmount well that was difficult to locate in the grass during the June 2016 inspection (well GMA5-6) was subsequently marked in the field with a stake and florescent flagging on July 19, as also noted in Table 1.

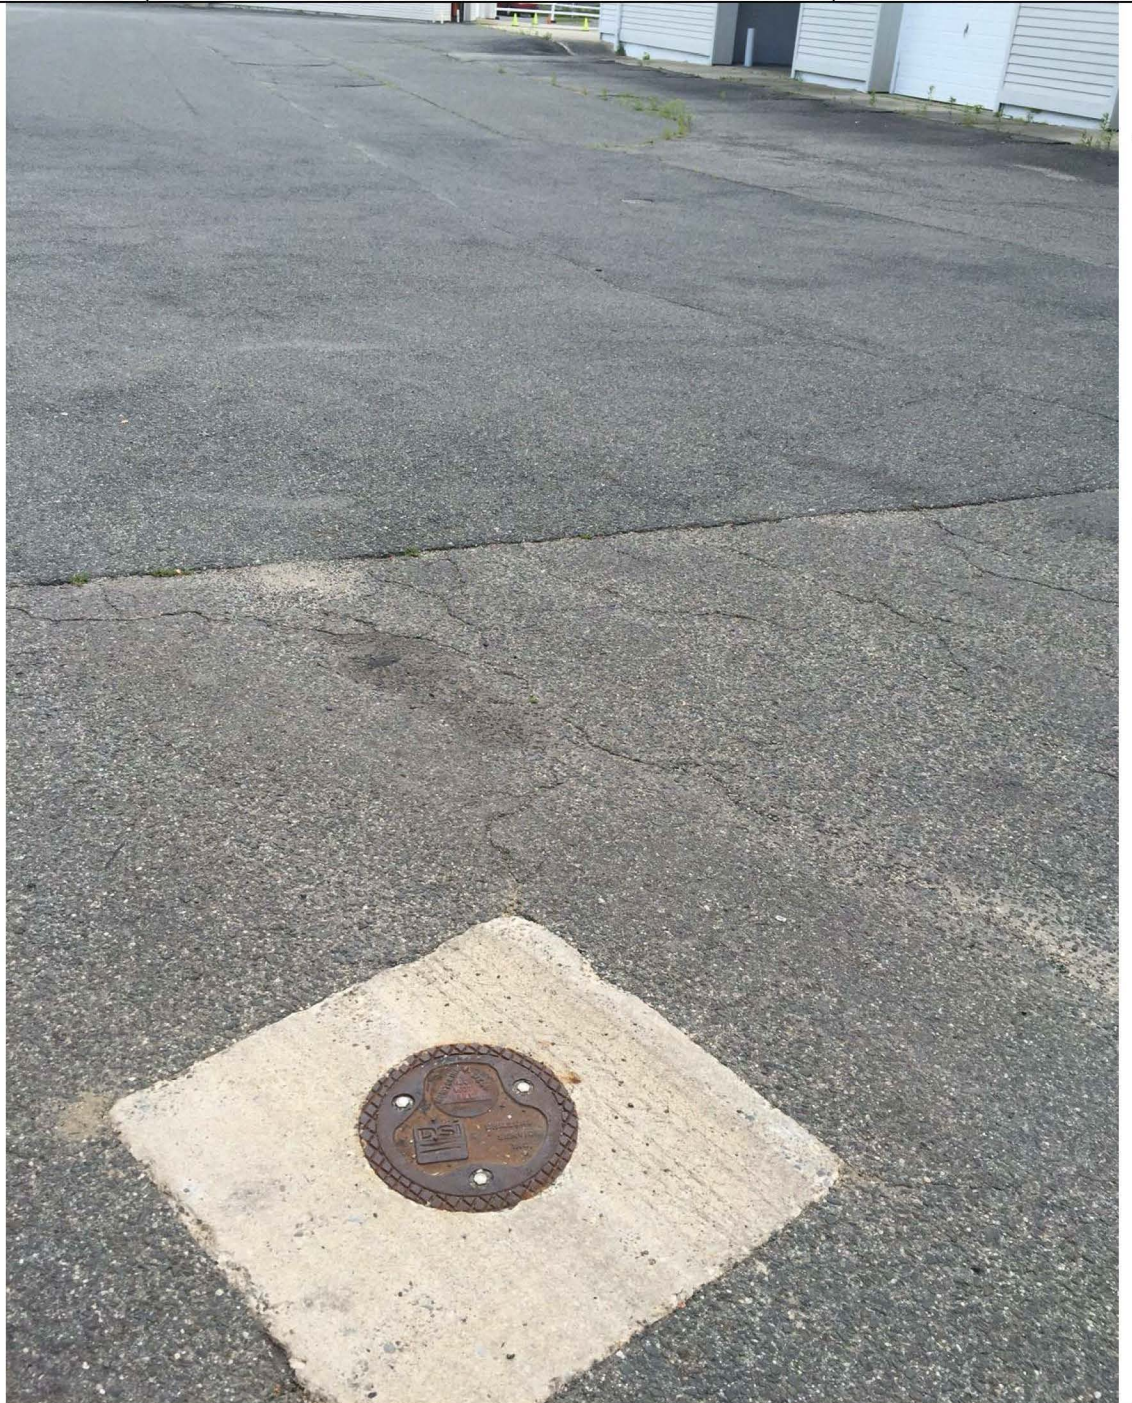
GMA5-3

Well I.D. Clearly Marked: YES NO
Well Completion: FLUSH MOUNT ABOVE-GRADE STANDPIPE
Lockable Cover: YES NO DAMAGED (Describe below)
Lock Present: YES NO ADDED Key Brand/Number: 2537 Masker
Measuring Point Marked: YES NO ADDED
Well Riser Diameter (inches): 2"
Well Riser Type: PVC Stainless Steel Other (Describe)

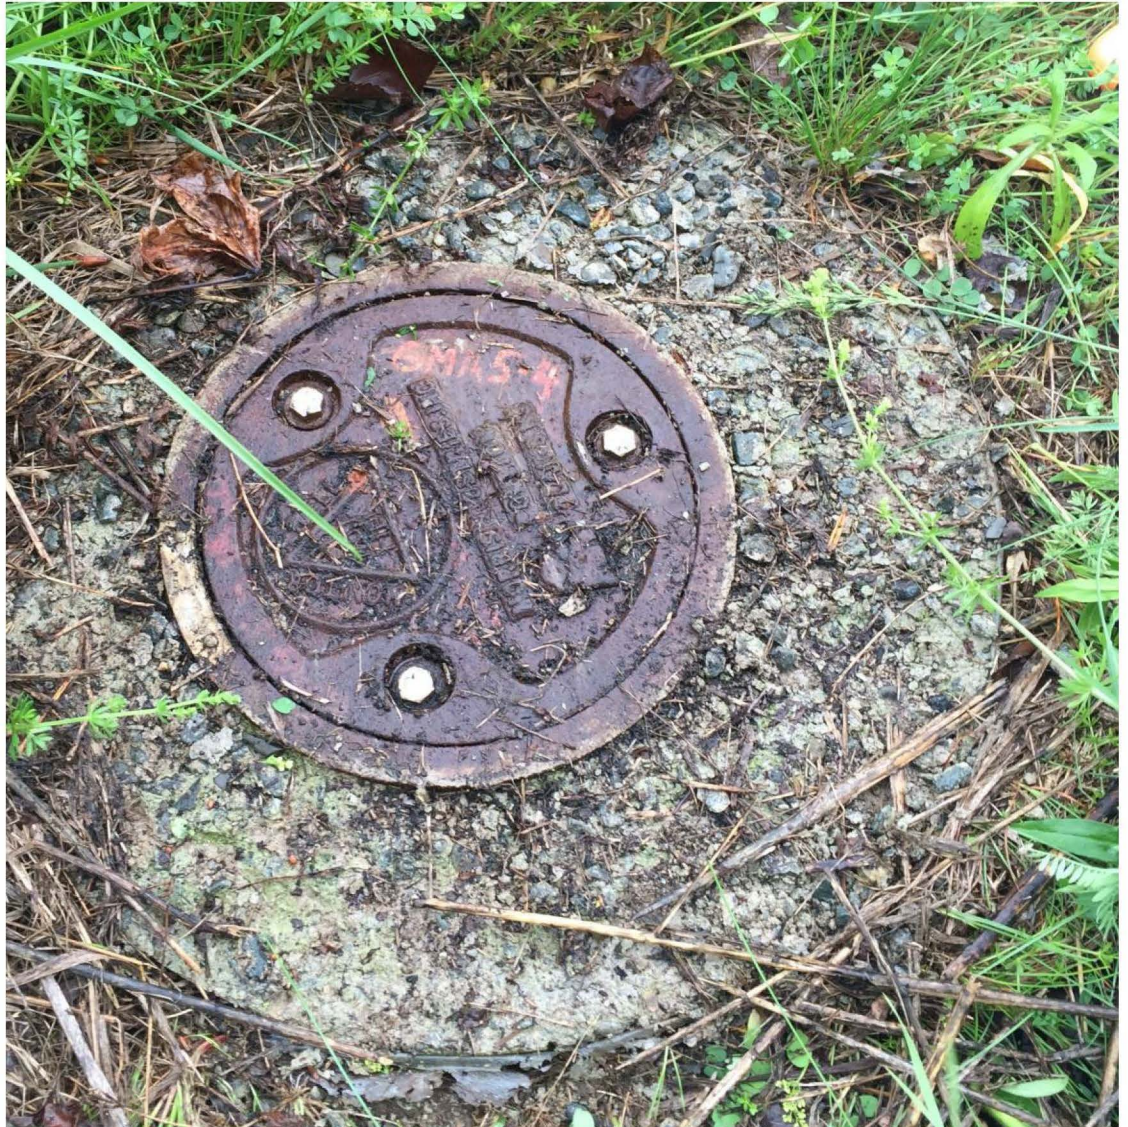
GMA5-4

Well I.D. Clearly Marked: YES NO
Well Completion: FLUSH MOUNT ABOVE-GRADE STANDPIPE
Lockable Cover: YES NO DAMAGED (Describe below)
Lock Present: YES NO ADDED Key Brand/Number: Master 2537
Measuring Point Marked: YES NO ADDED
Well Riser Diameter (inches): 2"
Well Riser Type: PVC Stainless Steel Other (Describe) ~~St~~

Repair Concrete/Surface Completion: YES NO
Re-Survey Well: YES NO If yes, list date performed: _____
Remove Sediment and Re-Measure Depth: YES NO If yes, list date performed: _____
Replace Well Cap: YES NO If yes, list date performed: _____
Replace Bolts: YES NO If yes, list date performed: _____
Other/Miscellaneous Observations: Vocs not detected

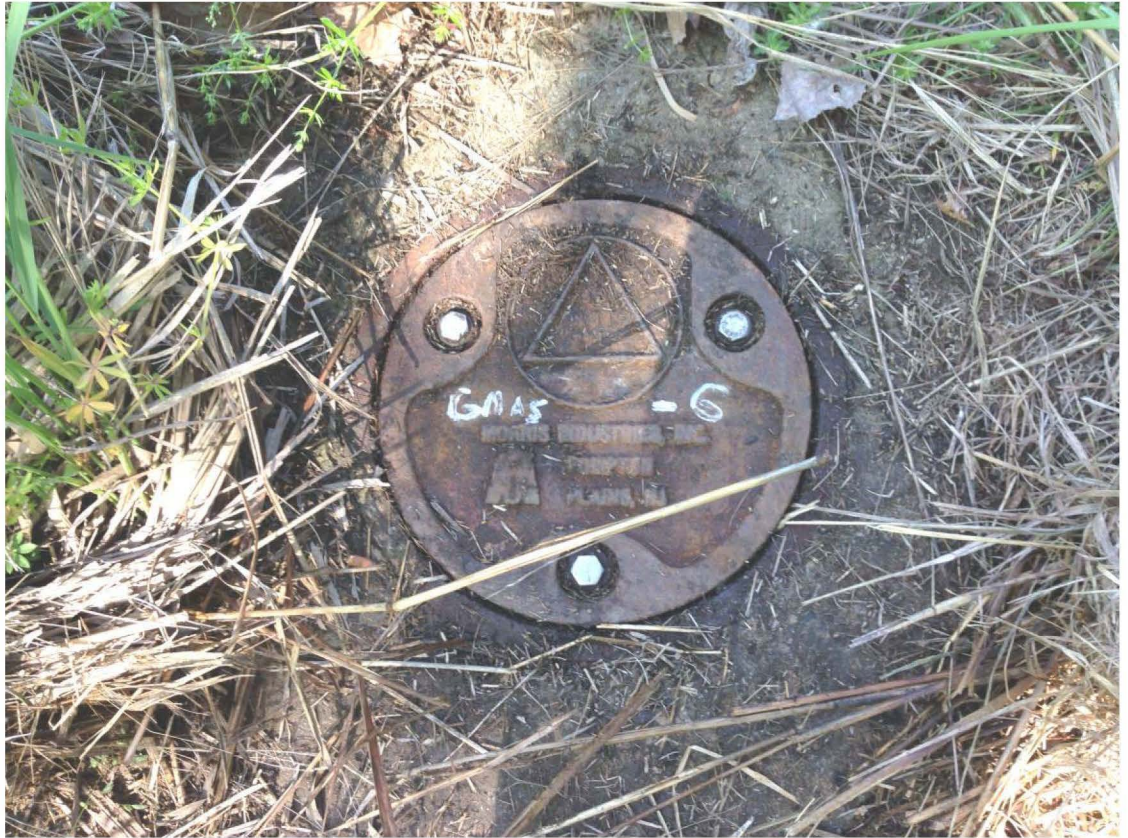
GMA5-6

Well I.D. Clearly Marked: YES NO
Well Completion: FLUSH MOUNT ABOVE-GRADE STANDPIPE
Lockable Cover: YES NO DAMAGED (Describe below)
Lock Present: YES NO ADDED Key Brand/Number: Master 2537
Measuring Point Marked: YES NO ADDED
Well Riser Diameter (inches): 2"
Well Riser Type: PVC Stainless Steel Other (Describe)

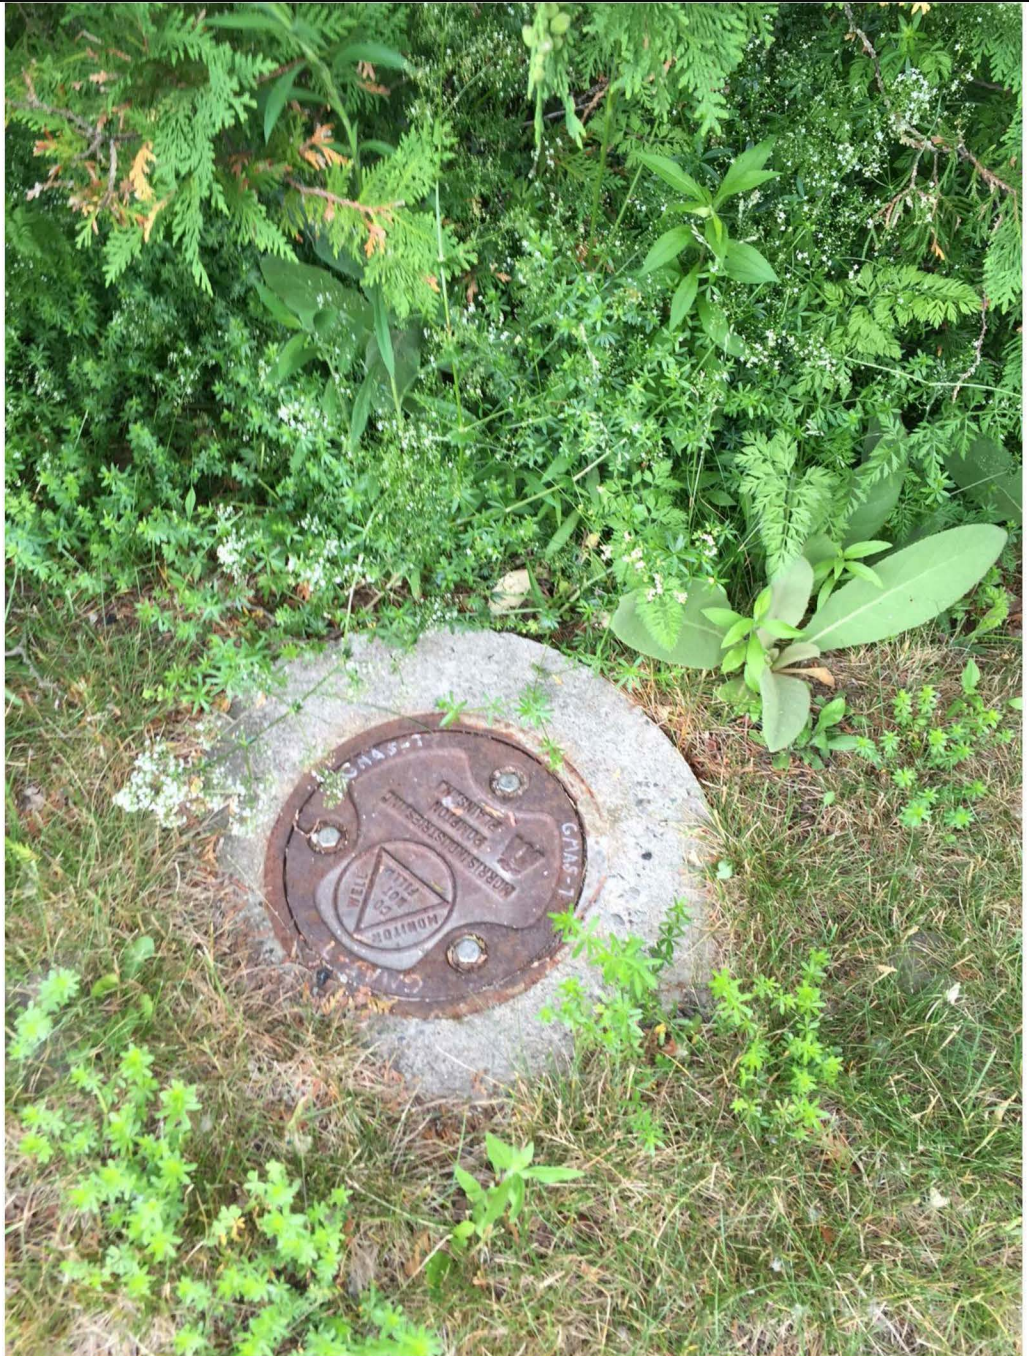
GMA5-7

Well I.D. Clearly Marked: YES NO
 Well Completion: FLUSH MOUNT ABOVE-GRADE STANDPIPE
 Lockable Cover: YES NO DAMAGED (Describe below)
 Lock Present: YES NO ADDED Key Brand/Number: Master 2537
 Measuring Point Marked: YES NO ADDED
 Well Riser Diameter (inches): 2"
 Well Riser Type: PVC Stainless Steel Other (Describe) _____

Repair Concrete/Surface Completion: YES NO
 Re-Survey Well: YES NO If yes, list date performed: _____
 Remove Sediment and Re-Measure Depth: YES NO If yes, list date performed: _____
 Replace Well Cap: YES NO If yes, list date performed: _____
 Replace Bolts: YES NO If yes, list date performed: _____
 Other/Miscellaneous Observations: NO ppm detected

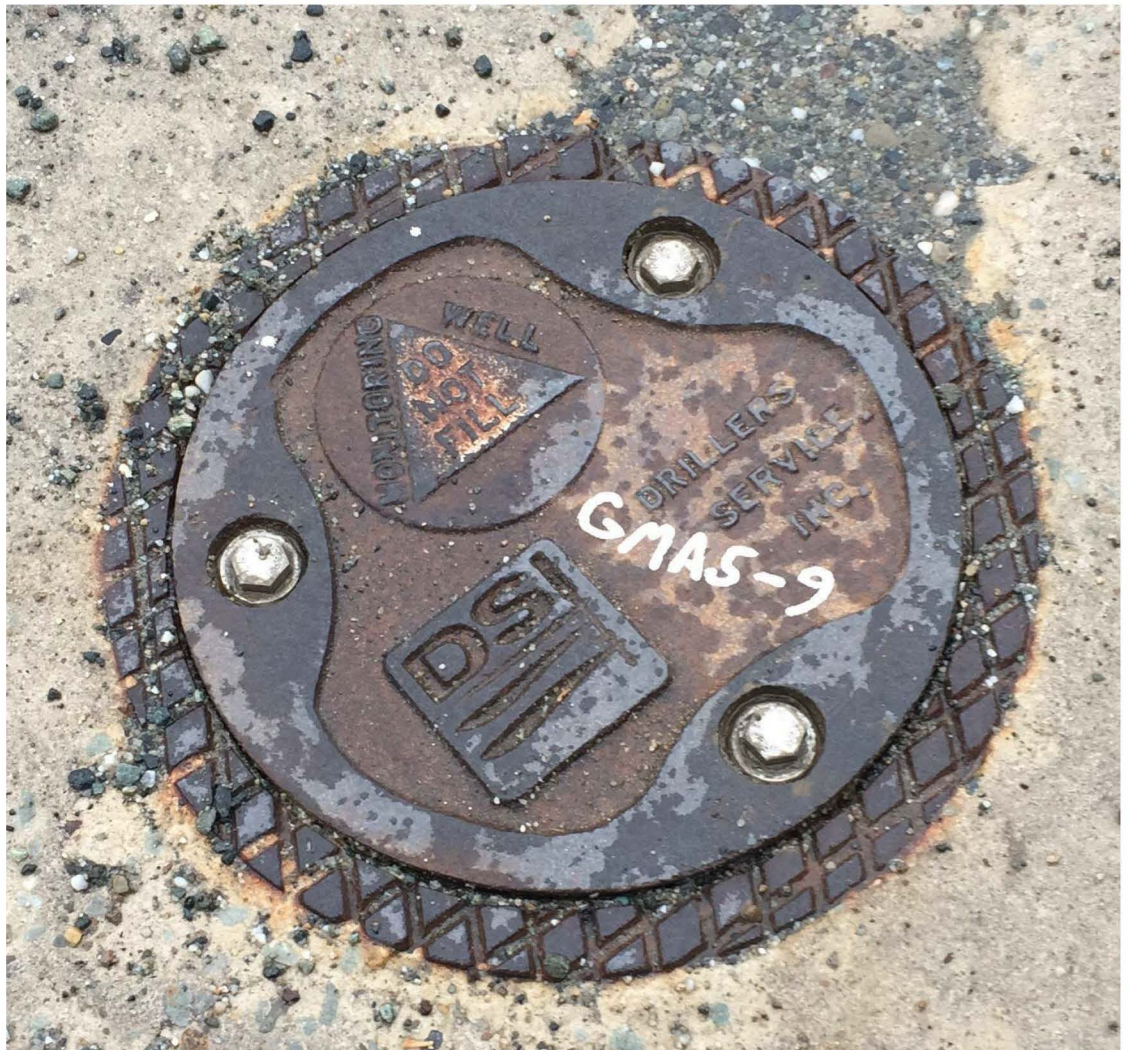
GMA5-9

Well I.D. Clearly Marked: YES NO
Well Completion: FLUSH MOUNT ABOVE-GRADE STANDPIPE
Lockable Cover: YES NO DAMAGED (Describe below)
Lock Present: YES NO ADDED Key Brand/Number: Master 2537
Measuring Point Marked: YES NO ADDED
Well Riser Diameter (inches): 2"
Well Riser Type: PVC Stainless Steel Other (Describe) _____

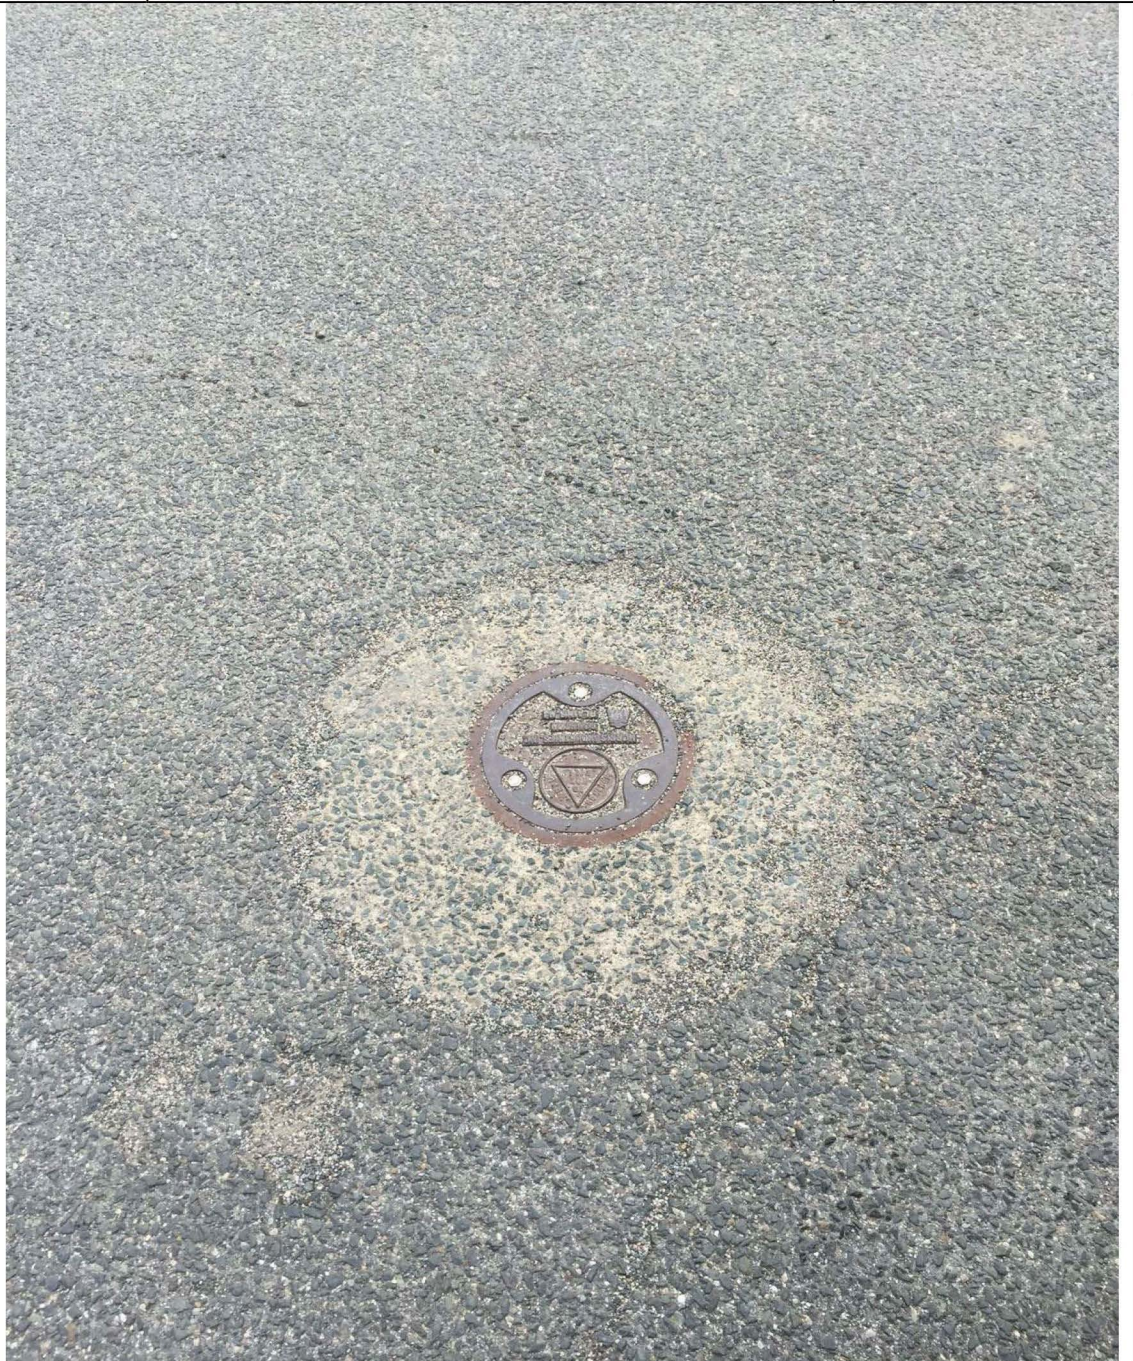
GMA5-10

Well I.D. Clearly Marked: YES NO
Well Completion: FLUSH MOUNT ABOVE-GRADE STANDPIPE
Lockable Cover: YES NO DAMAGED (Describe below)
Lock Present: YES NO ADDED Key Brand/Number: Master 2537
Measuring Point Marked: YES NO ADDED
Well Riser Diameter (inches): 2"
Well Riser Type: PVC Stainless Steel Other (Describe)
