**PHASE I  
ENVIRONMENTAL SITE ASSESSMENT**

**Old Village Mill, LLC  
57-59 & 65 Brunswick Avenue Ext.  
Plainfield, CT  
file 2672**

May 29, 2001

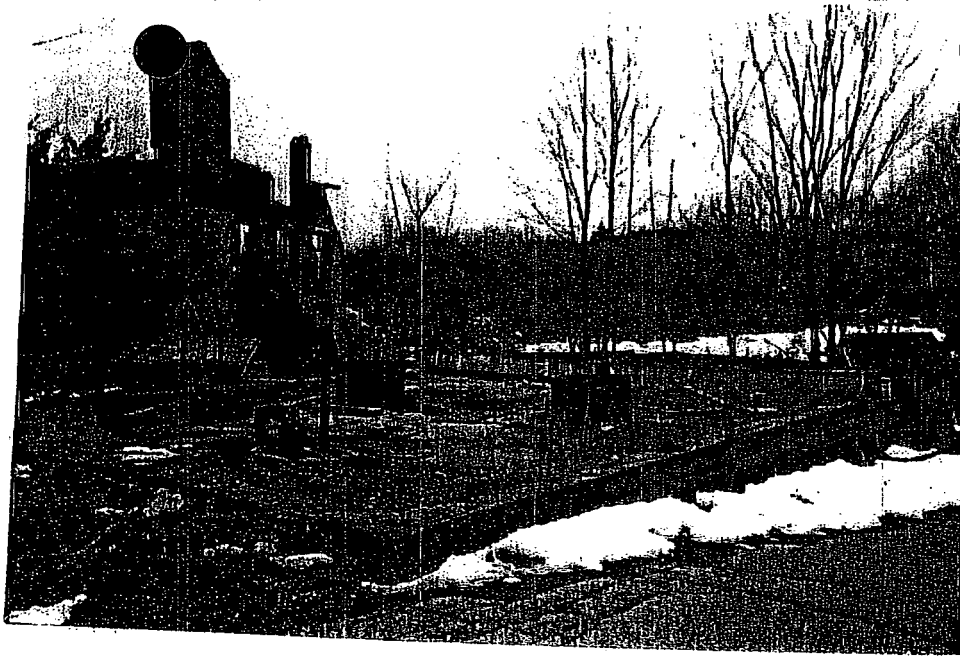
There are currently three known USTs on the site, each are 20,000 gallon heating oil tanks. Two 20,000 gallon heating oil USTs were installed circa 1956 and are located in a concrete bunker to the north of the Brunswick Mill building. The concrete foundation surrounding these tanks and associated piping is apparent above the ground surface in this area. Underground piping extends from the tanks to the boiler room which was located in the basement of the northeast portion of the building. One additional 20,000 gallon heating oil UST installed circa 1954 is located in a concrete

1.) Brunswick Mill Property, two USTs within concrete foundation

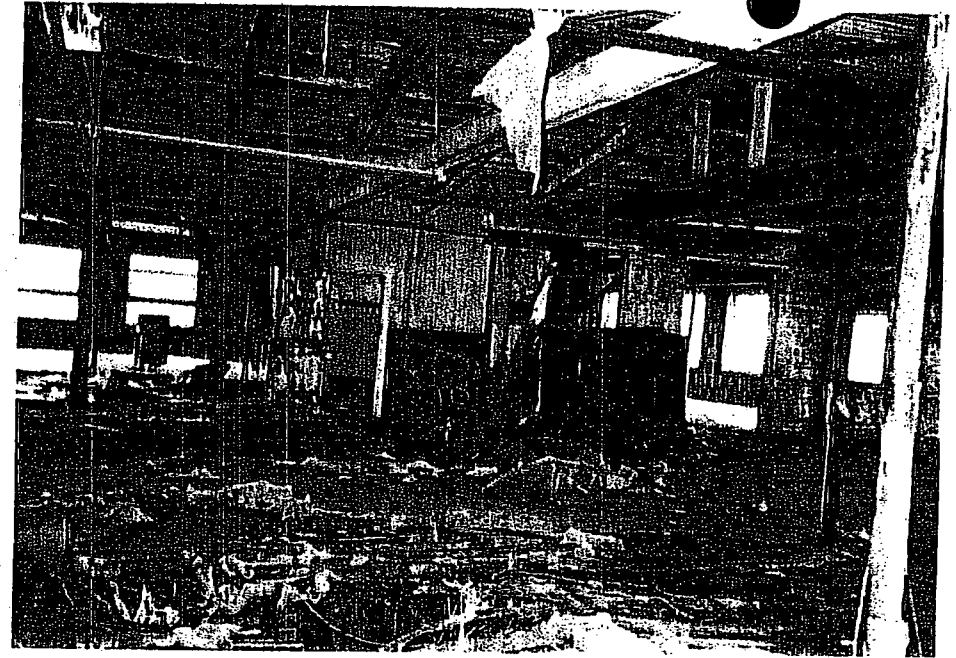
The Site buildings are in generally poor condition including both the remaining Brunswick Mill Building and the Carvill Combing Building. These buildings contain significant physical hazards, including; as holes in the first and second floors, holes with hanging debris from the roof, partially demolished buildings with unsupported walls remaining, pits and fall areas, and miscellaneous residual manufacturing and building debris throughout the buildings. Certain portions of the Brunswick Mill building and Carvill Combing building were not accessible for inspection due to physical hazards and obstructions; these areas include the boiler rooms, basement areas, and an apparent former manufacturing area within the burned portion of the Brunswick Mill Building.

3.) Interior of Carvill Combing Building, 2<sup>nd</sup> Floor

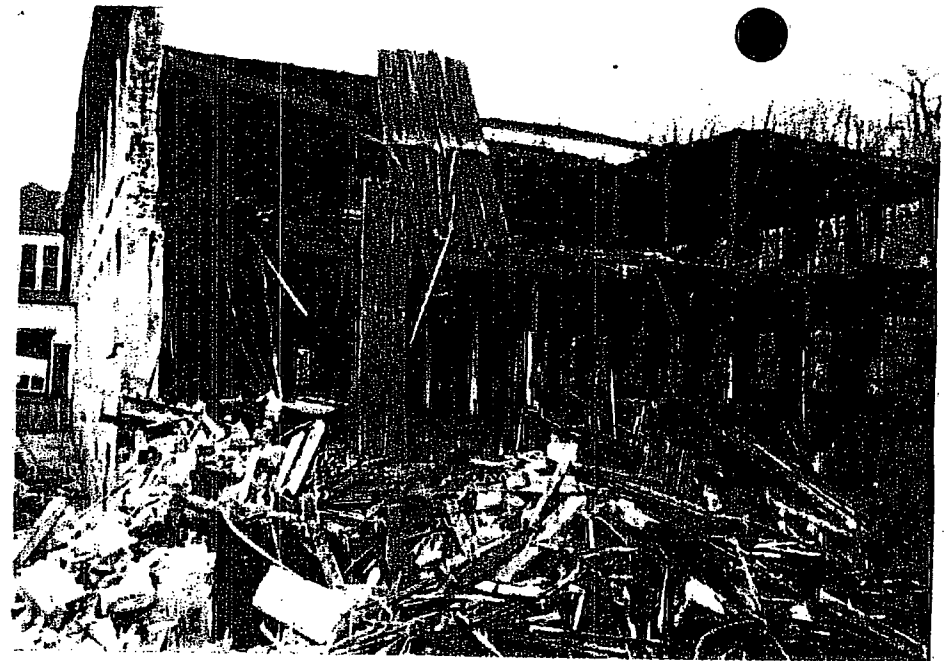
3.) Brunswick Mill building remains, looking west from debris piles

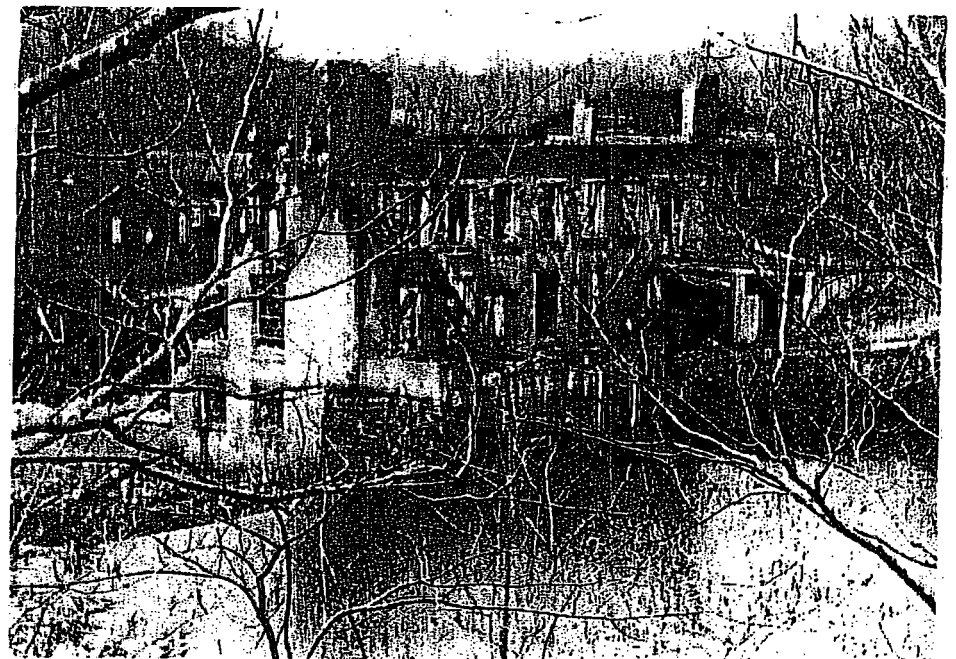
4.) Brunswick Mill building remains, looking from east side of River
