**SITE INVESTIGATION
FOR
MOHAWK TANNERY SITE
NASHUA, NEW HAMPSHIRE**

U.S. Environmental Protection Agency
Emergency Planning & Response Branch
60 Westview Street
Lexington, MA 02173

Roy F. Weston, Inc.
Technical Assistance Team
Region I

July 1989

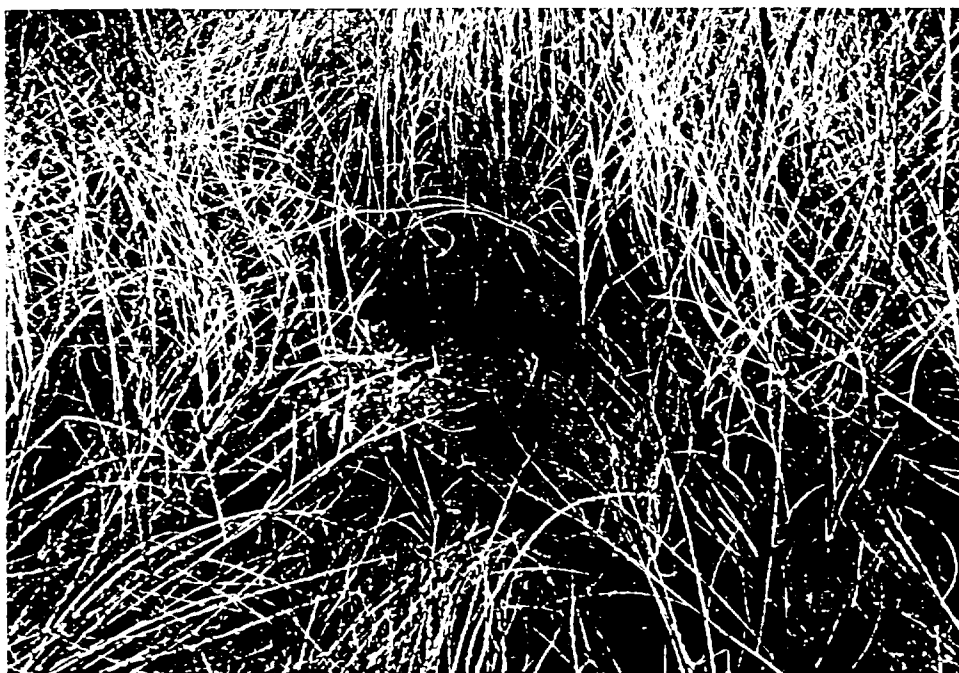
SCENE: SAMPLE LOCATION # 007
SITE NAME: MOHAWK TANNERY
FRAME NUMBER: 15 DATE: 05/26/89 TIME: 1340 SKY CONDITION: OVERCAST
PHOTO BY: LARRY ASPLAND WITNESSES: TOM GAUTHIER , JOSEPH PILON
CAMERA: OLYMPUS SETTING: AUTO FILM TYPE: 200 FILM ROLL: 6276
