Re: GE-Pittsfield/Housatonic River Site

**Rest of River (GECD850)**

**Revised Reach 5A Baseline Restoration Assessment Report**

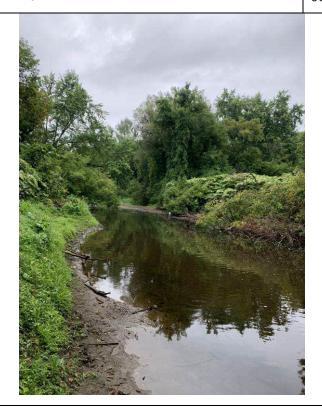
Station RBP 0-1 looking upstream contains a short run. The shoreline consists of grassy vegetation along with large bushes and trees. The banks have slight signs of erosion and bits of woody debris.

Substrate is largely composed of silt with smaller percentages of gravel, cobble, and clay.

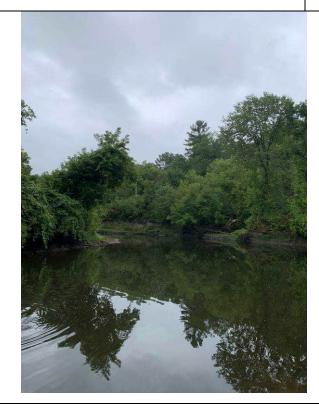
Description:
RBP 0-1 looking
downstream. This section
of RBP 0-1 was
dominated by a pool
environment with slight
shoreline erosion. Similar
to the previous image, the
pool is around five feet
deep and there is a partly
overhanging canopy.

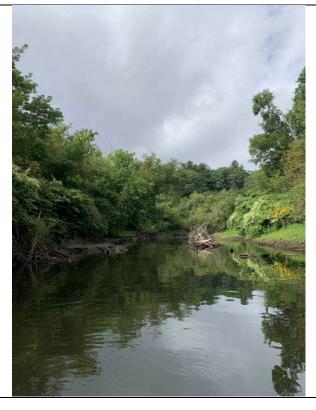
RBP 2-4 looking upstream shows a run with large cluster of woody debris in the middle of the river and smaller clumps closer to the shoreline.

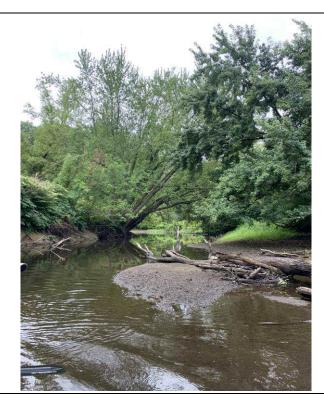
**Description:** Further downstream in RBP 2-4 looking downstream. This section contains a shallow riffle/run with a sand/gravel bar and woody debris piled on top. The left side of the image shows erosion and slope failure, leading to multiple trees leaning over the river.

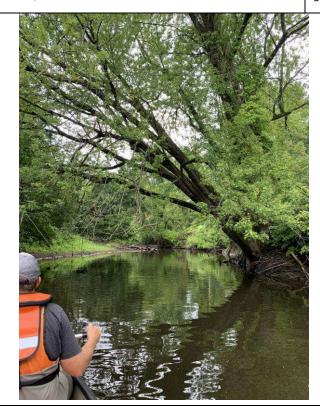
RBP 5-6 looking downstream. Maple trees provide a partial canopy over the river's run. Erosion is affecting the shoreline on the right side which is covered in shrubs and trees. Grassy vegetation and shrubs cover the left shoreline.

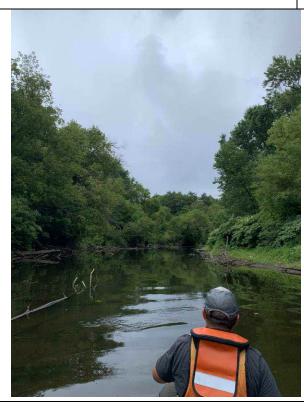
RBP 7-9 looking upstream. This run contains many groups of woody debris along both shorelines, resulting in good cover for epifaunal organisms and fish. This section of RBP 7-9 had slight erosion, but other parts had more moderate erosion issues.

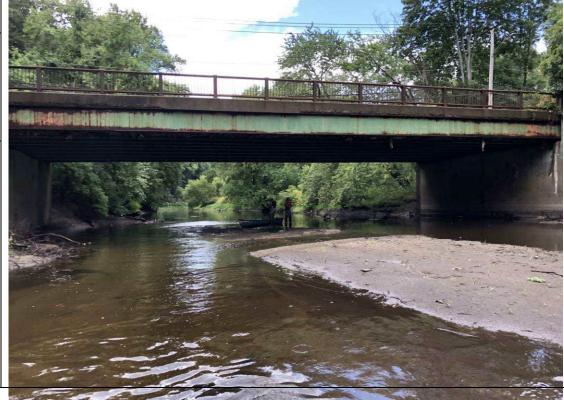
RBP 10-11 looking upstream near Pomeroy Ave Bridge. A shallow run flows underneath the bridge and past a deposited sand bar on both sides. Litter is scattered on the riverbed.

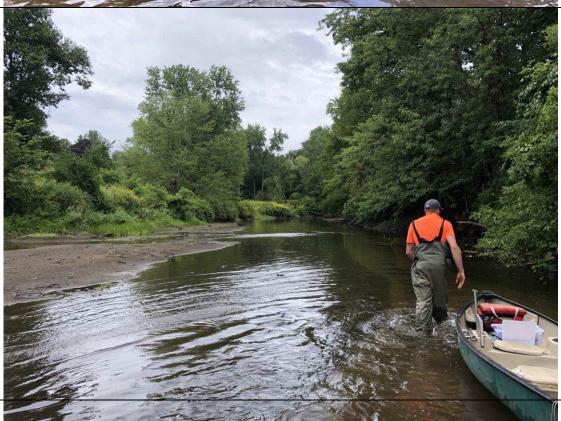
RBP 10-11 looking downstream. This section contains a short riffle that cuts through the sand bar. The rest of the stream in this section is a shallow run. Dense vegetation on both shorelines. Cobble covers the slope on the right shoreline.

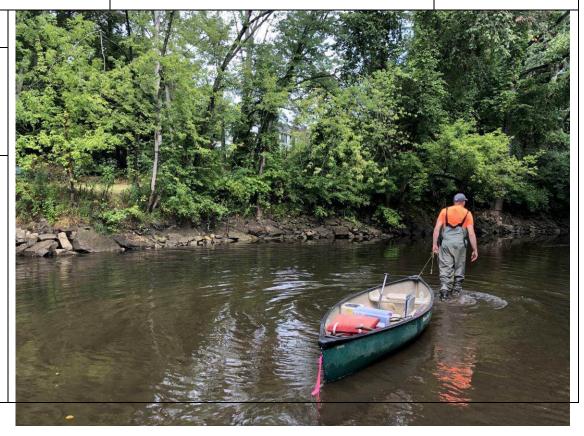
RBP 11 outer bend. The outer bend of RBP 11 contains rip rap to prevent shoreline erosion near houses. The water also gets deeper on the outer bend and changes from a run to a pool.

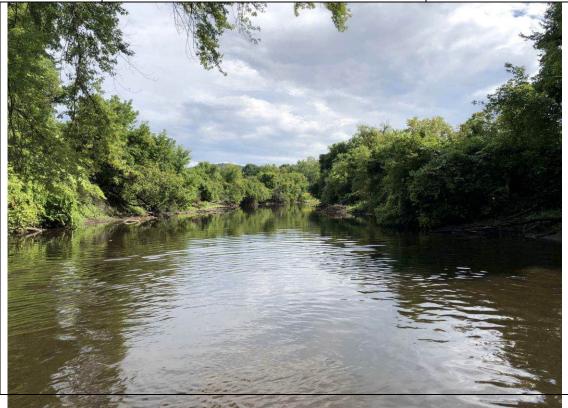
Photo No. 2

Beginning of RBP 12 looking downstream. Silver maple trees and shrubs cover the shorelines. This section contains many deep pools and sections of run. Woody debris piles can be found on the shorelines.

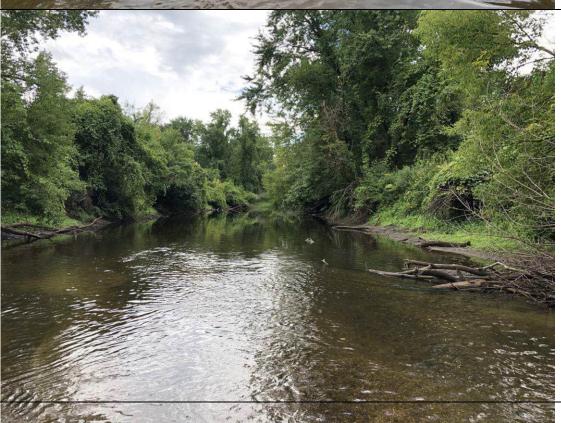
Lower half of RBP 12 looking upstream. Woody debris is scattered along the shorelines. In this section, there is a slight riffle, but mainly a run with a pool at the outer bend. Silver maple trees make up the majority of riparian vegetation.

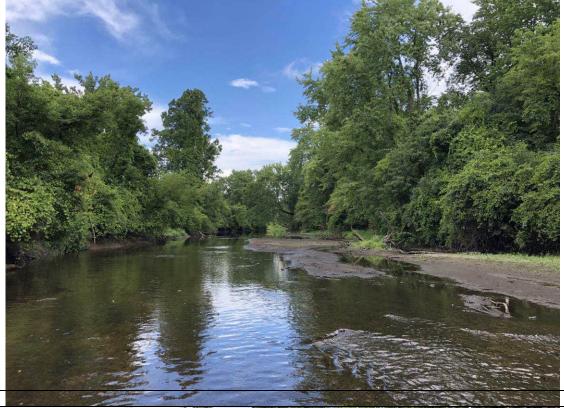
Lower half of RBP 12 looking downstream. This shallow section of RBP 12 contains riffles near the sand bars and runs near the left shoreline.

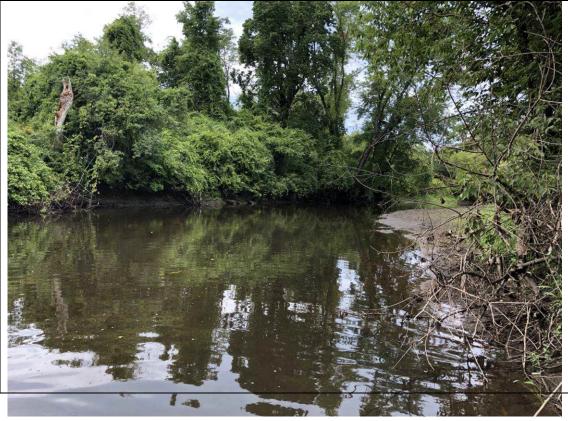
Description:
Beginning of RBP 13
looking upstream. This section contains a large pool on the outer bend with overhanging maple trees. Erosion can also be seen on the outer bend's shoreline.

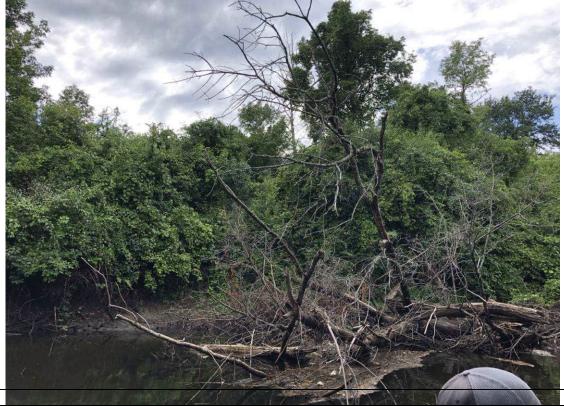
RBP 13 has large woody debris that provides good cover/habitat for underwater organisms. Floating debris is also being caught on the branches in this pool area. The shoreline is experiencing moderate erosion.

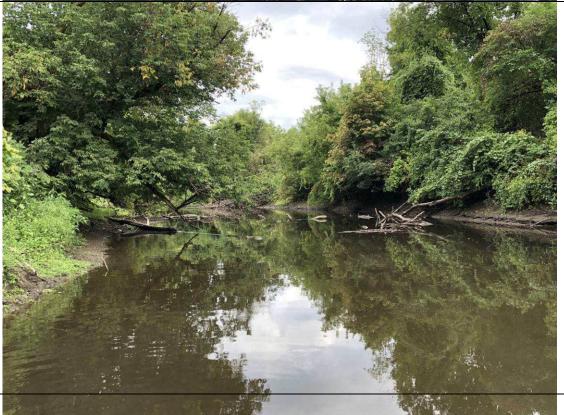
Downstream of RBP 13 has branches and other woody debris. The shorelines have slight erosion in this pool area. Silver maples and shrubs make up the riparian vegetation.

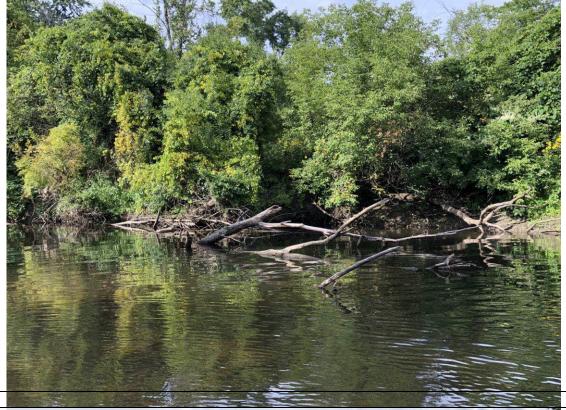
Beginning of RBP 14 with woody debris. The far side of the image contains a pool and the left side is a run.

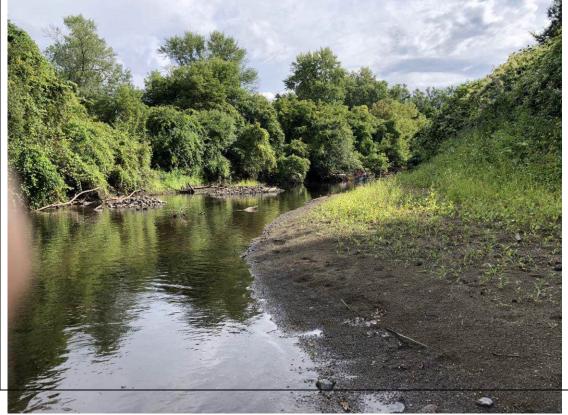
**Description:**Beginning of RBP 14
looking downstream. On the outer bend, there are cobble deposits and woody debris. The sand bar on the inner part of the bend has grassy vegetation before a steep slope.

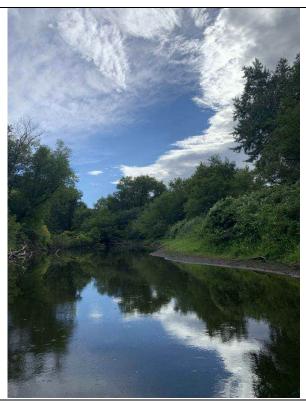
Further downstream of RBP 14, woody debris is collected on the shorelines. A small bar has formed on the right side. Shrubs and maple trees make up the riparian vegetation. There are also pools on the outer bends of the river.

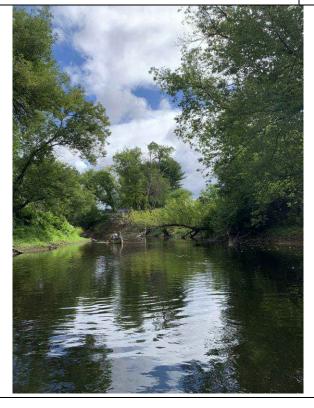
RBP 15-16 looking upstream. This section is a run with little woody debris.

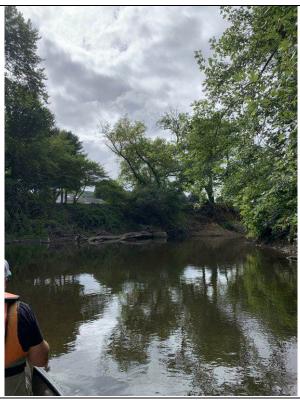
RBP 15 looking downstream. This section of the river is a pool with woody debris. Houses and private property reside over the bank's slope. Erosion is visible on the slope in areas lacking vegetation.

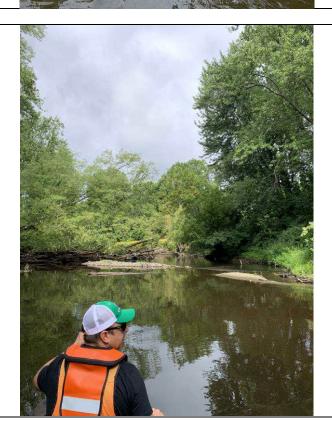
RBP 15-16 looking downstream. In this section, there is a cobble bar and sand bar. In between these two deposits is a riffle. A run leads to a pool on the left where a large collection of woody debris resides.

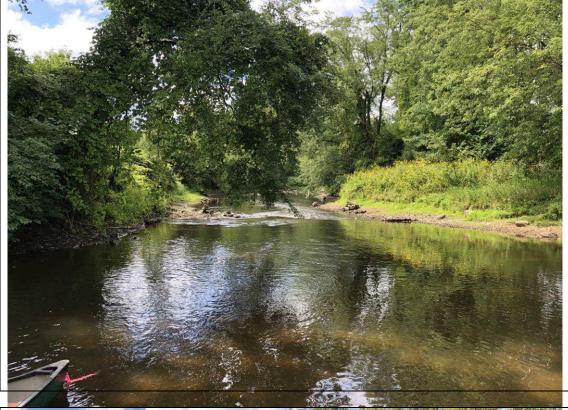
Beginning of RBP 17 looking downstream. The water depth is shallow in this area and a riffle is present. Large rocks/cobble deposits are near the riffle. The shoreline has contains gravel and a mix of shrubs.

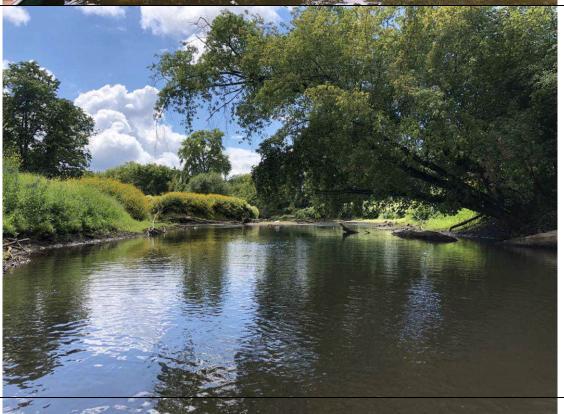
RBP 17 looking downstream. This section is a run, and the left bank has slight erosion. There is a fallen log and other woody debris. A sand bar and riffle can be seen in the distance.

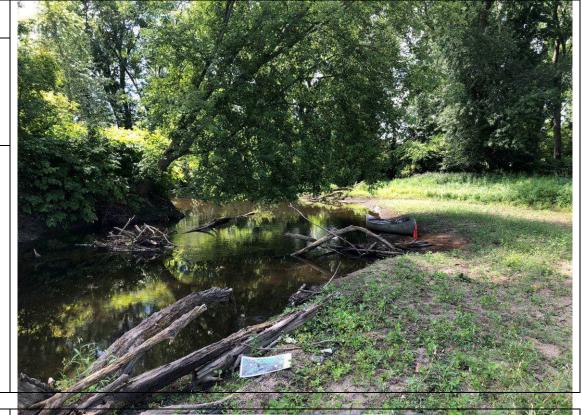
RBP 18 looking downstream. From this spot, wood debris is prevalent. A sand bar has formed on the inner bend of the river.

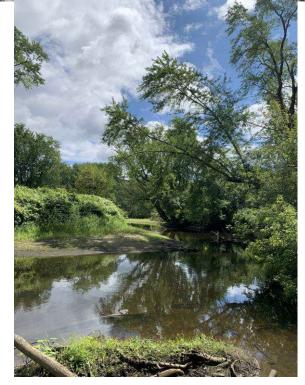
RBP 18 looking downstream, a small sand bar has formed around the bend of the river.

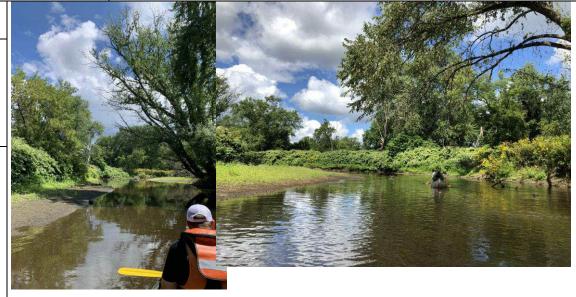
RBP-19. First photo taken looking downstream, second photo taken after the bend looking back upstream. In both images, a run is present. The outer bend has moderate erosion, while the inner bend has a sand bar with grassy vegetation.

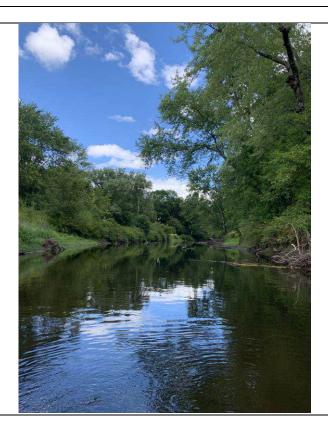
RBP-19 looking downstream. This section is a pool with branches and underwater woody debris. It later converts into a run with a few small riffles for the rest of RBP 19.

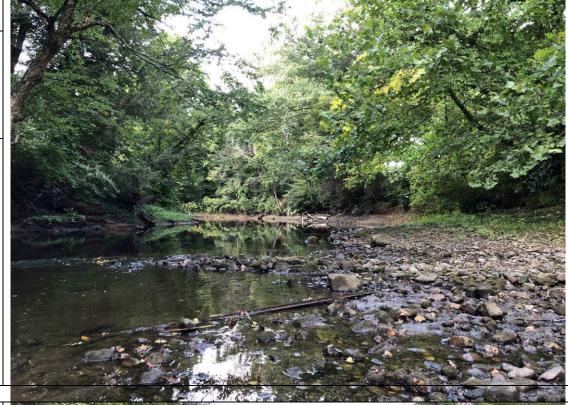
End of RBP 20 looking upstream contains cobble bars and shoreline. A run reaches the cobble area and turns into a riffle.

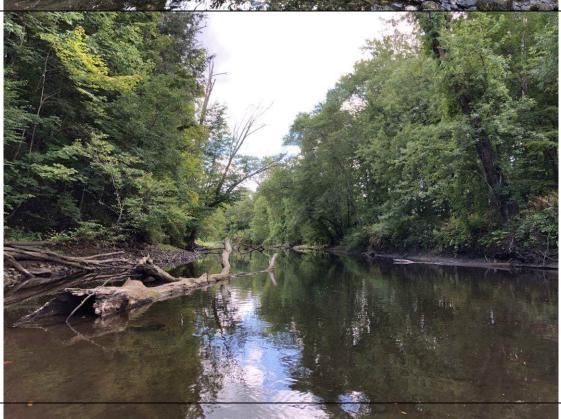
RBP 20-21 looking downstream. Large woody debris has fallen into the river. The bank is more stable on the left side and contains cobble, while the bank on the right is eroded and has lost stability. This section is a run.

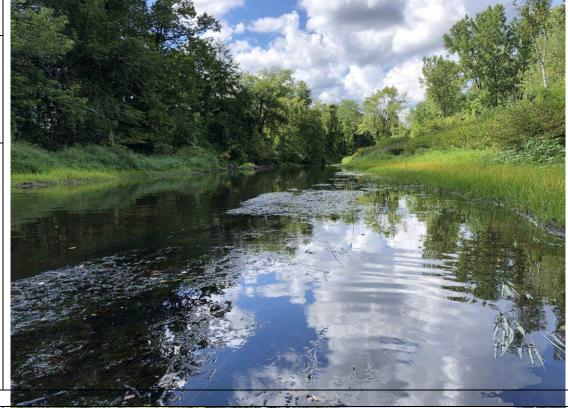
Description:
End of RBP 21 looking downstream. Coontail is the dominant aquatic vegetation. This area is a run with pockets of pool.

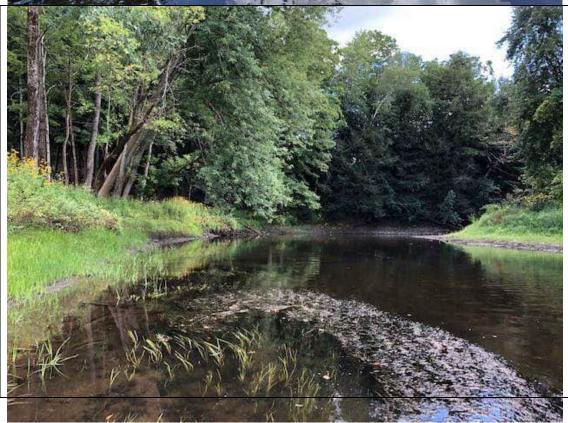
**Description:** RBP 22 looking downstream. This section also contains predominantly coontail. At the far bank, there is cobble/rip rap to prevent erosion.

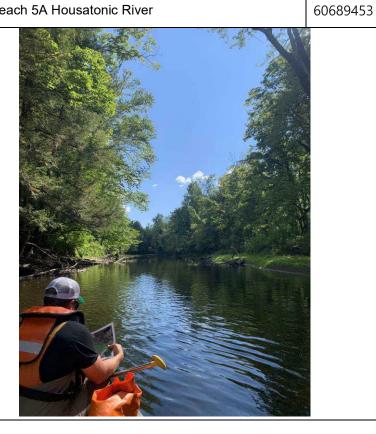
**Description:** RPB 23-24 looking downstream at a run. Cobble is present on the left bank along with woody debris on both sides.

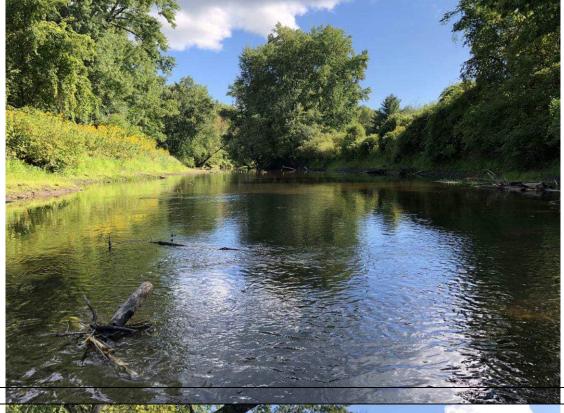
RBP 25 looking downstream. Maples and sunflowers occupy the banks. The water depth is shallow in this area and contains scattered pieces of woody debris. Some edges of the stream drop off into a pool.

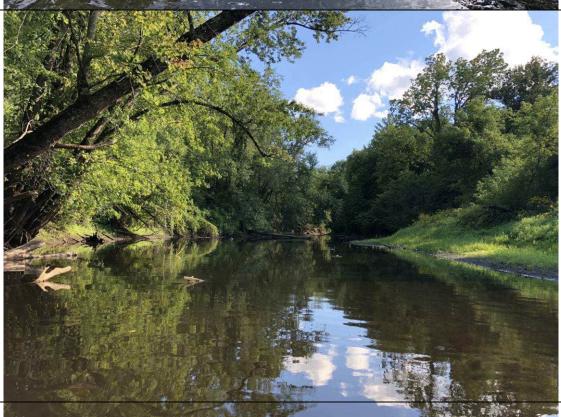
RBP 26 looking downstream. The river is predominantly a pool and contains waterlogged woody debris. Maples overhang the river and provide partial cover.

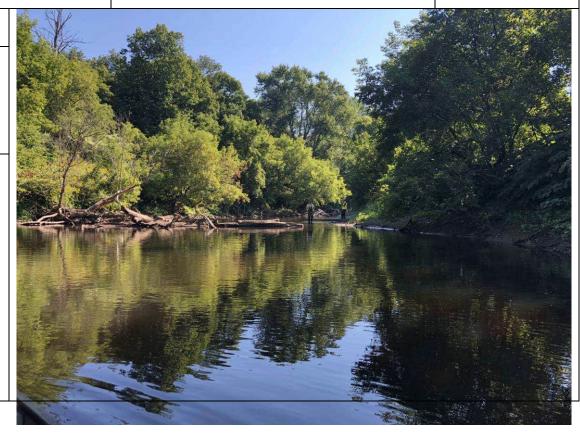
Description:
RBP 28 looking upstream.
A large pool with slight to
moderate erosion on the
right bank. Large logs have accumulated and dammed a part of the river.

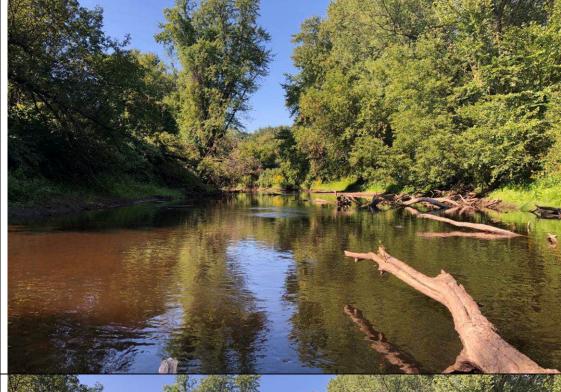
Description: RBP 29 looking downstream. The right side of the river is a large pool, while the left side is mainly a run. Woody debris has settled in the deep pool areas.

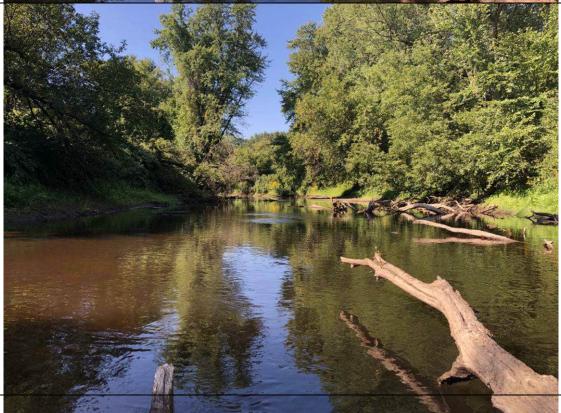
RBP 29 looking downstream. The right side of the river is a large pool, while the left side is mainly a run. Woody debris has settled in the deep pool areas.

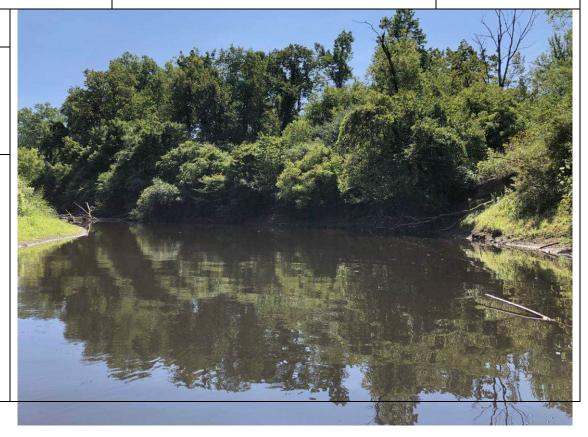
RBP 30-31 looking downstream at bend. A large deep pool makes up this area. Mature silver and red maples line the right bank. Erosion is visible on the outer bend and woody debris is present.

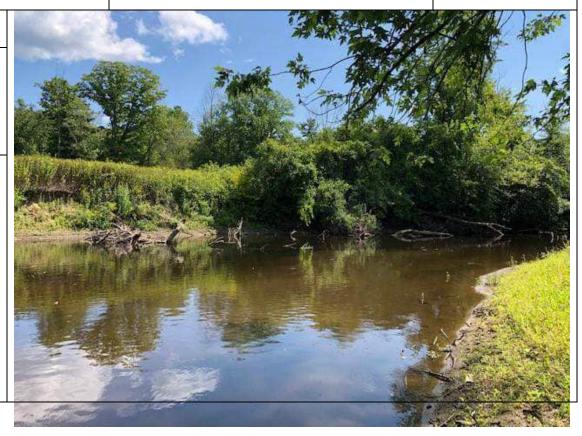
RBP 32 looking downstream. The outer bend is a pool with large clumps of woody debris and erosion. The inner bend is shallower and is a run. Moderate erosion has occurred at the outer bank and has shrubs growing on top of the slope.

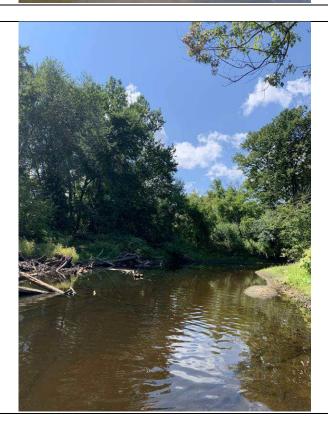
RBP 33-34 looking upstream. Most of this section is a pool with large amounts of woody debris. The substrate is predominantly sand with some silt.

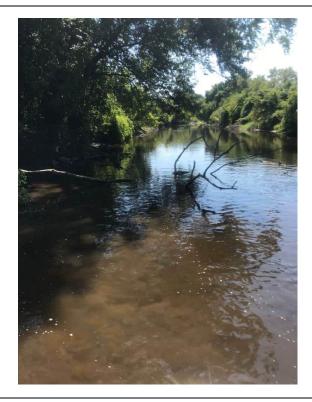
Location of one set of fishtraps at our northernmost fish trap area, within RBP 12 looking downstream. Fish nets were secured to the pictured woody debris.

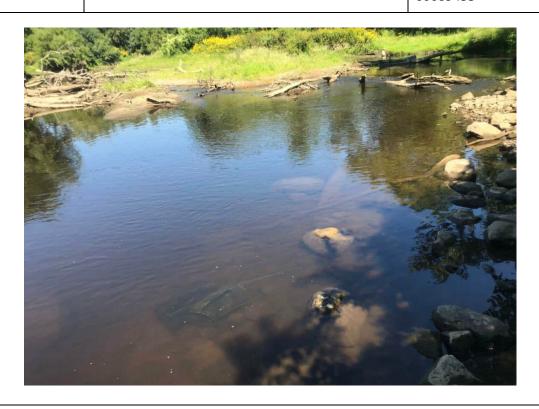
One of two fishtrap sets located within RBP 14 looking upstream. Fish nets were secured to the pictured boulders along the eastern bank.

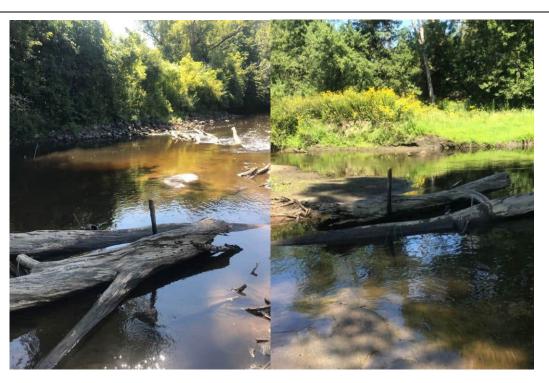
An upstream and downstream look at ne of two fishtrap sets located within RBP 14. Fish nets were secured to the pictured logs which sit in the middle of the channel.

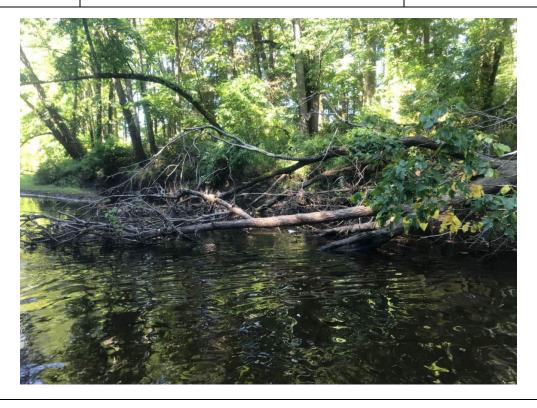
Location of one set of fish traps at the southernmost fishtrap location located within RBP 22 looking downstream. Fish nets were secured to the handing branches pictured over the western bank.

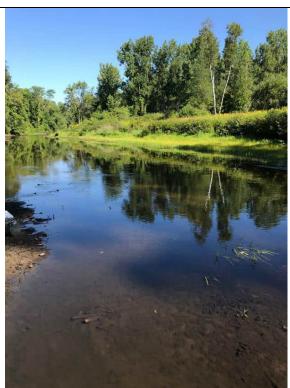
Location of one set of fish traps at the southernmost fishtrap location within RBP 22 looking upstream. Fishnets were secured using wooden sticks as planks amongst the submerged aquatic vegetation on the eastern bank.

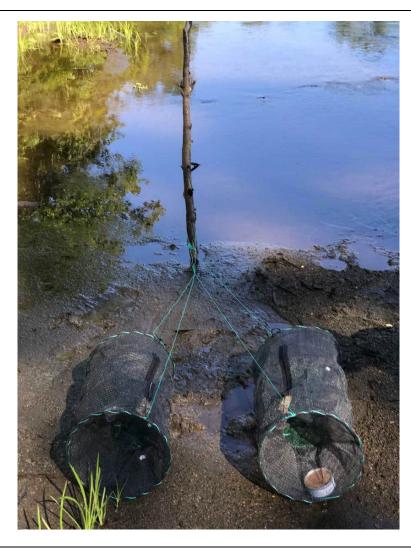
Example on the bank of how fish nets are set up in water. Baiting with bread and catfood is used to lure fish through holes in the nets and the traps themselves are secured to submerged woody debris upstream.

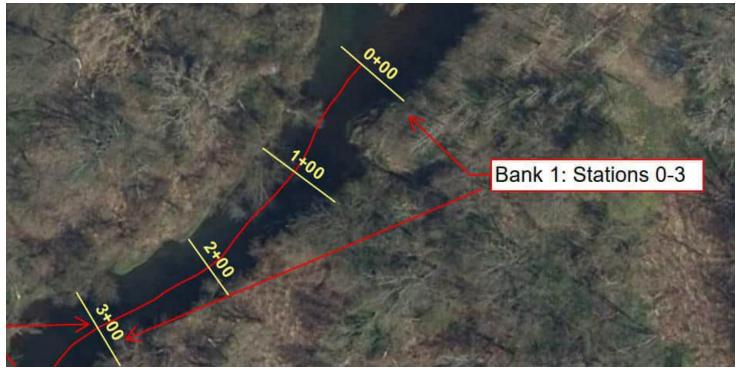
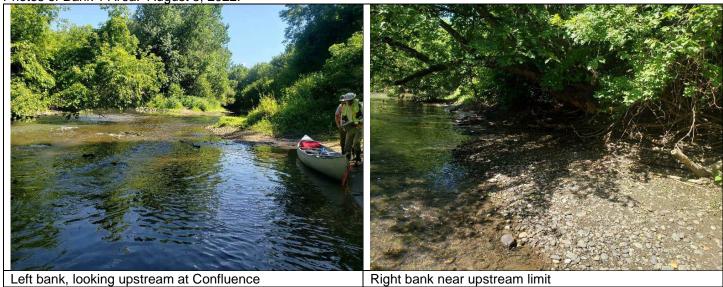
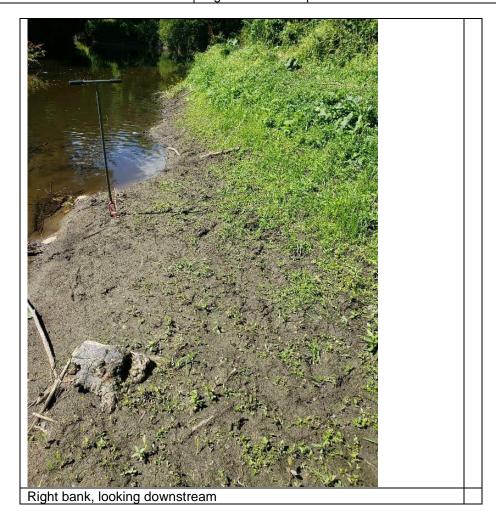
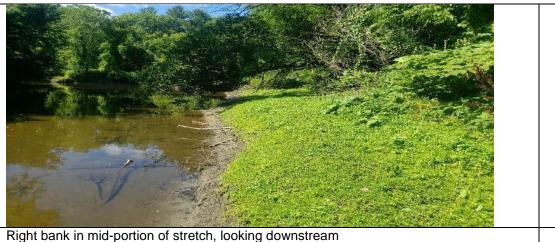
Photos of Bank 1 Area. August 3, 2022.

Bank 1: Stations 0-3. 300-ft of straight channel below the confluence

Views of left bank showing cut bank, largely vegetated

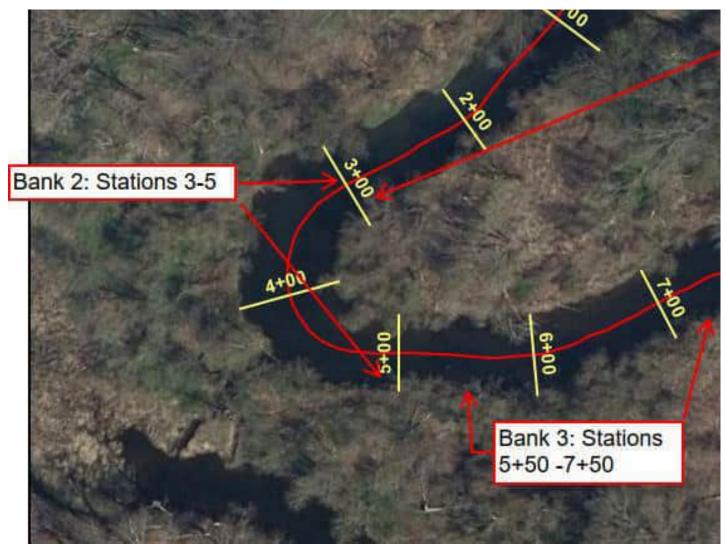
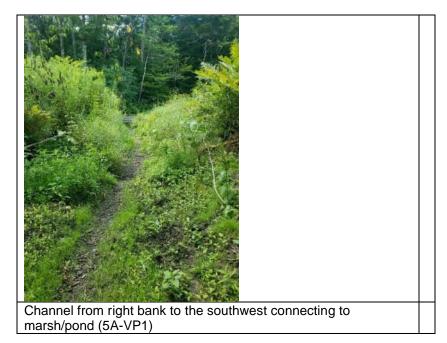
Photos of Bank 2 Area, August 3, 2023

Bank 2: Stations 3-5. 200 ft of sharp left bend. Vertical cut bank on outer bend. Gentle bank on inside with point bar development.

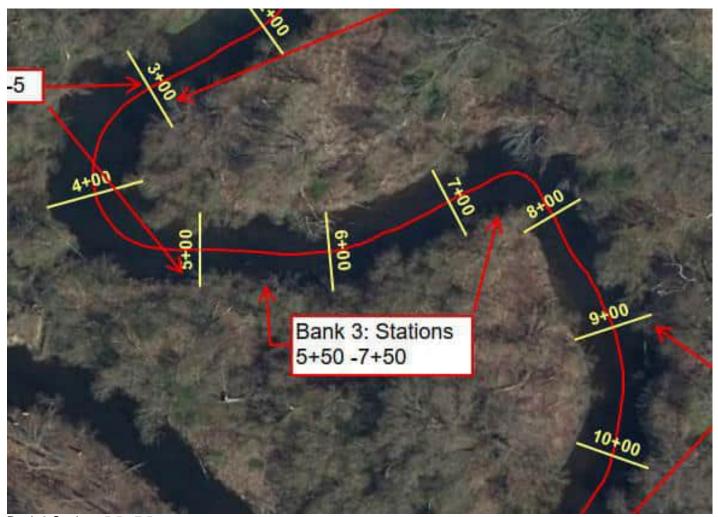
Photos of Bank 3 Area, August 3, 2023 Left bank Right bank (to left), left bank to right, looking upstream Right bank, looking upstream

Bank 3 Stations 5.5 - 7.5. 550-ft downstream of Confluence. 200-ft long straight stretch between tight bends

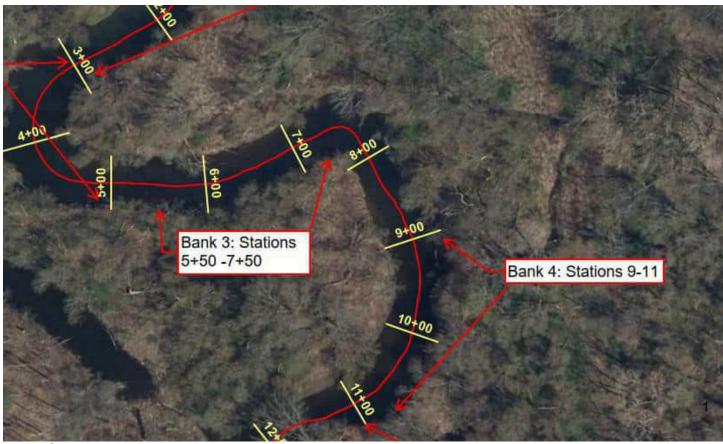
Bank 4 Stations 9-11. 900-ft downstream of Confluence. After sharp right bend and covering 200 ft of slight right curve in river.

Green frog				
	Wood pewee				
VII.	Habitat Degradation (identify specific location on b	ank segment if applicable)			
	☐ Evidence of significant levels of dumping				
		oblems			
	○ Occurrence of invasive plants:   Japanese knotweed, Morrow's honeysuckle, bishop's goutweed				
	Evidence of other human disturbance; describe:				
VIII	Restoration Opportunities				
	Presence of potential restoration resources (e.g., boulders, large trees or woody debris, root wad material for bank stabilization or hibernacula, plant propagation source material). Identify specific items:  Coarse woody debris along both banks, including root wads				
	Other restoration opportunities:				
	R: Compartmentalized Fill; Vegetated riprap; Log or	rock vanes; Root wads			
	L: Compartmentalized Fill; Reshape point bar				
	Invasive species control				
	Revegetation

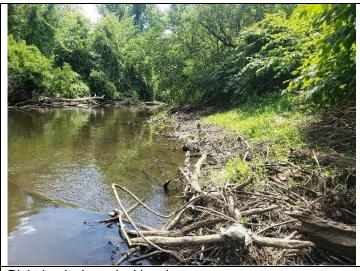
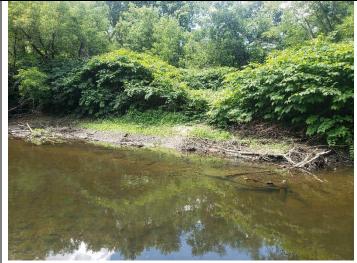
Right bank views, looking downstream

Right bank, Japanese knotweed

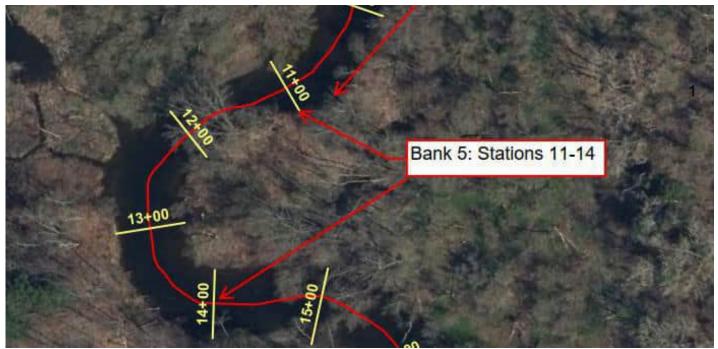
Bank 5: Stations 11-14. 1100-ft downstream of Confluence. 300-ft stretch from Stations 11-14 along sharp left bend

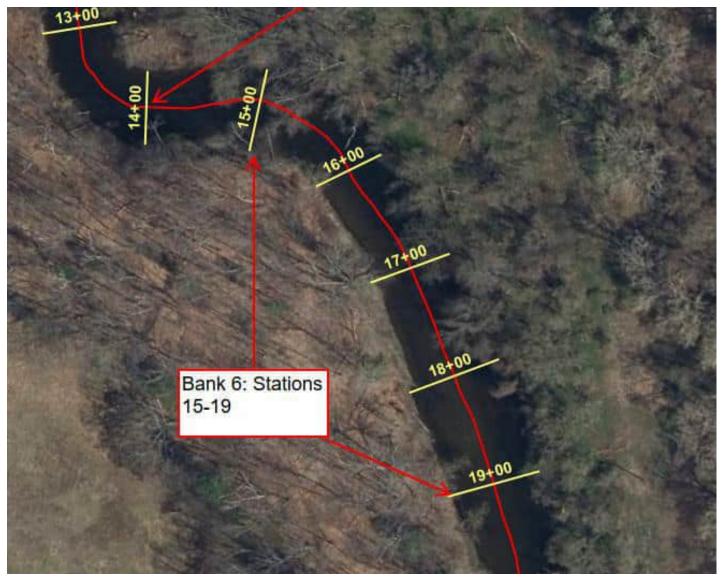
Bank 6 area: Station 15-19. 400' along Right bend at inflow from overflow channel on left bank followed by straight run.

Dragonflies						
VII. Habitat Degradation (identify specific location on b	ank segment if applicable)					
Evidence of significant levels of dumping	Evidence of significant levels of dumping					
Evidence of significant erosion or sedimentation problems						
○ Occurrence of invasive plants:   Bittersweet common on both banks at upper levels as well as in floodplain; Morrow's honeysuckle, common buckthorn, Japanese knotweed, bishop's goutweed, forget-me-knots						
Evidence of other human disturbance; describe:						
VIII.Restoration Opportunities						
☑ Presence of potential restoration resources (e.g., beank stabilization or hibernacula, plant propagation so Coarse woody debris along both banks, large trees, continuous.						
R: Coir matting;						
L: Grade bank/Coir matting; Bank spurs; Compartme	entalized fill					
Invasive species control						
Revegetation

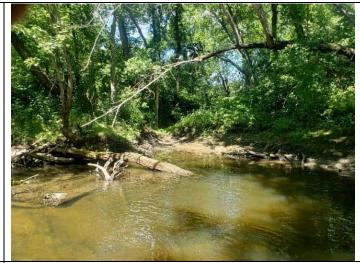
Left bank, looking at location where overflow channel discharges into river at Station 15+00

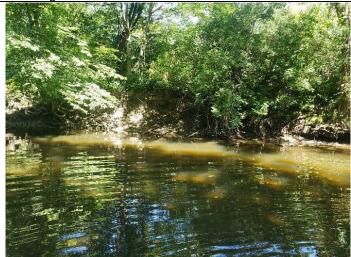
Left bank

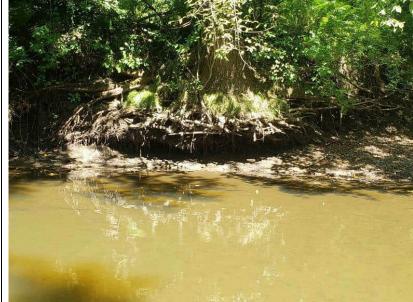
Left bank: undercut tree root system

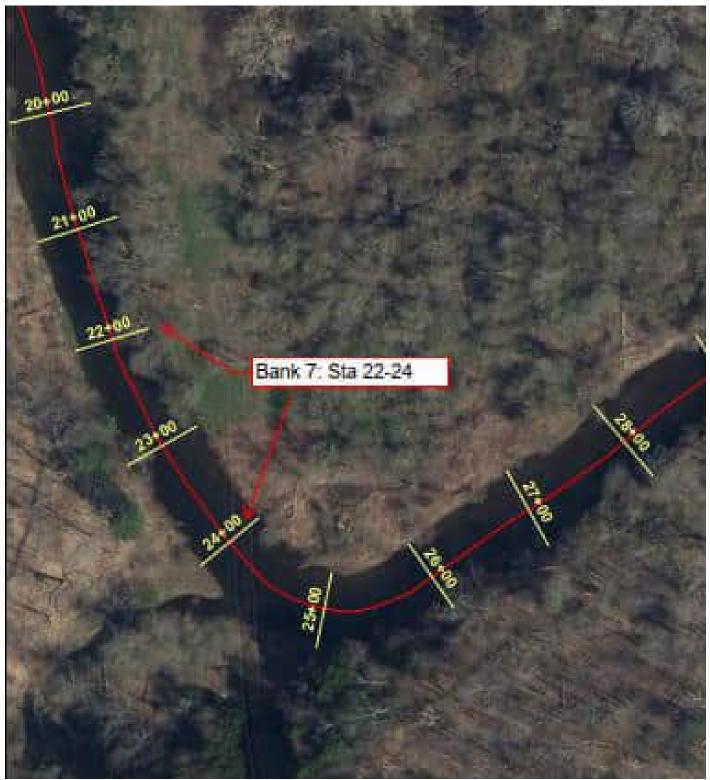
Bank 7: Stations 22-24. 200-ft Straight run before left bend

Photos of Bank 7 area. August 4, 2022. Left bank Left bank Left bank (left side) to right bank. Right bank CONT. N. W. Right bank at Station 24+20; inlet from Morewood Lake Right bank

eral Electric Housatonic Rest of River n RB-1: Riverbank Habitat Inventory Form					
VII. I	Habitat Degradation (identify specific location on b	ank segment if applicable)				
[	Evidence of significant levels of dumping					
[	Evidence of significant erosion or sedimentation pr	roblems				
	○ Occurrence of invasive plants:     Japanese knotweed, bittersweet, common buckthorn, forget-me-not					
	⊠ Evidence of other human disturbance; describe: Potential	ower line right-of-way crosses between Stations 23 - 24.				
VIII.F	Restoration Opportunities					
k	Presence of potential restoration resources (e.g., boank stabilization or hibernacula, plant propagation sources woody debris, Large trees, Cobbles	ooulders, large trees or woody debris, root wad material for urce material). Identify specific items:				
[	Other restoration opportunities:					
	R: Grade bank/Coir matting; Compartmentalized fill; I	Bank spurs

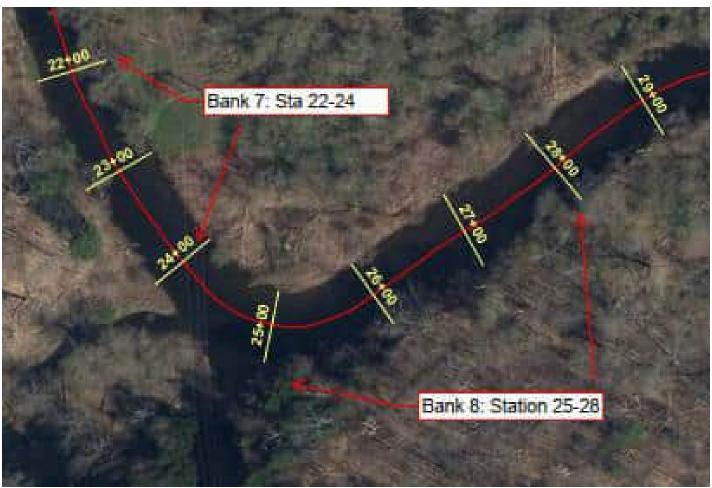
Bank 8: Stations 25-28. 300-ft stretch at left bend below Morewood Lake tributary into straight run.

Photos of Bank 8 Area. August 4, 2022 Right bank just below Morewood tributary Right bank at Station 26 Left bank at Station 26 Left bank at Station 25 Right bank from left bank Right bank

Tennessee warbler	
Green frogs	
VII. Habitat Degradation (identify specific location on ba	ank segment if applicable)
☐ Evidence of significant levels of dumping	
Evidence of significant erosion or sedimentation pro	oblems
○ Occurrence of invasive plants:     Bittersweet, Japanese knotweed, Morrow's honeysuc     □ □ □ □ □ □ □ □ □ □ □ □ □ □ □ □ □	kle
Evidence of other human disturbance; describe:	
VIII.Restoration Opportunities	
☑ Presence of potential restoration resources (e.g., both bank stabilization or hibernacula, plant propagation sour Coarse woody debris, large trees, cobbles	oulders, large trees or woody debris, root wad material for arce material). Identify specific items:
○ Other restoration opportunities:	
R: Vegetated riprap; Log or rock vanes; Grade bank/0	Coir matting
L: Reshape point bar	
Invasive species control	
Revegetation

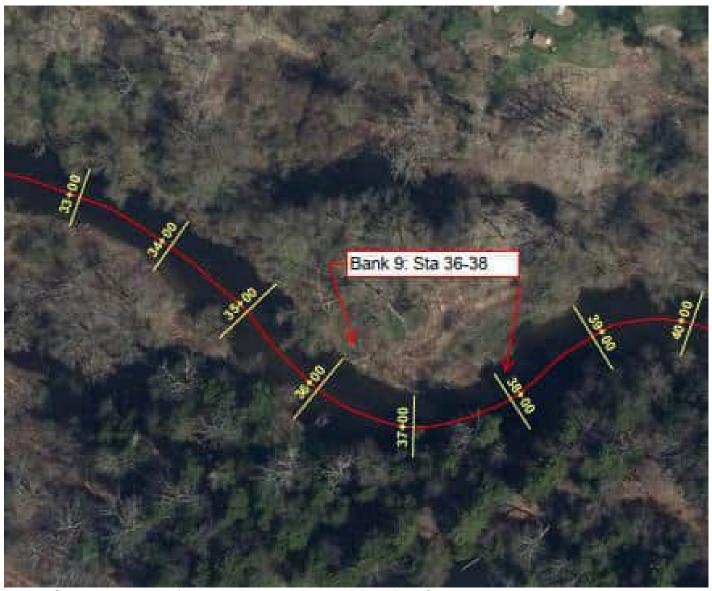
Bank 9: Stations 36-38. 200-ft stretch along a moderate left bend from Station 36-38

bank is on the right.

l Electric Housatonic Rest of River B-1: Riverbank Habitat Inventory Form			
VII. Hab	oitat Degradation (identify specific location on bank segment if applicable)			
	Evidence of significant levels of dumping			
	Evidence of significant erosion or sedimentation problems			
	○ Occurrence of invasive plants:     Bittersweet, Japanese knotweed, bishop's goutweed, purple loosestrife			
	Evidence of other human disturbance; describe:			
VIII.Res	storation Opportunities			
ban	Presence of potential restoration resources (e.g., boulders, large trees or woody debris, root wad material for k stabilization or hibernacula, plant propagation source material). Identify specific items: parse woody debris, root wads, large trees, cobbles			
	Other restoration opportunities:			
R:	Root wads; Log or rock vanes; Vegetated riprap			
L: I	Reshape point bar			
Inva	asive species control			
Rev	vegetation

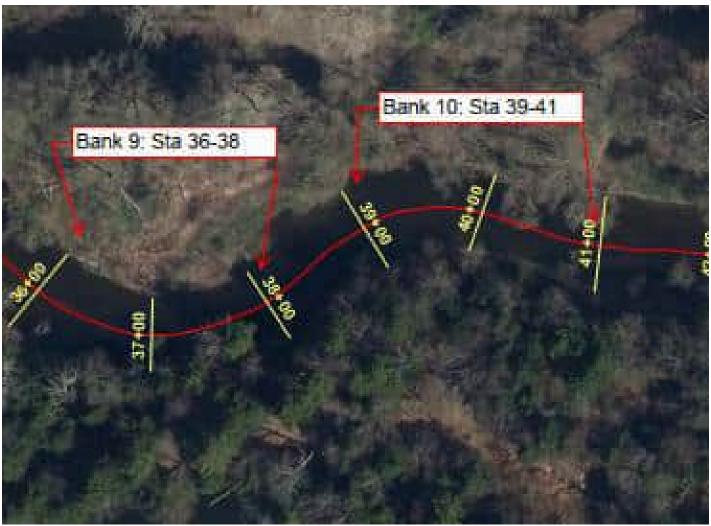
Bank 10: 200-ft stretch along a moderate right bend from Station 39-41.

General Electric Housatonic Rest of River Form RB-1: Riverbank Habitat Inventory Form	
VII. Habitat Degradation (identify specific location on b	ank segment if applicable)
☐ Evidence of significant levels of dumping	
Evidence of significant erosion or sedimentation pr	oblems
○ Occurrence of invasive plants:     Japanese knotweed, bittersweet, purple loosestrife	
Evidence of other human disturbance; describe:	
VIII.Restoration Opportunities	
☑ Presence of potential restoration resources (e.g., beank stabilization or hibernacula, plant propagation sour Coarse woody debris, large trees, cobbles	oulders, large trees or woody debris, root wad material for urce material). Identify specific items:
○ Other restoration opportunities:	
R: Vegetated riprap	
L: Grade bank/Coir matting	
Invasive species control	
Revegetation

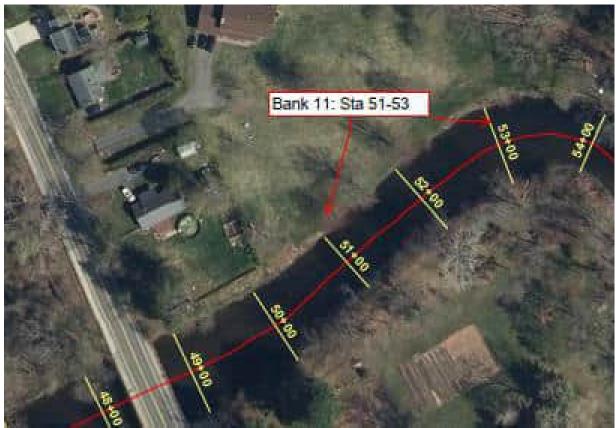
Bank 11: Stations 51-53. 200-ft stretch along a straight run from Station 51-53

General Electric Housatonic Rest of River Form RB-1: Riverbank Habitat Inventory Form	
/II. Habitat Degradation (identify specific location on b	ank segment if applicable)
☐ Evidence of significant levels of dumping	
Evidence of significant erosion or sedimentation process.	oblems
Occurrence of invasive plants: Bittersweet, common buckthorn, Morrow's honeys	uckle, hedge bindweed
⊠ Evidence of other human disturbance; describe: A	ctive mowed lawns along river
/III.Restoration Opportunities	
☑ Presence of potential restoration resources (e.g., bank stabilization or hibernacula, plant propagation so Coarse woody debris, large trees, cobbles	ooulders, large trees or woody debris, root wad material for urce material). Identify specific items:
○ Other restoration opportunities:	
R: Compartmentalized fill	
L: Grade bank/Coir matting; Log or rock vanes	
Invasive species control	
Revegetation

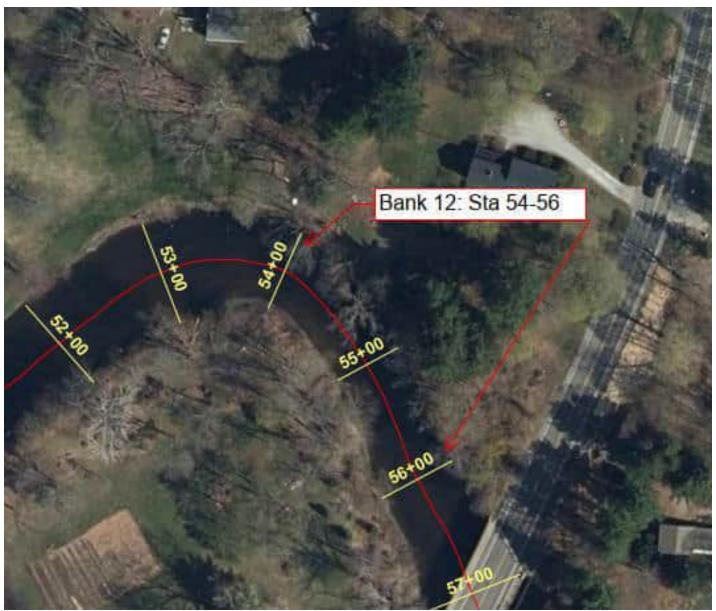
Bank 12: Stations 54-56. 200-ft stretch along a straight run from Station 54-56

Left bank at Station 54+50

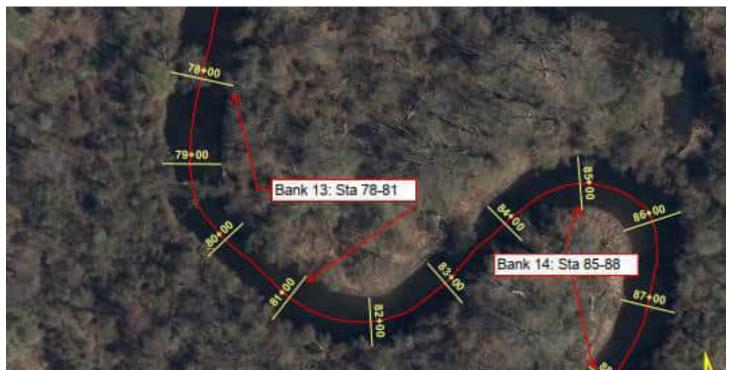
Bank 13: 300-ft stretch along a mild left bend from Station 78-81

Photos of Bank 13 on September 15, 2022: 300-ft stretch along a mild left bend from Station 78-81 Station 78 left bank (right) to right bank looking upstream Station 78 right bank Station 79 right bank Station 79 left bank Station 80 left bank Station 80 right bank

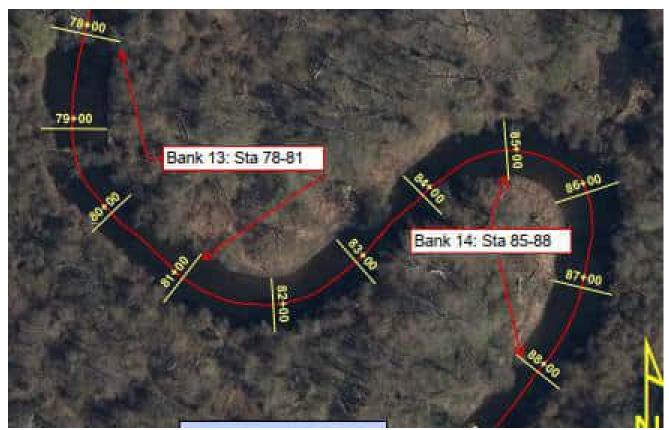
Bank 14: Stations 85-88. 300-ft stretch along a sharp right bend from Station 85-88

Station 87-88, right bank

Photos of Bank 14 Area. September 15, 2022. Station 85-86 right bank, looking upstream Station 86 left bank Outlet from backwater at Station 86, left bank Swale from backwater to left bank at Station 86

Station 88 left bank

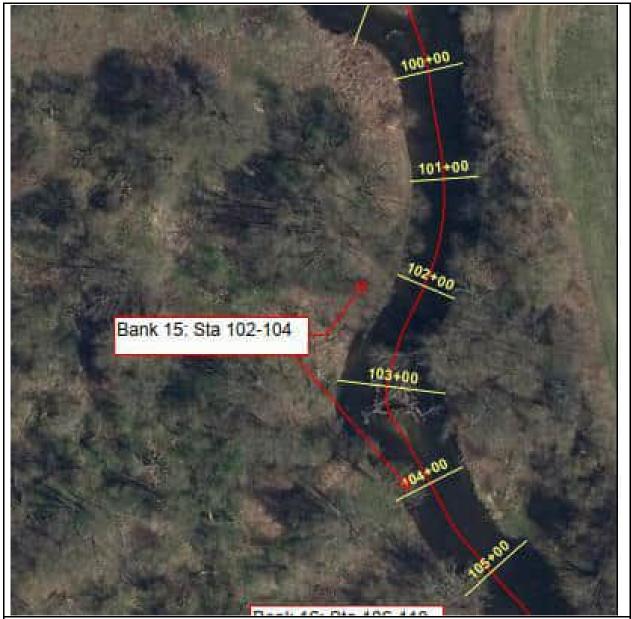
Bank 15: Stations 102-104. 200-ft bend to right and then left with large mid-channel bar at Station 103.

Photos of Bank 15 Area, August 30, 2022 Looking upstream from Station102. Right bank is on left side. Right bank at Station 102 Looking downstream at left bank (left) to right bank (right) Right bank looking downstream toward Station 103 toward Station 103 Right bank at Station 104 Right bank at Station 104

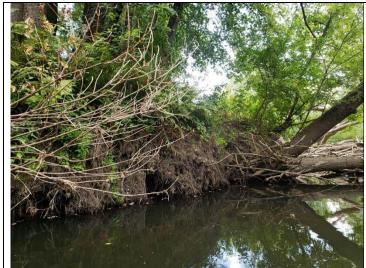
Left bank at upstream side of Station 103

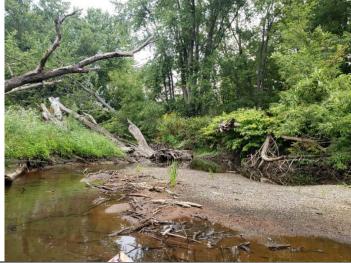
Left bank (right side) at downstream side of Station 103. Midchannel bar is to the left. Looking upstream.

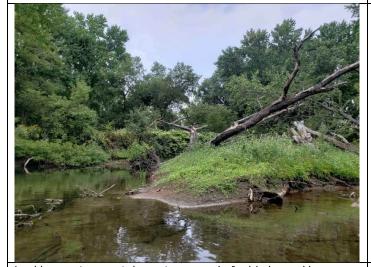
Looking upstream at downstream end of mid-channel bar. From Station 103+50

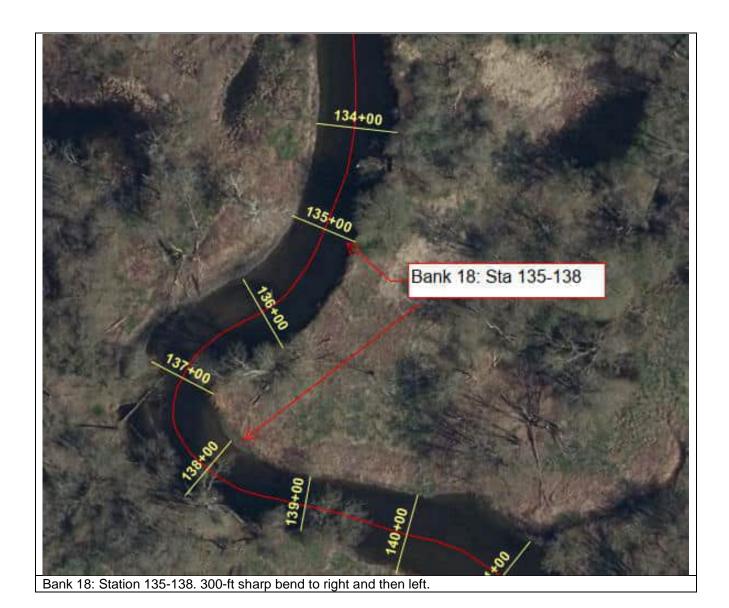
Left bank looking downstream from Station 135 +50

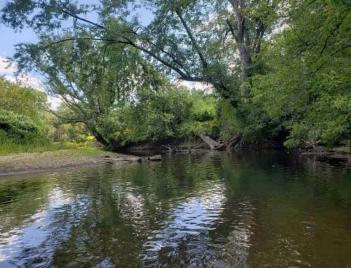
Left bank looking downstream from Station 136+50. Overhanging silver maple.

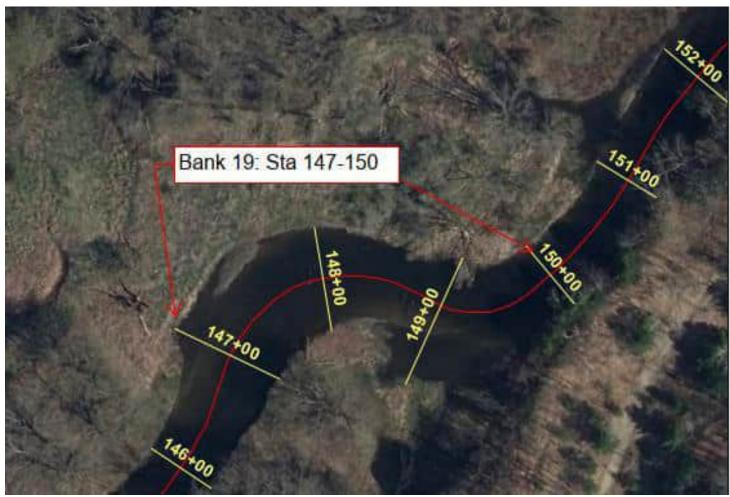
Bank 19: Station 147-150. 300-ft tight bend to right

Photos of Bank 19 Area. August 25, 2022

General Electric Housatonic Rest of River Form RB-1: Riverbank Habitat Inventory Form				
VII. Habitat Degradation (identify specific location on b	ank segment if applicable)			
Evidence of significant levels of dumping				
	oblems: Slumping along left bank			
○ Occurrence of invasive plants:     Japanese knotweed				
Evidence of other human disturbance; describe:				
VIII.Restoration Opportunities				
□ Presence of potential restoration resources (e.g., beank stabilization or hibernacula, plant propagation so Coarse woody debris, large trees, cobbles	ooulders, large trees or woody debris, root wad material for urce material). Identify specific items:			
○ Other restoration opportunities:				
R: Grade bank/Coir matting; Reshape point bar				
L: Log or rock vanes; Vegetated riprap; Root wads				
Invasive species control				
Revegetation

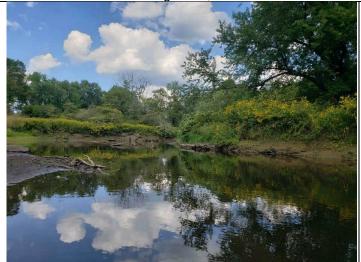
Right bank (right) to left bank (left) looking downstream from Station 146 +50

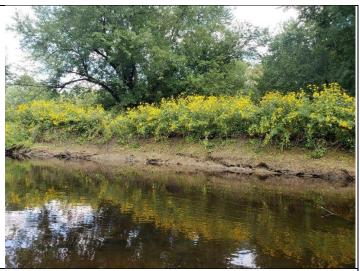
Right bank at Station 147.

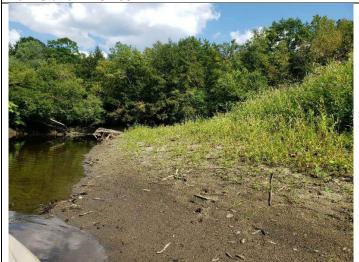
Right bank below Station 147 looking downstream. Bar formation with sandy material in higher elevations with siltier material lower down.

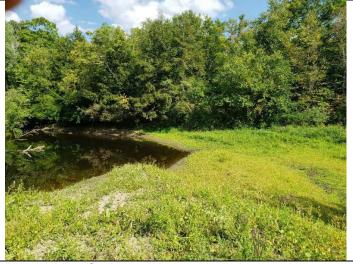
Right bank at Station 148 looking downstream, bar transitions to bankfull marsh in right cove. Trees to rear are near Station150 as river bends left
