Re: GE-Pittsfield/Housatonic River Site

**Rest of River (GECD850)**

**Revised Reach 5A Baseline Restoration Assessment Report**

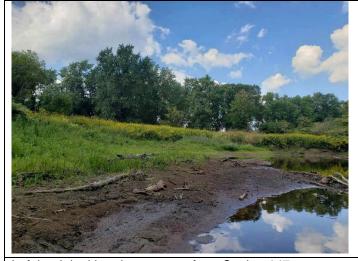
Left bank looking downstream from Station 147

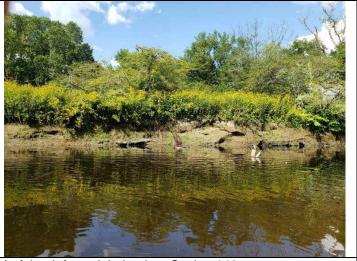
Left bank from right bank at Station 148

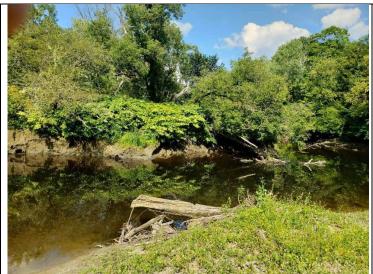
Left bank from right bank at Station 149

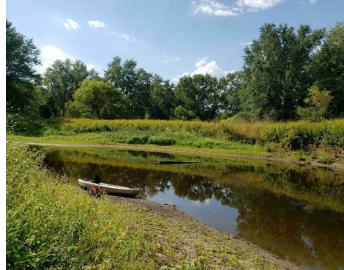
Left bank from right bank looking upstream from Station 149

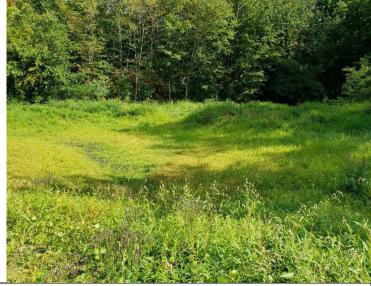
Bankfull marsh between Stations 149-150

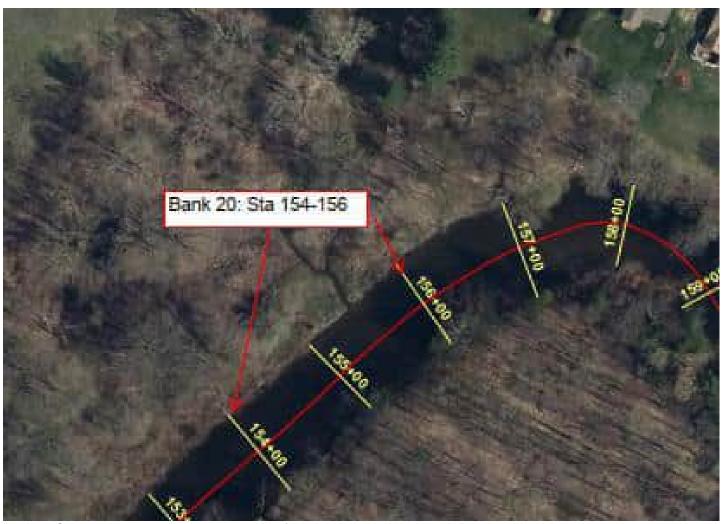
Bank 20 Stations 154-1156; straight channel before right bend below Joseph Road residential area

Photos of Bank 20 Area, August 16, 2022 downstream left bank (left side) to right bank from Station right bank at Station 155+50 155 Right bank at Station 156 Left bank at Station 156

General Electric Housatonic Rest of River Form RB-1: Riverbank Habitat Inventory Form		
VII. Habitat Degradation (identify specific location on b	ank segment if applicable)	
☐ Evidence of significant levels of dumping		
Evidence of significant erosion or sedimentation pr	oblems	
Occurrence of invasive plants: Bittersweet, forget-me-not		
Evidence of other human disturbance; describe:		
VIII.Restoration Opportunities		
☑ Presence of potential restoration resources (e.g., be bank stabilization or hibernacula, plant propagation sour Medium woody debris/Coarse woody debris, cobbletic.)		
○ Other restoration opportunities:		
R: Grade bank/Coir matting; Reshape point bar; Bank	c spurs	
L: Grade bank/Coir matting; Bank spurs		
Invasive species control		
Revegetation

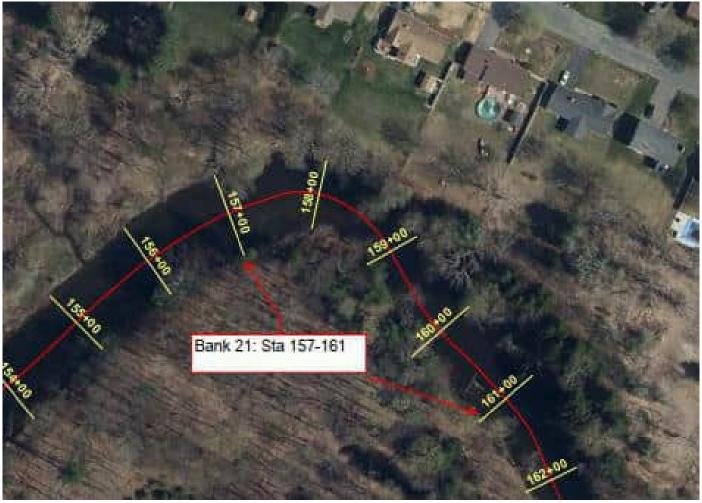
Bank 21: Stations 157-161. 400-ft stretch along sharp right bend to run from Station 157-161

Photos of Bank 21 Area. August 16 2022 Right bank (left side) to left bank at bend, looking Right bank near Station 158 upstream Left bank near Station 159 Right bank near Station 159

B-1: Riverbank Habitat Inventory Form	
VII. Hal	pitat Degradation (identify specific location on b	ank segment if applicable)
	Evidence of significant levels of dumping	
	Evidence of significant erosion or sedimentation pr	oblems
	Occurrence of invasive plants	
•	Common buckthorn, bittersweet, forget-me-not	
	Evidence of other human disturbance; describe: or	utlet culvert
VIII.Res	storation Opportunities	
ban	Presence of potential restoration resources (e.g., but stabilization or hibernacula, plant propagation so coarse woody debris, large trees, root wads, cobble	
$\boxtimes$	Other restoration opportunities:	
R	Reshape point bar	
L	: Coir matting; Vegetated rip rap	
Ir	nvasive species control	
R	Revegetation

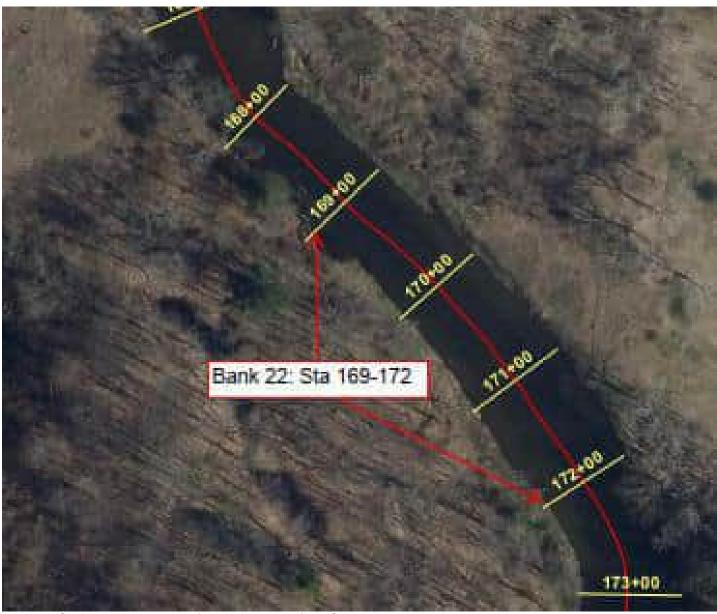
Bank 22: Stations 169-172. 300-ft straight stretch from Station 169-172

A.	Bank Characteriza	ation				
Phy	sical Dimensions	(ft):				
Ler	ngth: 300'	Width: 80'	Bank Height: R	4' L 4'		Slope: R 40% L 40%
Sec	diment / Substrate	composition:				
% 5	Sand 45	% Silt 45	% Clay			% Gravel/cobble 10
% E	Boulder/Bedrock	% Or	ganic matter			
Bar	nk stability / Obser	ved erosional condition	ns:			
				ut banks	S.	Both banks moderate BEHI and low NBS.
В.	Bordering Habitat	Types				
We	tland			Uplan	nd	
		loodplain forest			_	Northern Hardwoods-Hemlock-White Pine Forest
	☐ High terrace	floodplain forest				Rich mesic forest
	☐ Red maple sv	wamp				Red Oak-Sugar Maple Transition Forest
	∀ Vernal pool					Agricultural fields
	Black ash-red swamp	d maple-tamarack calc	areous seepage		$\leq$	Cultural grassland
	Deep emerge	ent marsh				Successional northern hardwoods
	☐ Shallow eme	rgent marsh				Spruce-fir-northern hardwood forest
	Shrub swamp     Shrub	)			$\leq$	Developed/disturbed cover types

General Electric Housatonic Rest of River Form RB-1: Riverbank Habitat Inventory Form				
VII. Habitat Degradation (identify specific location on b	ank segment if applicable)			
☐ Evidence of significant levels of dumping				
Evidence of significant erosion or sedimentation pr	oblems			
<ul> <li>☑ Occurrence of invasive plants:</li> <li>Reed canary grass, Eurasian water-milfoil, forget-me-not</li> </ul>				
	isturbed by foot traffic for canoe launching			
VIII.Restoration Opportunities				
□ Presence of potential restoration resources (e.g., bank stabilization or hibernacula, plant propagation so Coarse woody debris	poulders, large trees or woody debris, root wad material for urce material). Identify specific items:			
○ Other restoration opportunities:				
R: Grade bank/Coir matting				
L: Grade bank/Coir matting; Log or rock vanes				
Invasive species control				
Revegetation

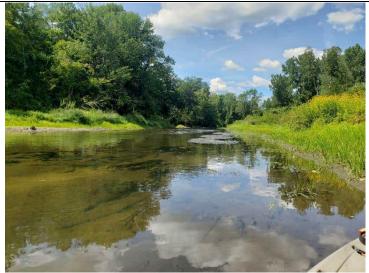
Left bank (right side) to right bank from Station 172 looking upstream

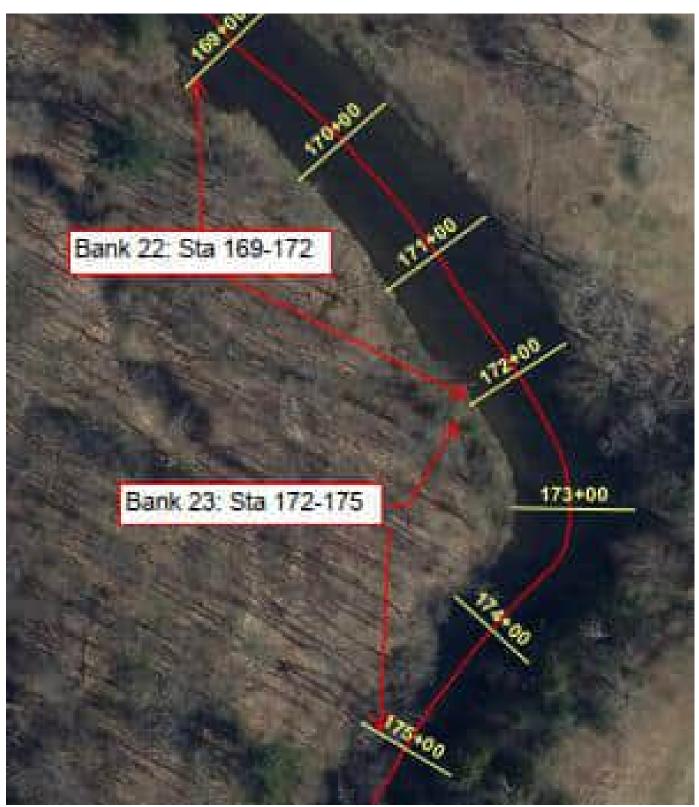
Bank 23: Stations 172-175. Right bend from Station 172 to 175. Left bank at bend in river

A.	Bank Characteriza	ation				
Phy	ysical Dimensions	(ft):				
Ler	ngth: 300'	Width: 80'	Bank Height: R 6-7	" L5	' Slope: R 80% L 90%	
Sec	diment / Substrate	composition:				
% \$	Sand 40	% Silt 40	% Clay		% Gravel/cobble 20	
% E	Boulder Bedrock	9	% Organic matter			
	Right bank is cut Thalweg runs alo	ng the left.		ndercu	utting, but rocky. Left bank has extreme NBS.

Right bank downstream of Station 174

General Electric Housatonic Rest of River Form RB-1: Riverbank Habitat Inventory Form	
VII. Habitat Degradation (identify specific location on b	ank segment if applicable)
☐ Evidence of significant levels of dumping	
Evidence of significant erosion or sedimentation pro	oblems
○ Occurrence of invasive plants:     Bittersweet, common buckthorn	
Evidence of other human disturbance; describe:	
VIII.Restoration Opportunities	
☑ Presence of potential restoration resources (e.g., b bank stabilization or hibernacula, plant propagation sou Coarse woody debris, large trees, root wads, cobble	
○ Other restoration opportunities:	
R: Grade bank/Coir matting	
L: Log or rock vanes; Root wads; Vegetated riprap	
Invasive species control	
Revegetation

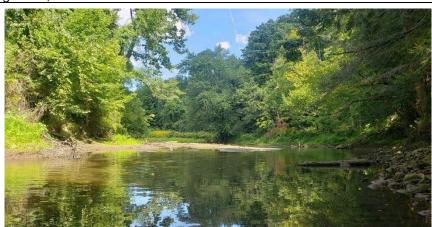
Looking upstream at point/mid-channel bar around Station 176-177. Right bank is left.

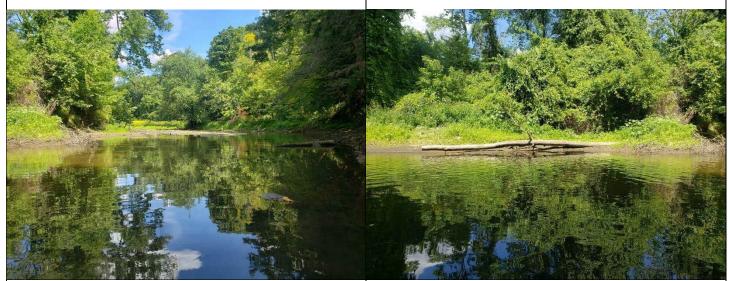
Looking upstream toward point/mid-channel bar at left bend in river at Station 177

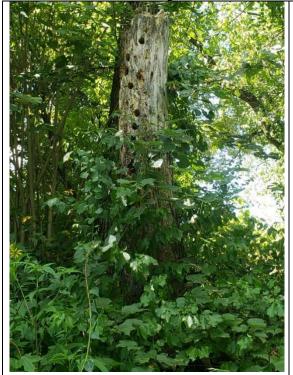
Right bank at upper limit of Bank 25, by WWTP fence near Station 189

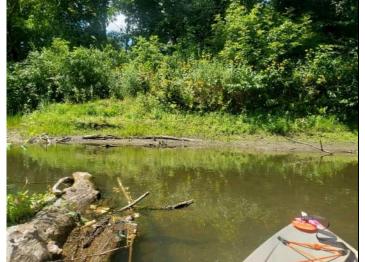
Looking downstream through Bank 25 area below Station 190.

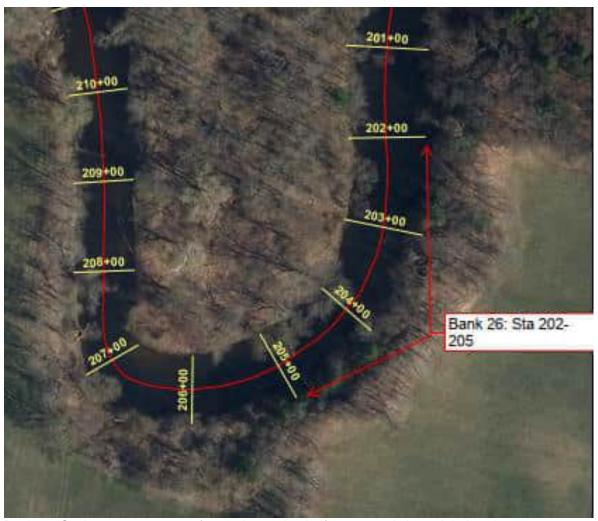
Bank 26: Stations 202-205. 300-ft stretch entering halfway around sharp right bend.

Photos of Bank 26 Area. August 10, 2022 Left bank (right side) to right bank (left side) Station 203 Left bank, looking upstream from Station 204 area Left bank (left) to right bank (right) looking downstream Left bank Station 203 area Left bank hemlock roots near Station 204 Right bank view from left bank; Station 204 area

General Electric Housatonic Rest of River Form RB-1: Riverbank Habitat Inventory Form			
VII. Habitat Degradation (identify specific location on b	ank segment if applicable)		
Evidence of significant levels of dumping			
Evidence of significant erosion or sedimentation pr	oblems		
○ Occurrence of invasive plants:     Japanese knotweed, bittersweet, common buckthorn, privet			
⊠ Evidence of other human disturbance; describe: Bı	ricks and metal debris near toe of left bank		
VIII.Restoration Opportunities			
□ Presence of potential restoration resources (e.g., beank stabilization or hibernacula, plant propagation sour Coarse woody debris, large trees, root wads, cobbe.			
○ Other restoration opportunities:			
R: Reshape point bar			
L: Log and rock vanes			
Invasive species control			
Revegetation

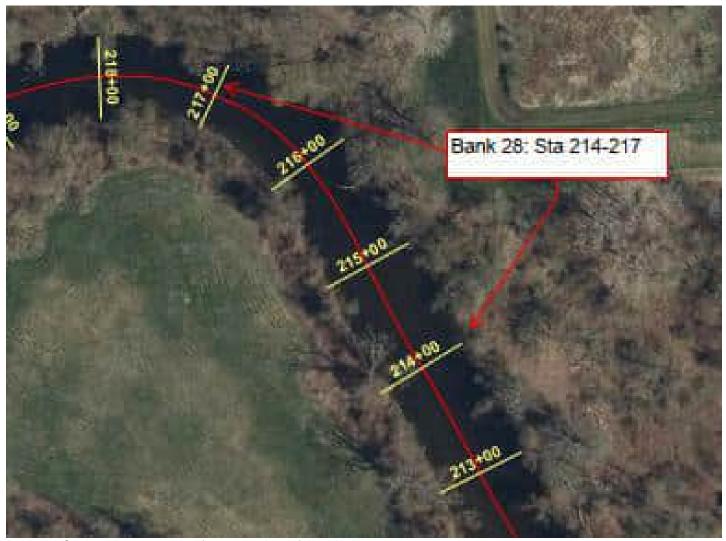
Bank 28: Stations 214-217. 300-ft run entering left bend.

A.	Bank Characteriza	ation						
Phy	sical Dimensions	(ft):						
Ler	ngth: 300'	Width: 70'	Bank Height: R 7	" L 6'	Slope%: R 90% L 40%			
Sec	diment / Substrate	composition:						
% 5	Sand 45	% Silt 45	% Clay		% Gravel/cobble 10			
% E	Boulder/Bedrock	Q	% Organic matter					
		ved erosional con						
	Right bank is stee	p with some slump	oing. Left bank is gentl	le and st	table. Thalweg runs along right side.

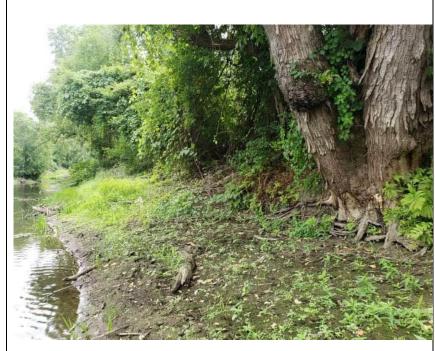
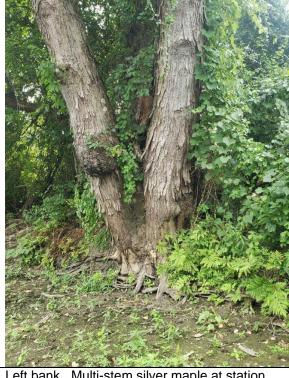
Left bank. Multi-stem silver maple at station 214

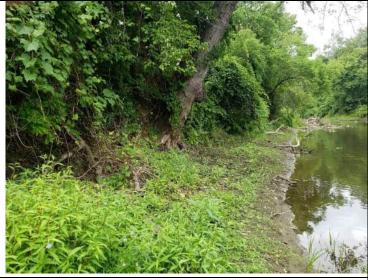
Left bank near Station 215 looking downstream

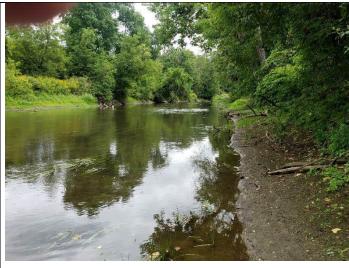
Left bank near Station 215 looking upstream

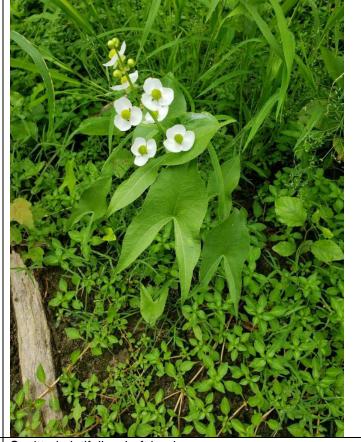
Sagittaria latifolia...Left bank

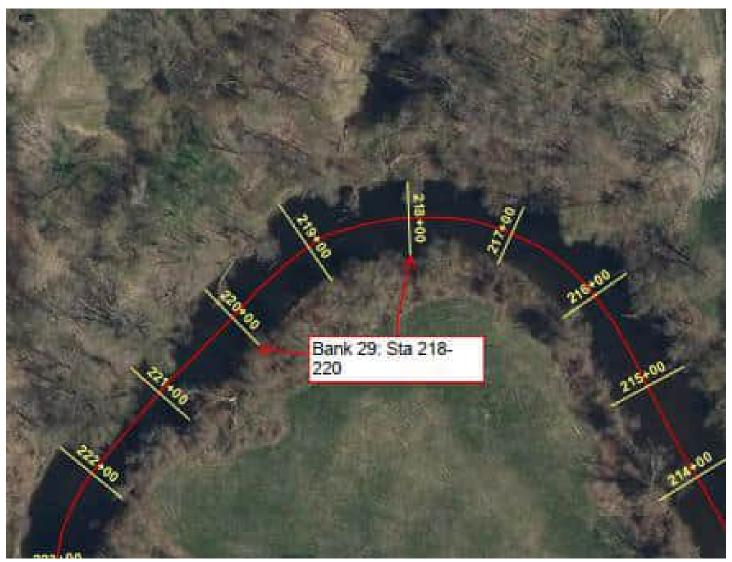
Bank 29: Stations 218-220. 200-ft stretch from halfway around left bend.

Photos of Bank 29 Area. August 10, 2022. Right bank Right bank Right bank

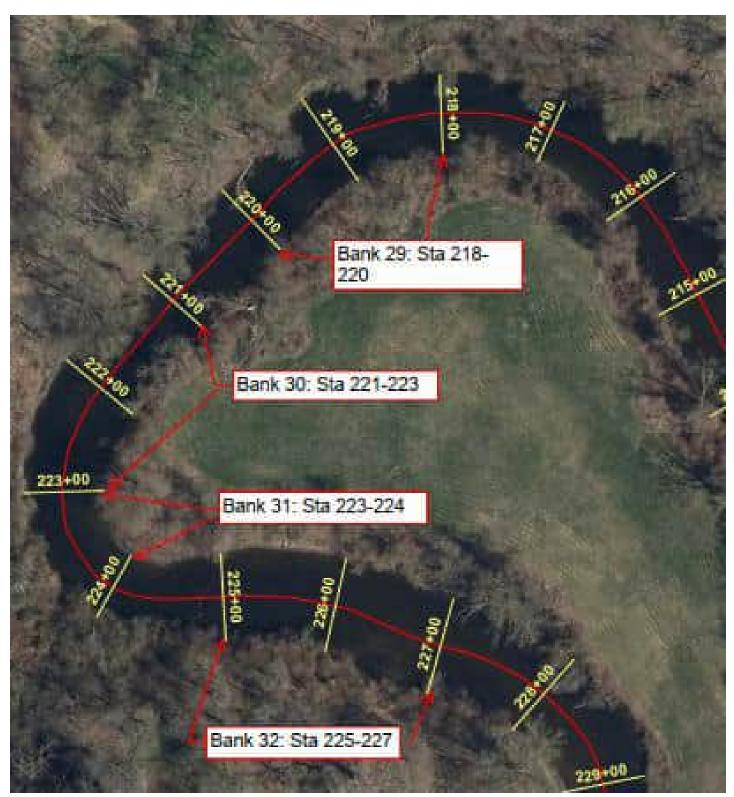
Bank 30: Stations 221-223. 200-ft stretch that enters left bend.

Right bank, downstream end of reach. Station 223.

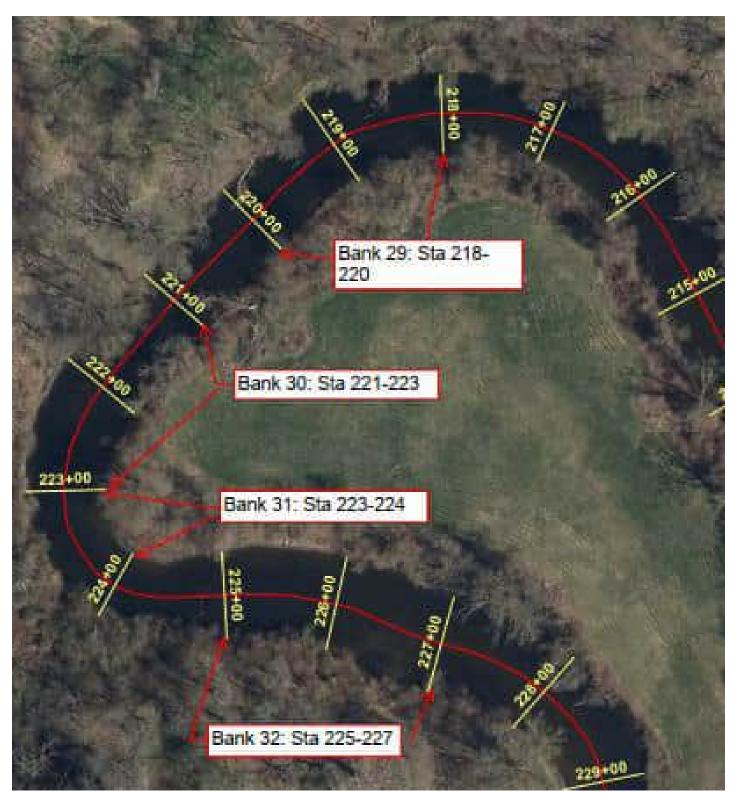
Bank 31: Stations 223-224. 100-ft sharp bend to left.

Photos of Bank 31 Area. August 10, 2022

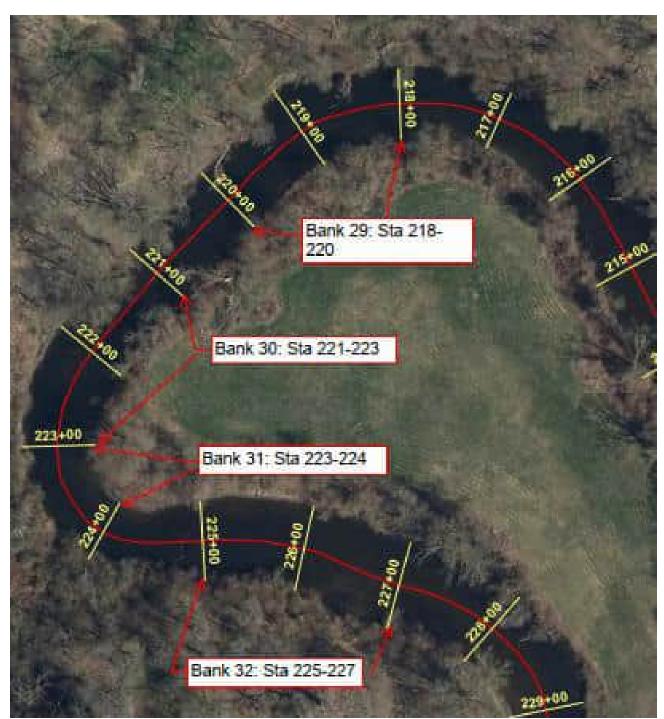
Bank 32 Stations 225-227. 200-ft mild right bend.

Photos of Bank 32 Area. August 10, 2022 Right bank above Station 226 Right bank near Station 226 Right bank (left) to left bank (right) looking upstream Left bank from Station 225 area Left bank from Station 225 area

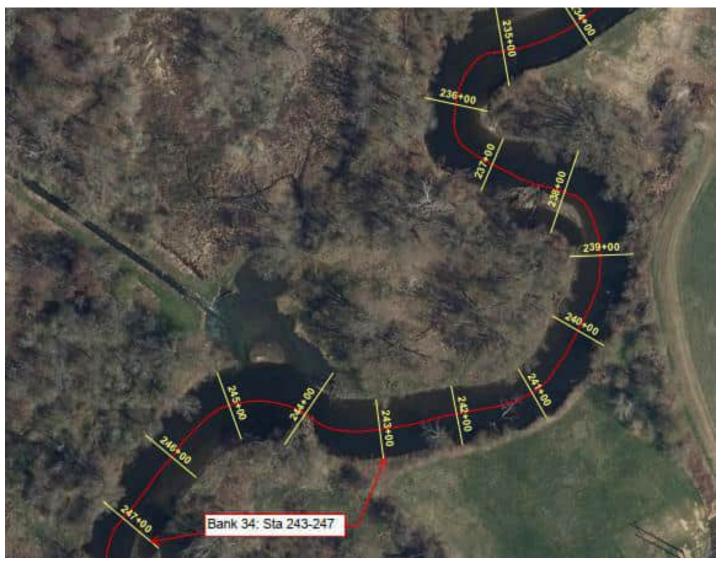
Bank 34: Station 243-247. 400-ft stretch around right to left bend. POTW discharge along right bank.

Photos of Bank 34 Area. August 16, 2022. Left bank upstream of Station 243 Right bank just above Station 245 Right bank Right bank near Station 245 Right bank near Station 244; POTW discharge to rear Right bank near Station 244

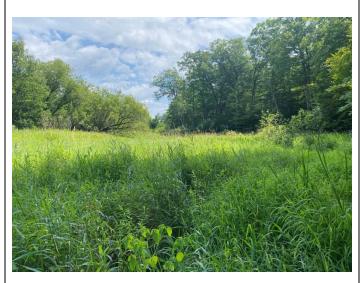
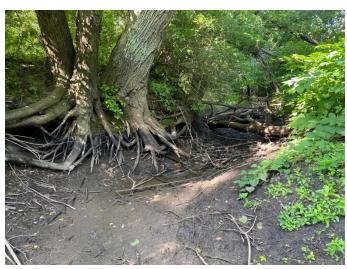
Photo No. 3 Date: 08/02/22 Photo No. 4 Date: 08/02/22

Description: View S, wet meadow dominated by reed Description: View N, high-flow channel through

canary grass transitional floodplain forest

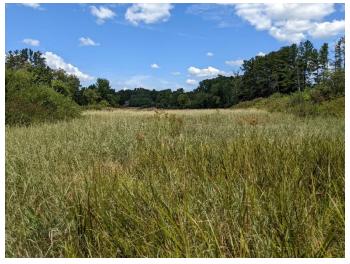
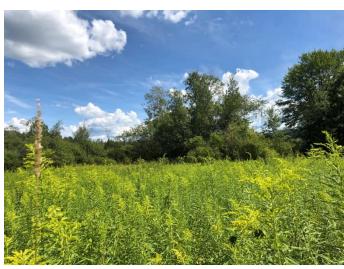
Photo No. 11 **Date:** 08/16/22 Photo No. 12 **Date:** 08/16/22

Description: View N, wet meadow and shallow emergent Description: View N, cultural grasslands / former marsh habitats in Canoe Meadows agricultural areas in Canoe Meadows

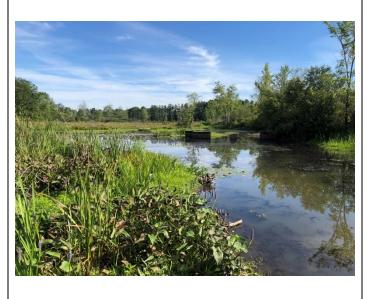
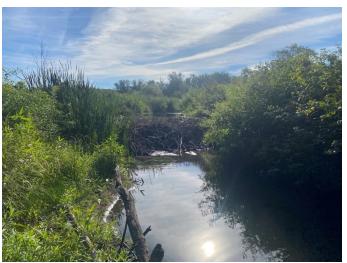
Photo No. 15 **Date:** 08/17/22 **Date:** 08/16/22 Photo No. 16

Description: View W, Canoe Meadows open water and shallow emergent marsh habitats with former concrete constructed dam/wier

Description: View NE, Canoe Meadows approximately 5foot tall beaver dam in Sackett Brook

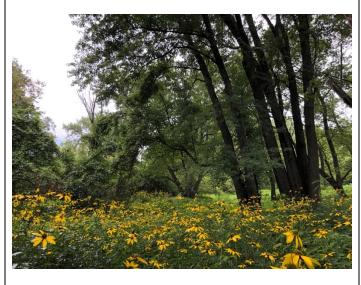
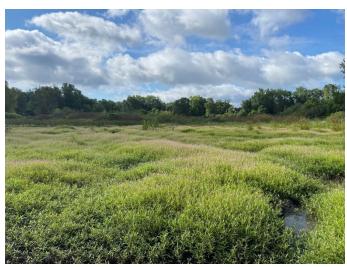
Photo No. 19 Date: 08/17/22 Photo No. 20 Date: 08/16/22

**Description:** View NNE, transitional floodplain forest by smartweed. Deep mucky/organic soils

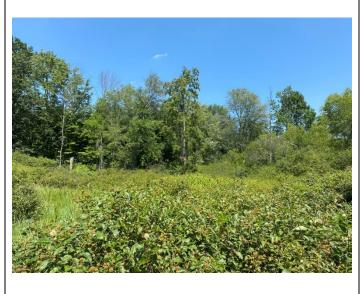
Photo No. 23 Date: 08/04/22 Photo No. 24 Date: 08/18/22

**Description:** View S, buttonbush shrub swamp and shallow emergent marsh habitats in 5A-VP-21

**Description:** View S, shallow emergent marsh and shrub swamp dominated by bur-reed, smartweed, silky dogwood and buttonbush

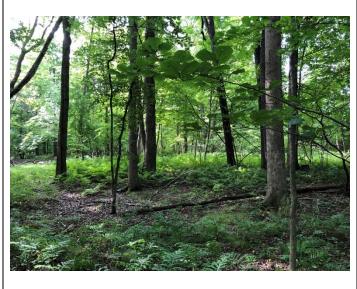
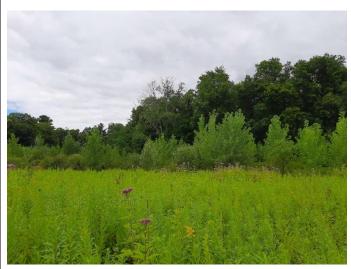
Photo No. 27 Date: 08/11/22 Photo No. 28 Date: 08/10/22

**Description:** View ESE, high terrace floodplain forest dominated by sugar maple, ash, American linden, witch-hazel and sensitive fern

**Description:** View SW, former agricultural fields / cultural grasslands
