Re: Martin Aaron Superfund Site

**SUMMARY OF HISTORICAL OWNERSHIP AND USES
OF THE MARTIN AARON SUPERFUND SITE
AND SELECT NEARBY PROPERTIES**

Prepared by *de maximis, inc.*

July 19, 2005

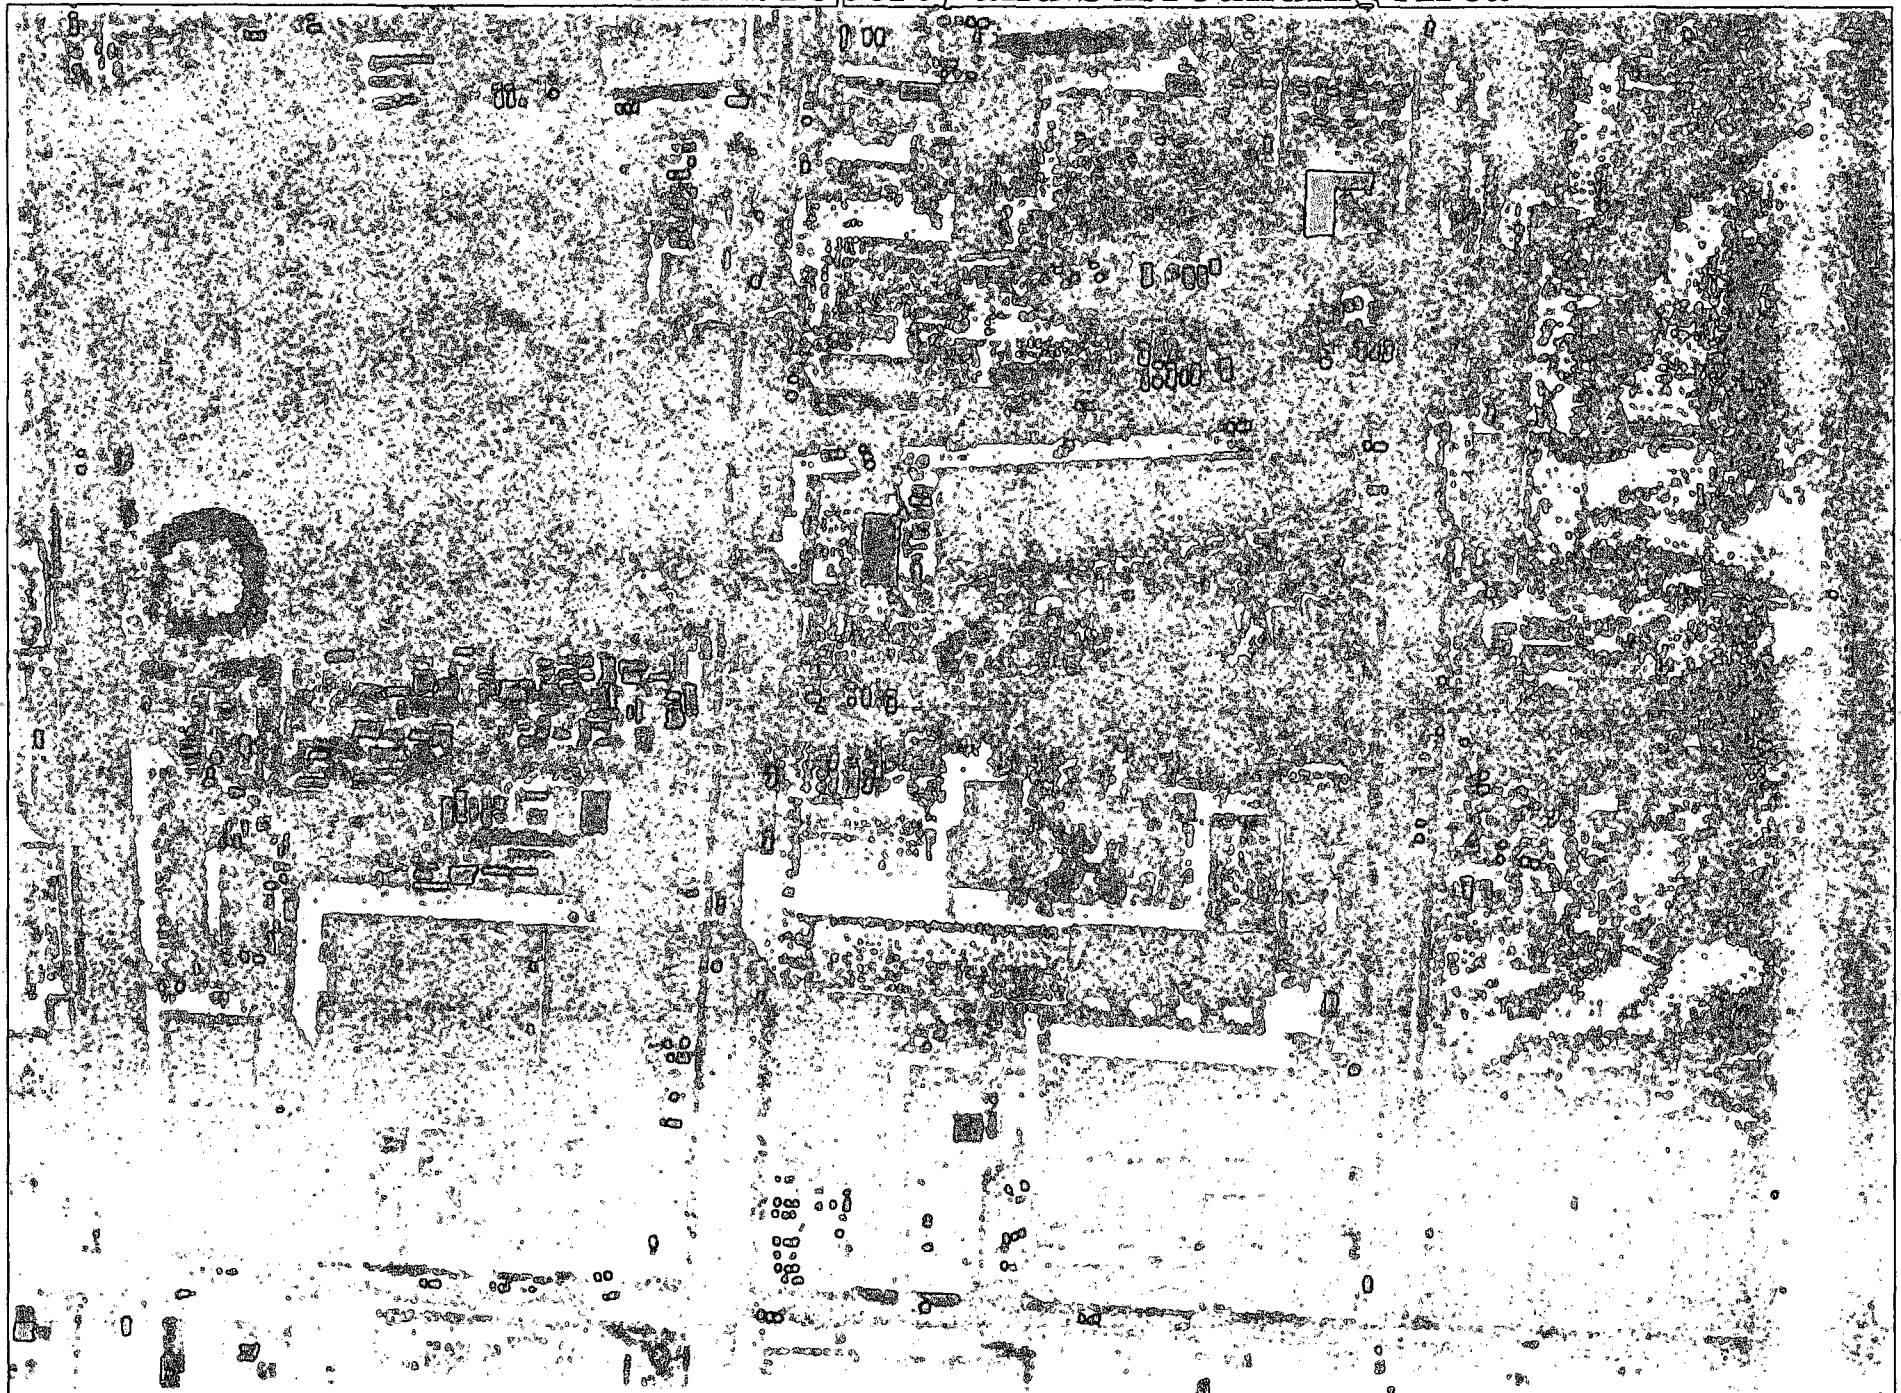
Figure 14

1971 Aerial Photo
Martin Aaron Property and Surrounding Area

1971 Aerial Photo (Figure 14) (Note – Martin Aaron took title to the property in 1968)

1971 Aerial Photo (Figure 14)
