TS-PIC-91097
October 1991

**EPA Site Analysis**
Horseshoe Road Site
Sayreville, New Jersey

EPA Region 2
and OERR

Site Analysis
Horseshoe Road Site
Sayreville, New Jersey

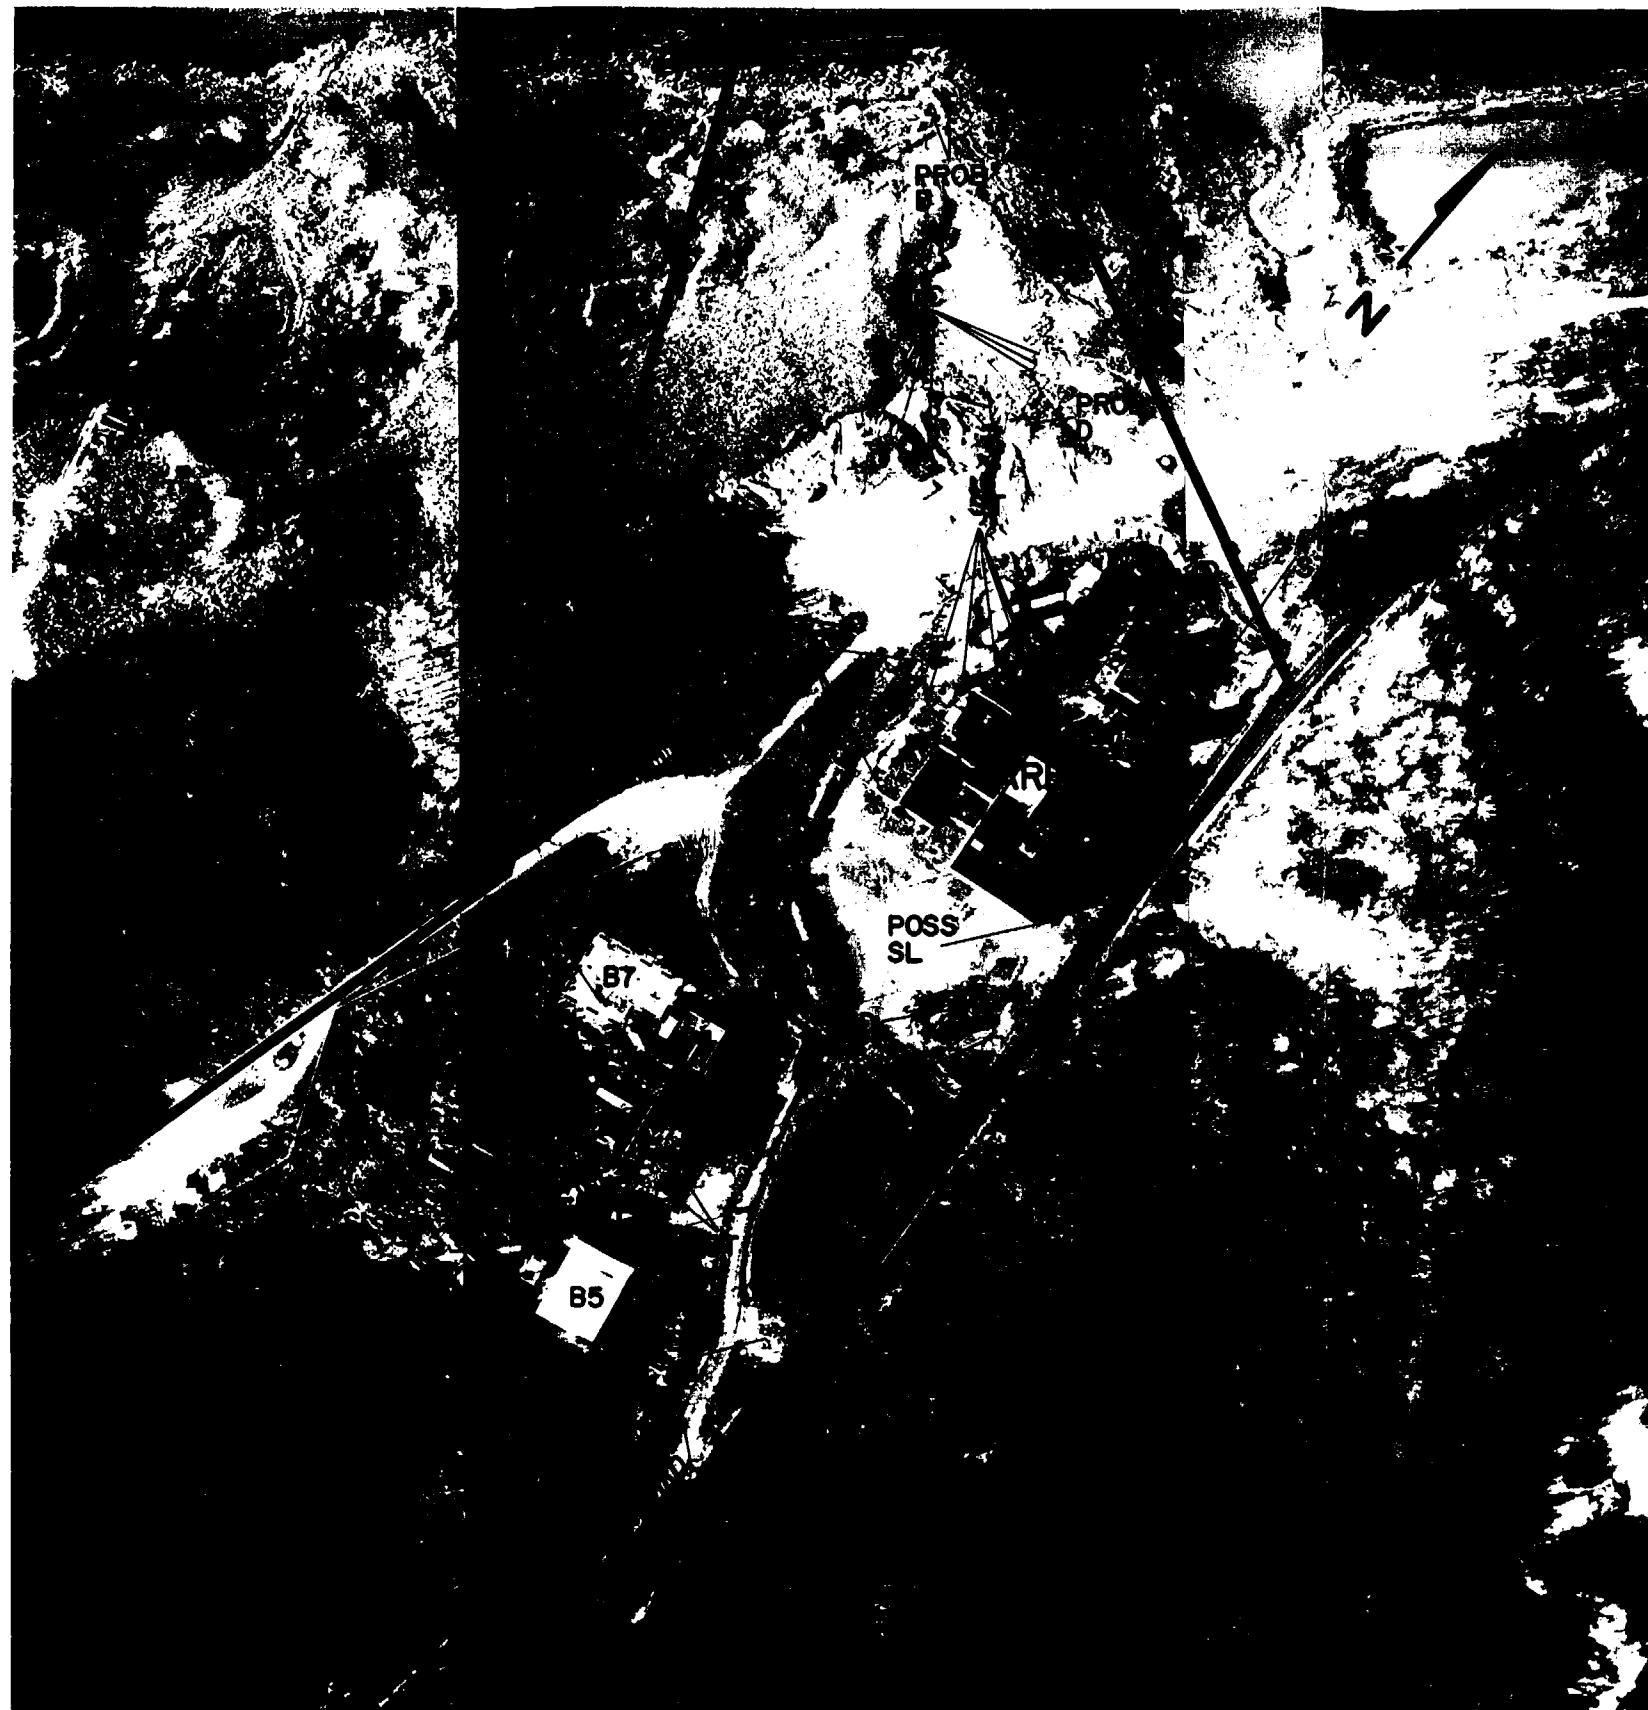
FIGURE 9
HORSESHOE ROAD SITE

DECEMBER 5, 1986 (FIGURE 9)

Three separate frames have been joined to create Figure 9. The scale of this photography is variable; therefore, the site boundary shown is approximate.

Area A - The Atlantic Resources Corporation abandoned the site in August 1985.* Multiple stains are visible in Area A. Drums have been piled north of B3. Farther east, a container appears to have spilled, leaving a probable stain. Possible standing liquid is noted at the southeast corner of B2.

Containers and probable drums can be seen within the wetland area west of the inactive Horseshoe Road Dump.

Area B - A fire occurred at B6 in 1983 and the building was gutted, exposing a considerable amount of debris.* Debris is seen west of B6 and around the cement pad* (former location of B7). Probable drums are observed east and west of B6. Probable debris is found on the east side of Horseshoe Road.

Rust-colored standing liquid is visible west of B5, adjacent to horizontal tanks (not annotated). This liquid flows into the drainage route noted in past years.

Containers and drums are visible on the slope of the inactive Sayreville Pesticide Dump.
