**FIFTH FIVE-YEAR REVIEW REPORT FOR
RAMAPO LANDFILL SUPERFUND SITE
ROCKLAND COUNTY, TOWN OF RAMAPO, NEW YORK**

**U.S. Environmental Protection Agency
Region 2
New York, New York**

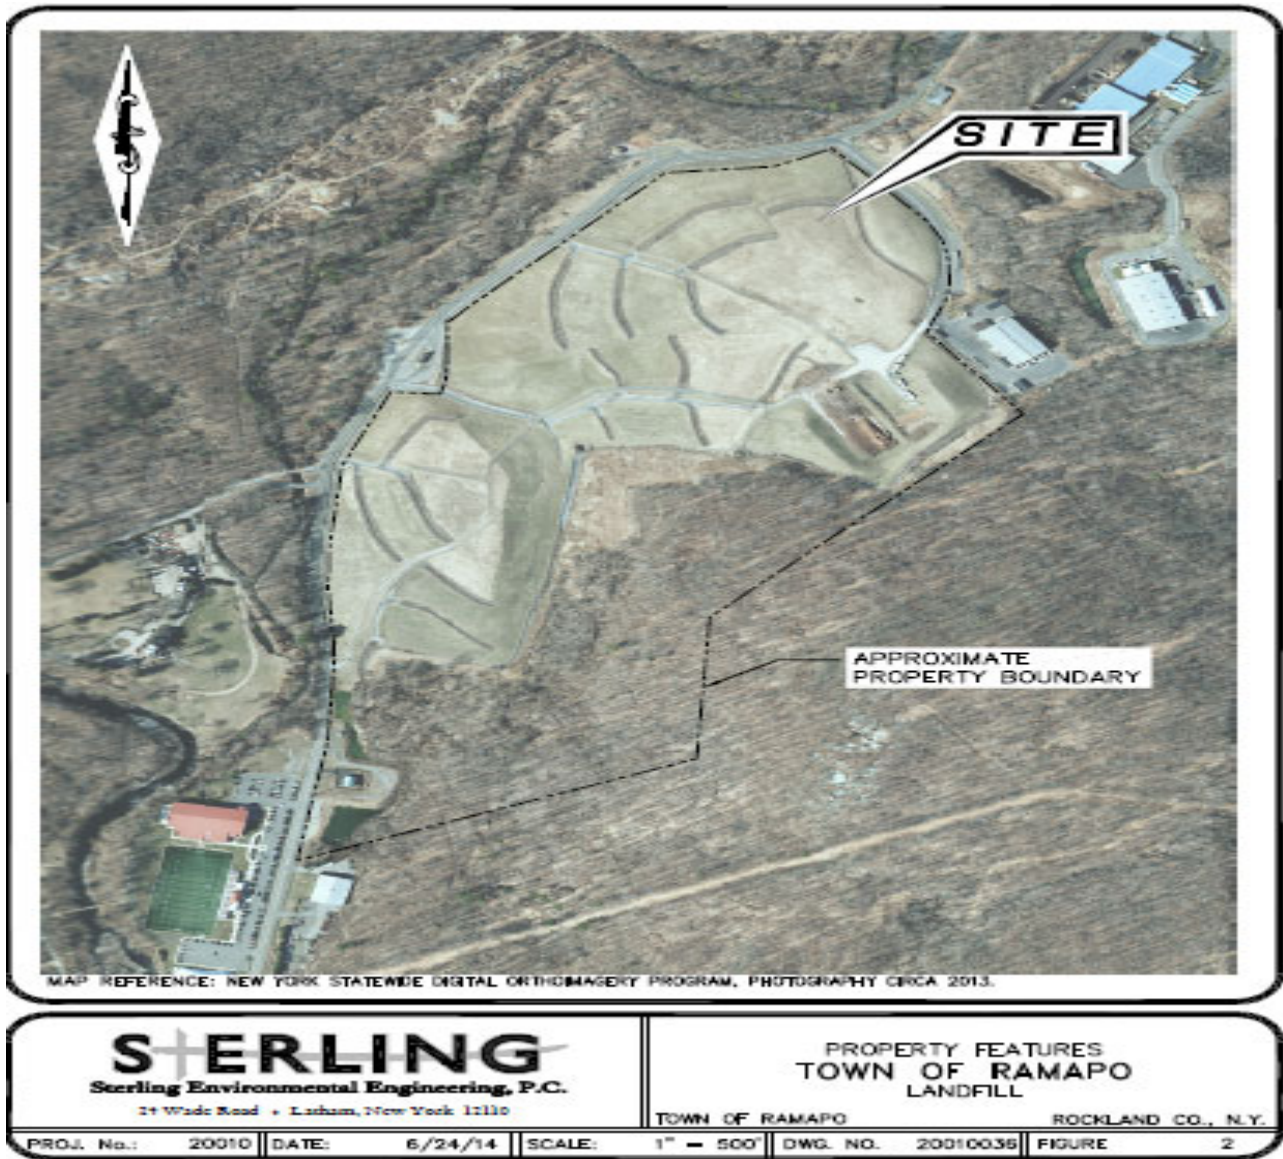
Figure 2: Site Boundary Map

The Ramapo Landfill site is located at 250 Torne Valley Road in the Village of Hillburn, Town of Ramapo, Rockland County, New York. See Figures 1 and 2.

The landfill, which is situated on a 96-acre tract, occupies approximately 60 acres. The landfill consists of two major lobes (northern and southern) and slopes steeply toward the west with grades ranging from less than one percent to greater than 30 percent. Both landfill lobes contain mixed refuse. Substances reportedly disposed of in the landfill include industrial sludge and other wastes from a pharmaceutical company, sewage sludge, municipal refuse, asbestos, construction and demolition debris, yard debris, paint sludge (presumably from an automotive plant), and liquid wastes from a paper company. Utility corridors lie on three sides of the site, high voltage power transmission lines are located to the east and west, and a high pressure gas line is situated to the south. A power substation is located just north of the site. The Ramapo Police Department currently uses a portion of the site for a shooting range.

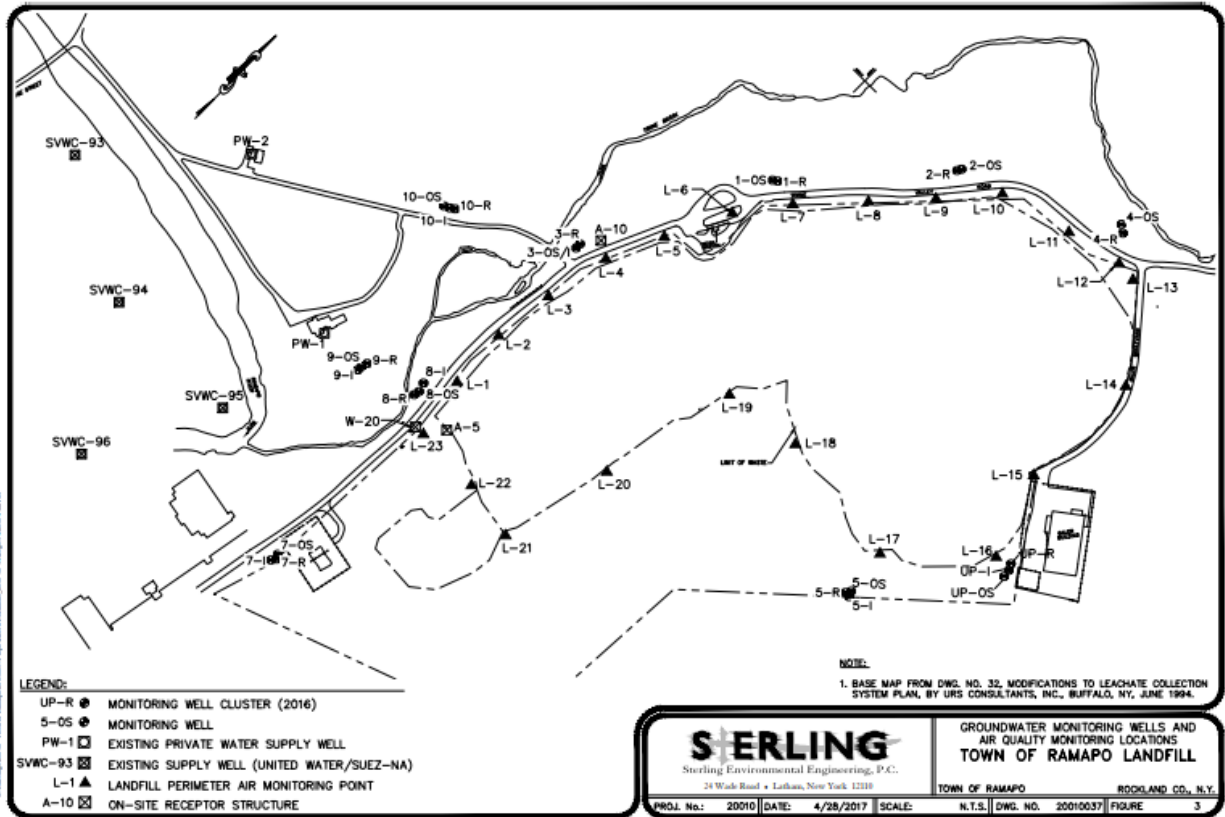
Figure 3: Groundwater monitoring locations

The groundwater monitoring includes shallow overburden monitoring wells (UP-OS, 1-OS, 2-OS, 4-OS, 7-OS, 8-OS, 9-OS, and 10-OS), intermediate overburden monitoring wells (UP-I, 3-OS/I, 8-I, 9-I, and 10-I) and bedrock monitoring wells (UP-R, 8-R, 9-R, and 10-R). Private water supply wells (PW-1 and PW-2) and Suez North America municipal supply wells partnered with Spring Valley Water Company (SVWC-93, 94, 95, and 96) located to the west of the site are monitored. See Figure 3 for the locations of the above-noted monitoring wells and water supply wells.
