**SIXTH FIVE-YEAR REVIEW REPORT FOR
MONROE TOWNSHIP LANDFILL SUPERFUND SITE
MIDDLESEX COUNTY, NEW JERSEY**

**U.S. Environmental Protection Agency
Region 2
New York, New York**

November 15, 2024

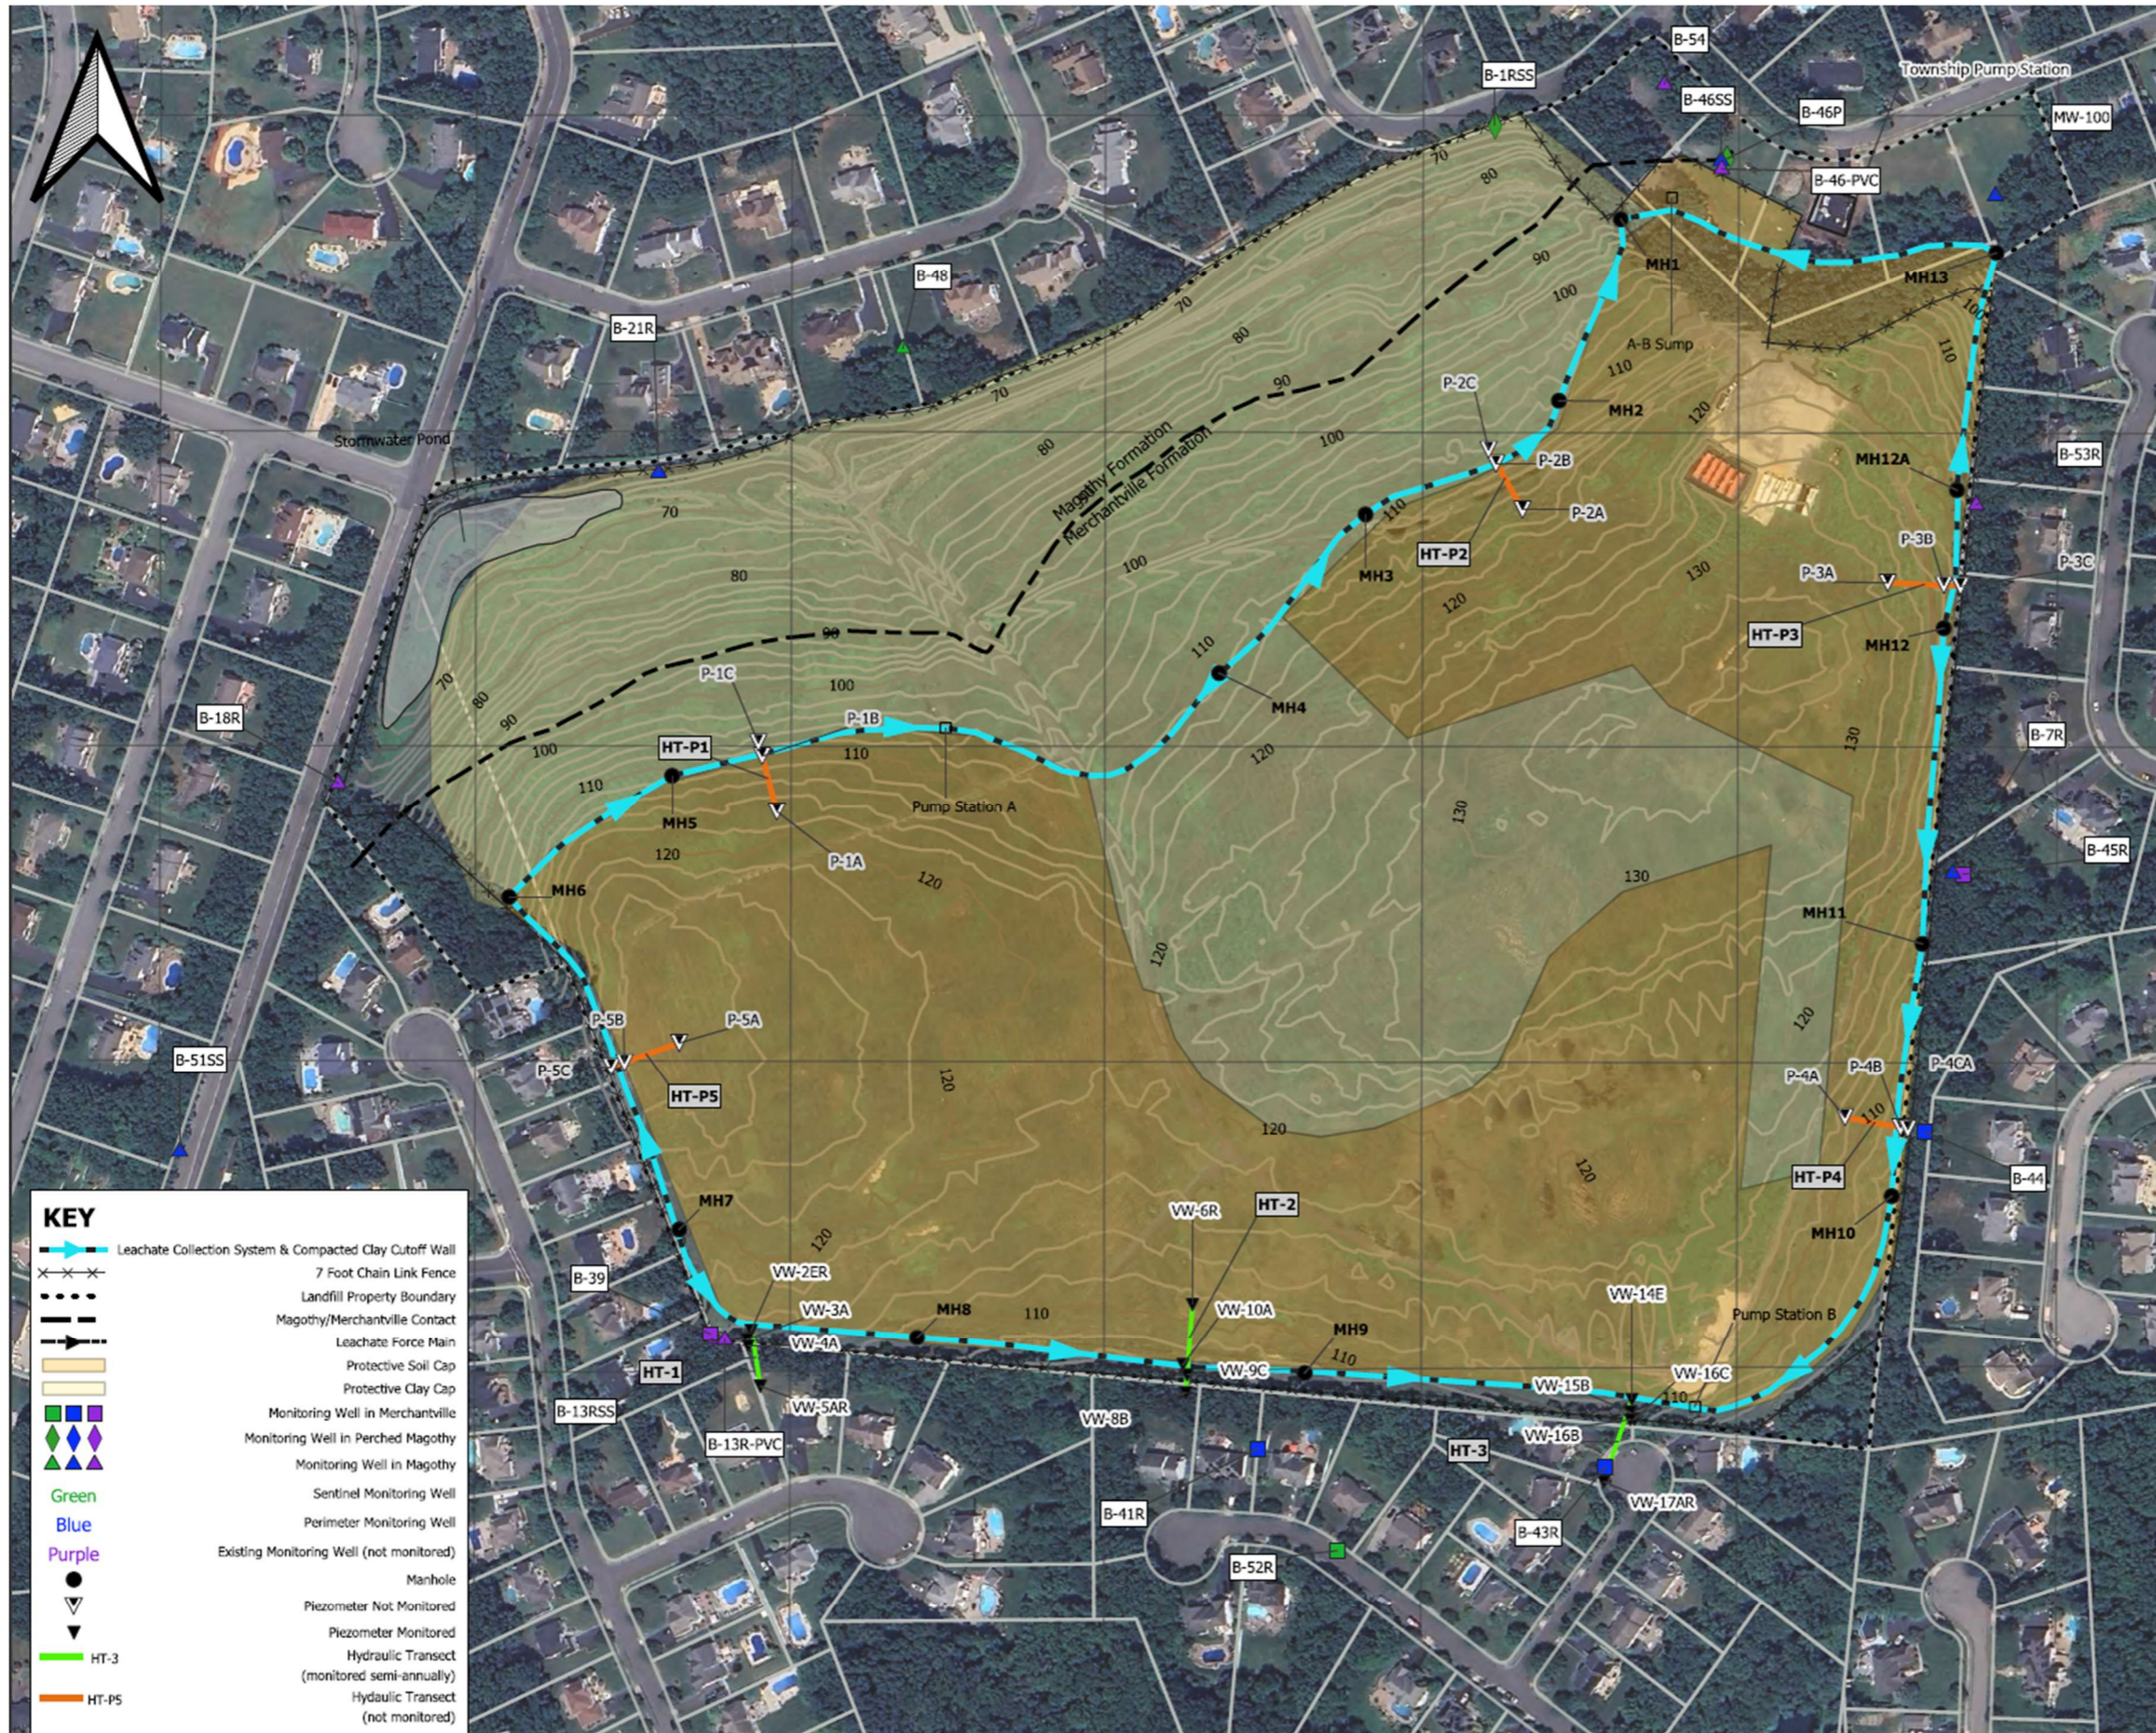
NOTES

1. Base Map Topographic contours provided by Cooper Aerial Surveys, Co. from aerial photography taken July 28, 2021; vertical datum is NAVD88.
2. Horizontal Coordinate System: New Jersey State Plane Feet NAD83. Locations of features and monitoring points are approximate.
3. Aerial Photo is from Google Earth Satellite, July 2023.
4. Tax Parcel boundaries are from Middlesex County Open Data Portal
5. Perimeter Monitoring Wells are sampled annually and are designed to assess the performance of the remedial systems and to track groundwater quality adjacent to the landfill
6. Sentinel Monitoring Wells are sampled annually and are designed to provide an early warning system for the migration of contaminants from the site.

Hydraulic gradients in the Merchantville Formation along the clay cut-off wall on the southern perimeter

of the site are monitored quarterly at three transects to ensure that inward gradients are maintained (Appendix B, Figure 2). Based on water-level data from this five-year review period, water level gradients were generally either flat or inward throughout the review period. Transect 2 exhibited slight outward gradients in October 2019, January 2021, and July 2022. Transect 3 exhibited slight outward gradients in October 2019, October 2020, and July 2021. It is suspected that the outward gradients are related to higher groundwater levels. The periods of observed outward gradients do not appear to result in migration of contaminants. Overall, the inward gradients have been consistently achieved.
