**SECOND FIVE-YEAR REVIEW REPORT FOR
VEGA BAJA SOLID WASTE DISPOSAL SUPERFUND SITE
VEGA BAJA, PUERTO RICO**

**U.S. Environmental Protection Agency
Region 2
New York, New York**

August 12, 2025

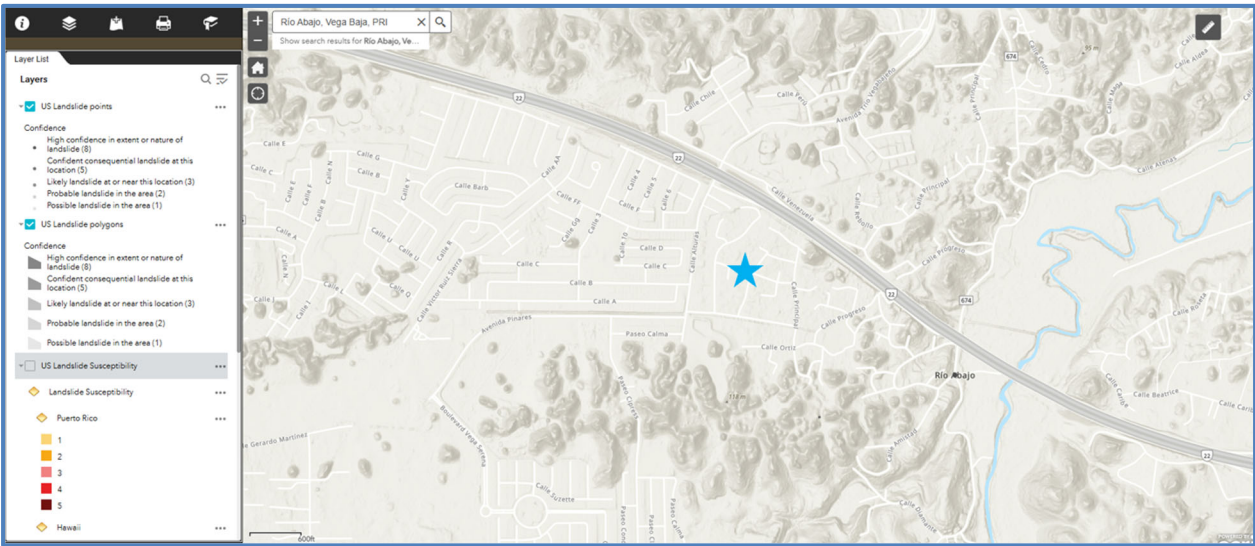
Figure A-9. Risk Factor, Landslide Potential in the Vicinity of Vega Baja Municipality, PR

Based on findings from the potential site impacts from severe weather events that have been assessed, there is no risk of flooding, sea level rise or landslides within the site. However, the remedy may be impacted by more frequent and sever hurricanes. Erosion on roadways and dense vegetation inside the Non-Residential Area were observed during inspections performed after Hurricane Maria in 2017 and Hurricane Fiona in 2022. Damages observed on roadways have been addressed by the municipality personnel and maintenance of the Non-Residential Area has been performed by the PRPs.
