LANDMARK PRESERVATION COMMISSION
FINAL DESIGN SUBMISSION

**REHABILITATION OF
CARROLL STREET BRIDGE
EAST ABUTMENT**

**CARROLL STREET BRIDGE
EAST ABUTMENT REHABILITATION**
09/2024

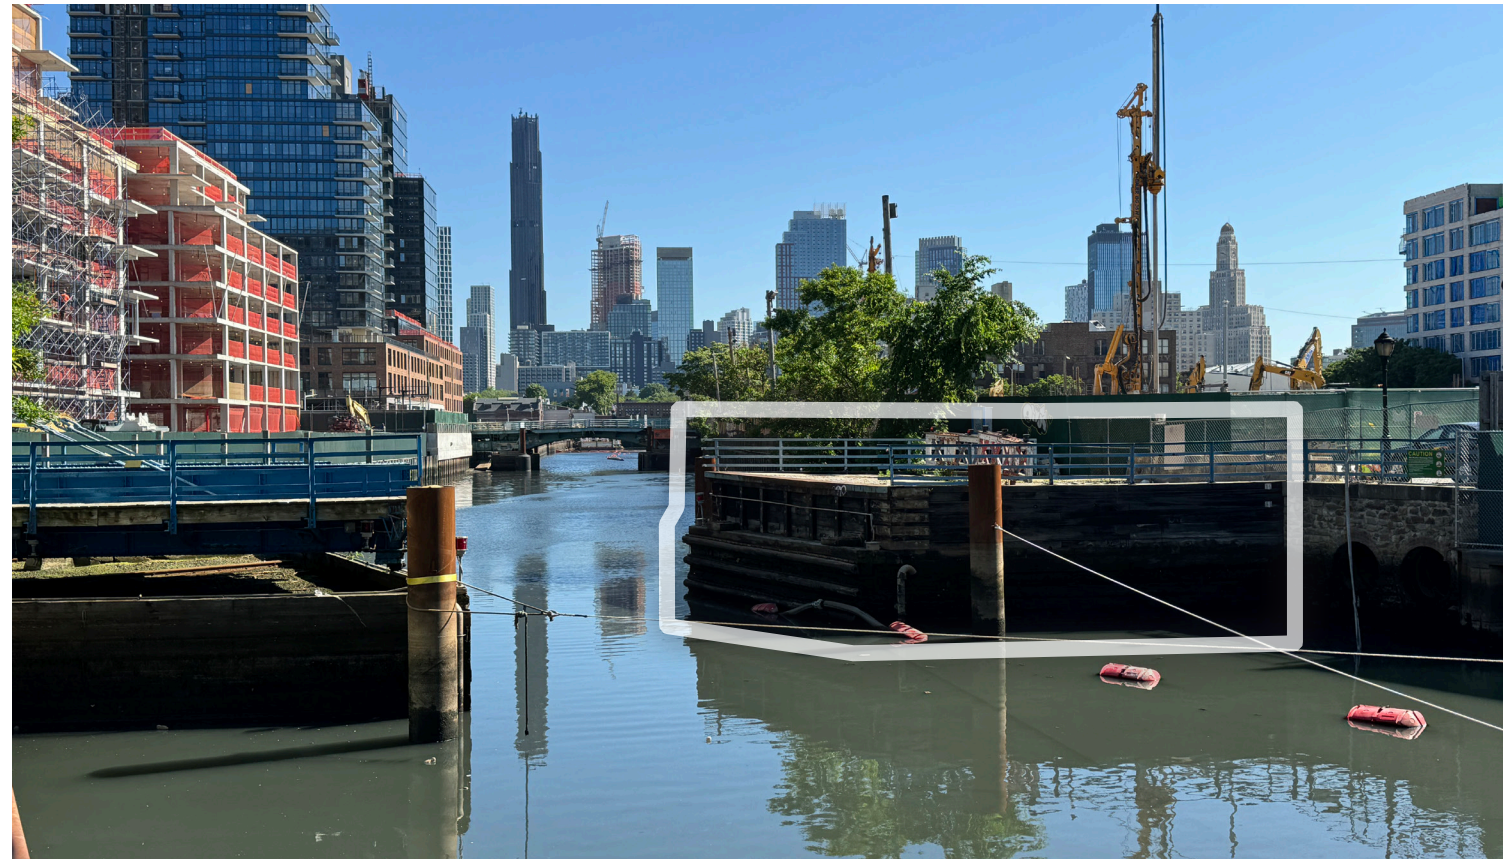
① CARROLL ST BRIDGE VIEW
LOOKING NORTHEAST
*PHOTO OF BRIDGE SOUTH ELEVATION
FROM GOWANUS CANAL*

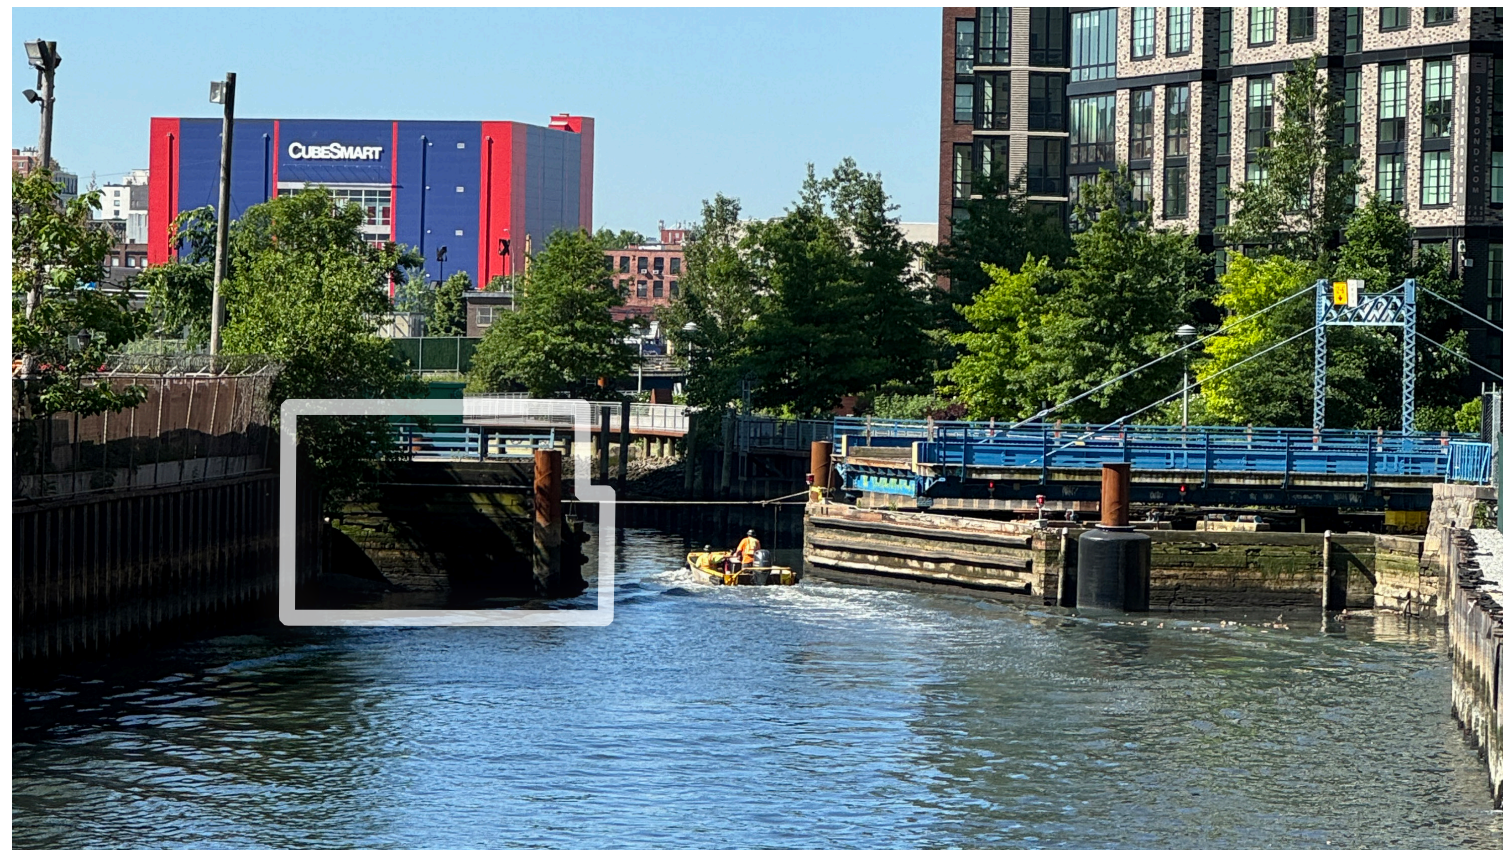
② CARROLL ST BRIDGE VIEW
LOOKING SOUTH
*PHOTO OF BRIDGE NORTH ELEVATION
FROM GOWANUS CANAL*

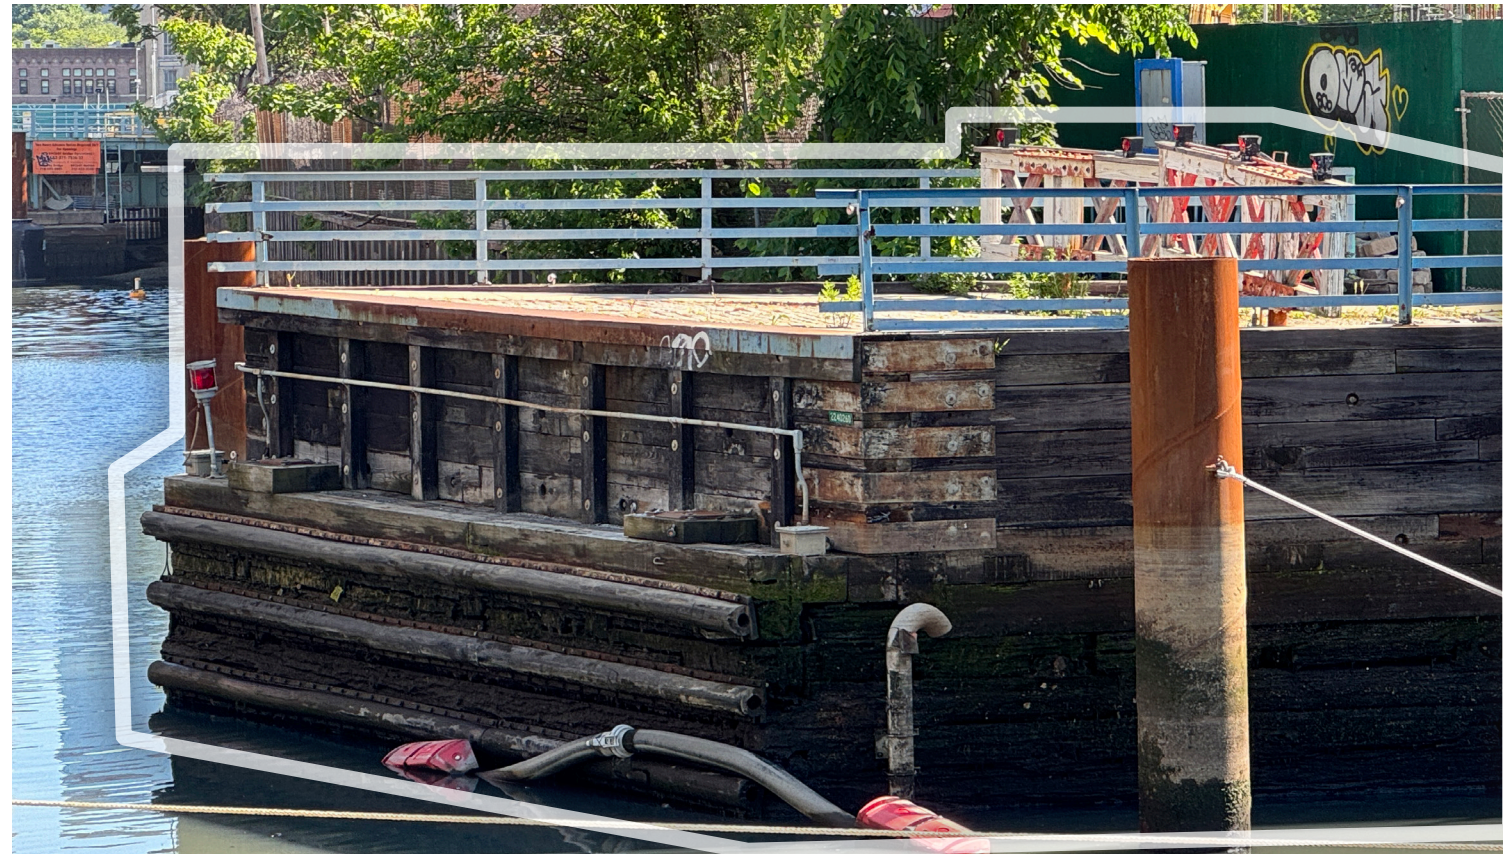
① EAST ABUTMENT VIEW
LOOKING EAST
PHOTO OF EXISTING TIMBER BULKHEAD

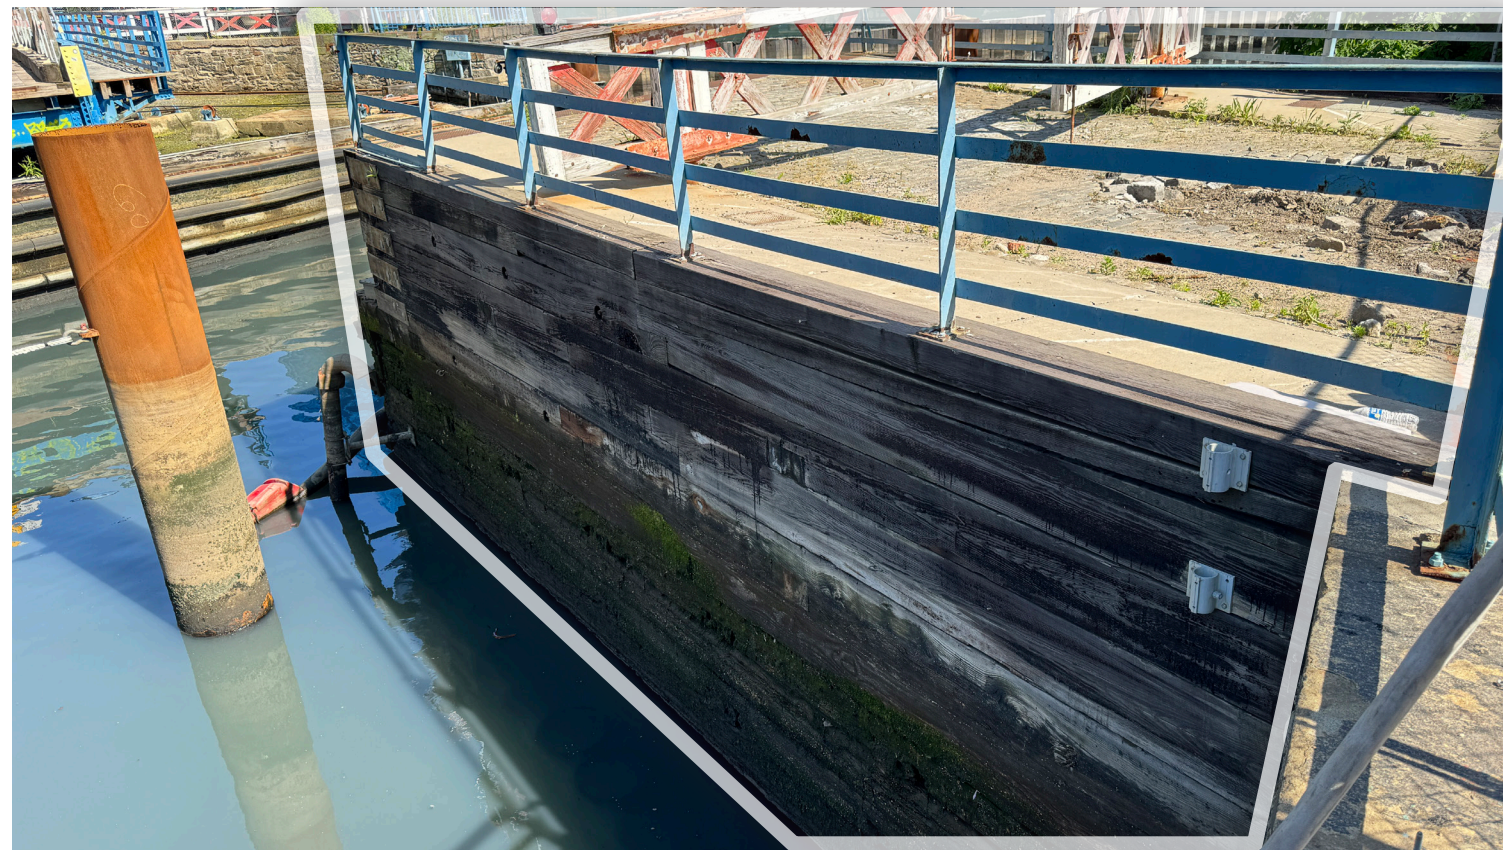
② EAST ABUTMENT VIEW
LOOKING NORTHEAST
*PHOTO OF EXISTING WINGWALL,
TIMBER CRIBBING, AND RAILING*

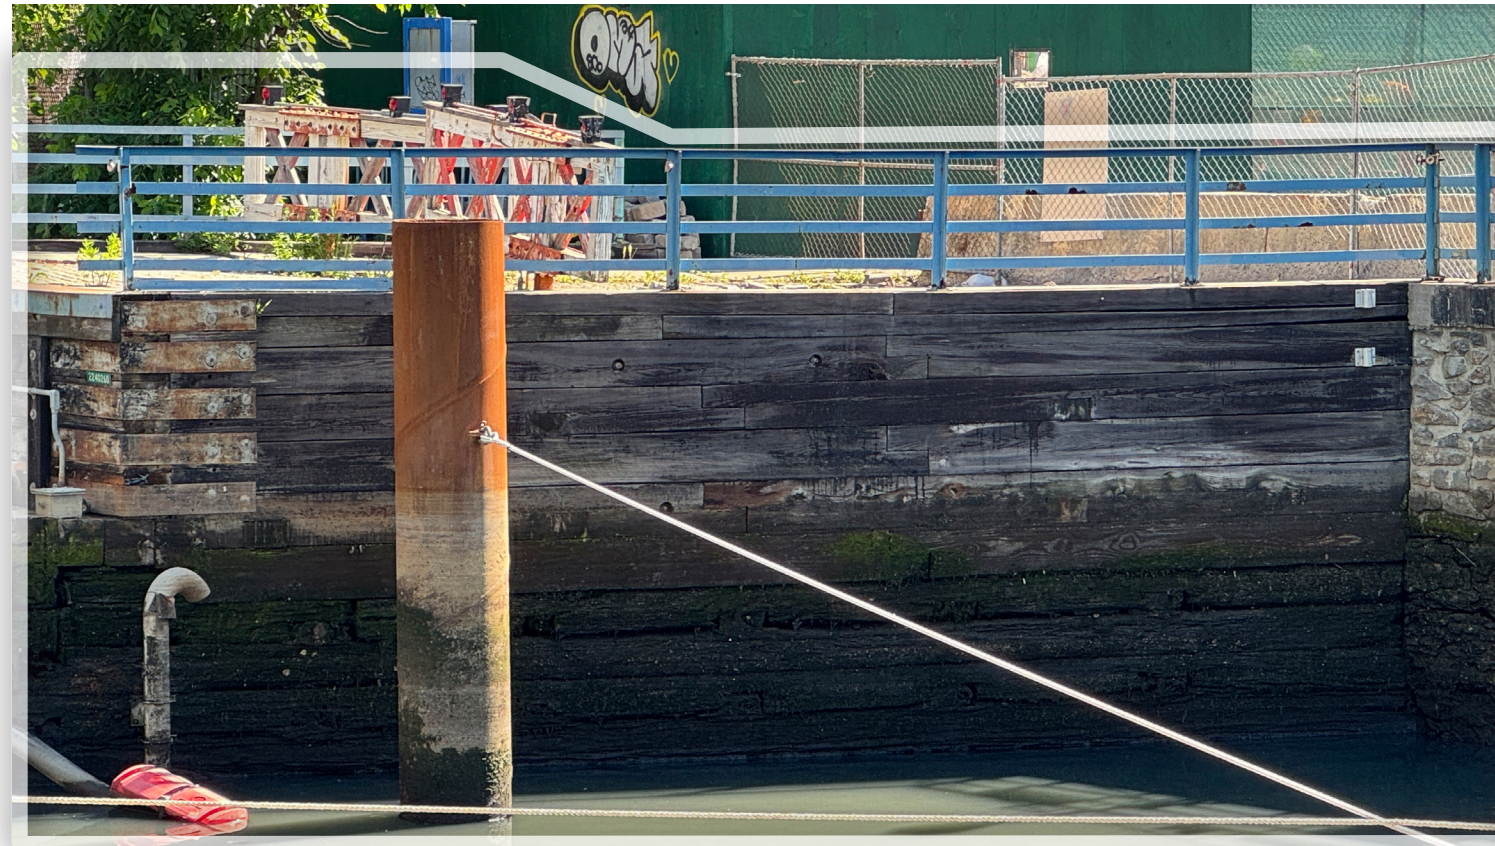
① EAST ABUTMENT VIEW
LOOKING NORTHEAST
PHOTO OF EXISTING TIMBER CRIBBING

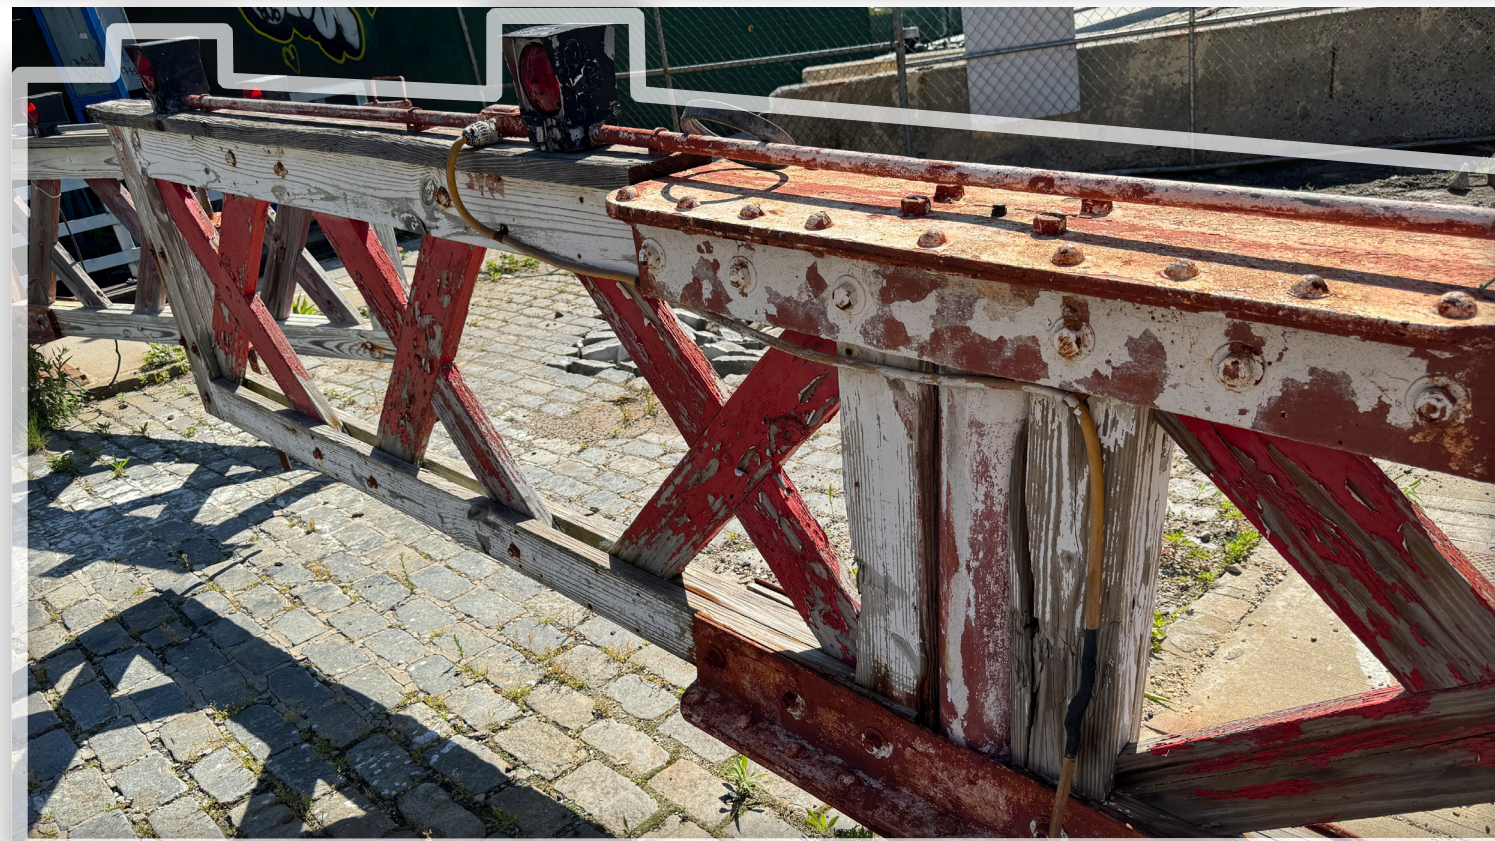
② EAST ABUTMENT VIEW
LOOKING EAST
PHOTO OF EXISTING BARRIER GATE

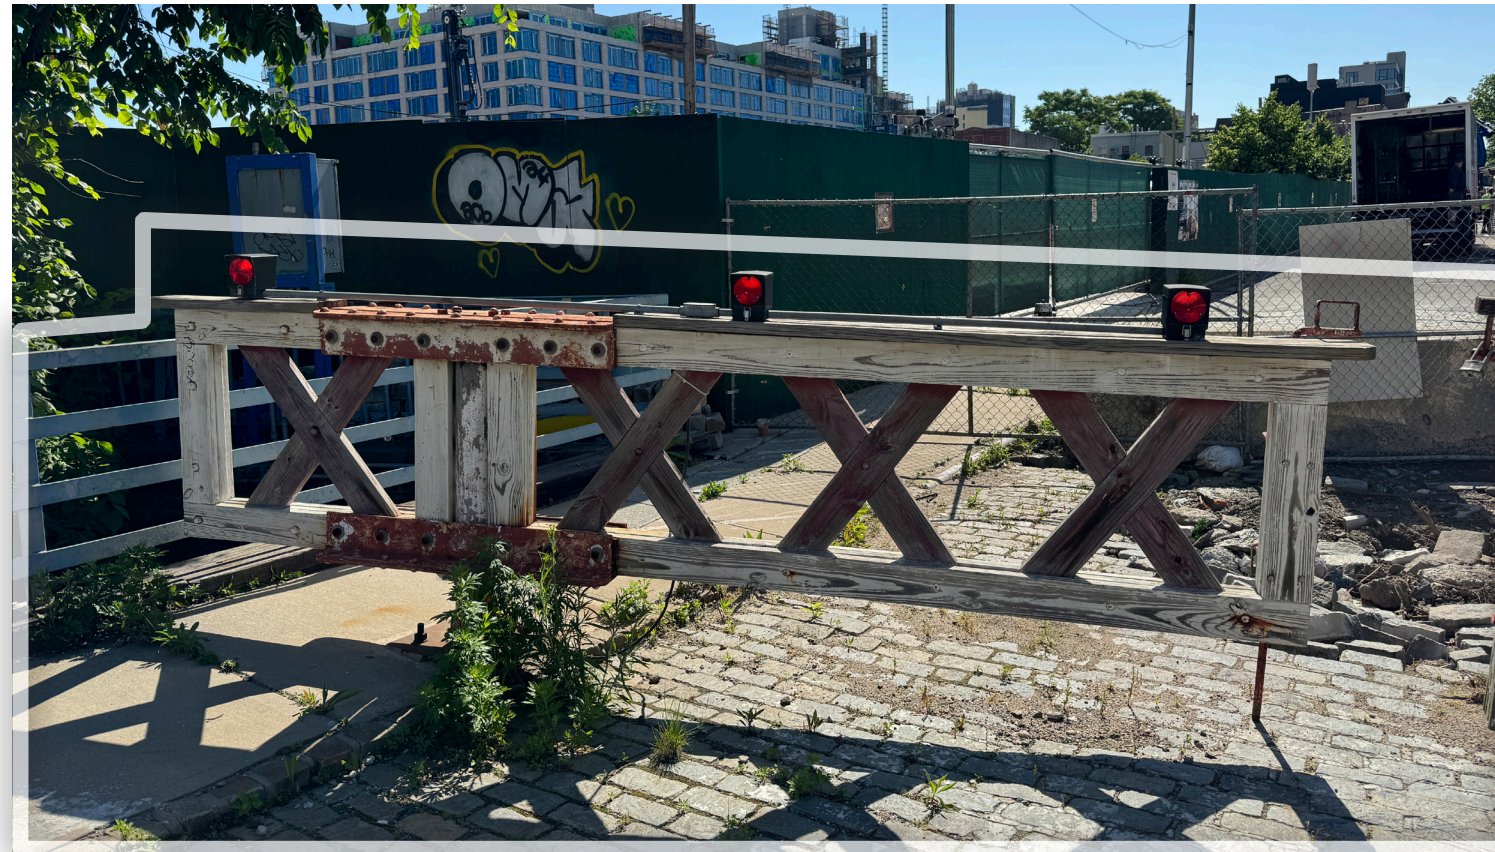
① EAST ABUTMENT VIEW
LOOKING EAST
*PHOTO OF EXISTING BARRIER GATE
AND NORTH SIDEWALK*

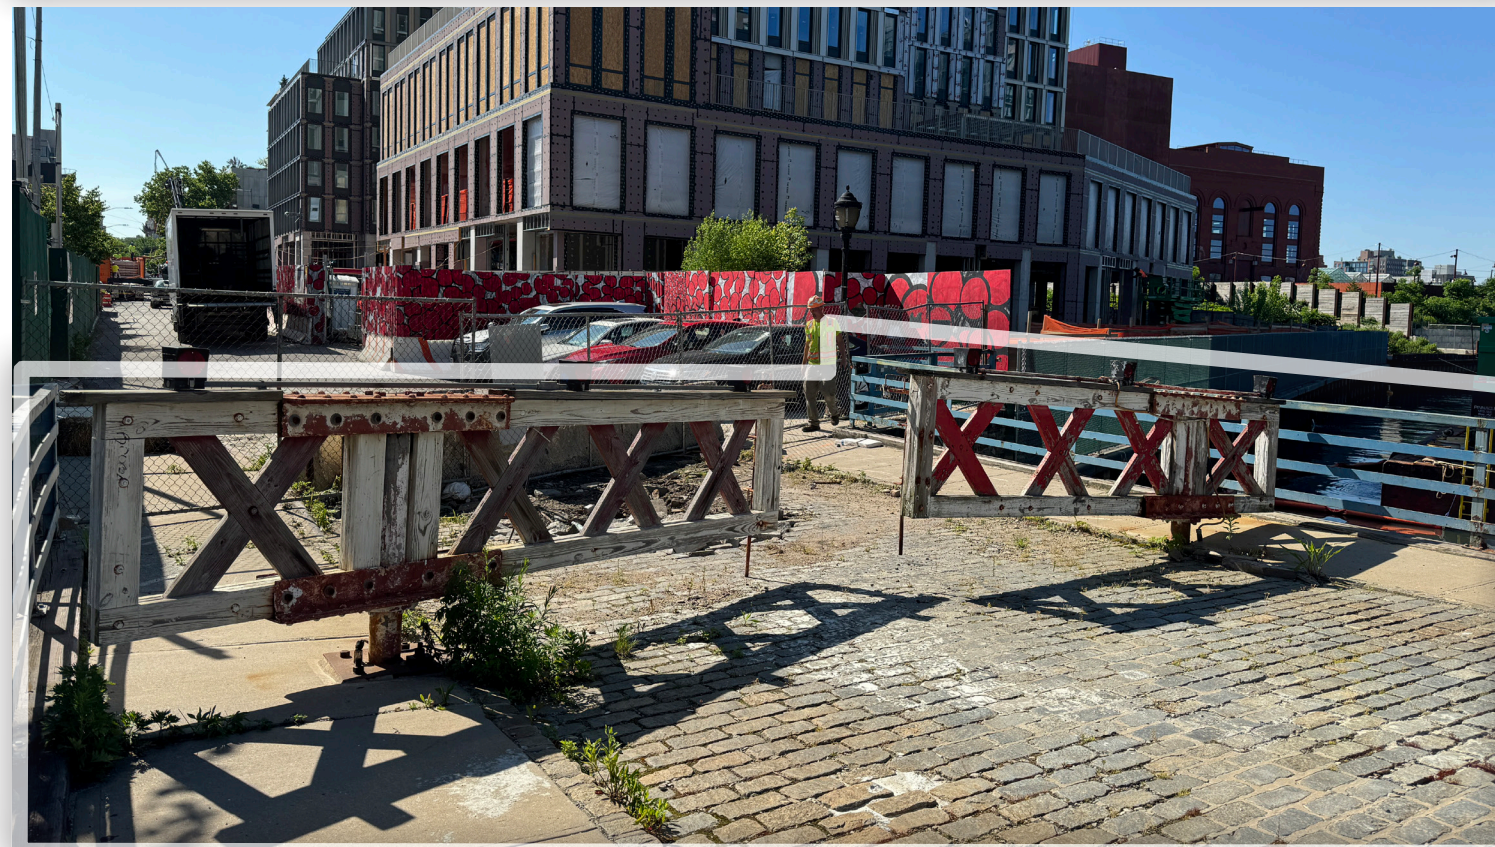
② EAST ABUTMENT VIEW
LOOKING SOUTHEAST
*PHOTO OF EXISTING BARRIER GATE
AND STONE PAVERS*

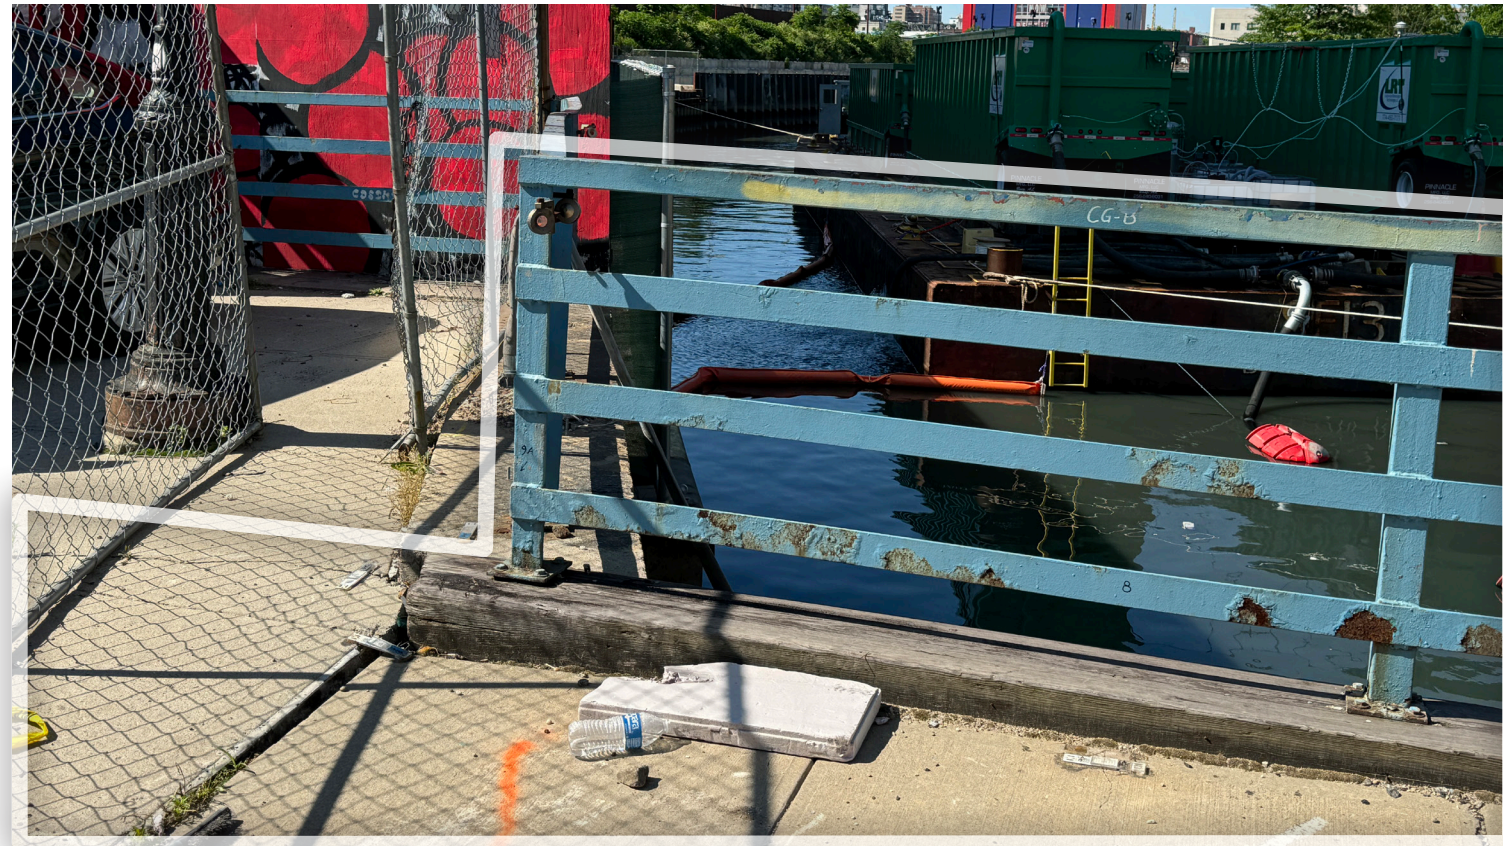
① EAST ABUTMENT VIEW
LOOKING SOUTH
*PHOTO OF EXISTING SOUTH SIDEWALK,
RAILING, AND CURB*

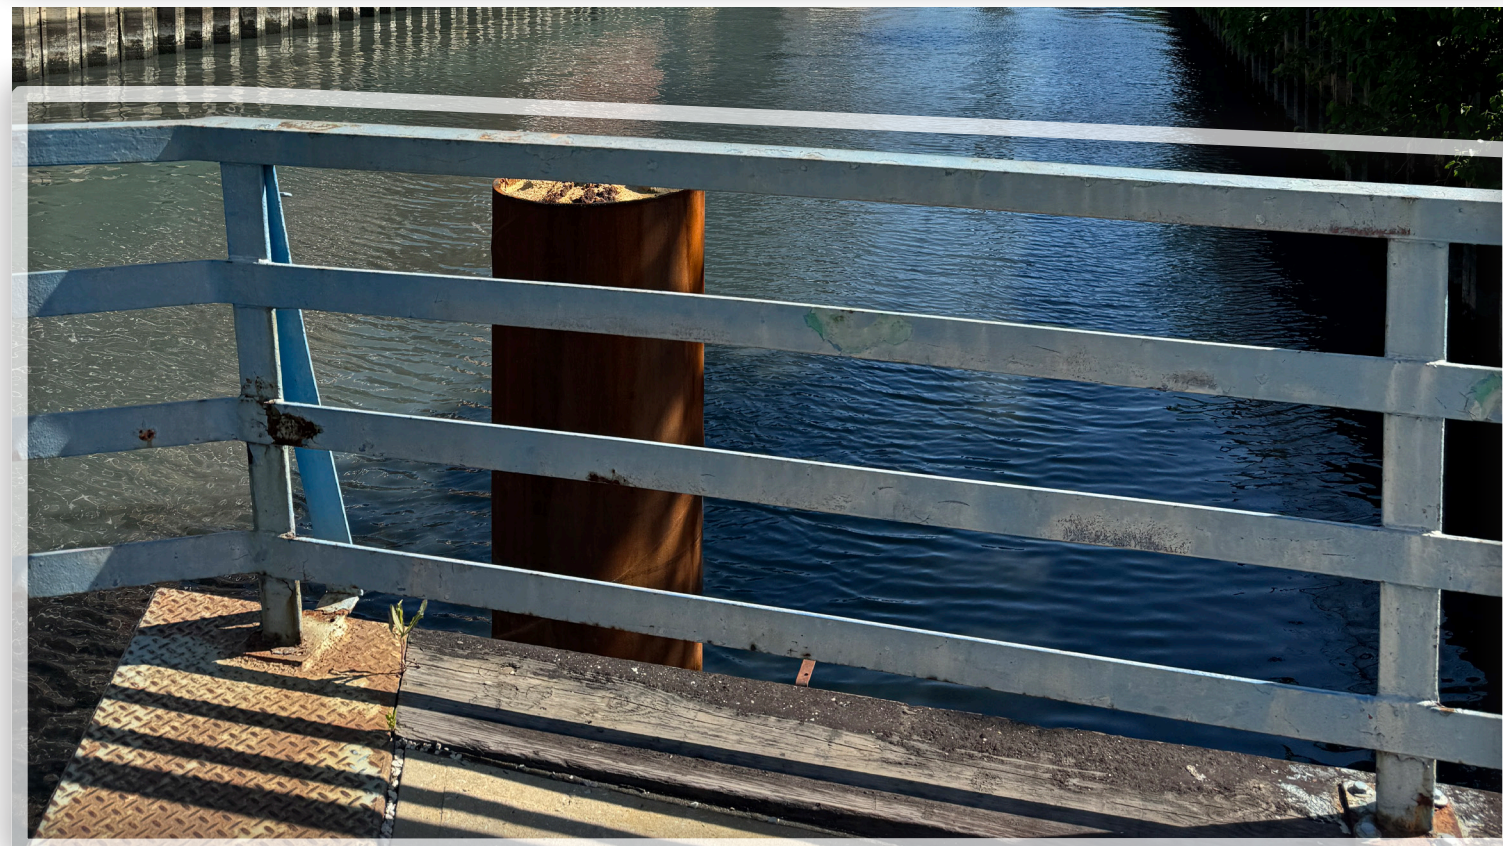
② EAST ABUTMENT VIEW
LOOKING NORTH
PHOTO OF EXISTING RAILING

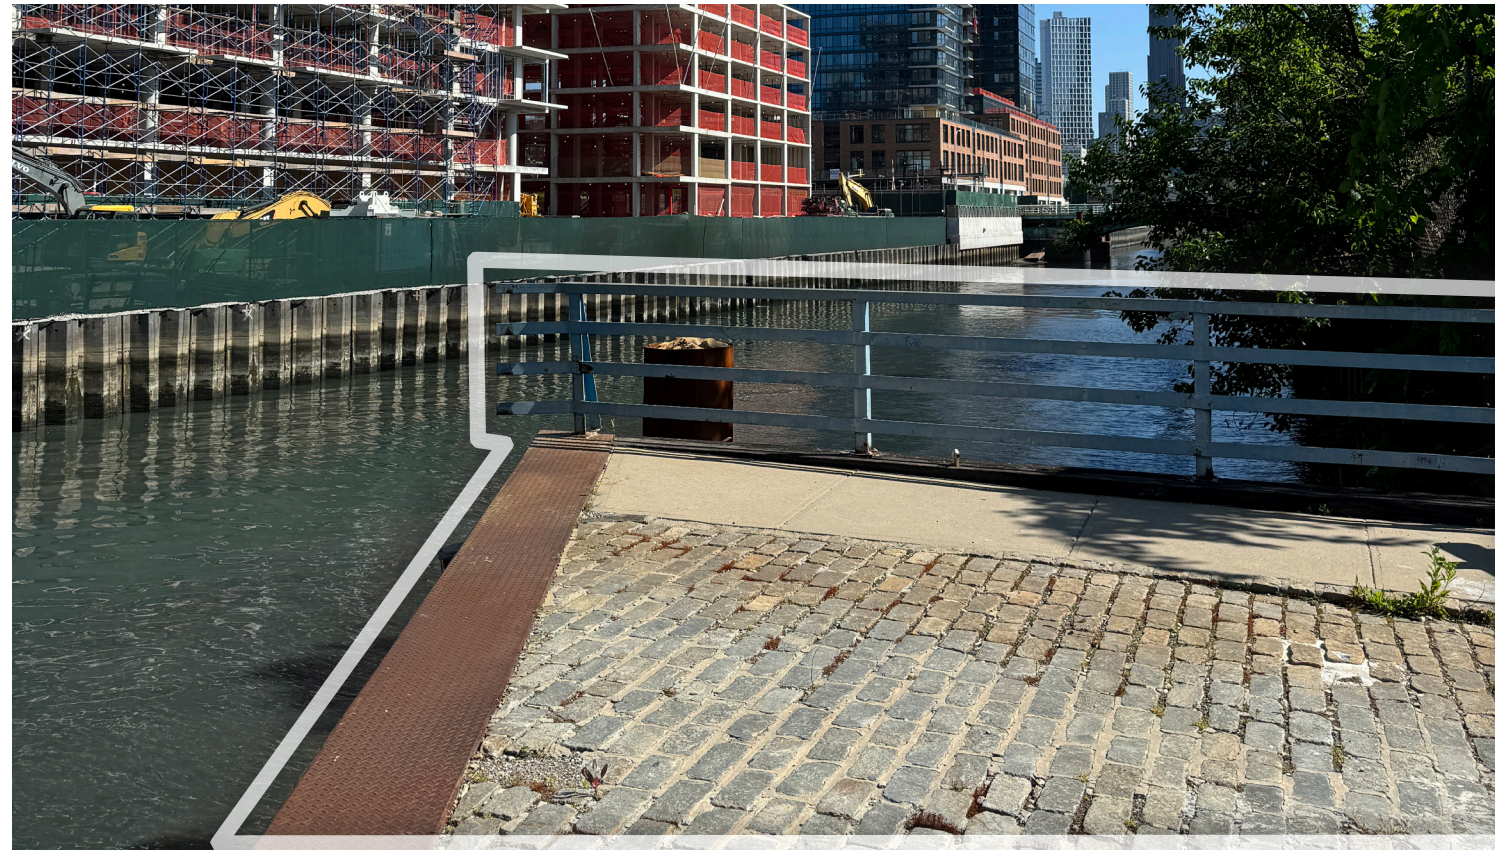
① EAST ABUTMENT VIEW
LOOKING NORTH
*PHOTO OF EXISTING STONE PAVERS,
NORTH SIDEWALK, BRIDGE PLATE,
AND RAILING*

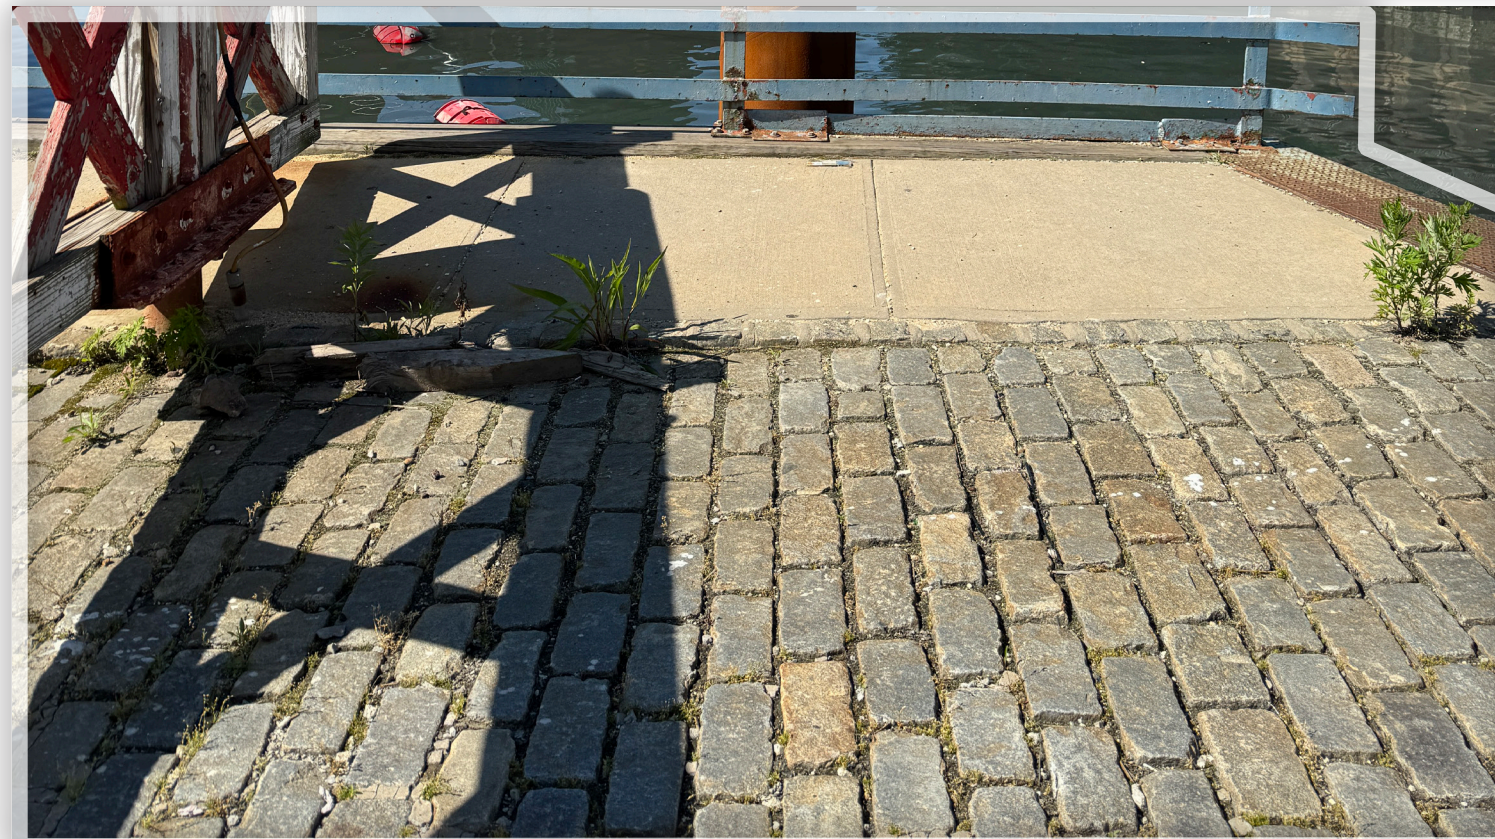
② EAST ABUTMENT VIEW
LOOKING SOUTH
*PHOTO OF EXISTING STONE PAVERS
AND SOUTH SIDEWALK*

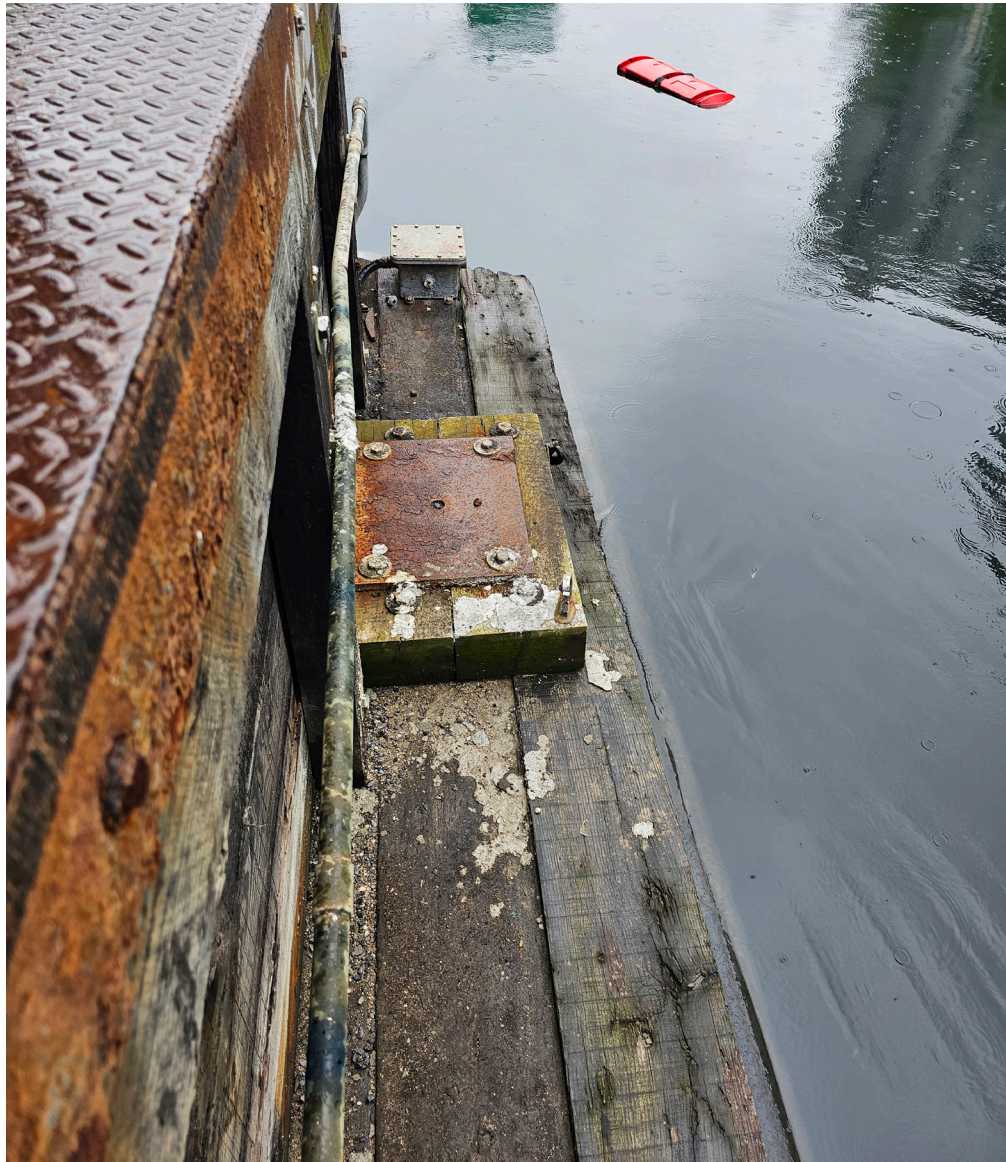
① SOUTH BRIDGE SEAT VIEW AT EAST ABUTMENT
PHOTO OF CRIBBING SETTLEMENT TAKEN AT BRIDGE SEAT

The original Carroll Street Bridge constructed in the 1880s is a historical landmark in the City of New York and one of the last operable retractile bridges within city limits and spans over the Gowanus Canal. In 2022, during an on-going EPA Superfund contract to clean the Gowanus Canal, the Contractor was installing steel pipe piles around the perimeter of the timber east abutment structure. As a result of the pipe pile installation, the timber cribbing began to settle vertically and horizontally towards the navigation channel. As a result, the retractile span can no longer extend to its closed position and properly meet up with the east abutment structure. The east abutment structure must be replaced in order to restore function of the bridge and for the roadway to be reopened.

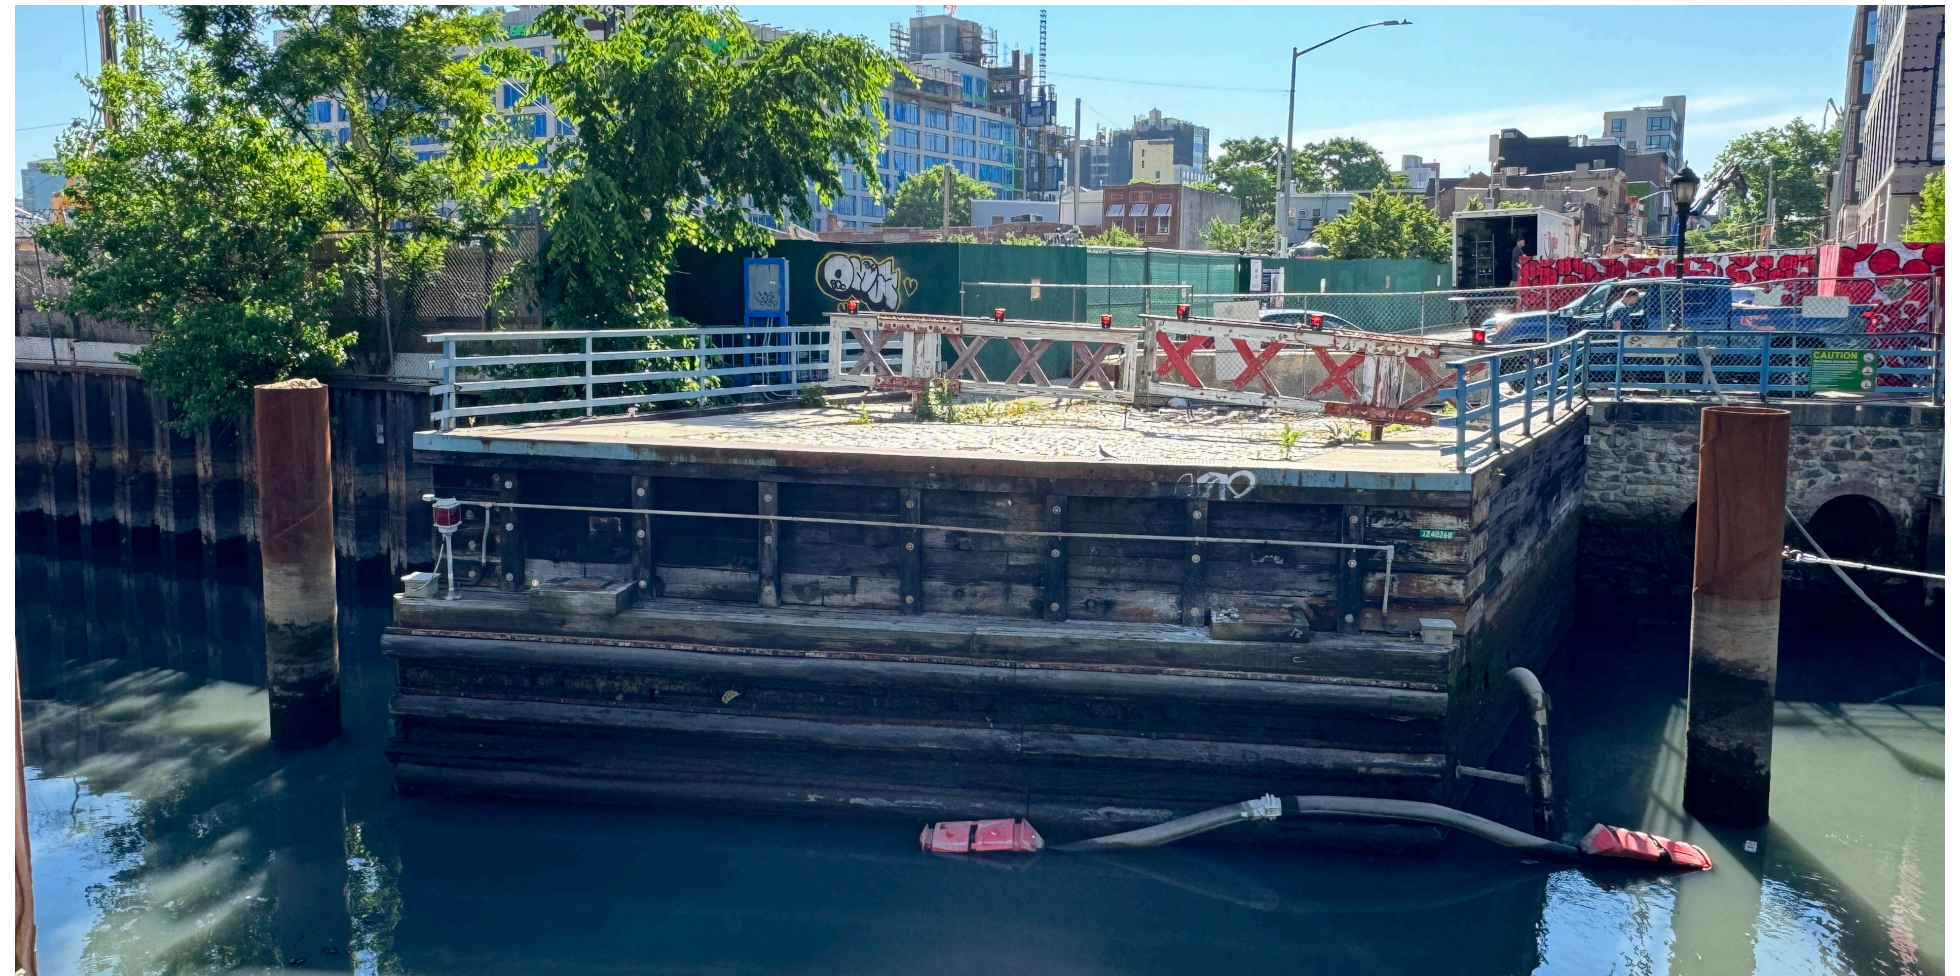
② FRONT VIEW OF EAST ABUTMENT
PHOTO OF CRIBBING SETTLEMENT AT EAST ABUTMENT WEST FACE

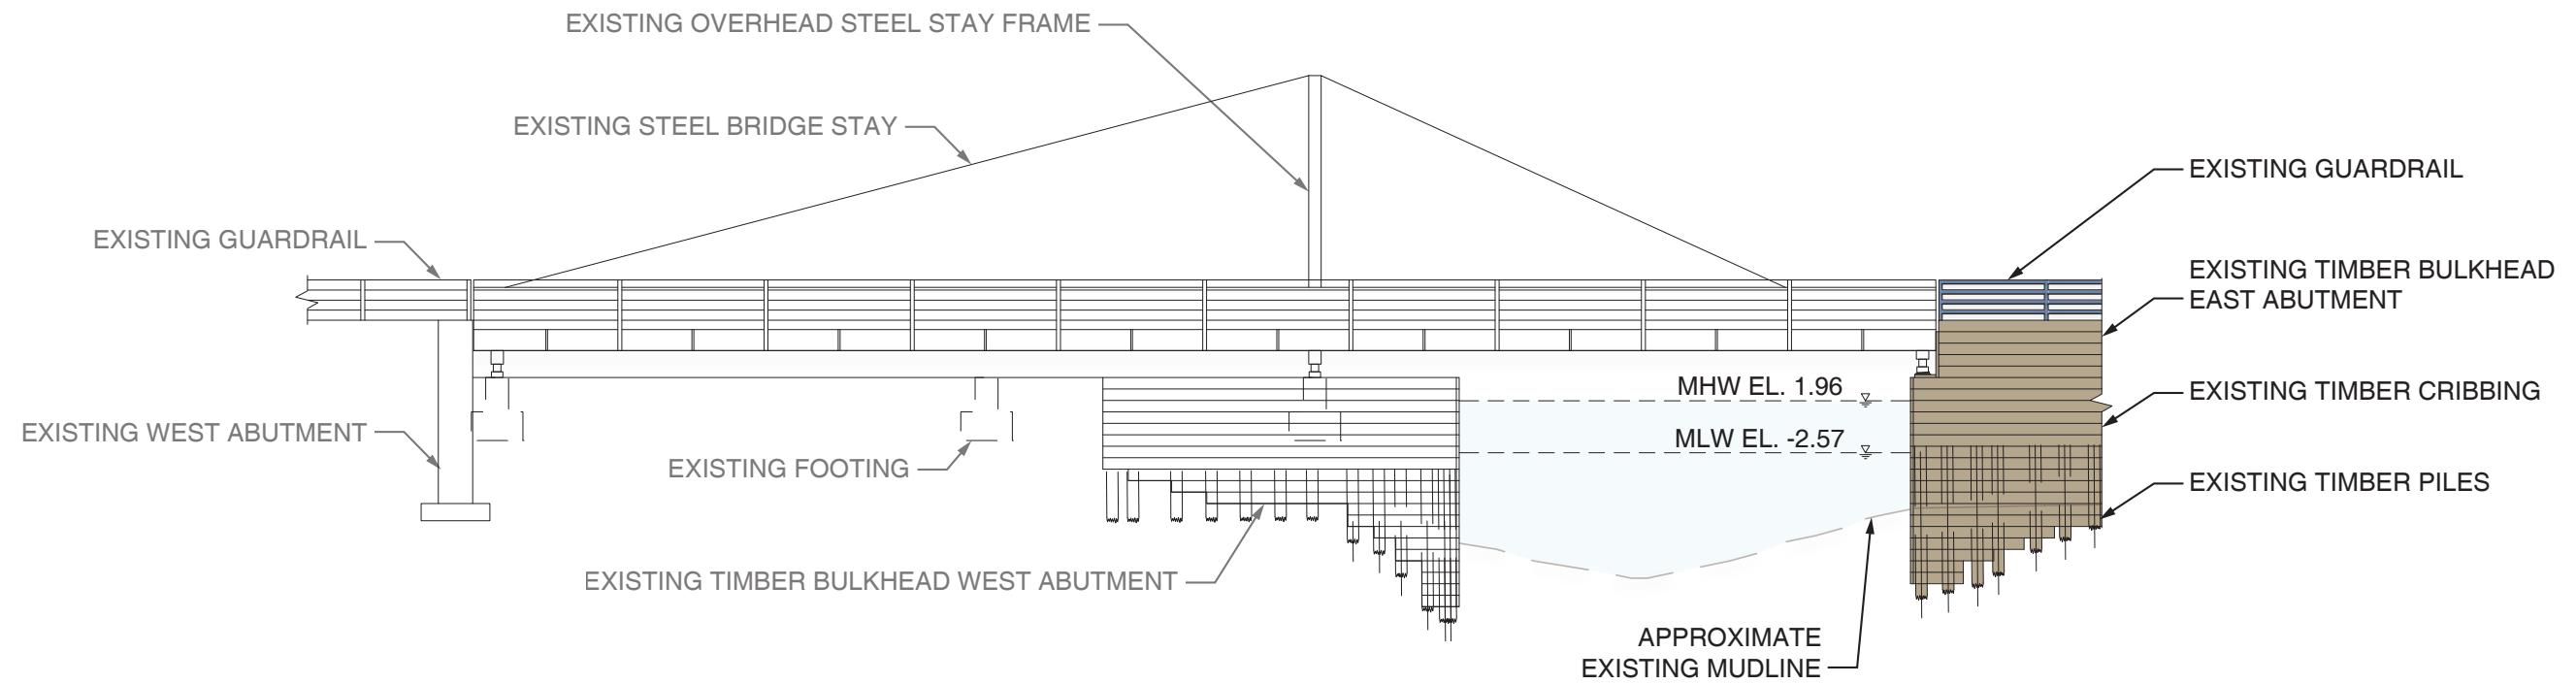
EXISTING CARROLL STREET BRIDGE ELEVATION

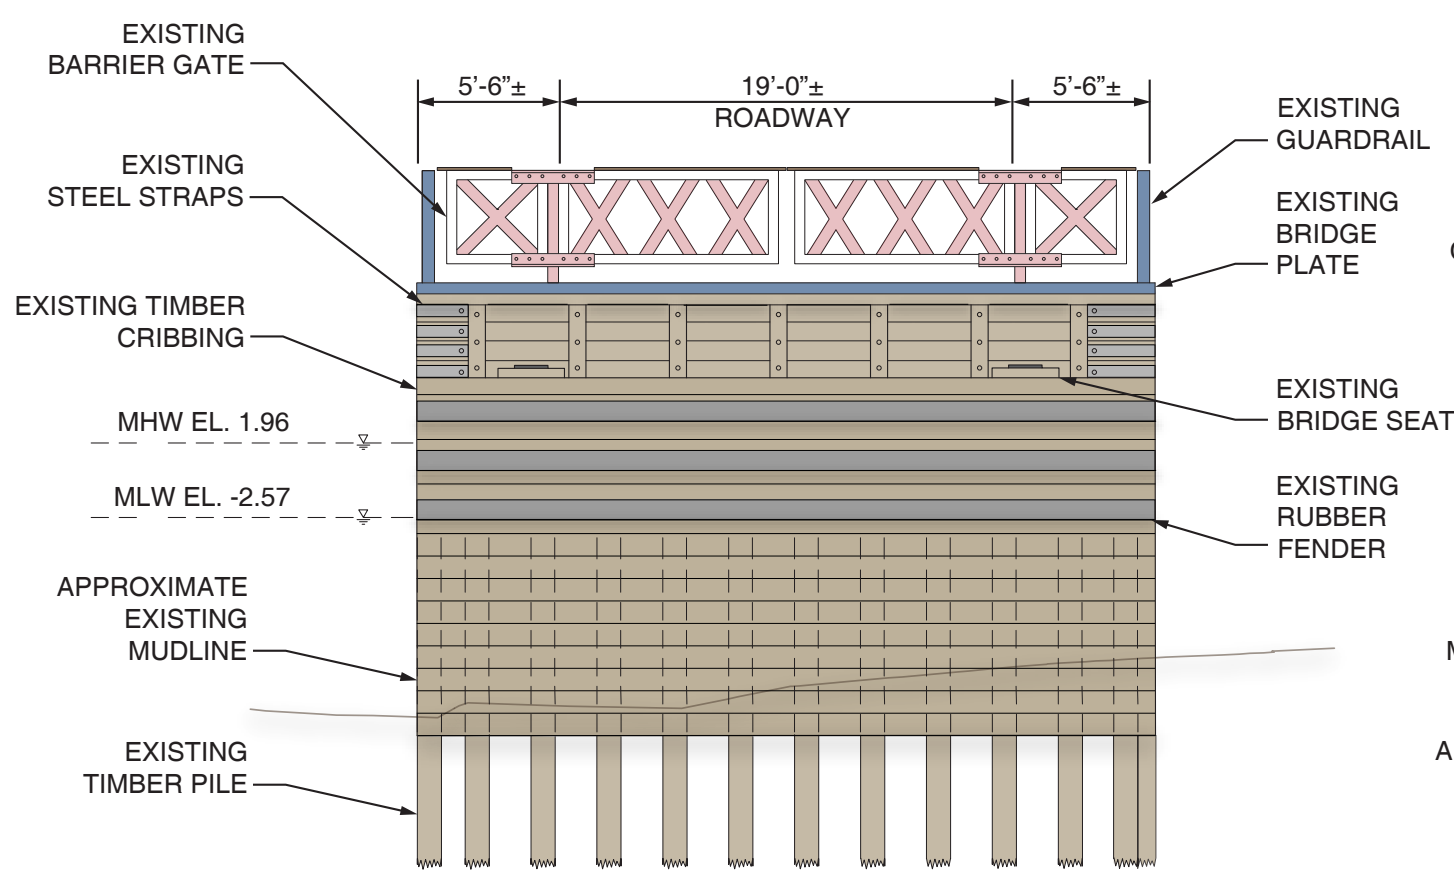
EXISTING EAST ABUTMENT ELEVATION
