LANDMARK PRESERVATION COMMISSION
FINAL DESIGN SUBMISSION

**REHABILITATION OF
CARROLL STREET BRIDGE
EAST ABUTMENT**

**CARROLL STREET BRIDGE
EAST ABUTMENT REHABILITATION**
09/2024

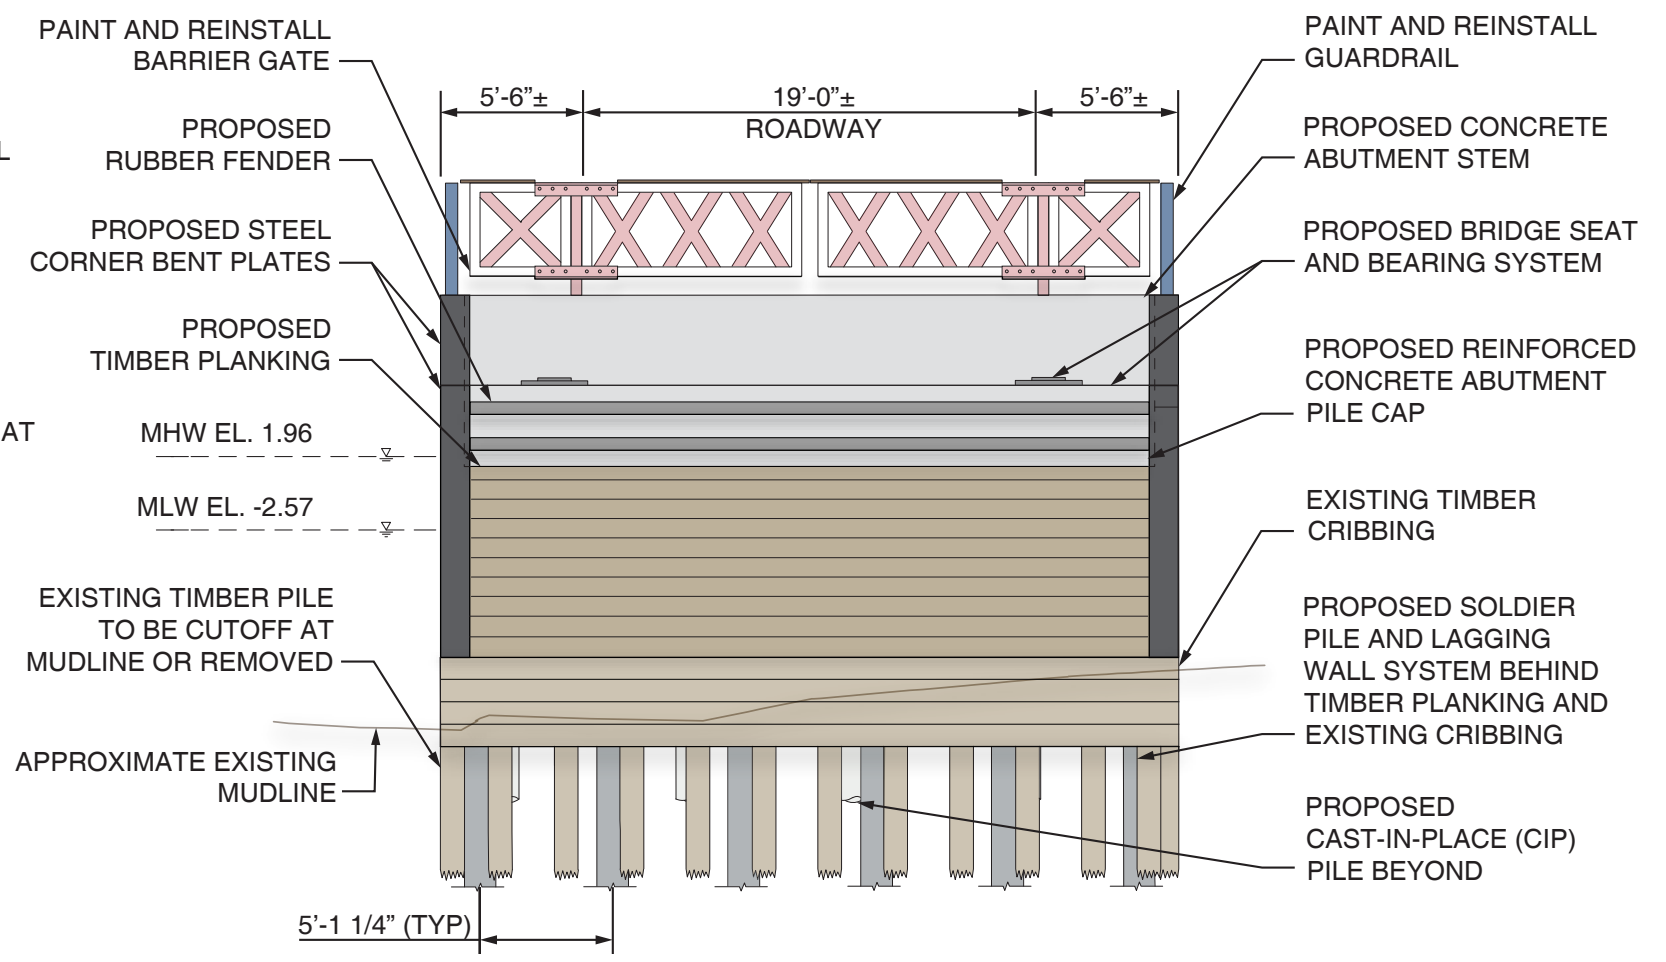
PROPOSED EAST ABUTMENT ELEVATION

While developing options for the east abutment replacement, the design criteria was set to ensure a minimum 50-year design life as per standard protocol for bridge rehabilitations. The effective service life of timber marine structures have been decreasing over time, primarily based on the limitation of treatments that can be used. Creosote and other materials that were once widely used to ensure longevity of these structures is no longer acceptable for environmental reasons, thus making a useful service life of timber much too short for it to be a practical material as the primary structural elements. As such, we are modifying the structure to utilize steel and concrete, which will be able to achieve the designated service life, while a timber façade will maintain the aesthetic of the original approach structure.

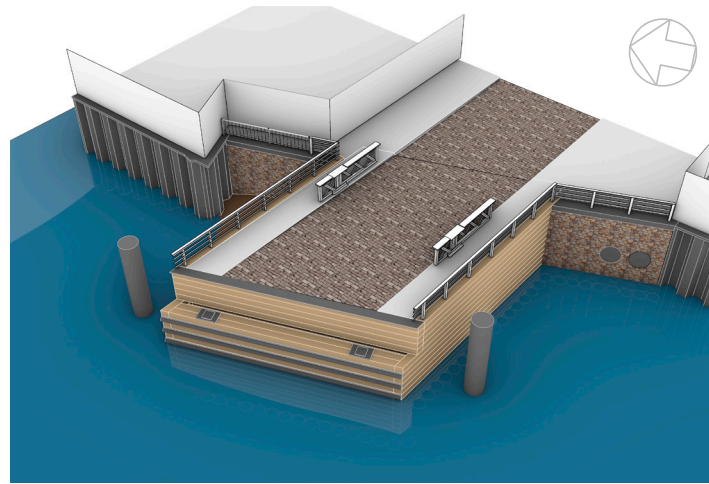
1- Existing Condition

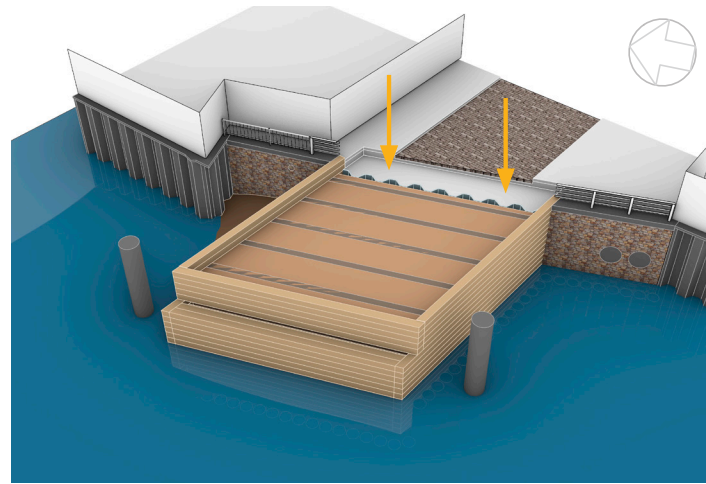
2- Remove Stone Pavement, Sidewalks, Railings, and Barrier Gates and Install Temporary Sheeting

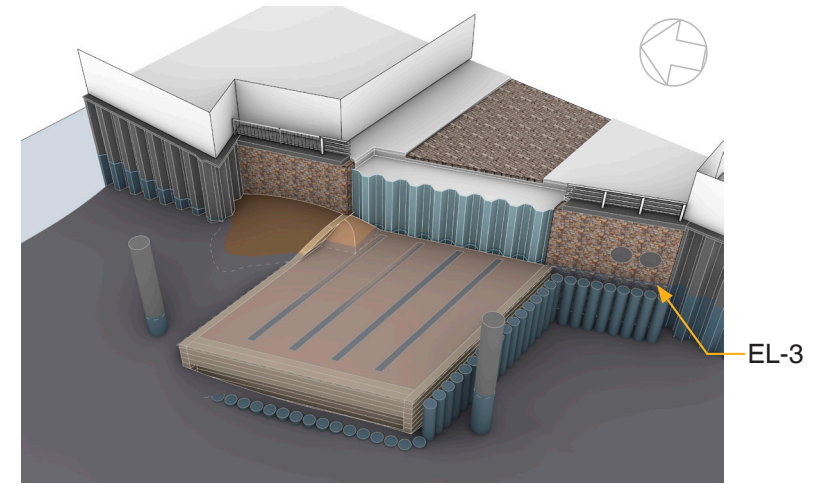
3- Remove Timber Bulkhead and Cribbing to EL-3

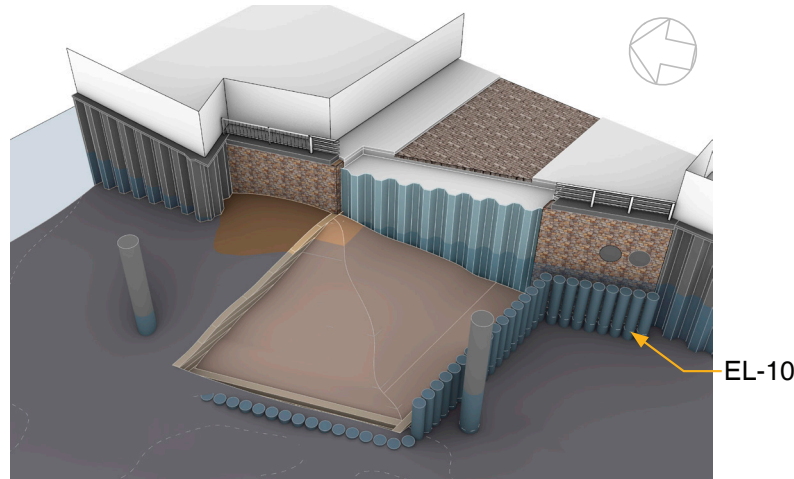
4- Remove Timber Bulkhead and Cribbing to EL-10

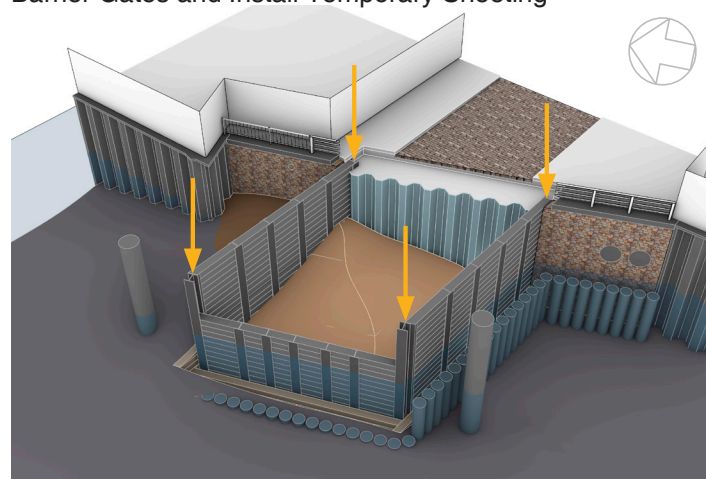
5- Install Soldier Piles and Lagging

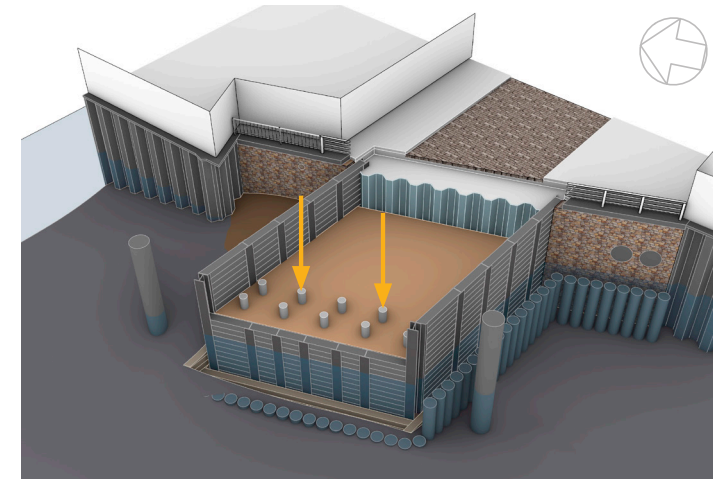
6- Install Micropiles and Partially Backfill

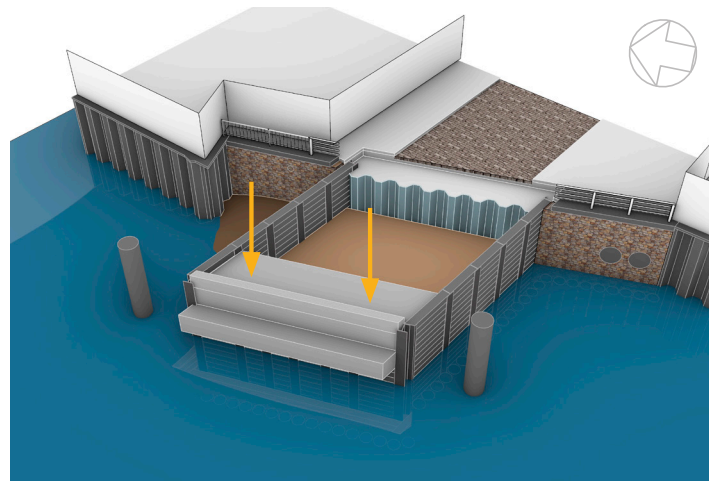
7- Install Abutment

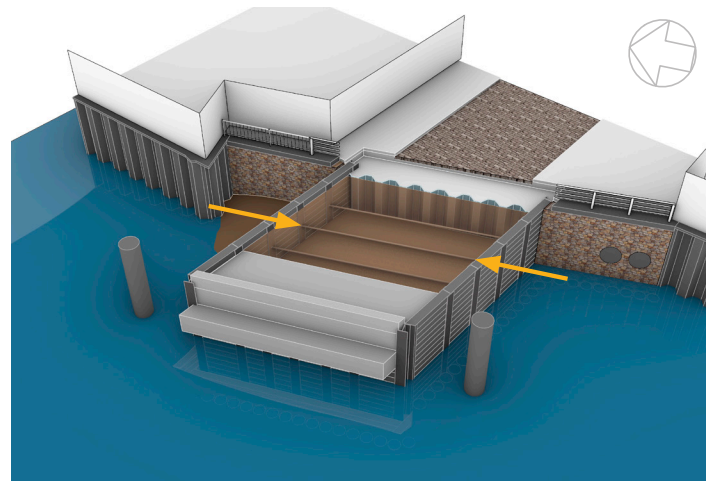
8- Install Tie Backs and Backfill

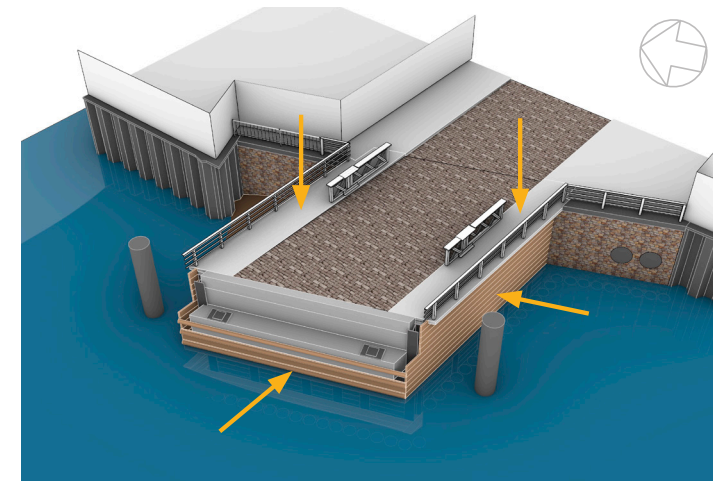
9- Install Approach Slab, Timber Facing, Stone Pavement, Sidewalks, Railing, Bearings, Fender Rub Rails
