**FIFTH FIVE-YEAR REVIEW REPORT FOR
GENERAL MOTORS (CENTRAL FOUNDRY DIVISION) SUPERFUND SITE
FRANKLIN COUNTY, NEW YORK**

**U.S. Environmental Protection Agency
Region 2
New York, New York**

December 19, 2025

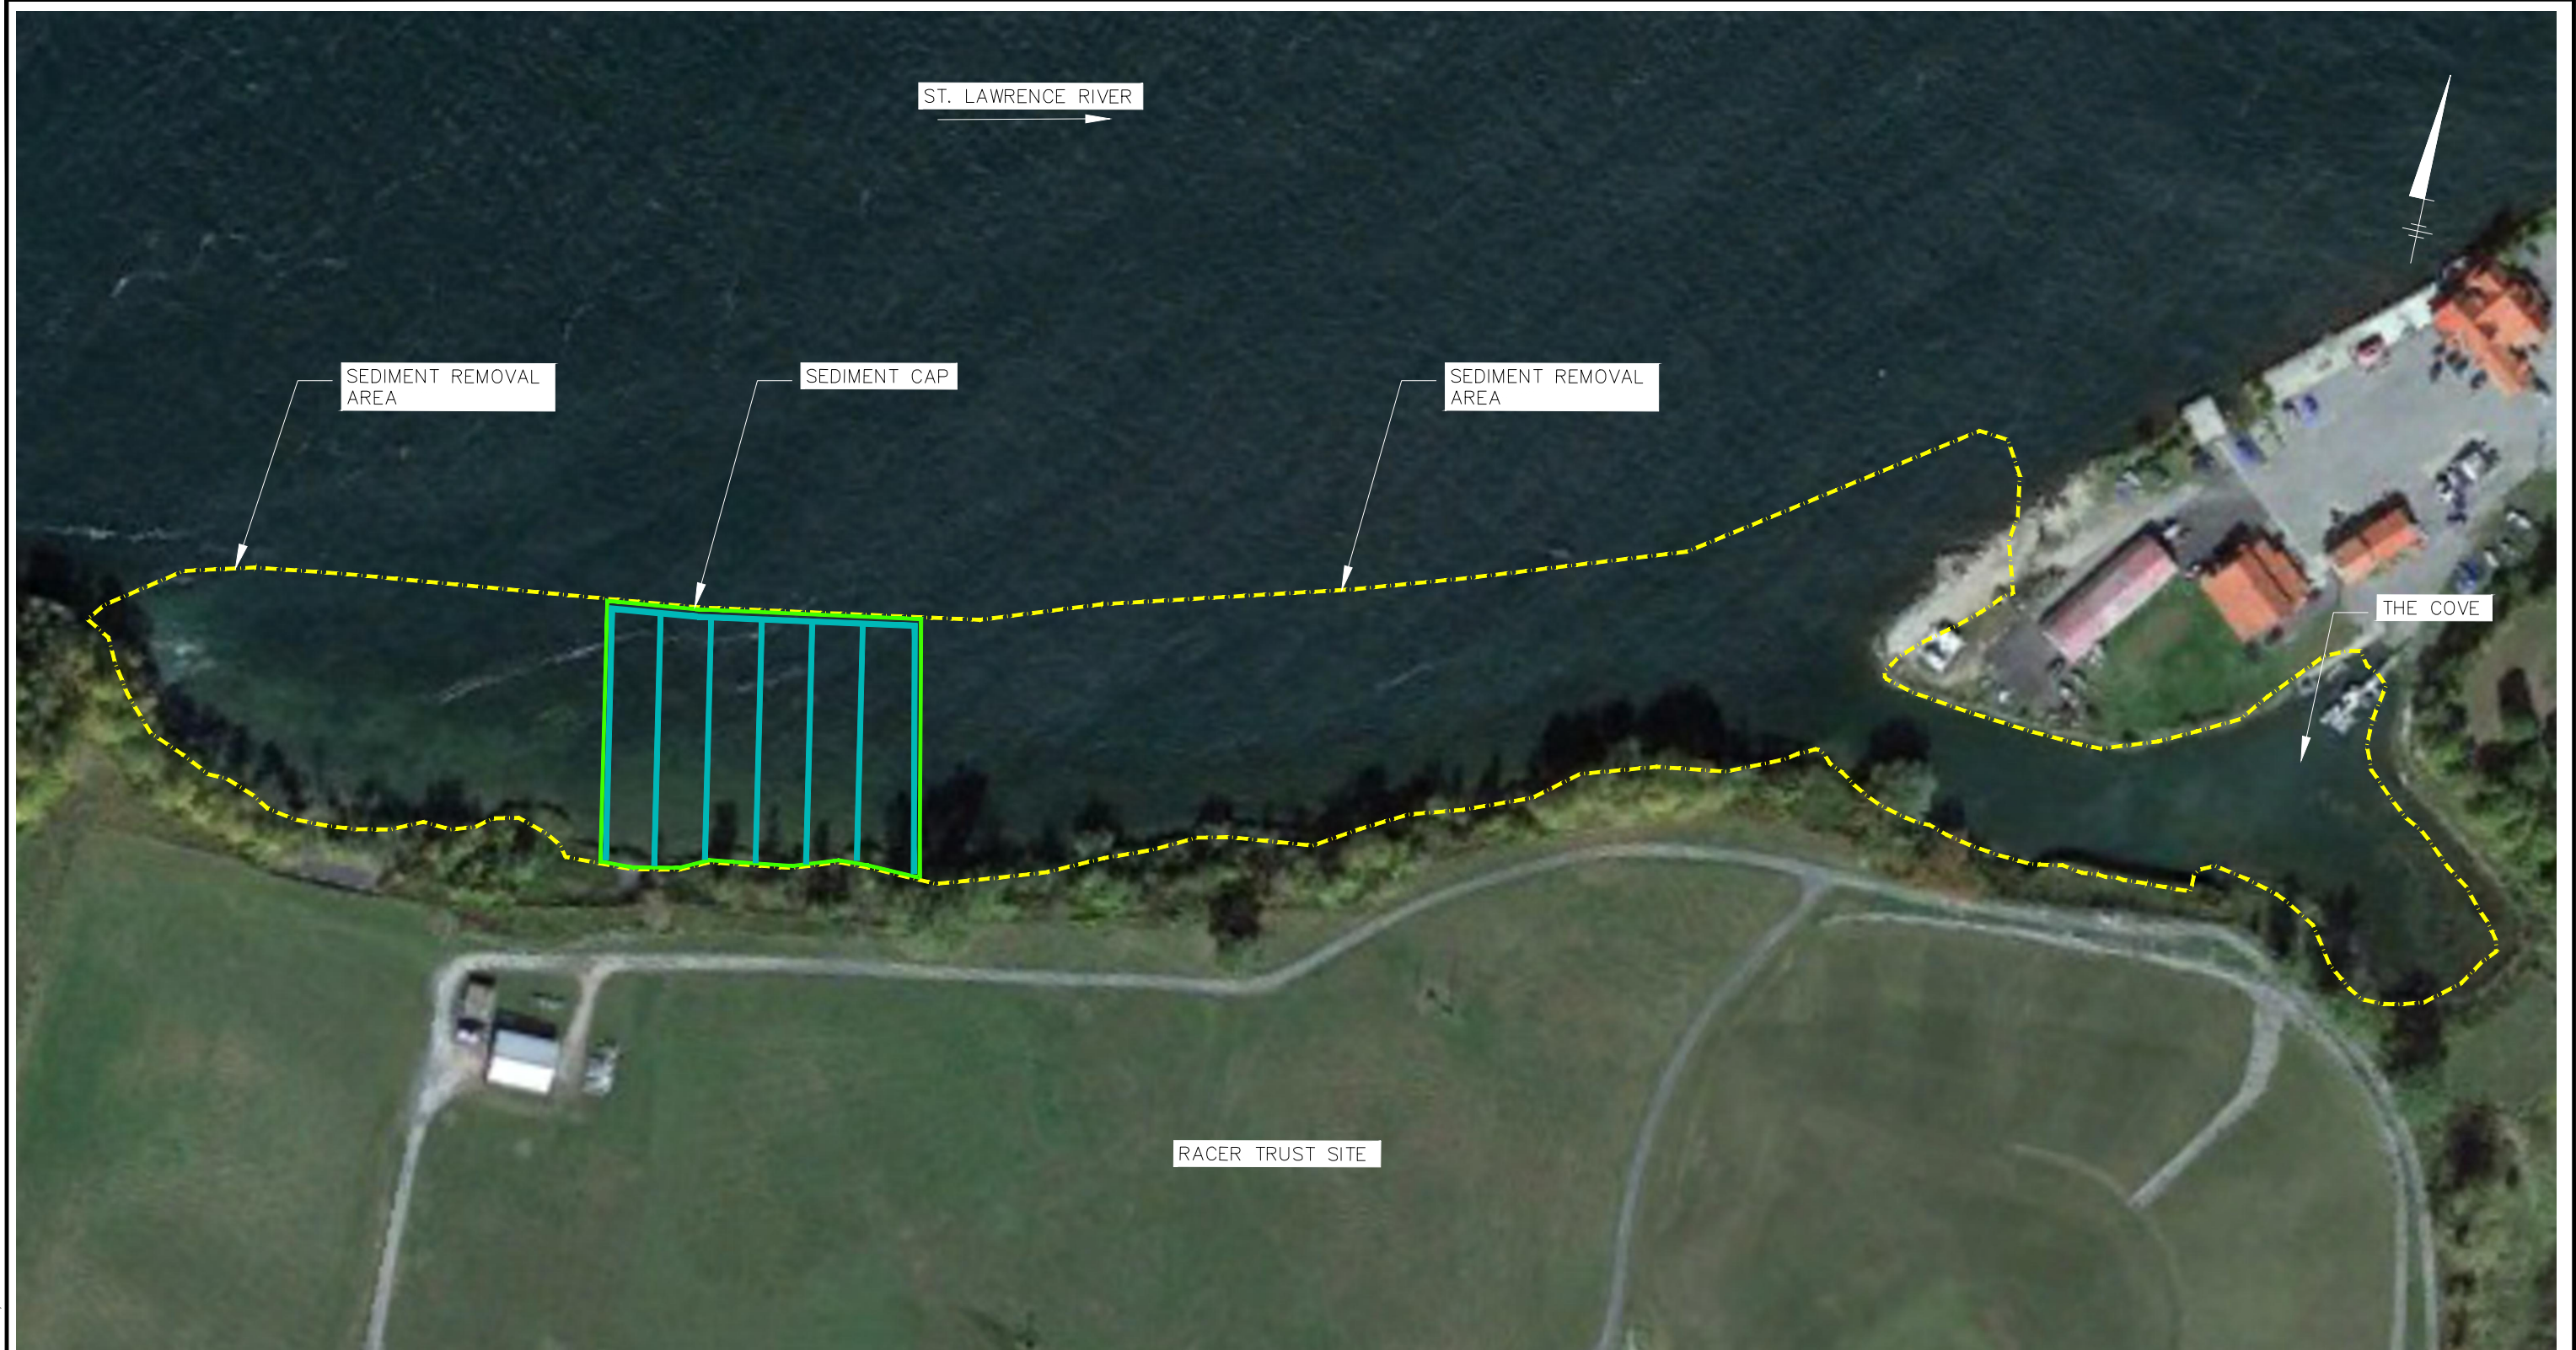
FIGURE
7

A physical inspection of the subaqueous SLR Cap was conducted on June 27th, and 28th 2023 by RACER consultants Arcadis, and the EPA Environmental Response Team (ERT) dive team, using an underwater video camera. Both a vegetation survey and cap inspection were performed. Based on the observations made during the 2023 vegetation survey and sediment cap inspection, the SLR sediment cap appears to be intact with no visual deficiencies or anomalies identified (**Appendix A, Figures 7 and 8**).

SEDIMENT REMOVAL AREA
	SEDIMENT CAP AREA
	TRANSECTS/AREAS VISUALLY INSPECTED BY DIVERS

Past inspections of the subaqueous SLR cap conducted in 1996, 1997, 2001, 2006, 2011, 2017 (with underwater video camera by EPA's ERT dive team), 2019 (by the EPA dive team during sampling) similarly indicated that the subaqueous cap had maintained its integrity and needed no repairs. During the 2019 SLR Passive Sampler and Sediment Assessment, no deficiencies in the cap were observed at sample locations.

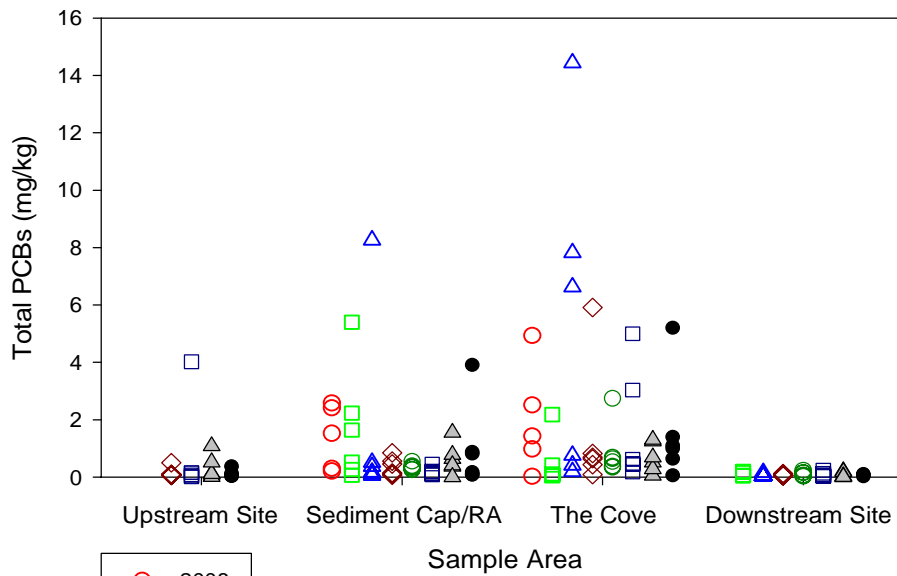
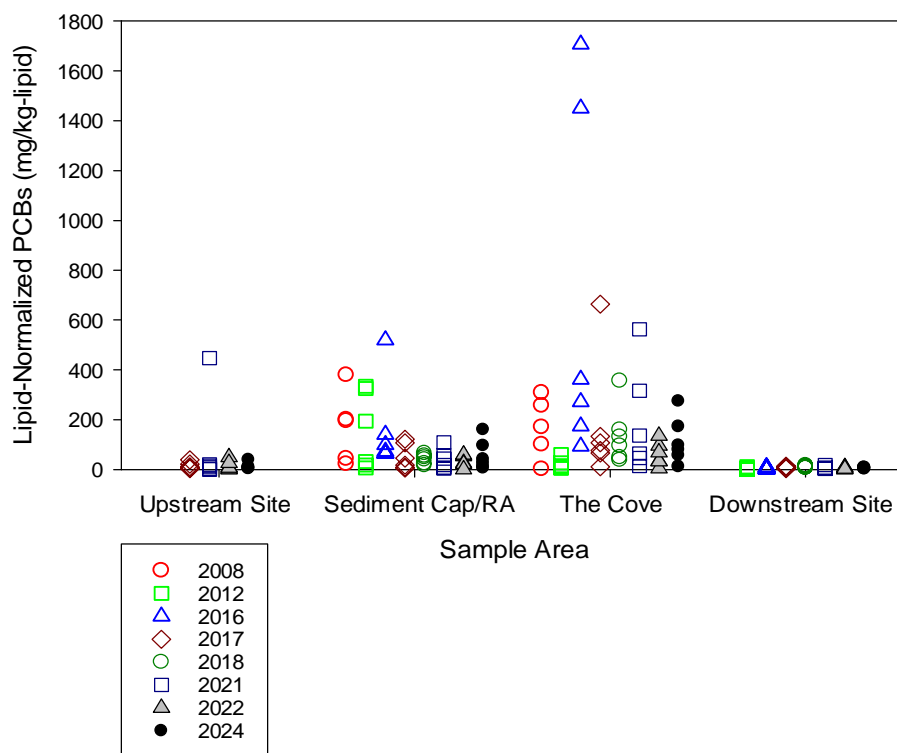
Figure
14

Bottom-Feeding Fish

1. Brown bullhead were targeted as the bottom-feeding fish species; white sucker were collected as a substitute species for brown bullhead when unavailable.
2. All adult fish samples were processed as individual NYSDEC standard fillets and analyzed for PCB Aroclors and percent lipids.
3. Sample results shown above are total PCB and lipid-normalized PCB wet-weight concentrations.
4. Data are shown for years fish were collected at a particular sample area; not all sample areas were targeted each collection year.
