**RI/FS OVERSIGHT FIELD TRIP REPORT  
FORMER WESTINGHOUSE ELEVATOR PLANT  
GETTYSBURG, ADAMS COUNTY, PENNSYLVANIA**

*Contract No. 68-W9-0005 (TES VIII)  
Work Assignment No. C03018  
Project No. P021-C01*

Prepared For:  
Mr. Frank Vavra, EPA WAM  
U.S. Environmental Protection Agency, Region III  
841 Chestnut Street  
Philadelphia, Pennsylvania 19107  
October 30, 1992

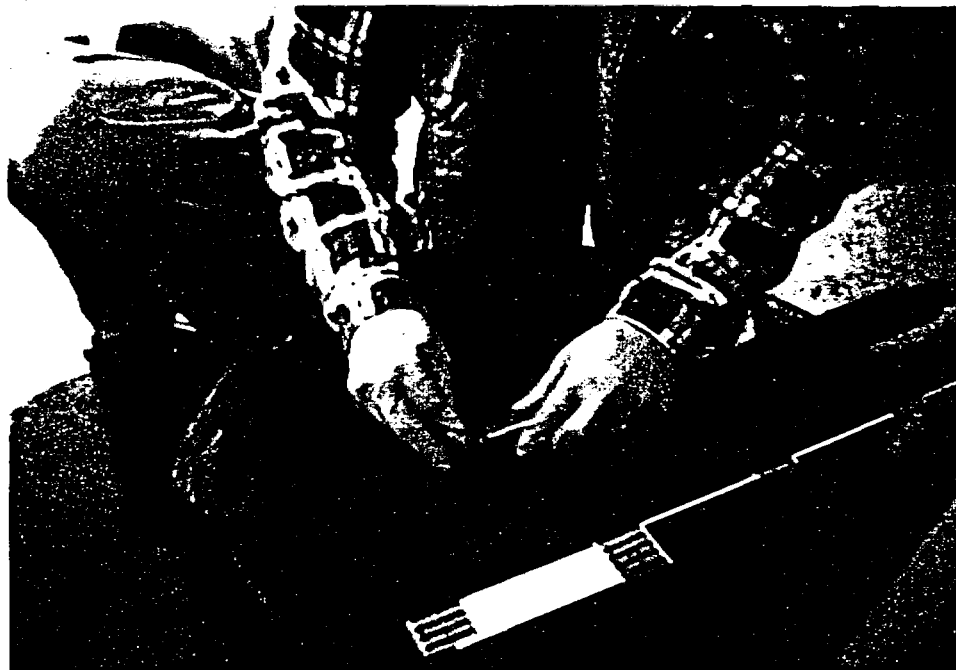
PHOTO OF R.E. WRIGHT COLLECTING VOA SAMPLE  
FROM RTB-8 AT 1.5'-3.5'. LOOKING NORTHEAST.

R.E. Wright collected their samples without using a deconned sample trowel or scoopula. R.E. Wright's sampler would break up the soil with his hands which were covered by latex gloves and fill their bottleware by hand. Dynamac was subjected to sample the same soil R.E. Wright was touching.
