**FEDERAL ON-SCENE COORDINATOR'S
AFTER ACTION REPORT**
for
**METROPOLITAN MIRROR & GLASS SITE
FRACKVILLE, SCHUYLKILL COUNTY, PA
2 June 1997 to 22 August 1997**

**Federal On-Scene Coordinator's After Action Report
Metropolitan Mirror & Glass Site**

PROJECT # 423
FACT SHEET

SITE: Metropolitan Mirror & Glass Site

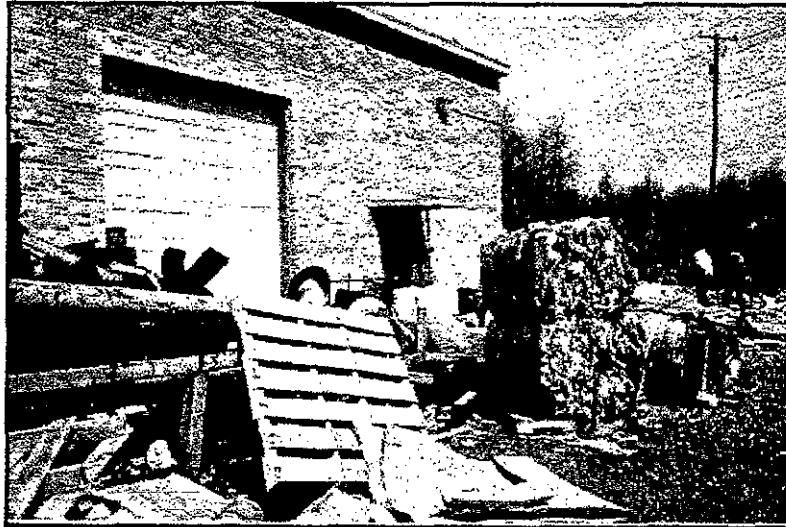
Description: The area to be excavated in the north corner of the manufacturing building.

On 16 June 1997, ERCS backfilled the north corner of the manufacturing building with local certified clean fill after analytical results did not detect any lead levels above those levels established in the action memorandum. FAMA completed the sewer connection and ERCS submitted the analytical results for the lagoon surface water samples. Based on the analytical results, FAMA approved discharge to the local POTW and established discharge rates.

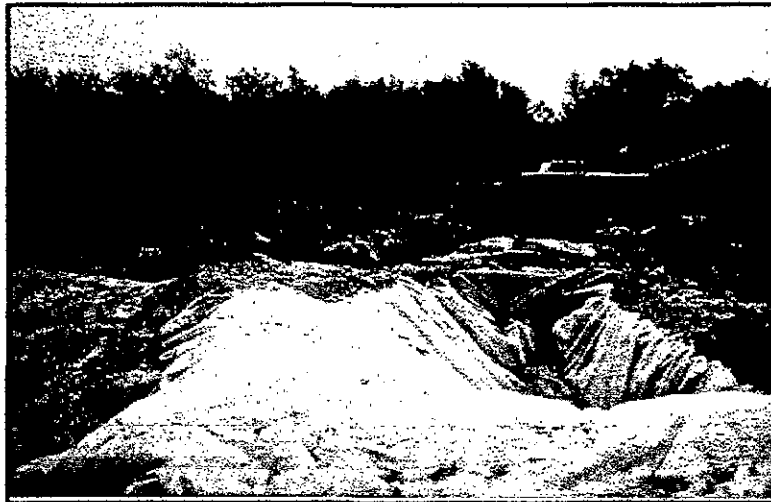
Description: The sludge staging/drying pits in use.

Their main purpose was to stage the sludge that was excavated from the lagoons. The sludge in the lagoons was staged to allow water trapped in the media to drain back into the lagoons by gravity.

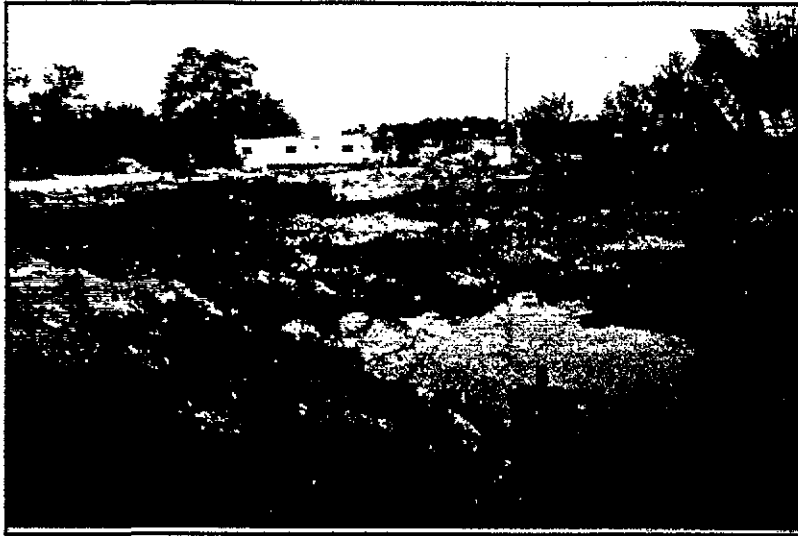
Description: A view from the southeast corner of lagoon #2. Note the excavation of the earthen berm, the pump located on the berm to pump groundwater, and the water reduction in the lagoons.

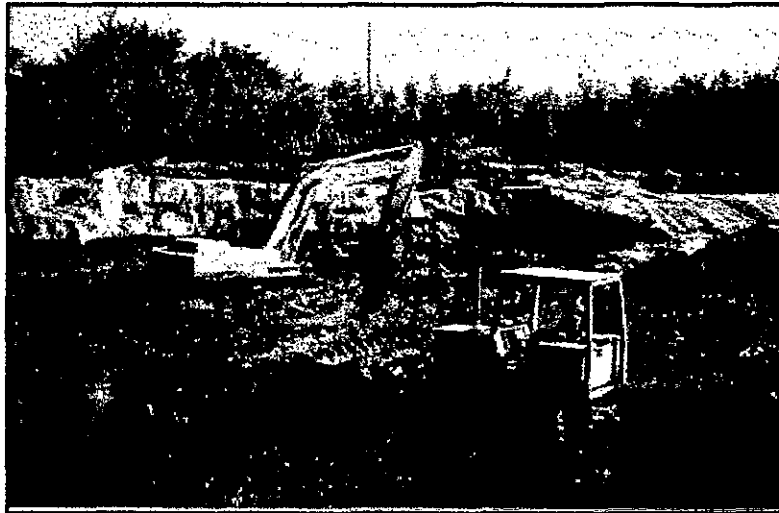
Description: Two pieces of heavy equipment in lagoon #1 mixing up the lime, fly ash and cement kiln dust that was used to bulk the sludge in the lagoon. The white powder (lime dust) on the bank of the lagoon and the sludge in the staging pits in the background.

The OSC and ERCS determined that fly ash, a by-product of coal incineration, would be used to dry up the liquid bond in the sludge. On 6 July 1997, ERCS began using a mixture of specific operation by-products for bulking operations. Those by-products included fly ash, cement kiln dust and lime kiln dust. With the additional use of lime kiln dust, the ERCS crew upgraded their level of personal protection to level C due to the high pH of the materials.

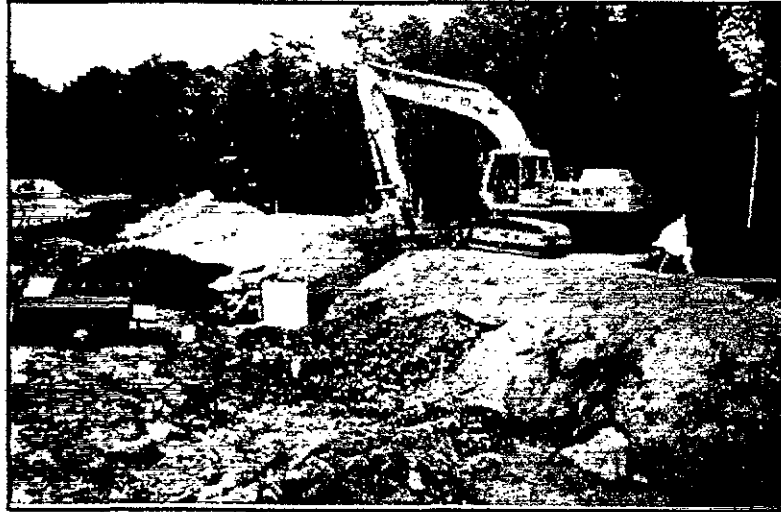
Description: ERCS crew members installing the grate on top of the concrete catch basins. Two were installed in the lagoon to allow overflow water to discharge into Stony Creek. Note the black corrugated pipe that connects the catch basin to Stony Creek.

On 4 August 1997, ERCS received two prefabricated concrete catch basins on 4 August 1997, that were connected to overflow pipes, to allow overflow water to drain into Stony Creek.
