# **REMEDIAL INVESTIGATION REPORT**

## **SAFETY LIGHT CORPORATION OPERABLE UNIT 1 (OU-1) - BUILDINGS**

**BLOOMSBURG, COLUMBIA COUNTY, PENNSYLVANIA**

**JULY 2009**

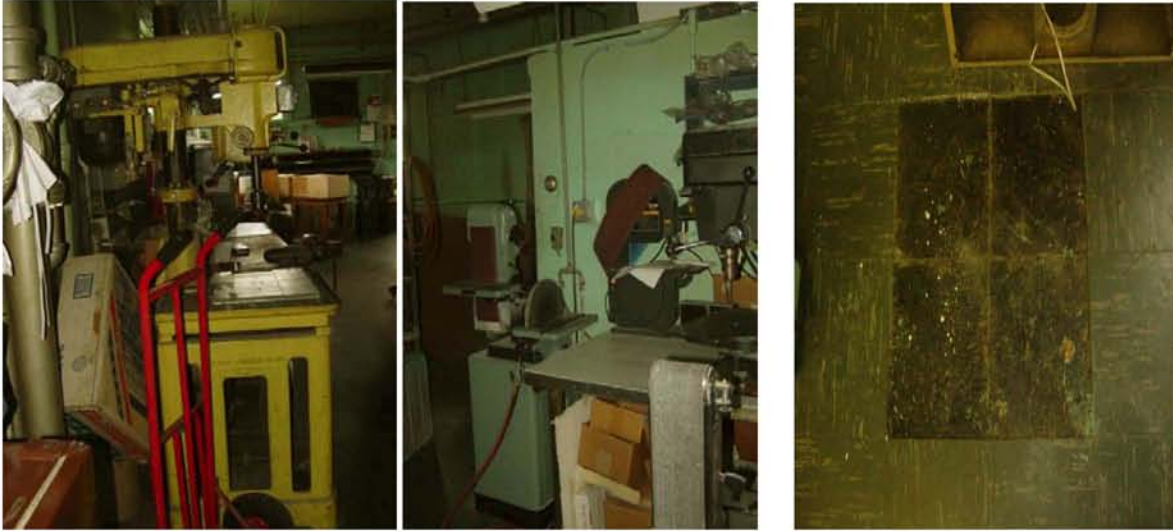
All interior building surfaces were surveyed. Elevated readings were found on an overhead heating unit, an area of the ceiling, an opening in the west floor (sump with removable cover), and on the north wall. Elevated measurements along the area on the north wall was thought to be influenced from the known contaminated ground area just outside of the building, and not the building surface. Two items of debris in the building were found to be contaminated (an old fan and a stool) and moved to a controlled area as addressed in Sections 2.2.3 and 2.4. The pictures below show the interior of the Machine Shop.

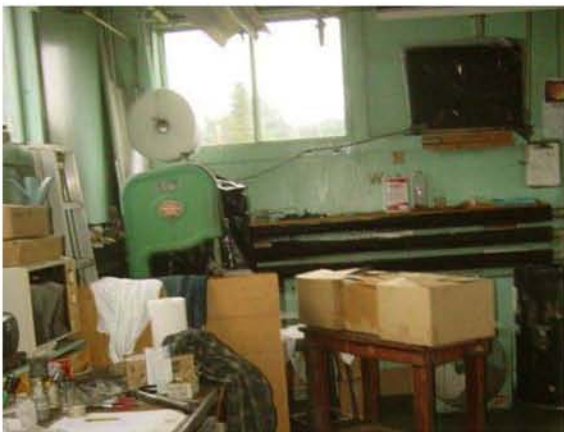
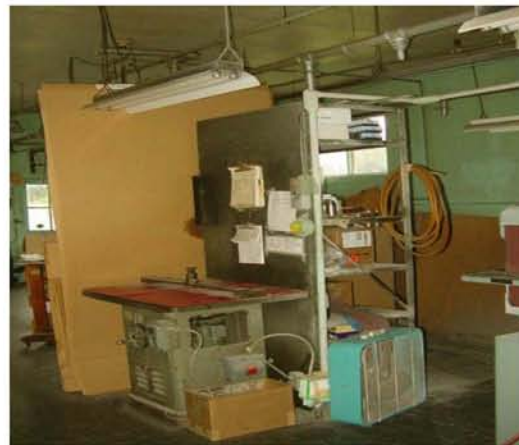
Two samples were taken in the Machine Shop. One sample was taken from the northwest wall of the building. The other sample was taken from the middle of the floor slightly toward the northwest end of the building. The photos below show the sample area for the north wall and west floor.

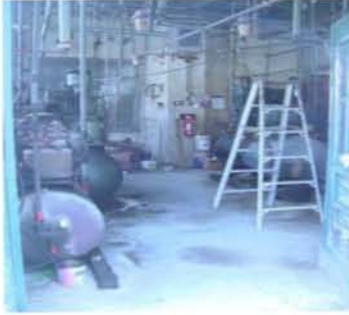
All surfaces were surveyed with the exception of the ceiling in the east and middle rooms due to safety reasons. The Compressor Room, located on the west end of the building, was the only room with radioactivity above DCGLs. Fixed contamination was found in the majority of the room at levels up to 16,050 dpm/100cm<sup>2</sup> beta-gamma and 1,812 dpm/100cm<sup>2</sup> alpha. Transferable contamination (alpha) was found on the floor, back generator, front compressor, floor drain, and switch panel. After coordinating with the Plant Manager, the areas were either painted with three layers of different color paint to fix the contamination in place or barricaded (and posted) to restrict access. The photo below shows the Compressor Room.

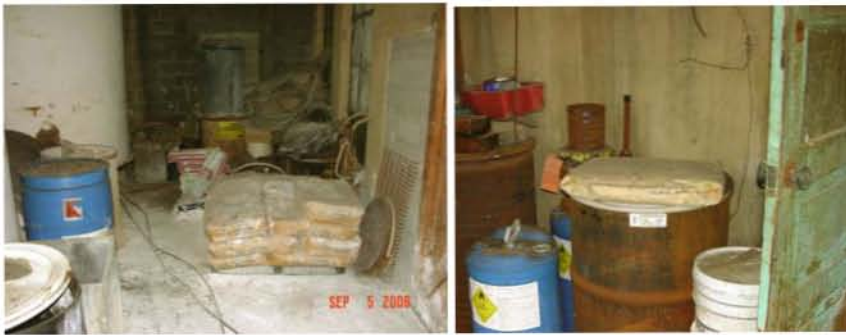
Four samples were taken in the Multi-Metals Building. Two floor samples were taken in the Compressor Room (pictured above), one on the northeast end of the building and one on the northwest end. The other two samples were taken in the Tank Room, one on the northwest wall and the other on the southwest corner floor. The pictures below show the Tank Room floor and wall sample areas.

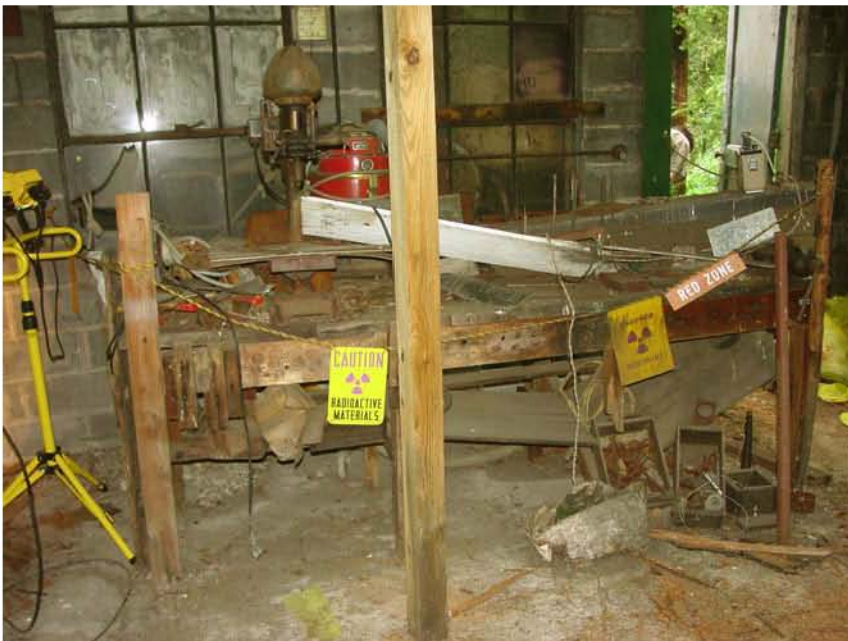
All interior building surfaces on the west half of the building were surveyed and most found to be contaminated. The high background due to the Pole Building prevented a building surface scan from being performed on the east end of the room. Also in the east end of the room, there are extremely high contamination levels due to the explosion years ago of a radioactive source. In this area, fixed contamination levels with a beta dose rate of 30 mRAD/hour above the already high background of 0.6 mR/hr were detected. The maximum fixed alpha contamination was 762,090 dpm/100cm<sup>2</sup>. Fixed contamination (other than in the east corner) was found in the majority of the room at an average of 16,000 to 25,000 dpm/100cm<sup>2</sup> beta-gamma. Transferable contamination (alpha and beta-gamma) was also found in the shop, but at lower levels than the fixed. The area around the east wall and table (highest transferable contamination) was barricaded and posted "Contamination Area". No items were removed from the building. Doors were re-sealed upon survey completion. The picture below shows the east end of the Carpenter Shop.

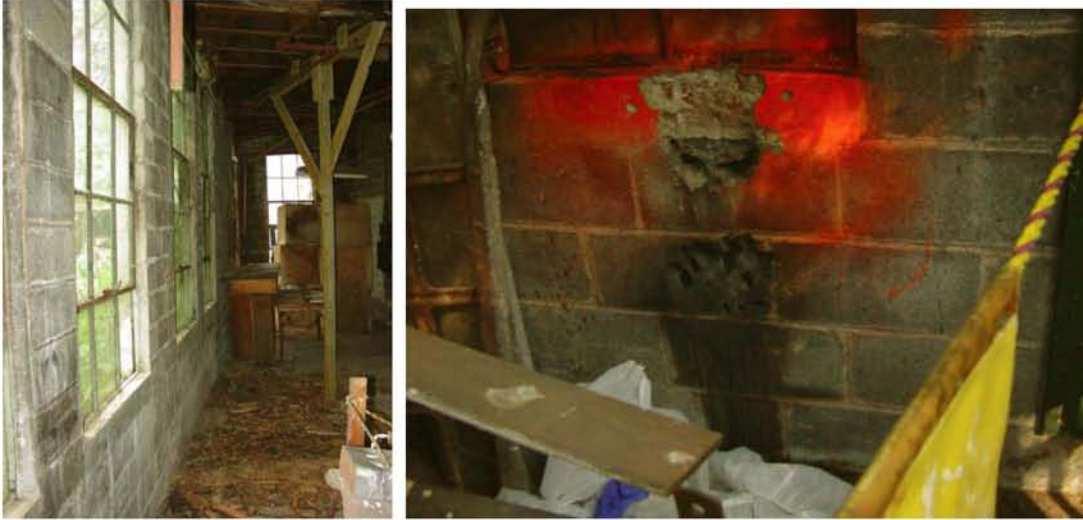
Four samples were taken in the Carpenter Shop. The "East Window" and "East Machine Table" samples were taken on the wall and table shown in the above picture. The "SE Wall" sample was taken on the back wall and the "S Floor" sample was taken on the south floor along the wall. The pictures below show the south wall and the east wall sample areas.

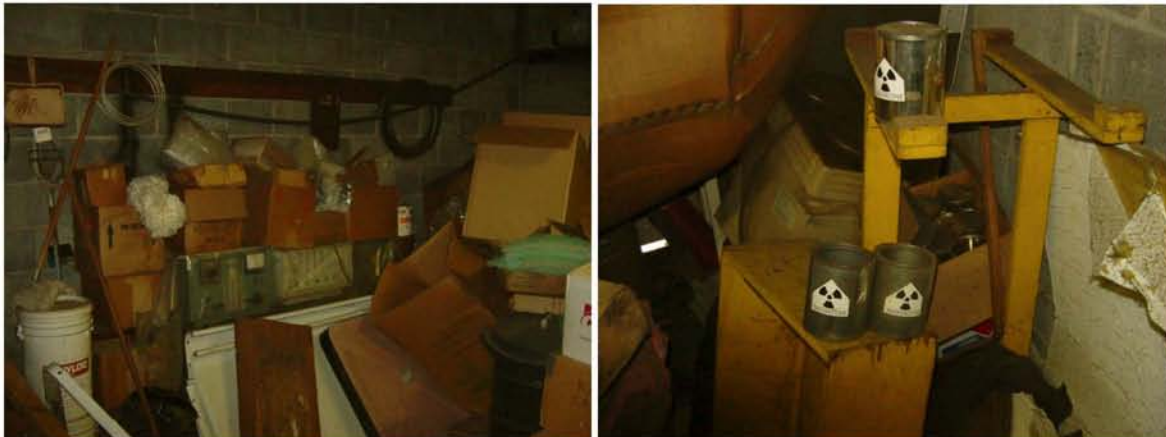
All interior building surfaces were surveyed. Fixed contamination was found on the majority of the floor at levels up to 226,958 dpm/100cm<sup>2</sup> beta-gamma and 382 dpm/100cm<sup>2</sup> alpha. Walls and ceiling were not contaminated with the exception of some conduit, shelving, a door, and a wall mounted heater that could not be removed prior to building removal. One item in the building was found to be contaminated (hot plate) and moved to a controlled area. Small amounts of mercury were found in a storage cabinet, placed in an appropriate container, and relocated to the main building. The pictures below show the interior of the building.

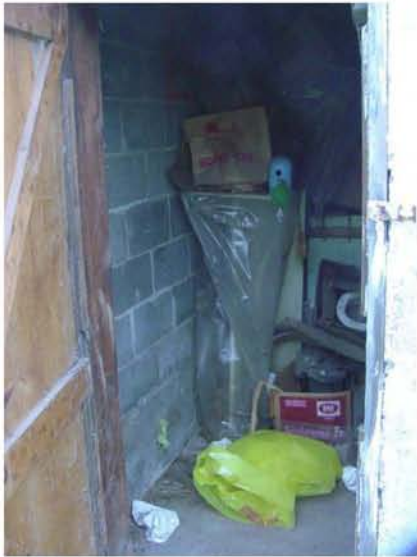
Due to lack of tritium instrumentation, no items could be moved or removed from the building and all interior building surfaces could not be surveyed. Of the areas surveyed, fixed contamination was found on accessible surfaces at levels up to 1,271,947 dpm/100cm<sup>2</sup> beta-gamma and 215 dpm/100cm<sup>2</sup> alpha. All walls and the floor and ceiling showed elevated readings. No debris items were surveyed because of the potential for high H-3 levels. All waste (i.e., PPE) was bagged and left in the building. The picture below shows the interior of the building

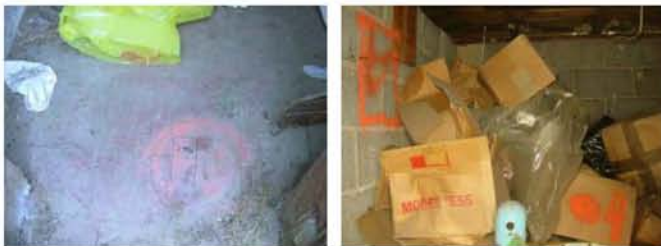
Four samples were taken in the 8'X8' Building. Two wall samples were taken (south and northeast) and two floor samples were taken (southwest and just inside the door). After packaging, the samples could not be sent to the lab because of high activity; therefore only smear samples for H-3, C-14, and Ni-63 were prepared. The pictures below show the floor at the door and the south wall sample locations. Table 3-5 presents results of the static measurements and building material samples from this survey unit. Results presented for static measurements and sample media above the 1E-06 DCGLs established for the survey unit are presented on the table and results above the 1E-04 DCGL are bolded. The smear sample showed elevated levels of H-3 and Ni-63. Based on the elevated levels of activity of the building samples which could not be shipped, other isotopes are expected to be found at elevated levels.

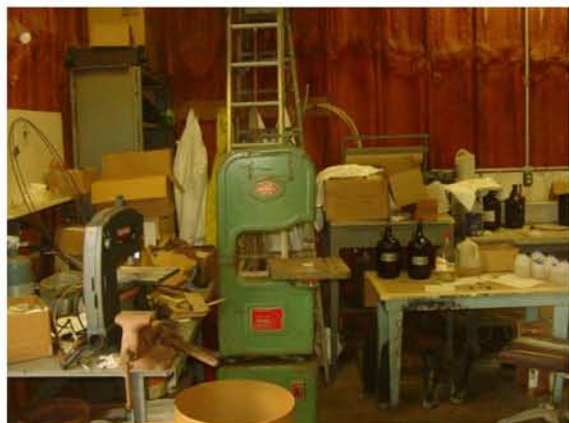
“Radioactive Material”. The picture below shows the interior of the building and the area where H-3 cocktails are made.

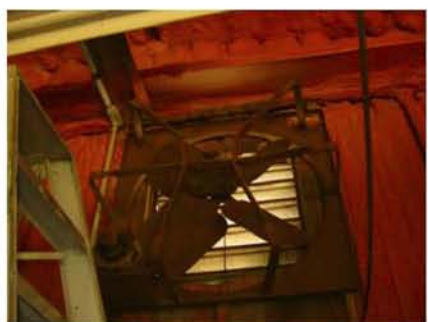
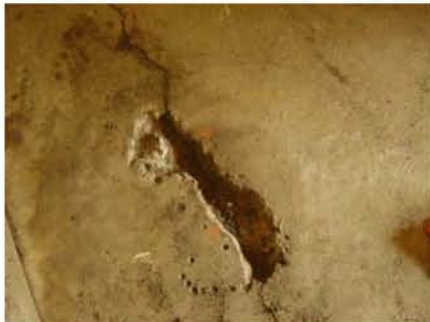
Two samples were taken from the floor, one was near the work table in the northeast portion of the survey unit and one was taken at the crack described above in the center of the building. The pictures below show the exhaust fan and the crack in floor after the sample was taken. Table 3-6 presents results of the static measurements and building material samples from this survey unit. Results presented for static measurements and sample media above the  $1E-06$  DCGLs established for the survey unit are presented on the table and results above the  $1E-04$  DCGL are bolded. Radioisotopes detected at elevated levels in both floor samples were H-3 and Ra-226 with Ra-226 exhibiting activity above the  $1E-04$  risk DCGL.

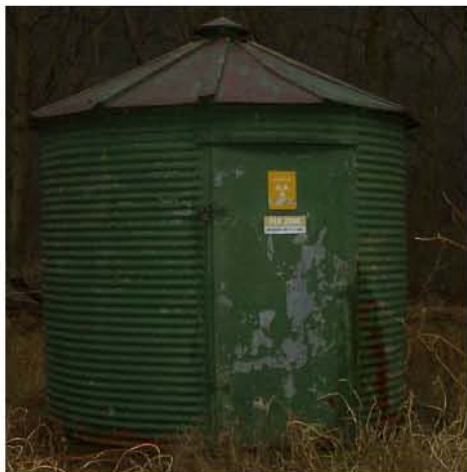
The Metal Silo (Building 14 on Figure 1-2) was a metal structure (approx. 2 m<sup>2</sup>) on the outer southeast side of the main property. The floor was soil covered with plastic and concrete block circled the floor against the walls of about 30 percent of the structure. The silo was locked to prevent access by personnel and radiologically posted as "Radiation Area". The majority of items in the building were contaminated items with fixed and transferable contamination which were packaged and labeled as radioactive material. Labels on some items indicated H-3, including urine samples and drums marked as leaking; these were not disturbed during the RI. Pictured below is the silo exterior; no interior pictures of the silo are available.

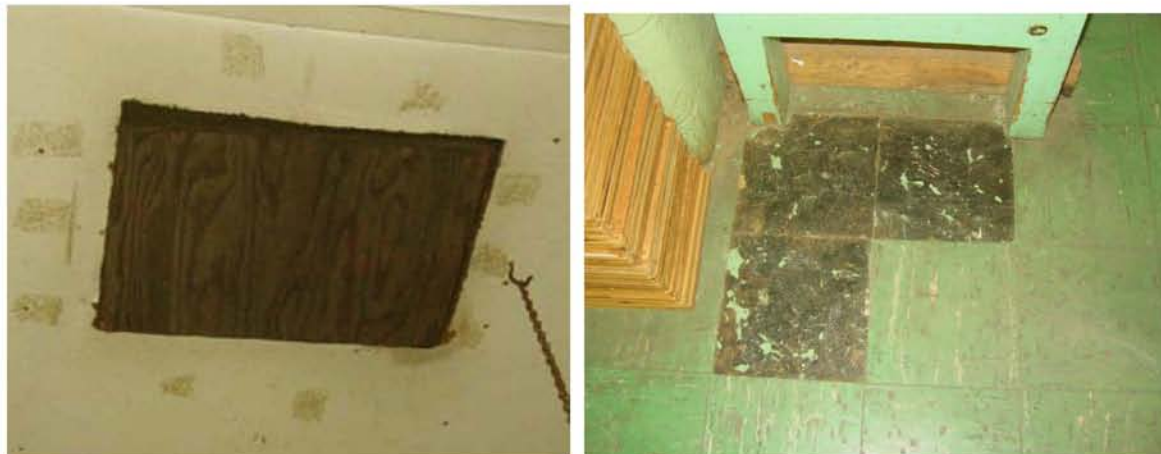
Three samples were taken in the Etching Building. Two were ceiling samples (one each from the older section and newer section) and one was a floor sample taken from the southwest paint shop (old portion of building). The pictures below show the ceiling sample location outside of restrooms and the floor sample. Table 3-8 presents results of the static measurements and building material samples from this survey unit. Results presented for static measurements were below DCGLs; however, sample results showed levels of H-3 and Pb-210 slightly above the 1E-06 DCGL established for the survey unit. All samples showed Ra-226 above the 1E-06 DCGL with one sample above the 1E-04 DCGL.

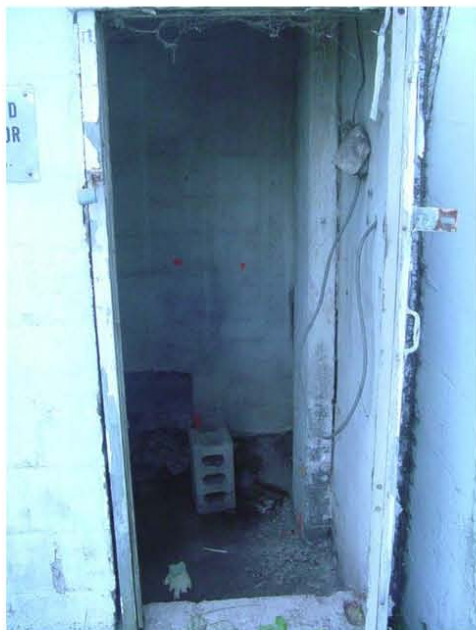
Because of the small size of the room, the majority of the surfaces were surveyed and found to be highly contaminated (fixed and transferable). The room contained no items with the exception of an installed pipe just inside the door having the highest fixed contamination of 3,115,991 dpm/100cm<sup>2</sup> beta-gamma and 35 dpm/100cm<sup>2</sup> alpha. Note that alpha result is from a second survey; the first survey showed non-detected alpha contamination. Maximum transferable contamination was 144,136 dpm/100cm<sup>2</sup> beta-gamma and 15 dpm/100cm<sup>2</sup> alpha. The picture below shows the interior of the hut.

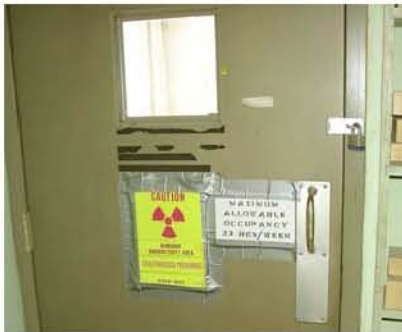
The Main Building (Building 16 on Figure 1-2) Attic (approx. 230 m<sup>2</sup>) consisted of a finished room at the top of the stairs and two crawl spaces (east and west). A roof access door opened to the south end of the building. Surface materials were wood floors, plaster walls, and plaster ceiling. The only personnel allowed access to the attic is for necessary maintenance (i.e. heating and cooling repair). The stairwell had broken windows causing a problem with pigeons and their droppings in both the stairwell and attic. The stairwell door was posted "Airborne Radioactivity Area" for radon only (with established stay times), but maintenance personnel wore respiratory protection for health reasons associated with the bird waste. Most material and debris in the area was non-releasable and not surveyed due to the condition of room. No pictures are available for the attic, with the exception of the door at the bottom of the stairs shown below.

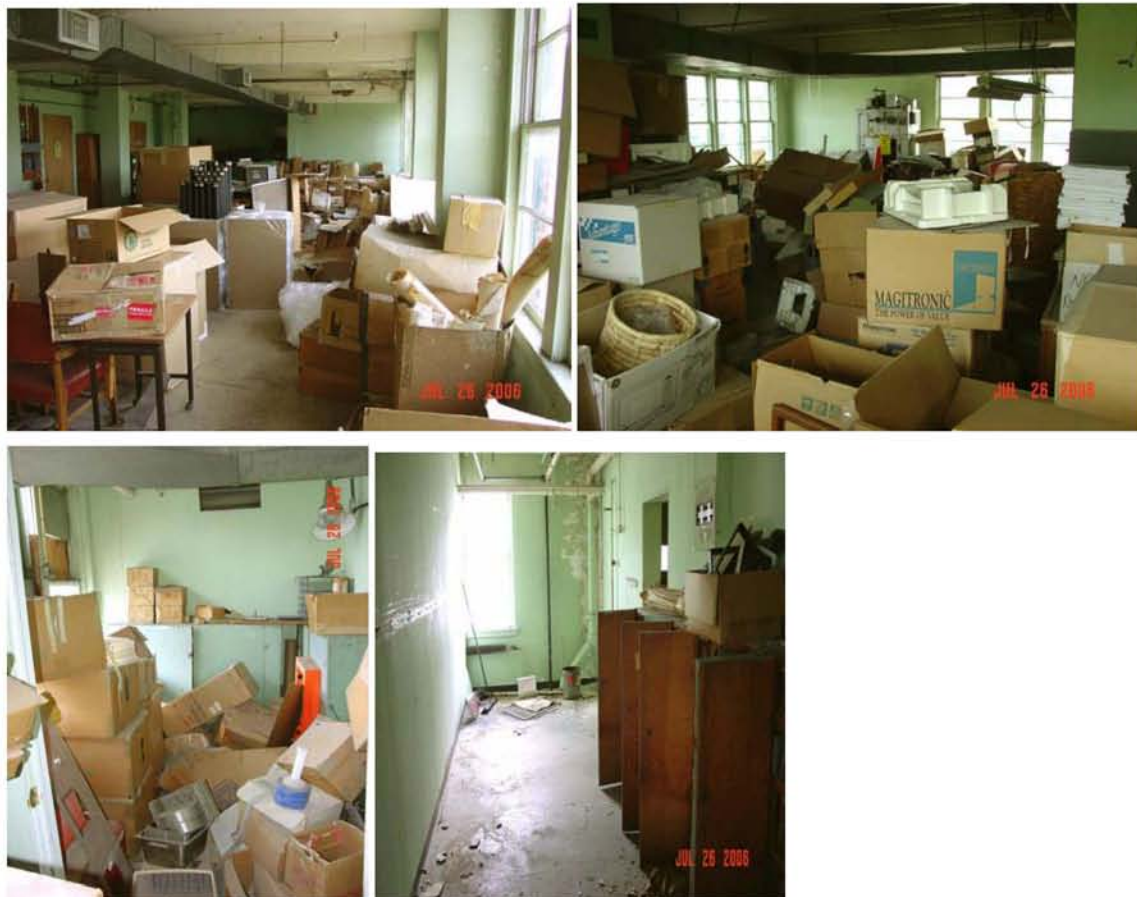
Debris items were packaged and moved to a controlled area. The pictures below show Room 218 west, 218 east, 218 southwest hall, and 218 closet (clockwise from left).

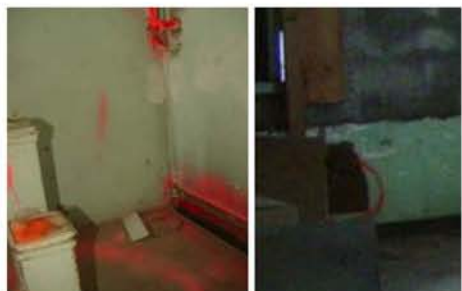
Four samples were taken in Survey Unit A. The first sample was taken in the south wall of the closet (south end of the building behind Room 217) under the window. Two wall samples were taken in Room 218, one on the northwest wall and one on the east wall next to the dumb waiter. A floor sample was taken from the east stairwell landing. The pictures below show the stairwell and wall beside dumbwaiter sample locations. Table 3-11 presents results of the static measurements and building material samples from this survey unit above DCGLs. H-3 and Ra-226 were the only radionuclides detected and were present in all building material samples. Ra-226 was detected in two samples above the 1E-04 DCGL.

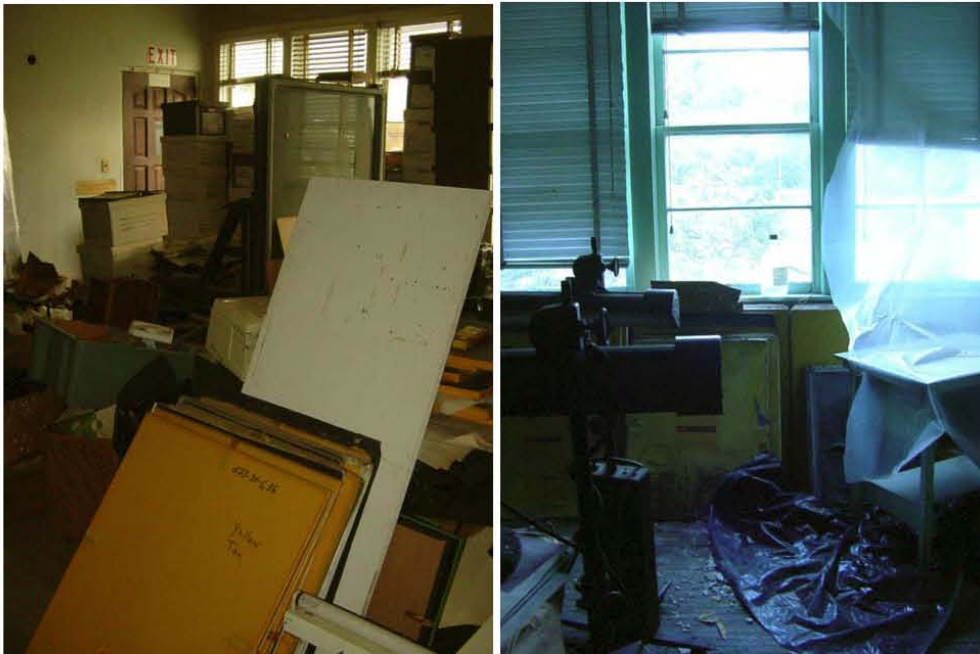
The majority of building surfaces were surveyed. The rooms were contaminated in isolated random areas at levels up to 1,200,017 dpm/100cm<sup>2</sup> beta-gamma and 3,526 dpm/100cm<sup>2</sup> alpha. All stairwell steps and rails were contaminated. Contaminated items of debris were packaged and moved to a controlled area. The pictures below show Rooms 206 and 211.

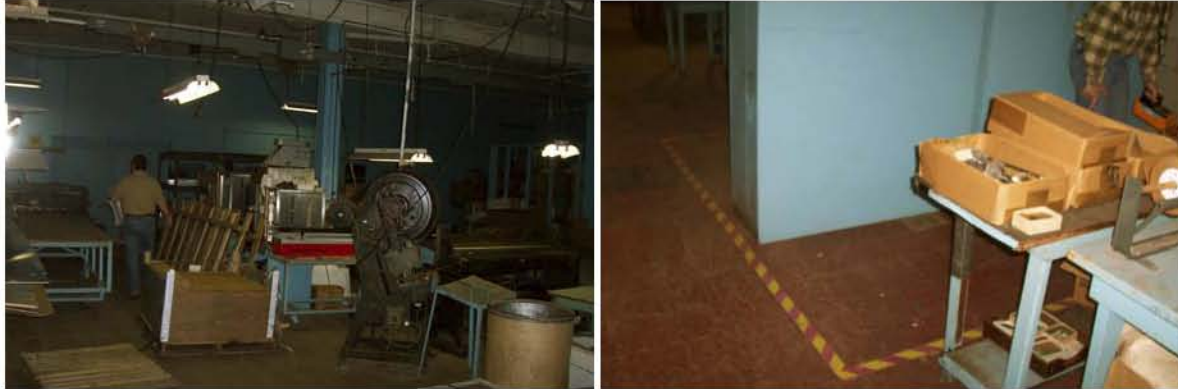
Pictures below, from left to right, are Room 93 and Room 97.

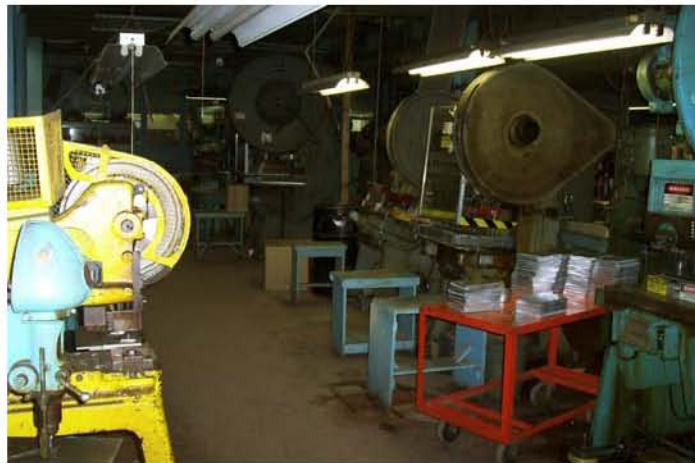
surveys being performed by USR Metals, materials in these rooms were not surveyed as part of the RI. Several contaminated items found during building surface surveys were packaged and moved to a controlled area. The photo below shows Room 100.

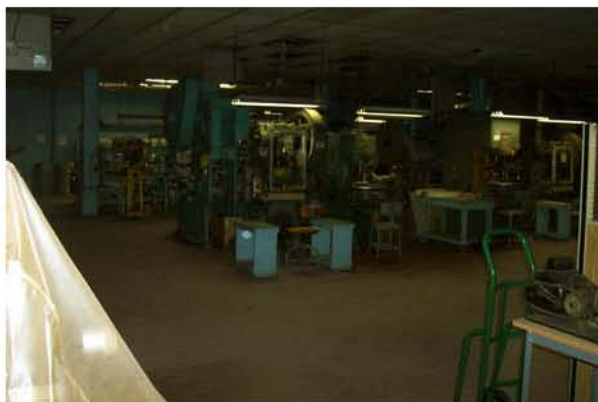
Four samples were taken in this survey unit. In Room 100, a sample was taken in the center floor, the floor of the hall at the end of the southwest hallway, and from the northeast door. The last sample was taken from Room 116 from the timecard rack in the southeast corner. The photo below shows the sample location of the center floor in Room 100. Table 3-18 presents results of the static measurements and building material samples above the  $1E-06$  DCGL; results above the  $1E-04$  DCGL are in bold. One of the samples from Room 100 showed elevated levels of H-3, Np-237, and Ra-226. One sample had Pb-210 at levels above DCGLs. No radionuclides above DCGLs were detected in the other sample; however a smear sample also showed elevated levels of H-3. No radionuclides were detected above DCGLs in the sample from Room 116.

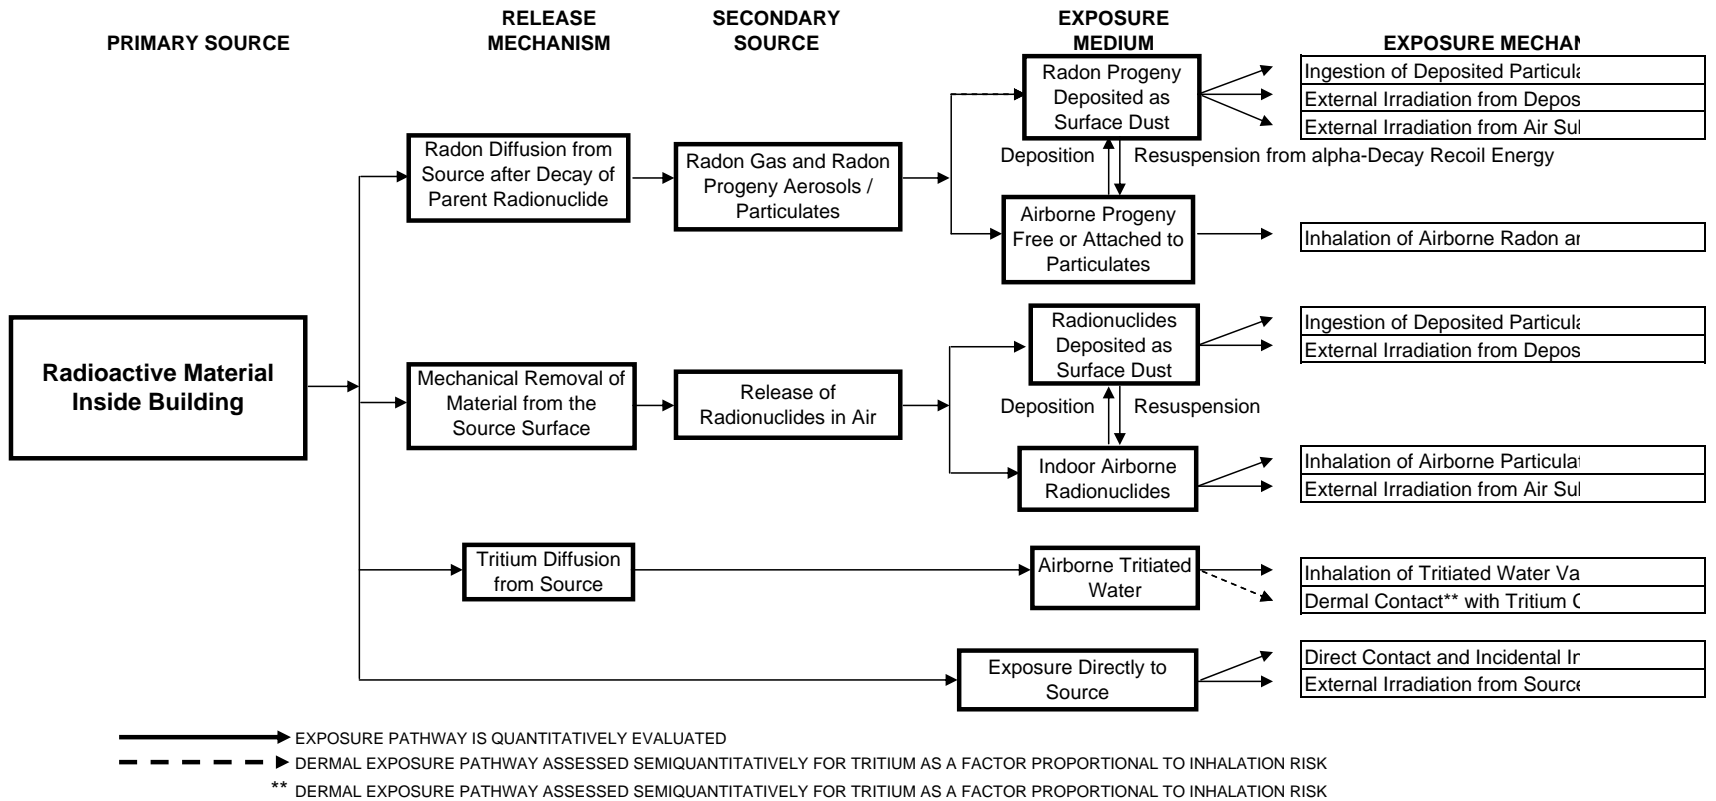
**FIGURE 5-1  
CONCEPTUAL SITE MODEL - HUMAN HEALTH RISK ASSESSMENT  
SAFETY LIGHT CORPORATION SITE OU-1  
BLOOMSBURG, PENNSYLVANIA**

to be completed because the building currently contains quantities of stored radiological waste. All other onsite buildings were evaluated for receptor exposure to radionuclides, and quantitative risks were estimated using RESRAD-BUILD for each of the following areas of interest:
