**FIFTH FIVE-YEAR REVIEW REPORT FOR
HRANICA LANDFILL SUPERFUND SITE
BUFFALO TOWNSHIP, BUTLER COUNTY, PENNSYLVANIA**

**U.S. Environmental Protection Agency
Region 3
Philadelphia, Pennsylvania**

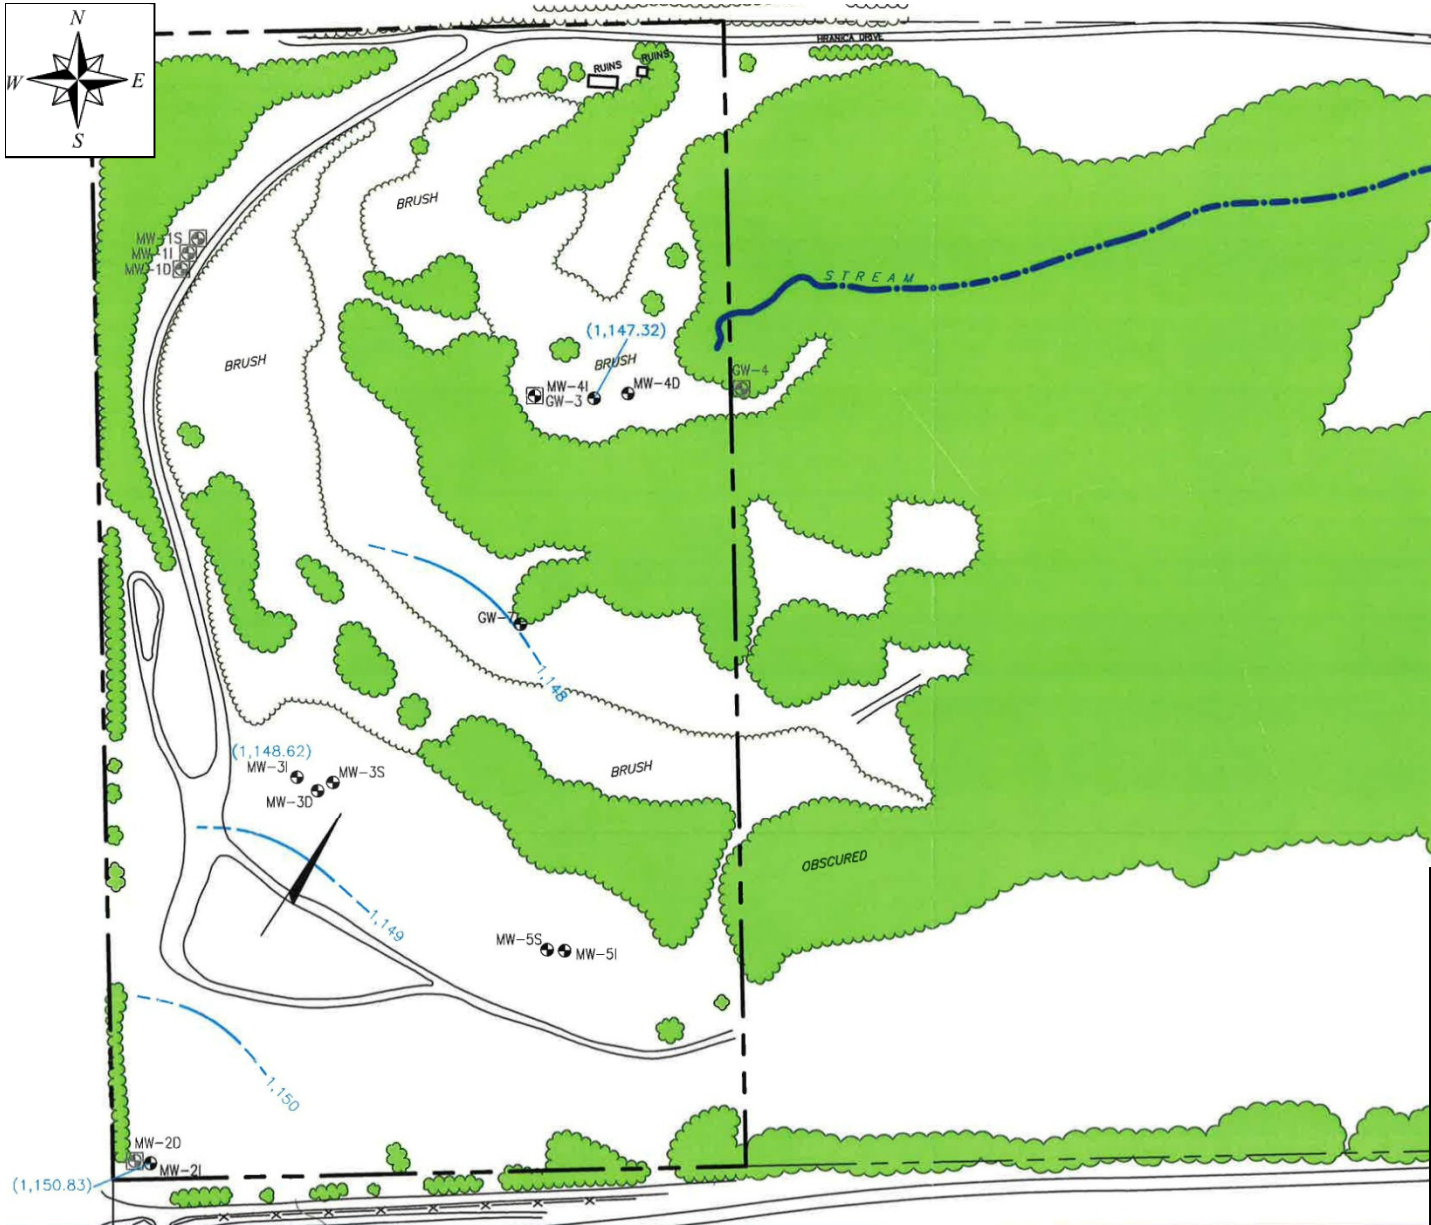
- SITE BOUNDARY
- - - APPROXIMATE LIMITS OF PROPERTY LINE
- WOODED AREAS
- STREAM
- MONITORING WELL
- ABANDONED MONITORING WELL
- GROUNDWATER FLOW
- 1,148 --- GROUNDWATER CONTOUR (feet)
- 1,148 - - - INFERRED GROUNDWATER CONTOUR (feet)
- (1,148.62) GROUNDWATER ELEVATION (feet)
- CONTOUR INTERVAL 1.0 (feet)

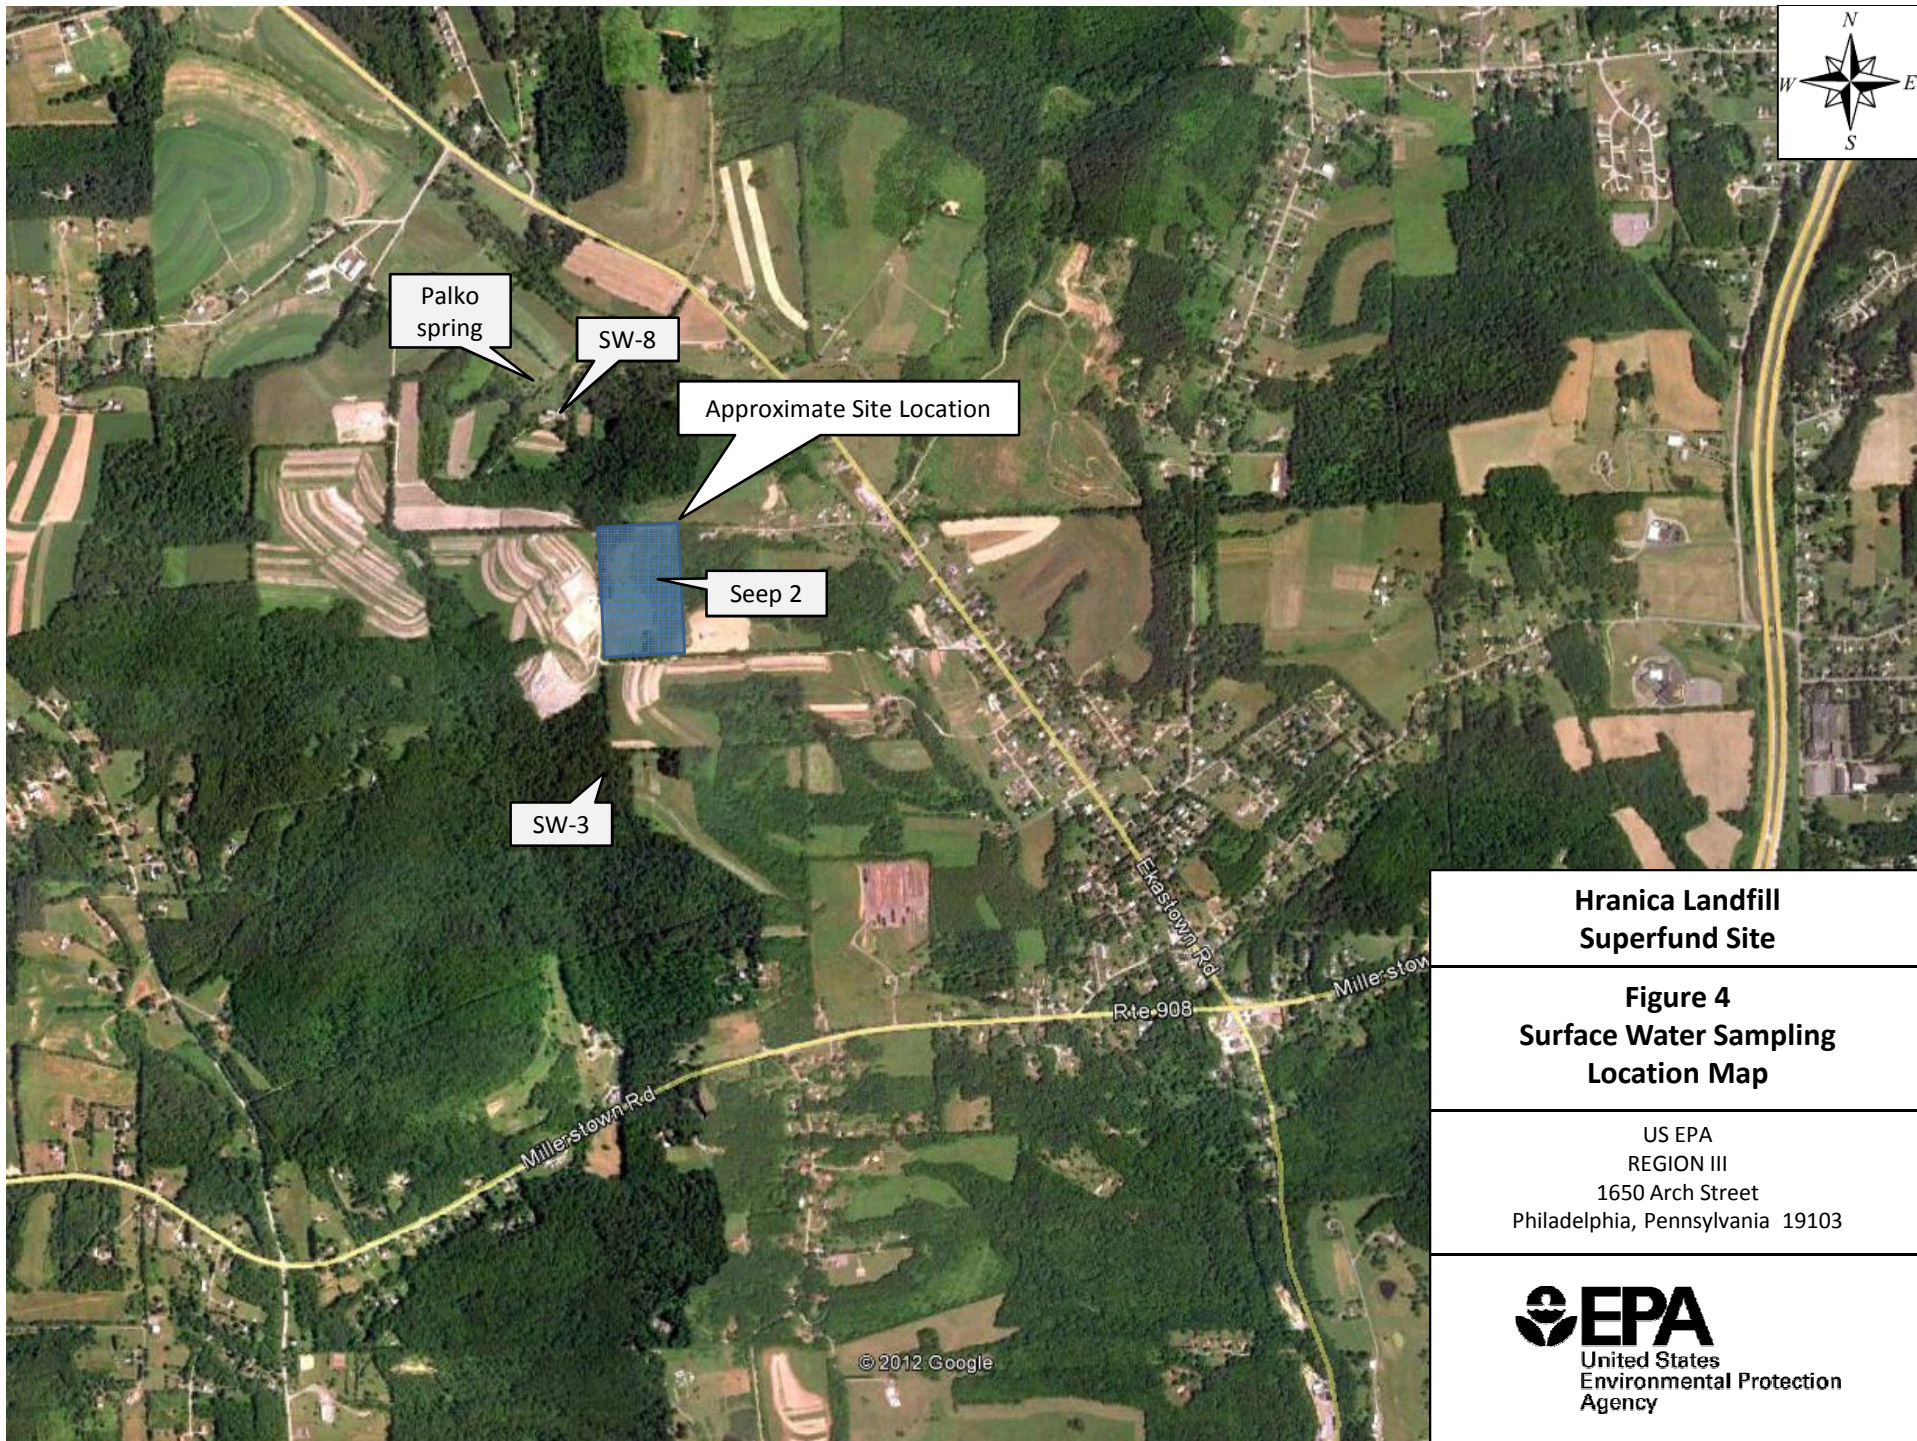
**Figure 4
Surface Water Sampling
Location Map**

In the 2016 sampling event, there were increases in the surface water metals concentrations. Due to this condition being the first increase in surface water metals concentrations and the increase occurring at onsite and offsite locations, the future data should be closely monitored to determine if this was a one time event.

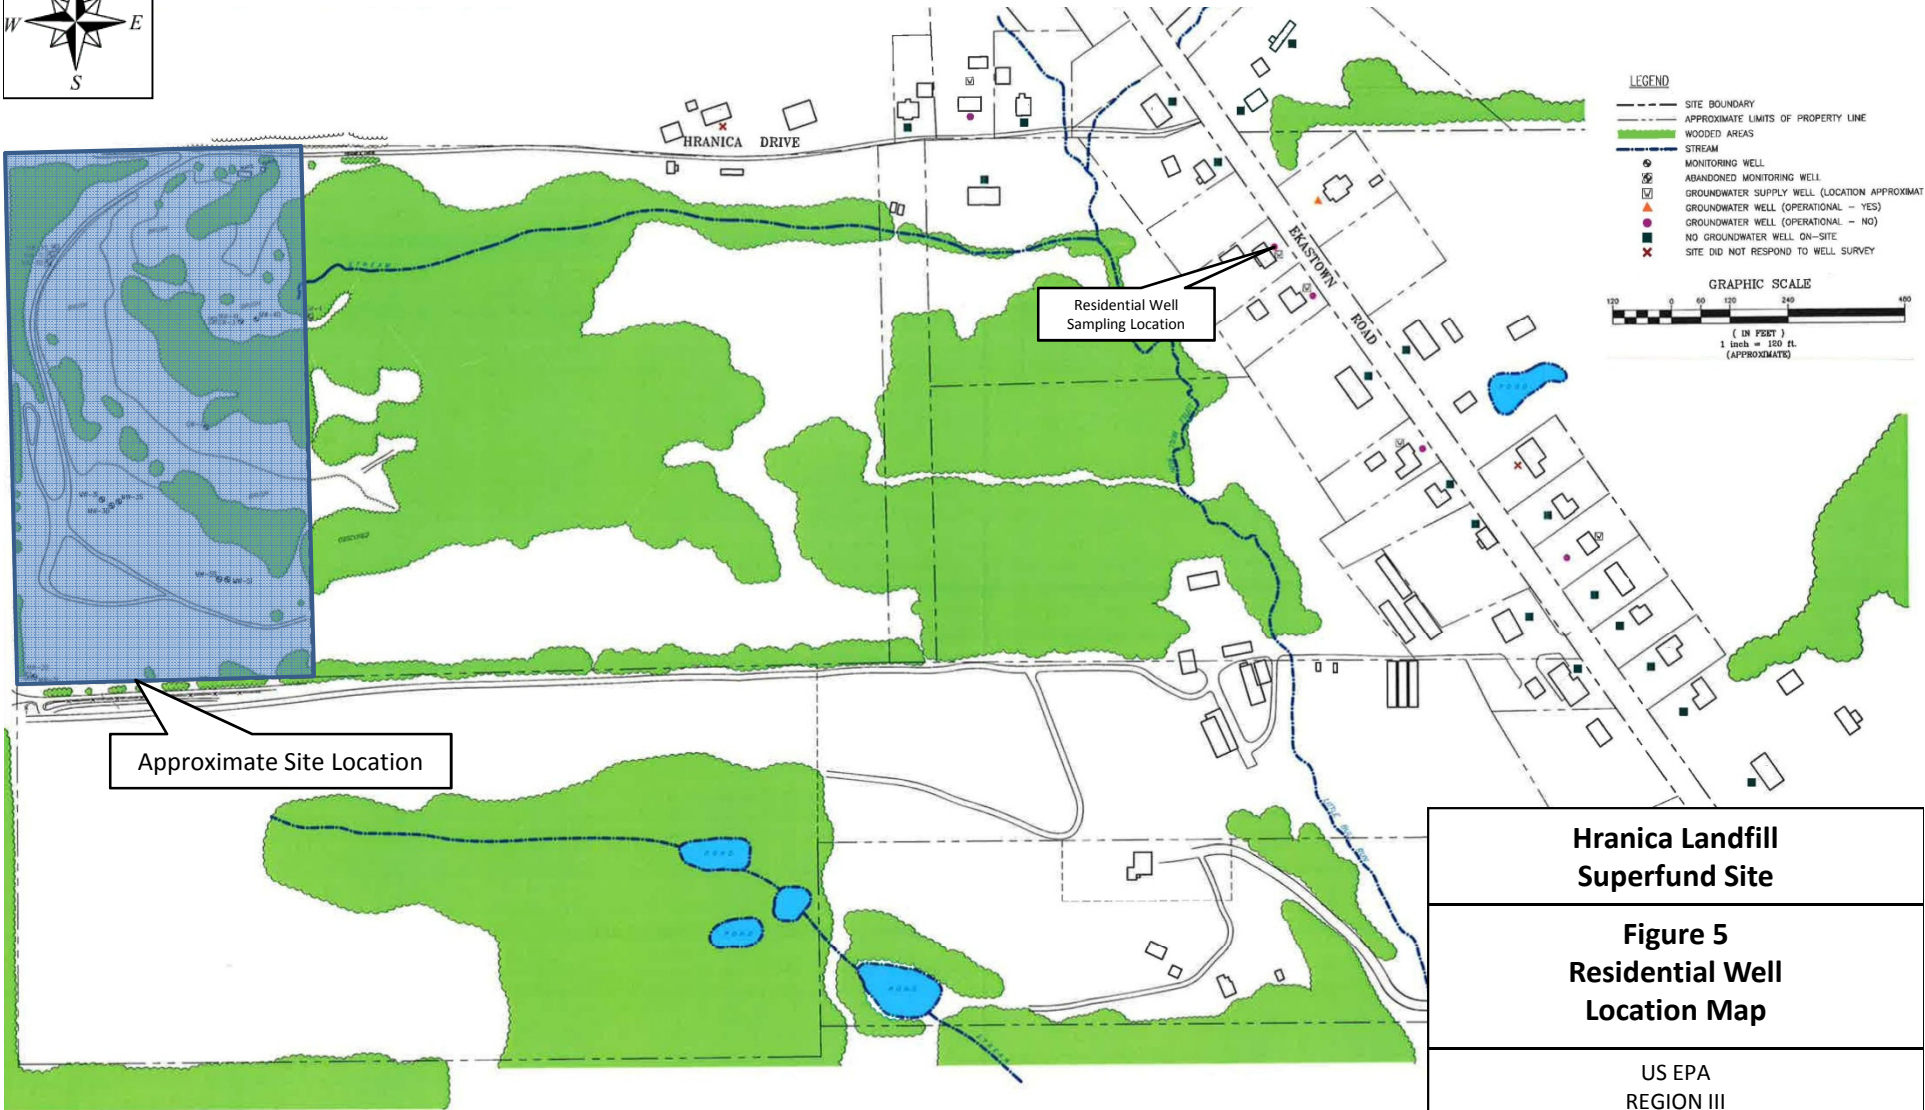
In 2015, naphthalene was observed at a concentration of 0.46 J $\mu\text{g/L}$ which is above its respective RSL of 0.17 $\mu\text{g/L}$. No other VOCs or SVOCs were detected in the residential well samples, nor have VOCs or SVOCs historically been detected in residential well samples.
