**THIRD FIVE-YEAR REVIEW REPORT FOR  
ELIZABETHTOWN LANDFILL SUPERFUND SITE  
LANCASTER COUNTY, PENNSYLVANIA**

**JUNE 2018**

**U.S. Environmental Protection Agency  
Region 3  
Philadelphia, Pennsylvania**

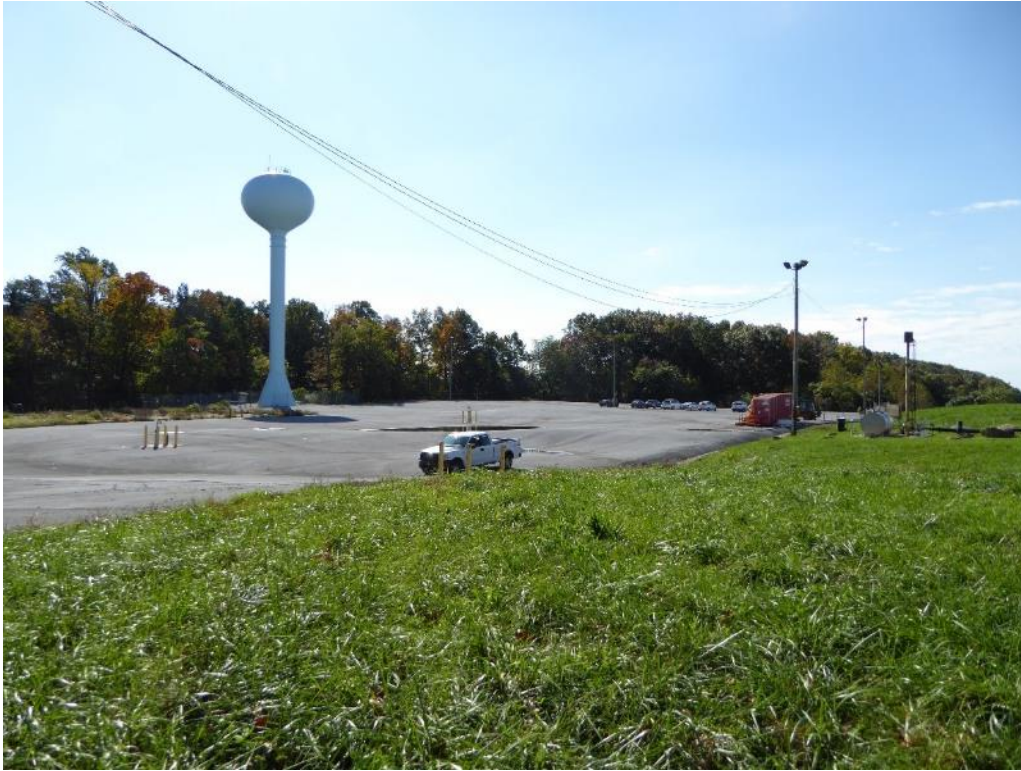
The LFG flare was in operation at the time of the inspection; it was in good condition and well maintained. Site inspection participants also observed the water tower installed outside the landfill cap. The tower, owned by the Elizabethtown Area Water Authority and installed prior to the 2013 FYR, is surrounded by a tall, locked fence to prevent tampering. Site inspection participants observed a frac tank on the asphalt cover. WMDSPA representatives indicated that the tank is storing development water from newly installed monitoring wells and will remain on Site until additional pump tests are conducted as part of the pre-design activities.

Asphalt cap and water tower on site property. Gas flare is at right.

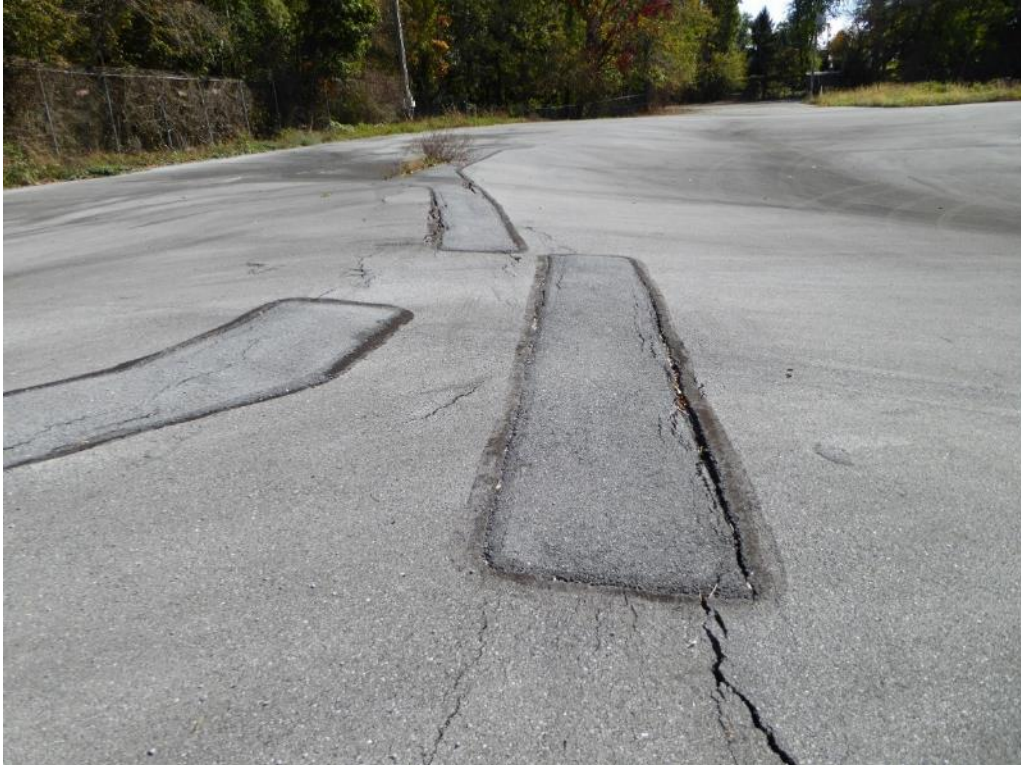
Site inspection participants observed the asphalt cap area of the landfill. Patched areas of asphalt on the eastern side were beginning to show signs of stress. Cracks were observed around the perimeter of the patched areas; vegetation was growing in one of the cracks. Pooled water was also observed in two slightly depressed areas in the asphalt cap.

Cracks in previously repaired area of asphalt cap.

- Repair cracks observed in the asphalt cap on the southern portion of the Site.
- Address animal burrows in the clay cap as soon as they are identified.
- Ensure that all monitoring wells and gated enclosures are locked and secured for the safety of the grazing cattle on the adjacent property and to maintain the integrity of the Site's remedial components.

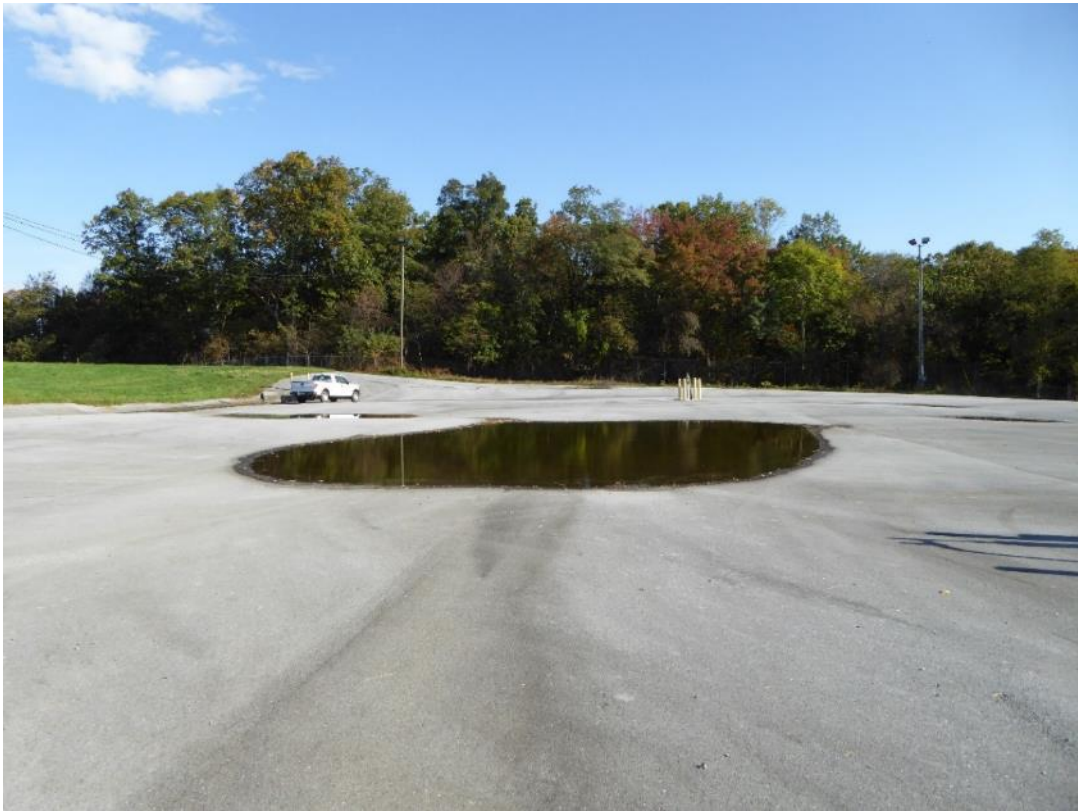
Ponded water on asphalt cap.

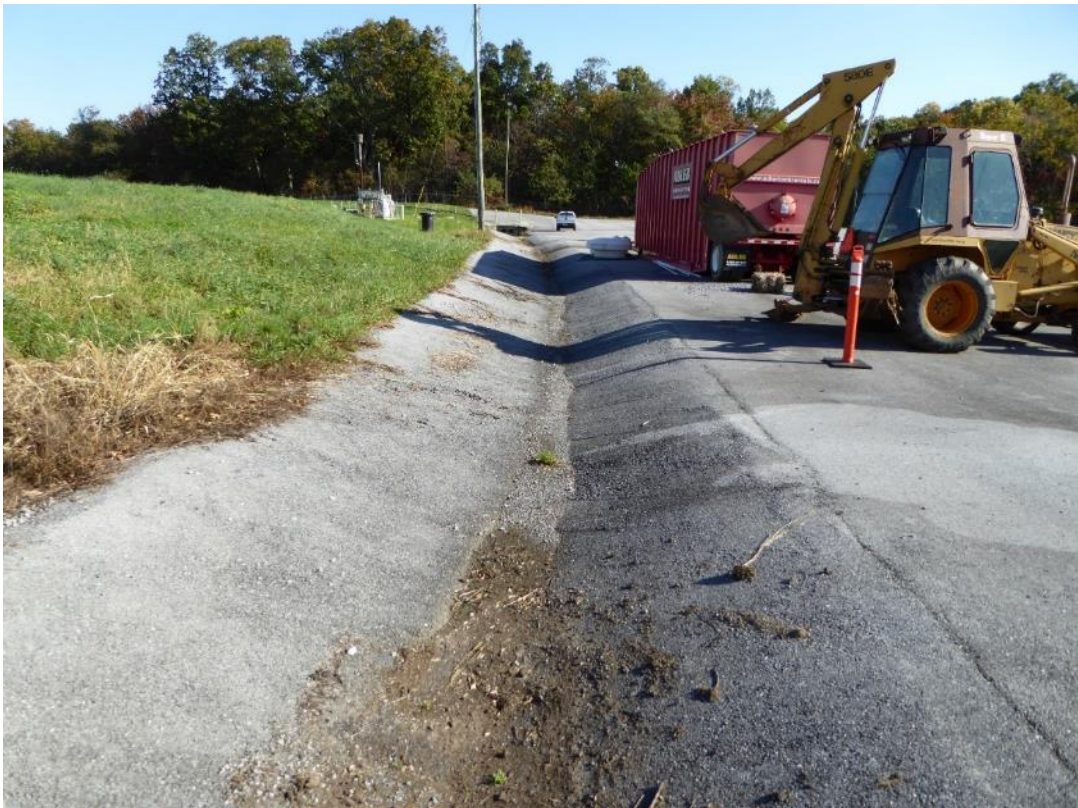
The stormwater letdown channel, constructed of cable concrete, and the stormwater collection basin were in good condition. Vegetation was observed growing in the letdown channel; however, it did not appear to be substantial enough to impede flow. The collection basin was dry at the time of the inspection.

Surface water runoff collection ditch.

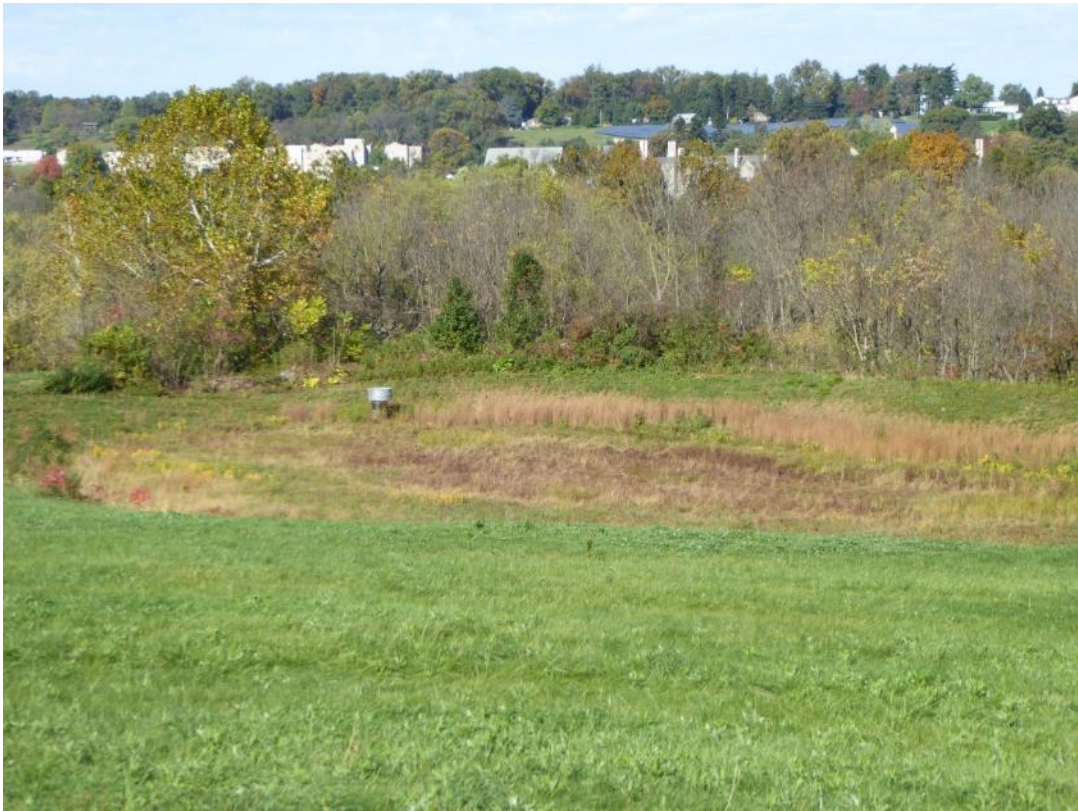
Surface water retention pond.

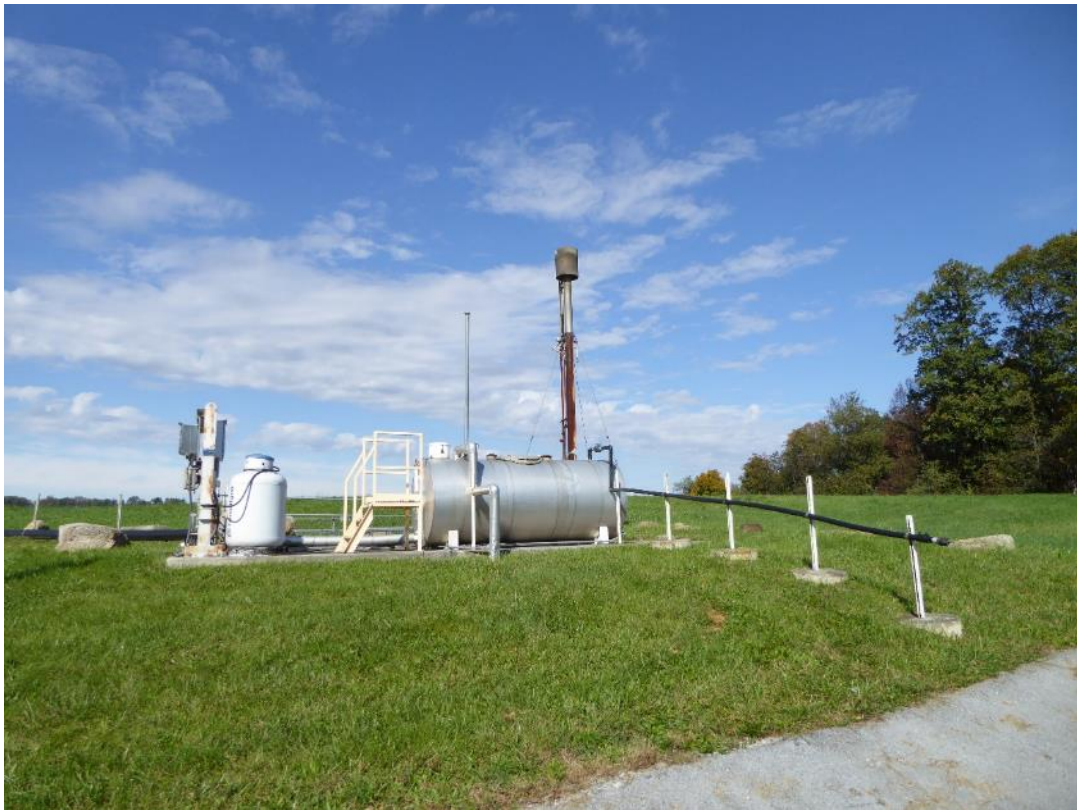
Landfill gas flare (in operation).

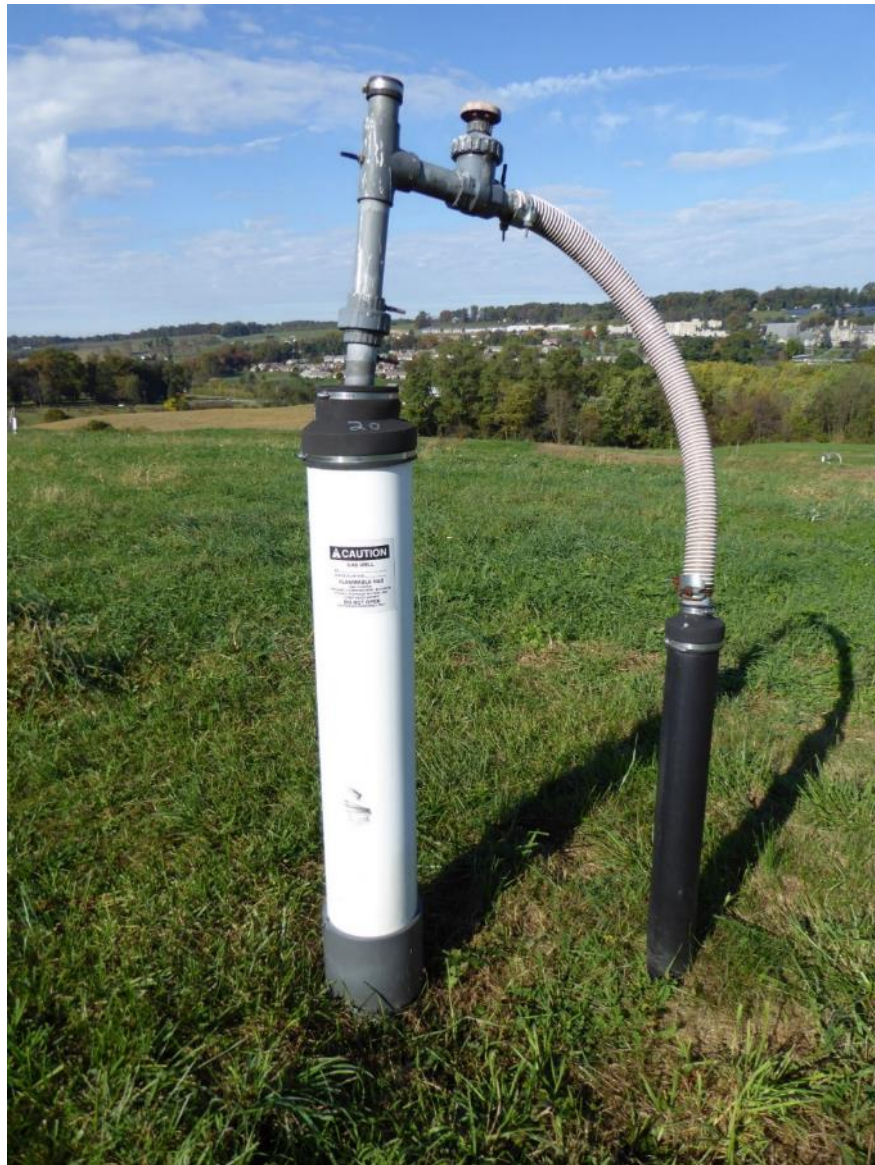
Vegetation on the northern cap was well established, except for a small area on the northwestern slope of the landfill where vegetation was sparse. LFG collection wells were operational and appeared to be in good condition.

Landfill gas collection well.

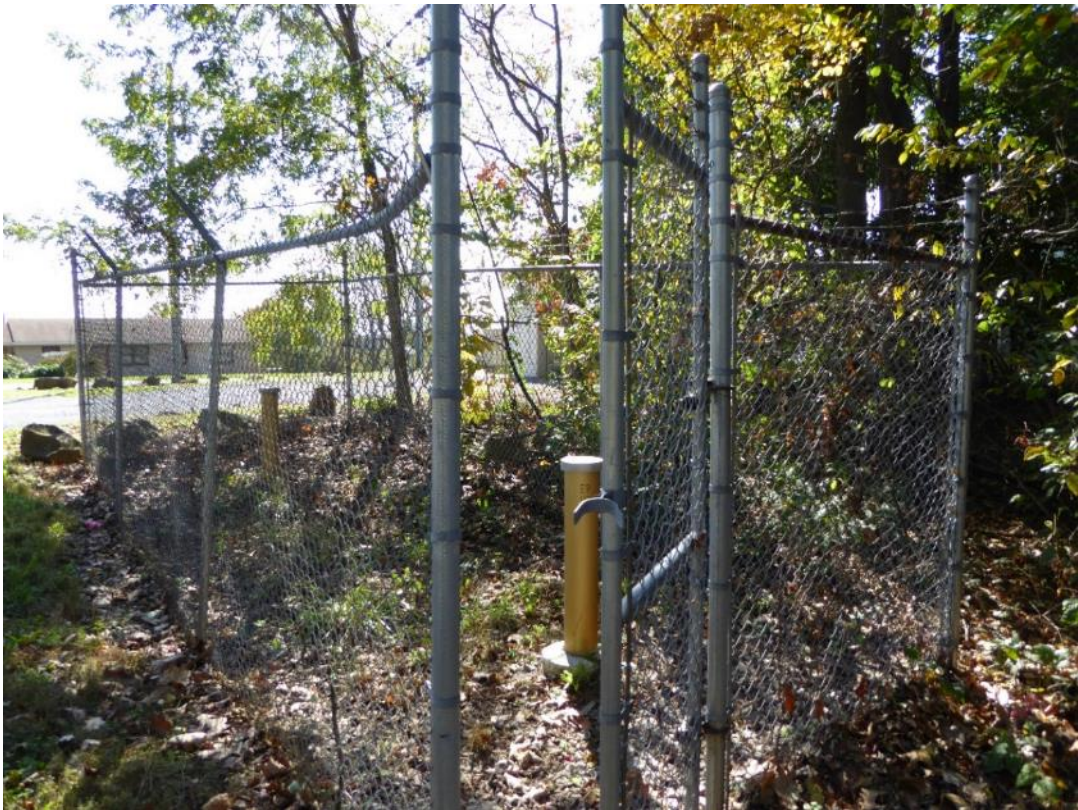
Monitoring wells around the vegetated cap area, including new wells installed in the summer of 2017, appeared to be in good condition; all but one of the wells were secured with locks. The representative from HGL locked the unsecured monitoring well during the site inspection.

Monitoring well EP02, near entrance to site property. Gate is not locked.

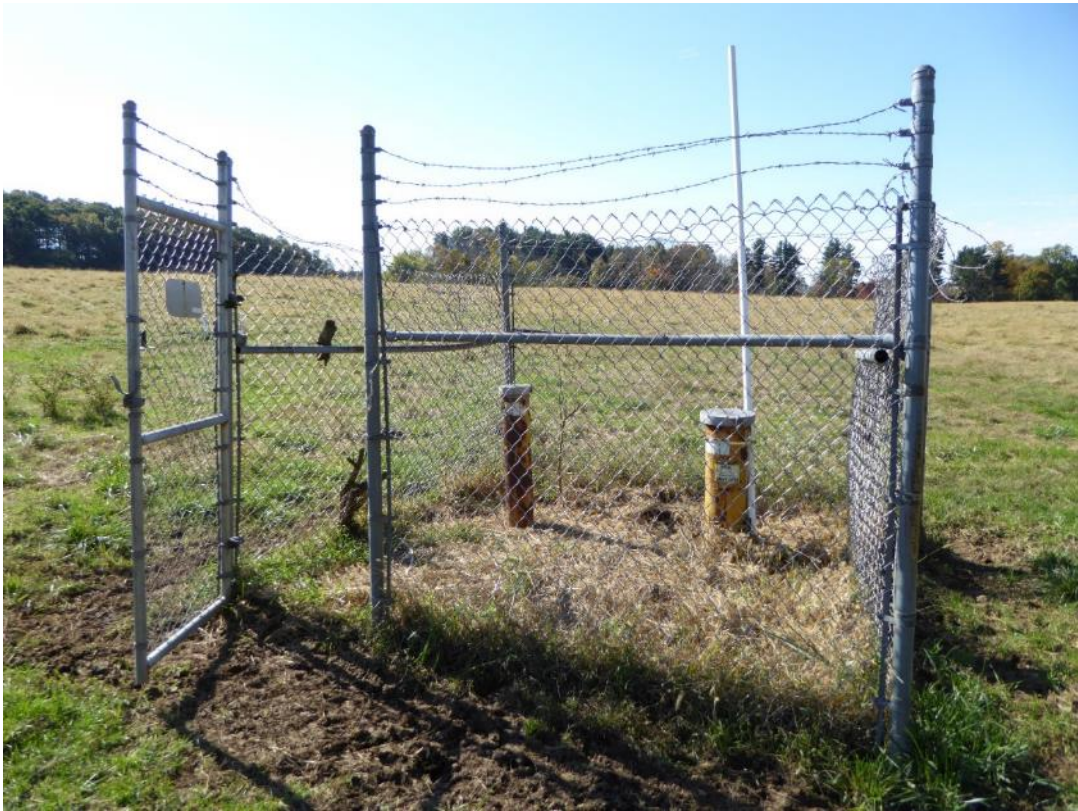
Site inspection participants also accessed the western property adjacent to the Site to inspect monitoring wells installed on the property. Chain-link fence that surrounds monitoring well ED10IR on the adjacent property was unsecured. Additional wells were also found unsecured. EPA noted that the fences and wells should be locked to keep out cattle and to maintain the integrity of the monitoring wells.

Monitoring well ED11IR in cow pasture. Gate is not locked.

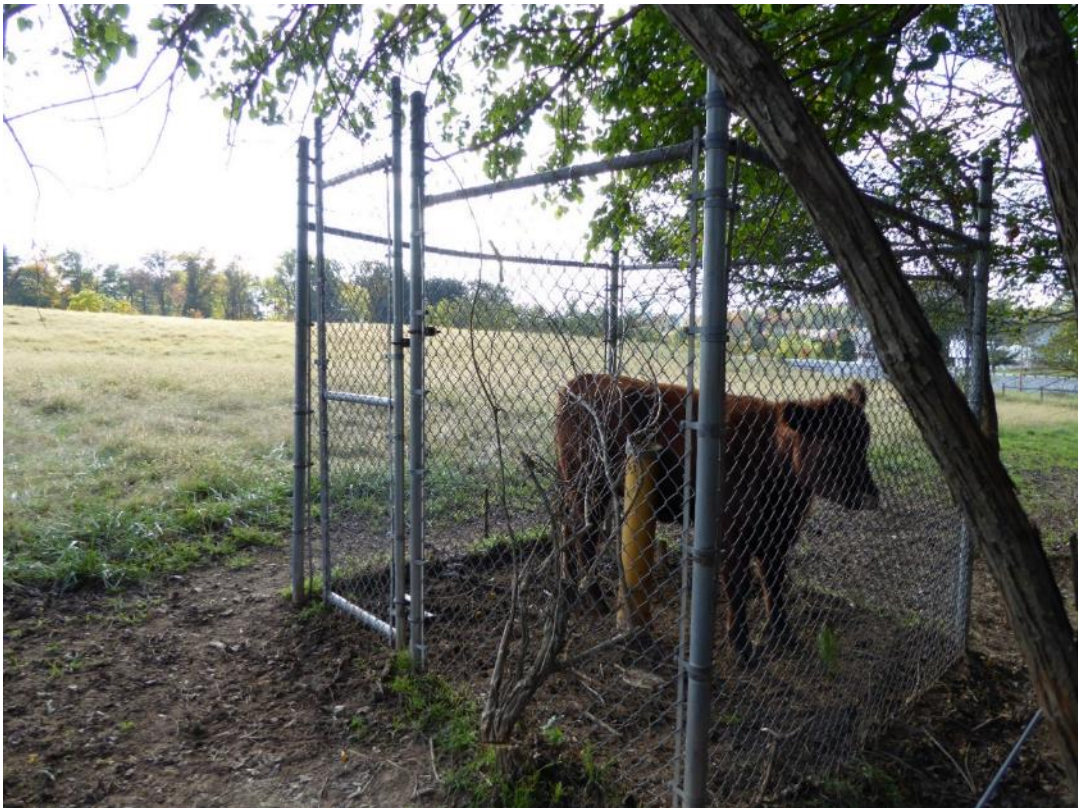
Following the site inspection, EPA observed a cow trapped within the fenced enclosure for monitoring well ED23, located on the adjacent property. EPA notified the property owner, Masonic Village, and a representative was able to release the cow from the enclosure. EPA notified WMDSPA of the need to keep all monitoring well enclosures locked and secured for the safety of the grazing cattle and to maintain the integrity of the Site's remedial components. WMDSPA has added locks to all gated enclosures.

Steer trapped in fence surrounding monitoring well ED23. Gate is not locked. Cap knocked off well.

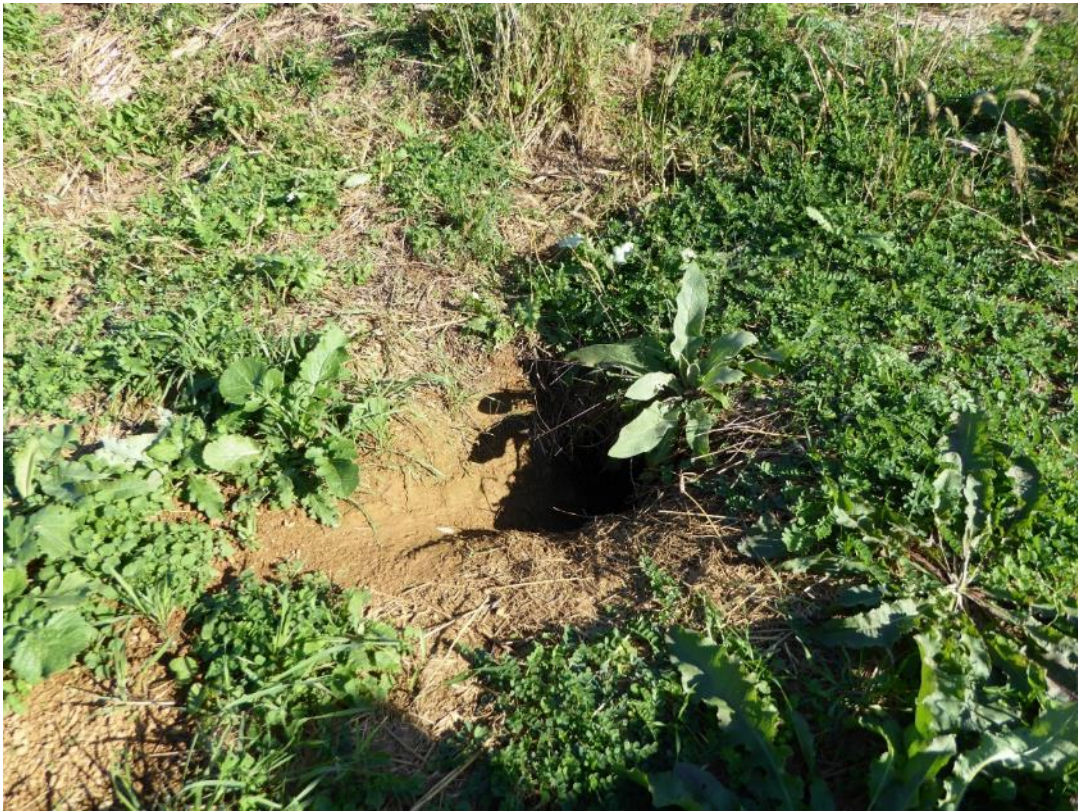
Numerous animal burrows were observed across the vegetated landfill but no waste was exposed. An 8-foot chain-link fence with a locked entrance gate surrounds the landfill property. Vegetation was observed growing on the fence on the eastern side of the Site. A fallen tree had also struck the fence.

One of several animal burrows in clay cap.

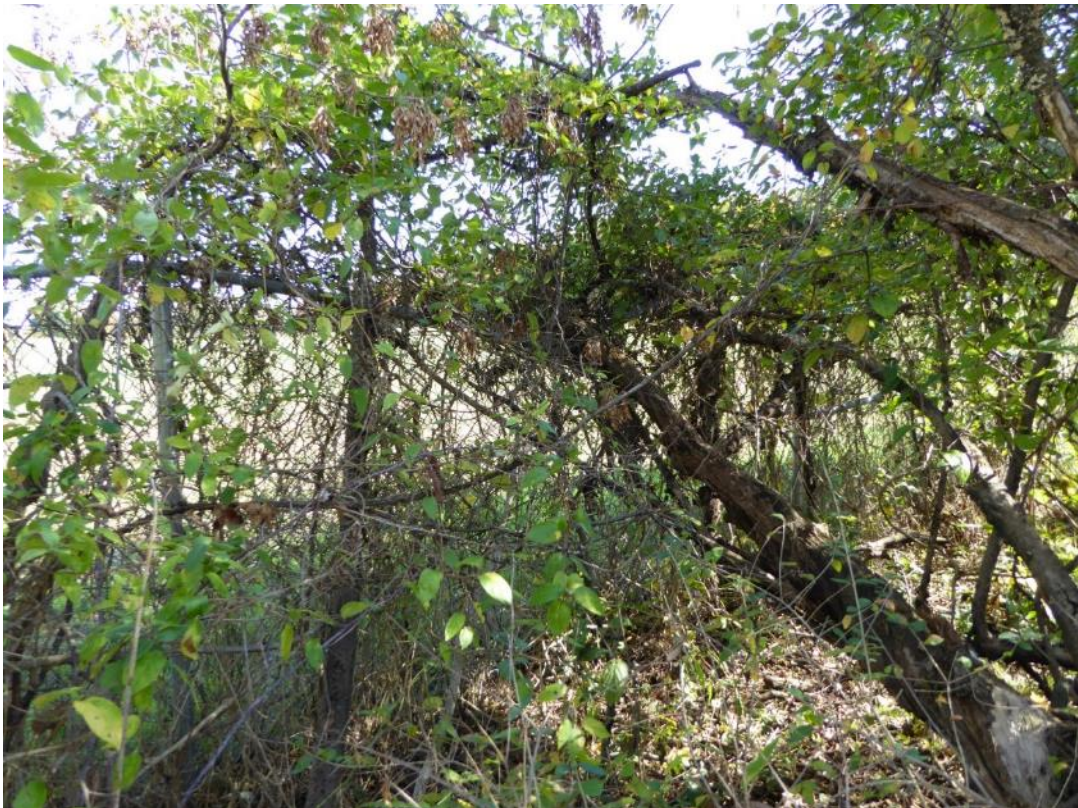
Down tree and vegetation on site fence near monitoring well ED08R.

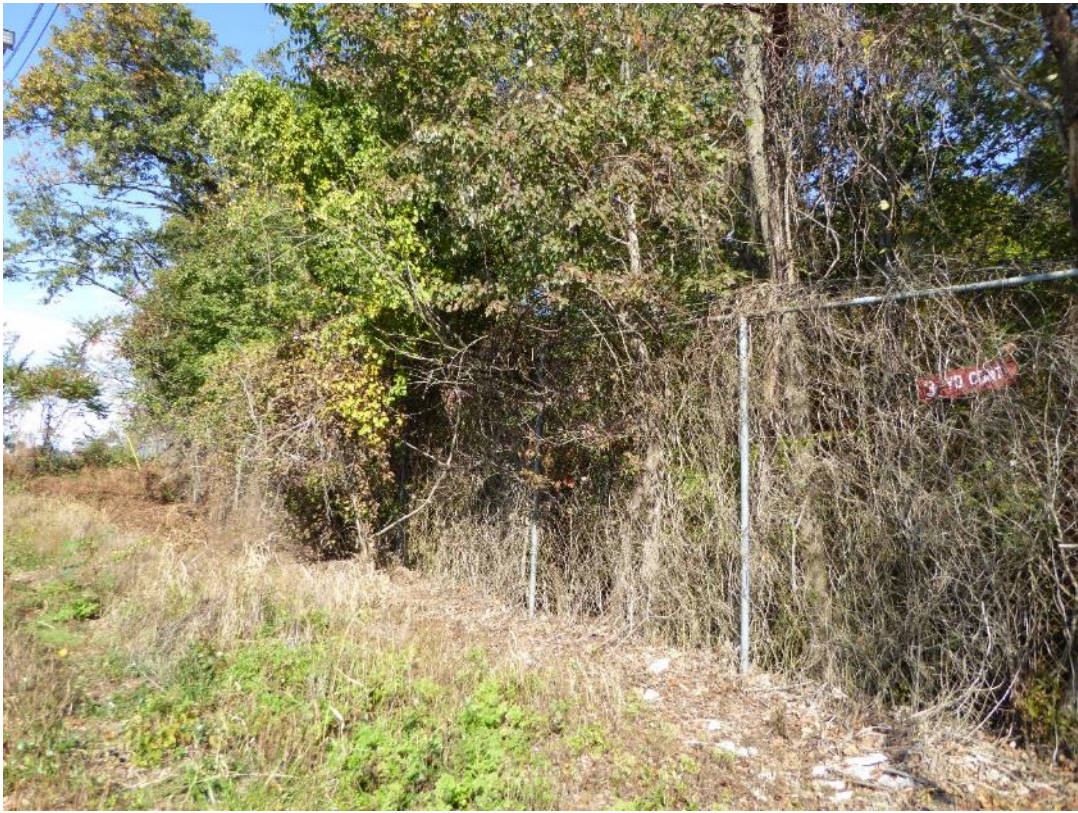
Vegetation on site fence.

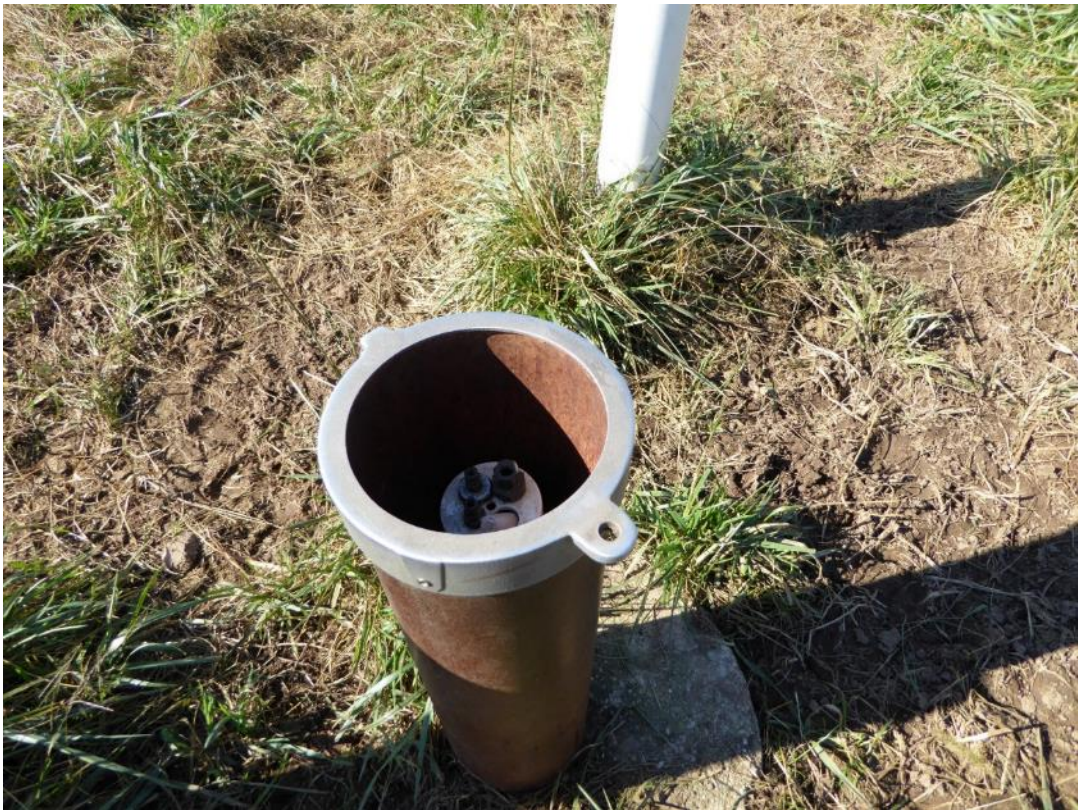
Monitoring well (missing cap).
