**FIFTH FIVE-YEAR REVIEW REPORT  
TYSON'S DUMP SUPERFUND SITE  
UPPER MERION TOWNSHIP  
MONTGOMERY COUNTY, PENNSYLVANIA**

**U.S. Environmental Protection Agency  
Region 3  
Philadelphia, PA**

*August 13, 2019*  
**Date**

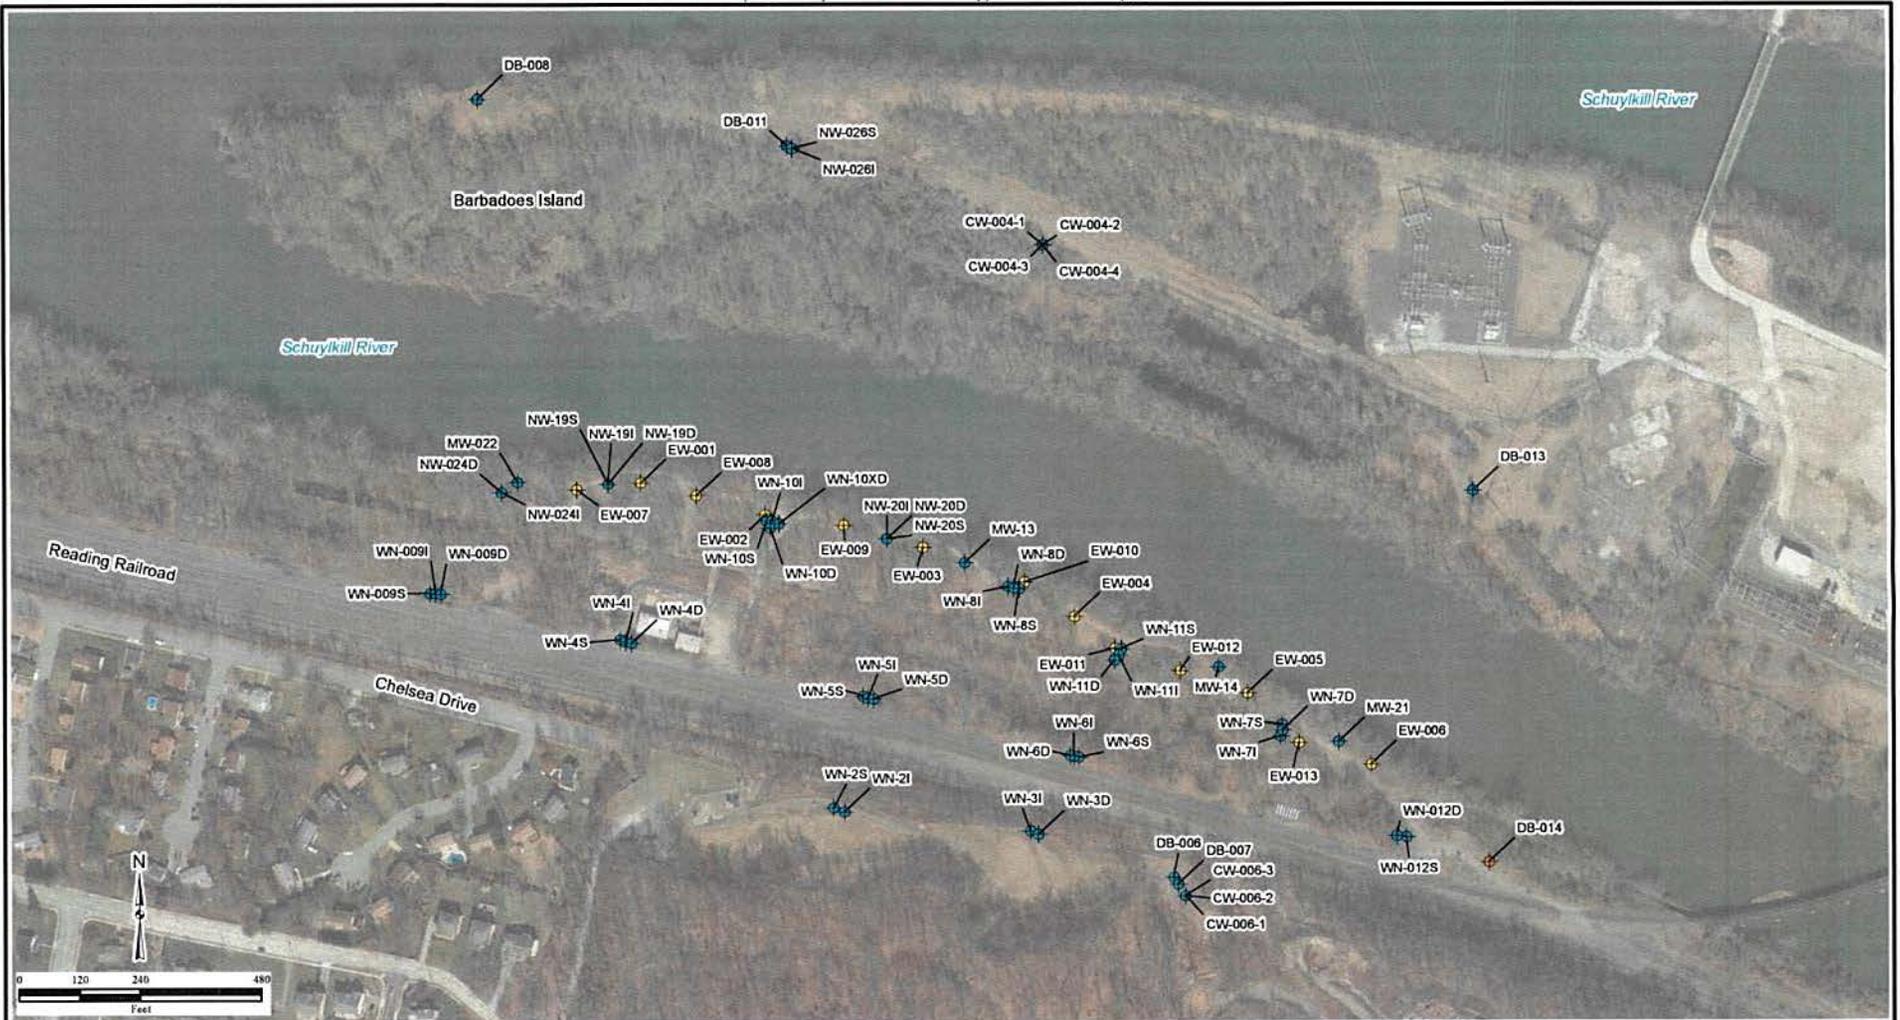
**Figure 2**  
**Well Locations**

- ◆ Monitoring Well
- ◆ Shallow Monitoring Well
- ◆ Deep Extraction Well

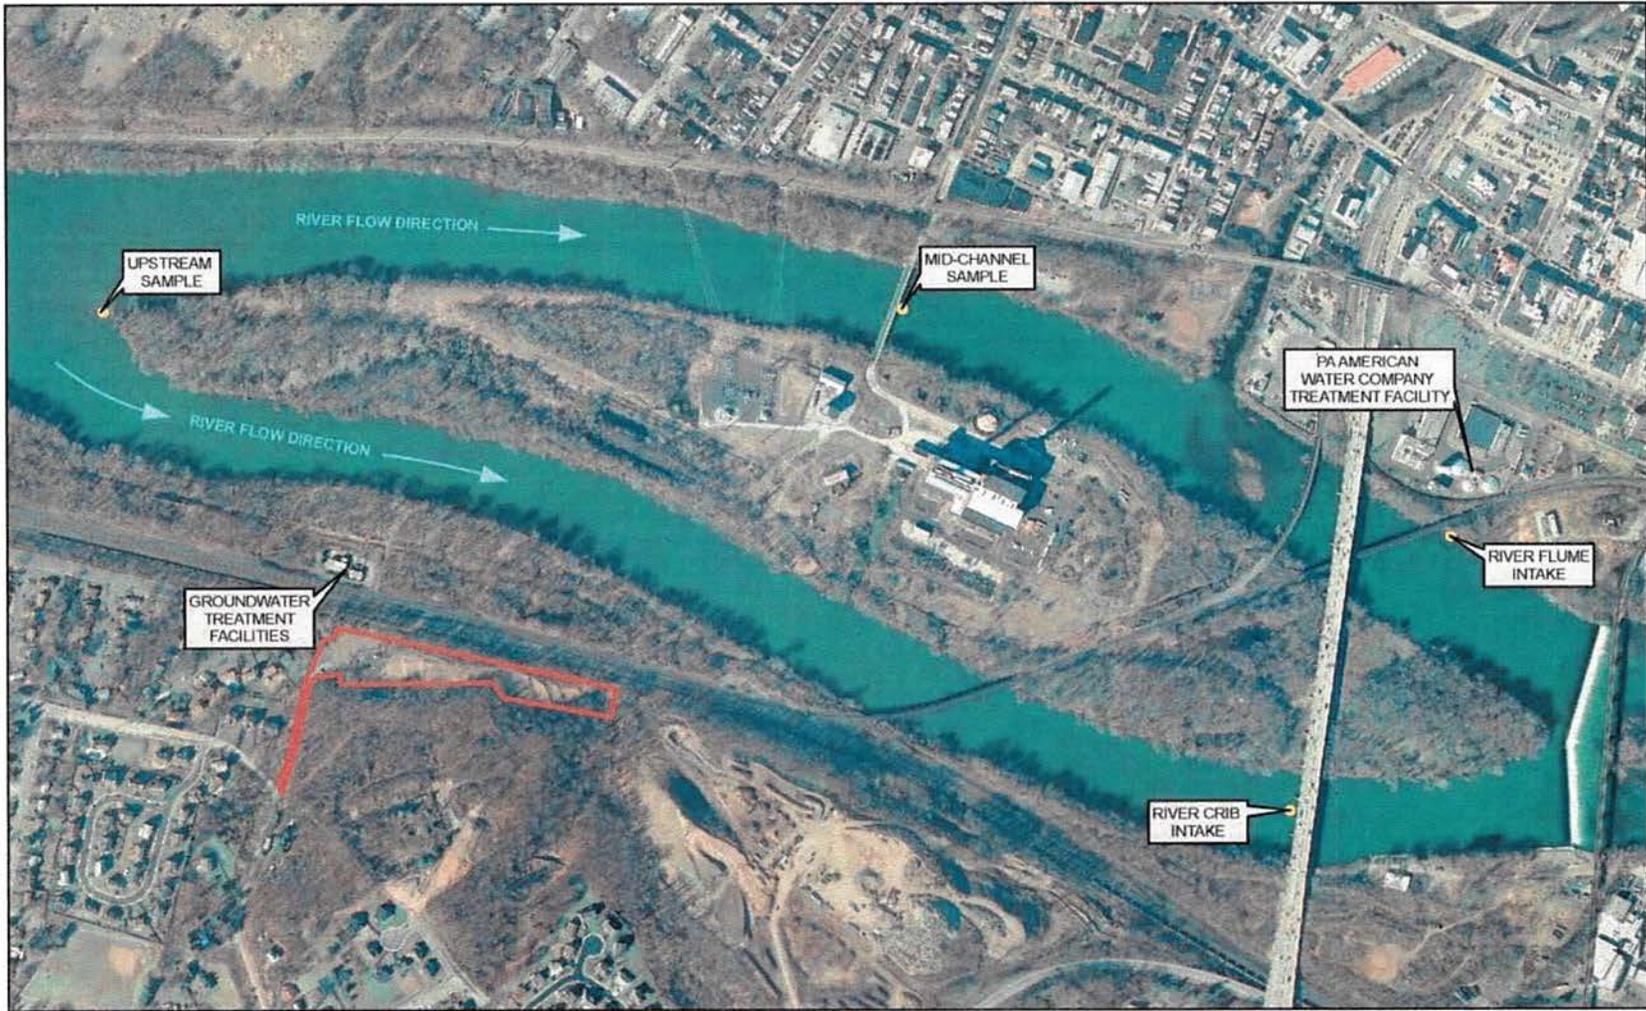
**Figure 3**  
**Surface Water**  
**Sample Locations**  
**in the Schuylkill River**

- Approximate Sample Location
- Approximate Site Location

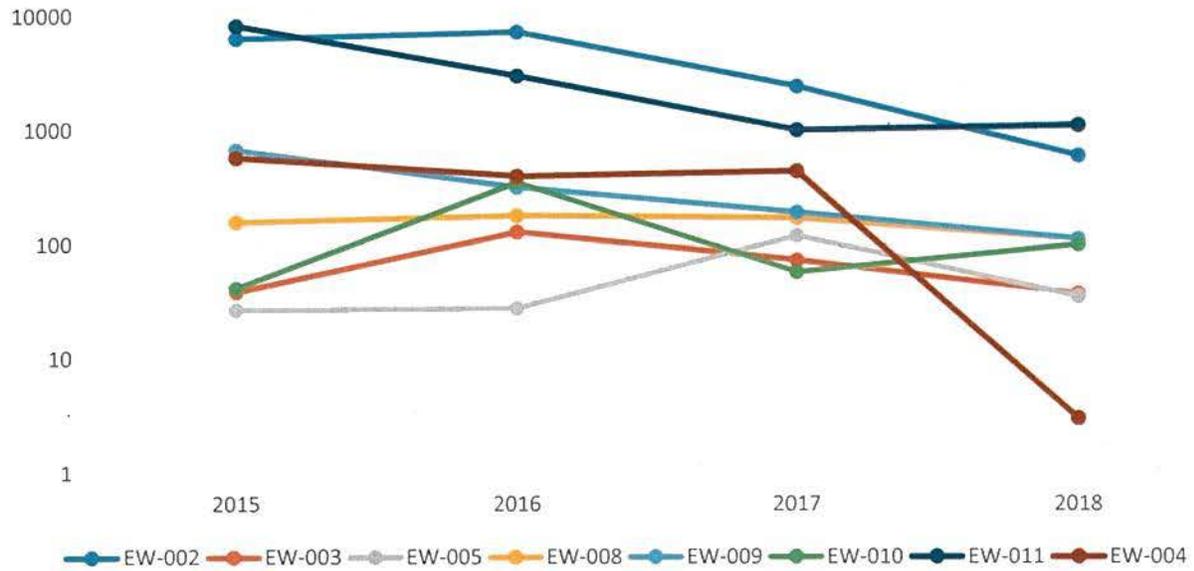
**Figure 6. 1,2,3-TCE Concentrations in Extraction Wells**

In 2016, packer testing of the EWs was performed. During the packer testing, some of the intervals in the EWs had much higher concentrations of 1,2,3-TCP than the concentrations noted during the annual monitoring events. For example, the 1,2,3-TCP in EW-002 were 210,000  $\mu\text{g/L}$  (98-108 feet), 18,000  $\mu\text{g/L}$  (115-125 feet), and 10,000  $\mu\text{g/L}$  (125-175 feet). The highest 1,2,3-TCP concentration detected in EW-011 was 20,000  $\mu\text{g/L}$  in the 90-100 feet interval. In EW-003, packer testing results showed a 1,2,3-TCP of 23,000  $\mu\text{g/L}$  in the 155-165 feet interval, and in EW-004 the highest 1,2,3-TCP concentration was found in the 104 to 119 feet interval (5,300  $\mu\text{g/L}$ ).

1,2,3-Trichloropropane Concentrations ( $\mu\text{g/L}$ ) in Extraction Wells, 2015 -2018

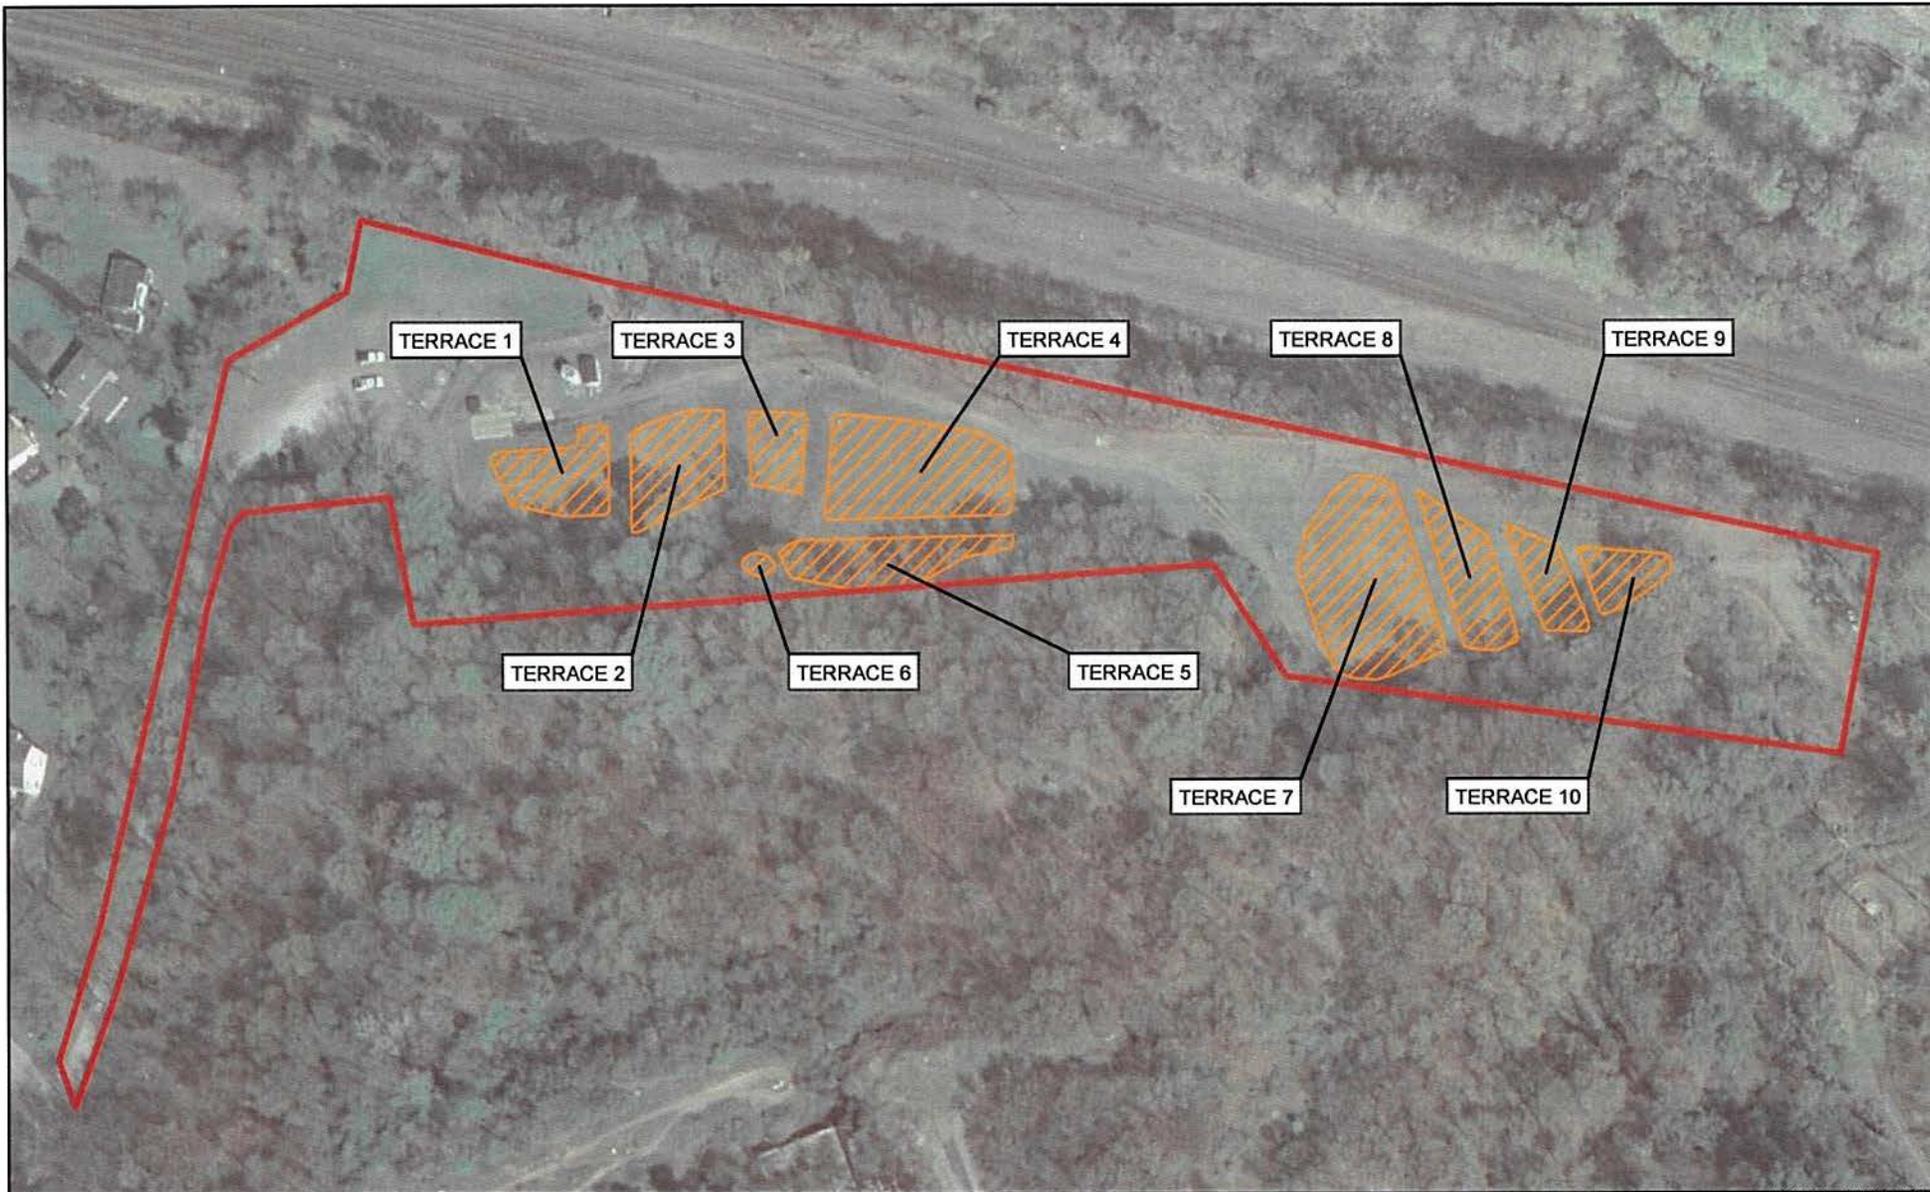
Figure 8. Wet Soil Cover Profile of Terraces 1 through 4

- A vegetated cover;
- A barrier layer of low permeable soil material to be maintained at saturated conditions by either natural precipitation or irrigation to control and eliminate the upward migration of vapors; and
- A vent layer of high permeable material to control lateral migration of vapors.

Water levels within the barrier layer are monitored daily to ensure that saturation conditions are maintained at all times. Water sprinklers are present on each terrace and are used to supplement natural precipitation to maintain saturation of the barrier layer. The irrigation system can be turned on manually when additional water is needed. There is overland flow of water from seeps and the oversaturation of the WSCS terraces. This overland flow is not contaminated by the Site and, therefore, poses no risk to ecological receptors.

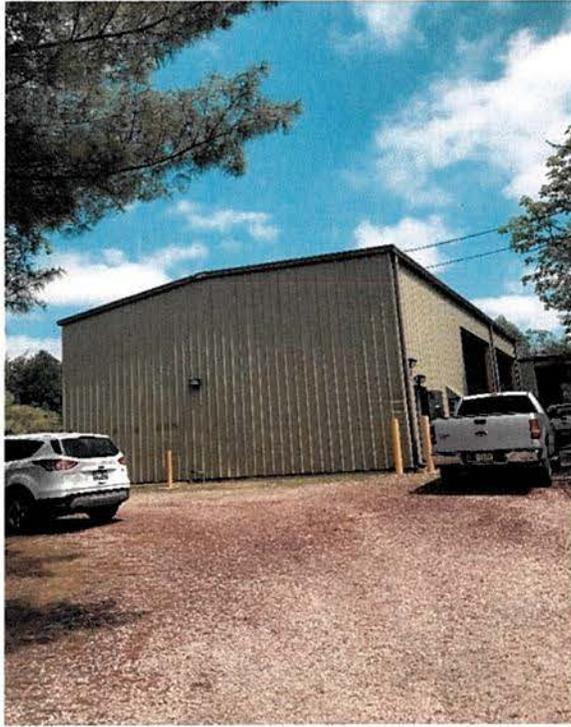
5.	<b>Treatment Building(s)</b> <input type="checkbox"/> N/A <input checked="" type="checkbox"/> Good condition (esp. roof and doorways) <input type="checkbox"/> Needs repair <input checked="" type="checkbox"/> Chemicals and equipment properly stored Remarks _____ _____

Picture 1. Groundwater treatment building

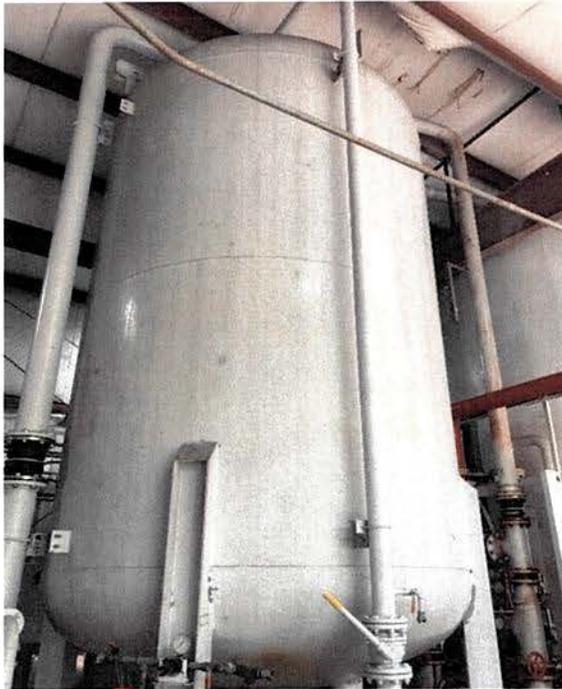
Currently the groundwater treatment system consists of two 20,000-gallon GAC units. These units will be replaced in summer/fall 2019 with two smaller units (10,000 gallon) to improve the efficiency of the system. O&M of both the WSCS and GWTP have been successful with minimal issues.

Picture 2. Granular activated carbon unit (20,000 pound)

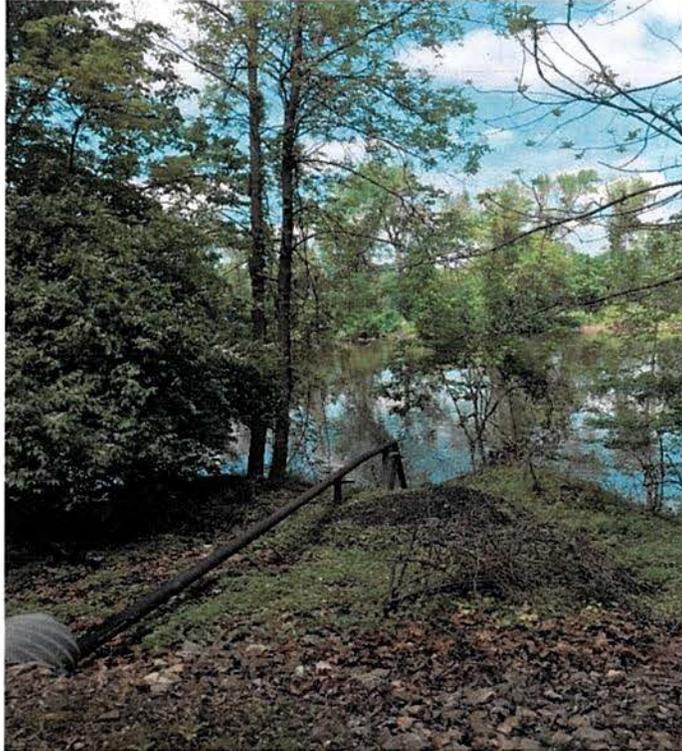
4.	<b>Discharge Structure</b> <input checked="" type="checkbox"/> Functioning <input type="checkbox"/> N/A Remarks <u>Observed discharge pipe in river.</u> _____	
<b>VIII. VERTICAL BARRIER WALLS</b> <input type="checkbox"/> Applicable <input checked="" type="checkbox"/> N/A

Picture 3. Groundwater treatment plant discharge to Schuylkill River

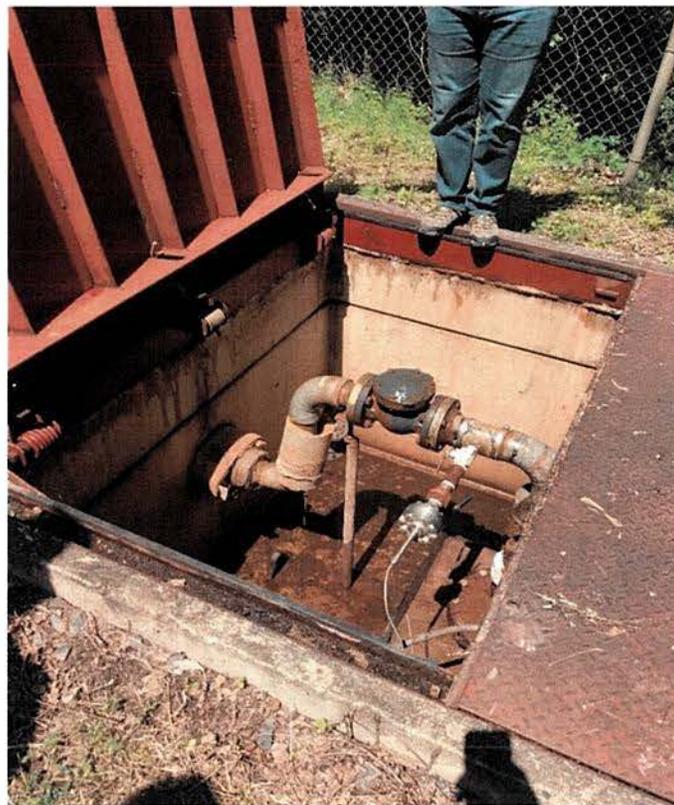
6.	<b>Monitoring Wells</b> (pump and treatment remedy) <input checked="" type="checkbox"/> Properly secured/locked <input checked="" type="checkbox"/> Functioning <input checked="" type="checkbox"/> Routinely sampled <input checked="" type="checkbox"/> Good condition <input checked="" type="checkbox"/> All required wells located <input type="checkbox"/> Needs Maintenance <input type="checkbox"/> N/A Remarks _____ _____
<b>D. Monitoring Data</b>

Picture 4. Monitoring well DB-014

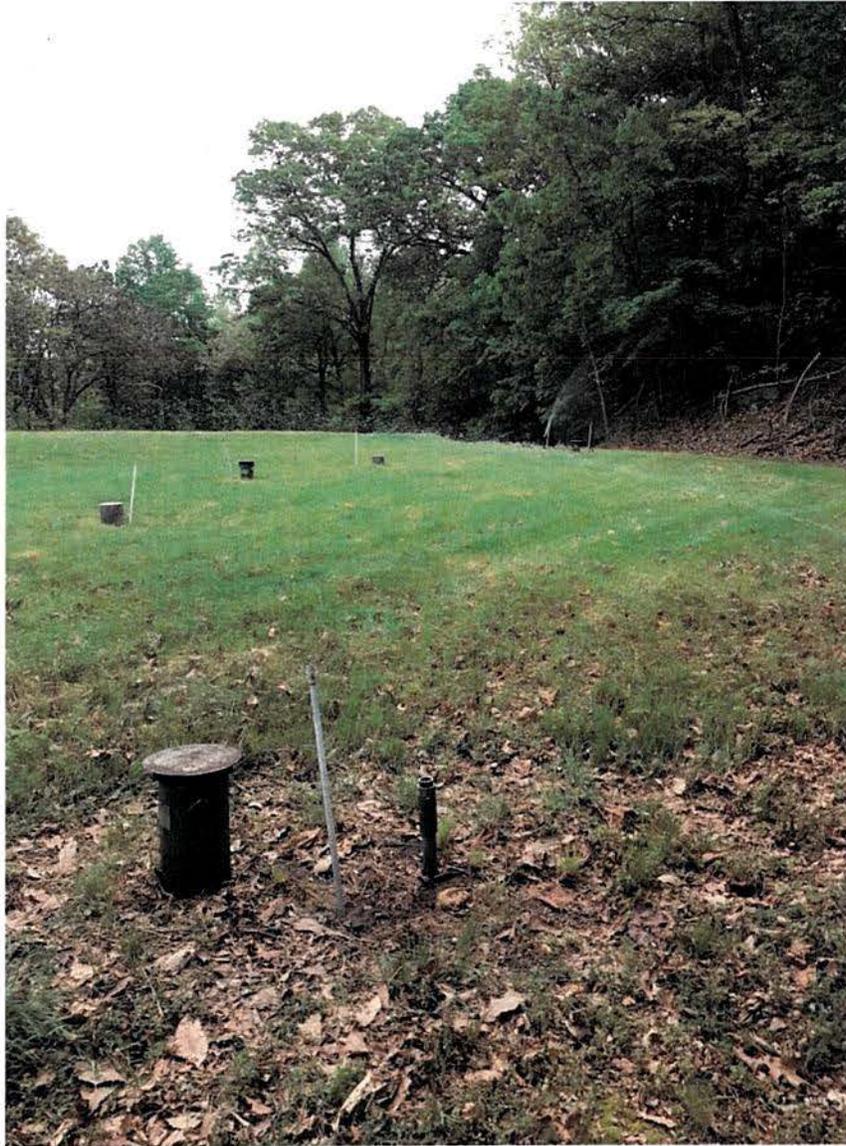
Regular inspections are conducted and samples are collected to monitor performance of the WSCS. The vegetative cover as well as soil erosion and surface water controls are inspected on a weekly basis. The cover is mowed twice a year, and corrective actions are taken to address any issues, such as improper drainage, burrow holes, erosion, ponding, and adverse changes in the soil conditions. Depending on the component, inspections of the irrigation system are conducted at either a weekly or monthly interval. Shallow piezometers are continually controlled by a programmable logic controller (PLC) to monitor the saturated zone thickness. When necessary, the PLC turns on the irrigation system to maintain at least 4 inches of saturated soils on the WSCS.

8.	<b>Wet Areas/Water Damage</b>	<input checked="" type="checkbox"/> Wet areas/water damage not evident	
	<input type="checkbox"/> Wet areas	<input type="checkbox"/> Location shown on site map	Areal extent _____
	<input type="checkbox"/> Ponding	<input type="checkbox"/> Location shown on site map	Areal extent _____
	<input type="checkbox"/> Seeps	<input type="checkbox"/> Location shown on site map	Areal extent _____
	<input type="checkbox"/> Soft subgrade	<input type="checkbox"/> Location shown on site map	Areal extent _____
	Remarks <u>Areas that are supposed to be wet, were adequately wet.</u>

Picture 5. Wet soil cover, Terrace 7, sprinklers operating
