**FOURTH FIVE-YEAR REVIEW REPORT FOR  
RIVER ROAD LANDFILL (WASTE MANAGEMENT, INC.) SUPERFUND SITE  
MERCER COUNTY, PENNSYLVANIA**

**AUGUST 2019**

**U.S. Environmental Protection Agency  
Region 3  
Philadelphia, Pennsylvania**

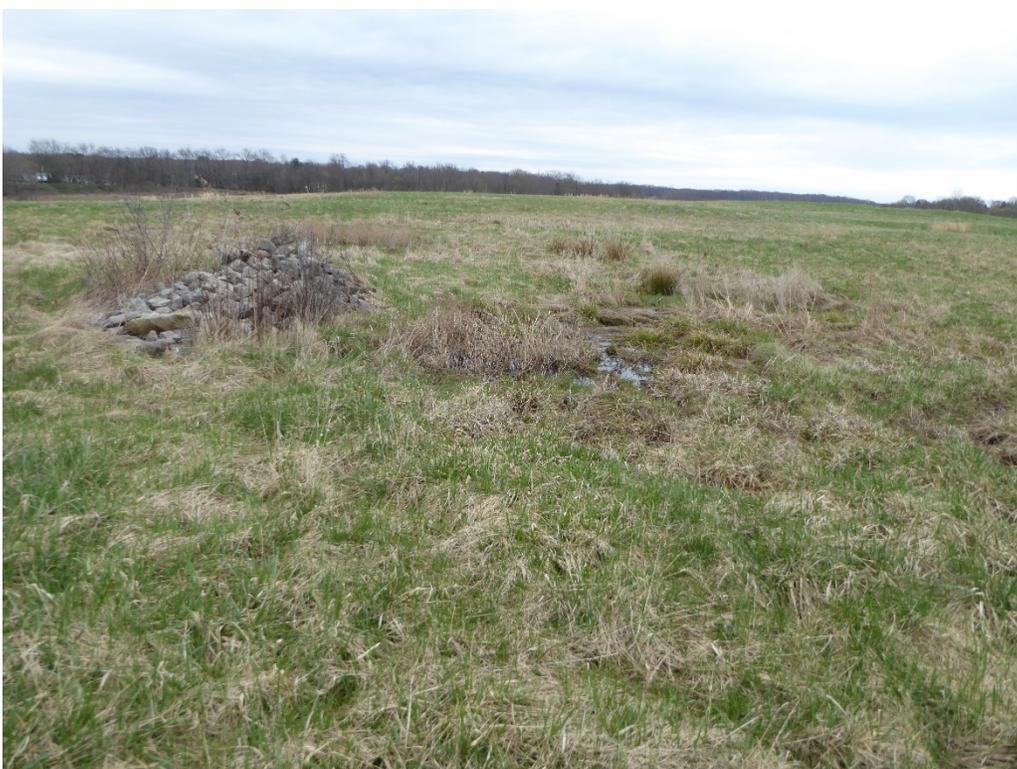
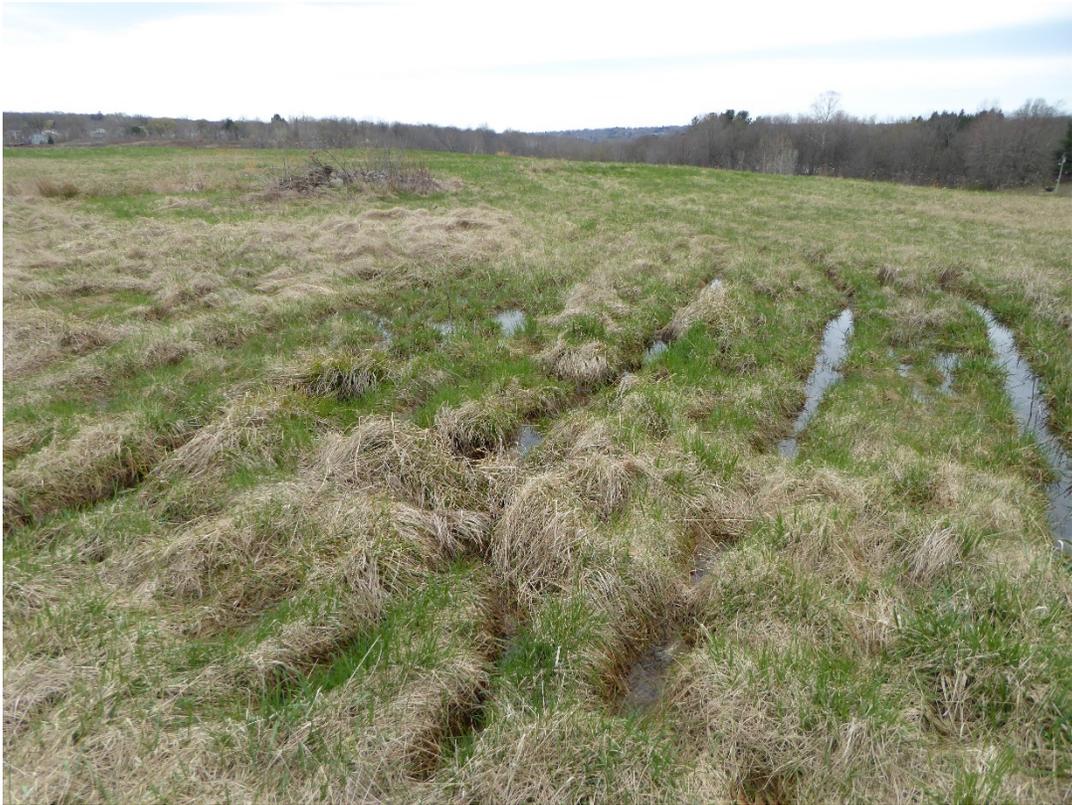
The landfill cap is well vegetated with grass. Site inspection participants observed some ponding on the top of the landfill. No groundhog burrows were observed; however, a few smaller burrows were present. Areas surrounding the landfill mound have shrubs and small trees. Site inspection participants observed birds and signs of deer and beaver on the Site; however, the Site is not actively managed as wildlife habitat. Natural gas production continues to occur at the Site outside the footprint of the landfill.

Ponding on top of landfill

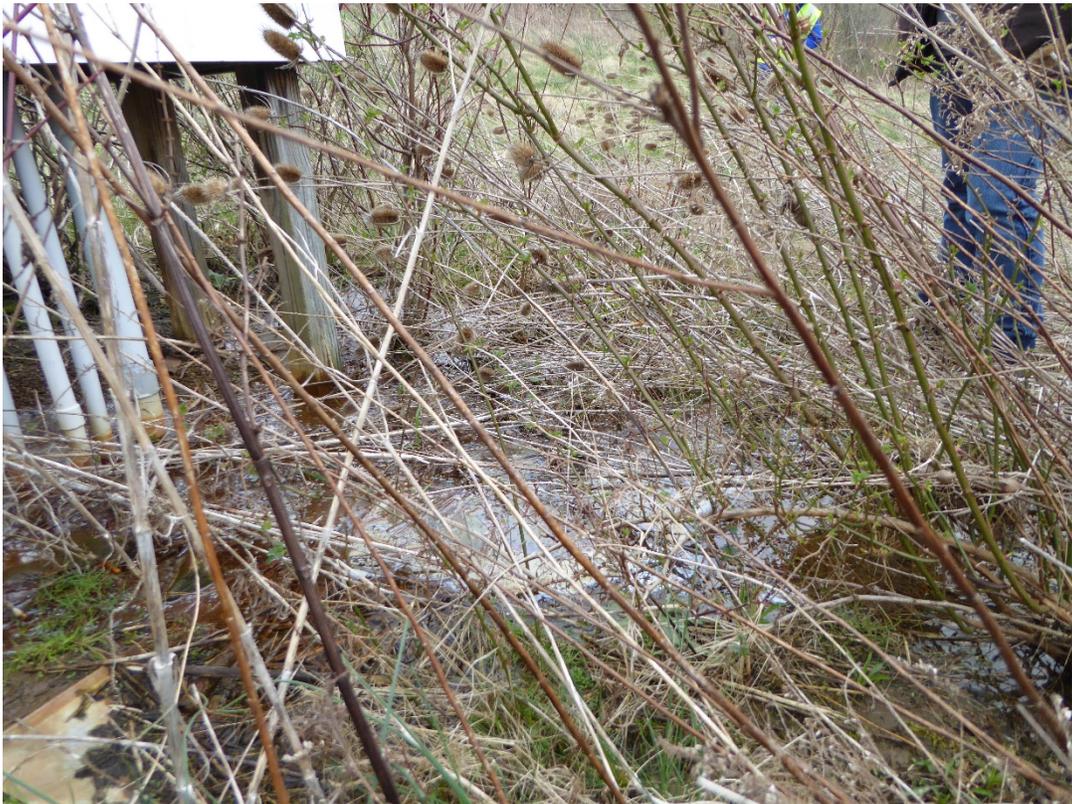
Site inspection participants observed leachate and/or groundwater overflowing from a leachate manhole located northwest of Sedimentation Basin B (LS-2), between the landfill and the Shenango River. An oily sheen was present on puddles next to the manhole and downgradient from the manhole. The adjacent leachate manhole (MH-4) to the west of LS-2 also had leachate and/or groundwater flowing out, leaving an orange stain on the ground. Site inspection participants opened the leachate manhole's lid, that was unlocked, and observed that the water level was at ground level, indicating that there is likely a blockage in the leachate pipeline downgradient of the two overflowing leachate manholes.

Oily sheen on puddles next to overflowing leachate manhole

OU: OU1	<b>Issue Category:</b> Remedy Performance			
	<b>Issue:</b> During the April 2019 FYR site inspection, the groundwater/leachate collection system was overflowing from two manholes, indicating that there is likely a blockage in the leachate pipeline.			
	<b>Recommendation:</b> Clear the leachate pipeline or upgrade the groundwater/leachate collection system in some other way to prevent discharge of leachate onto ground surface. Sample the leachate discharging and underlying soils and address any unacceptable residual contamination.			
<b>Affect Current Protectiveness</b>	<b>Affect Future Protectiveness</b>	<b>Party Responsible</b>	<b>Oversight Party</b>	<b>Milestone Date</b>
No	Yes	PRP	EPA	9/30/2020

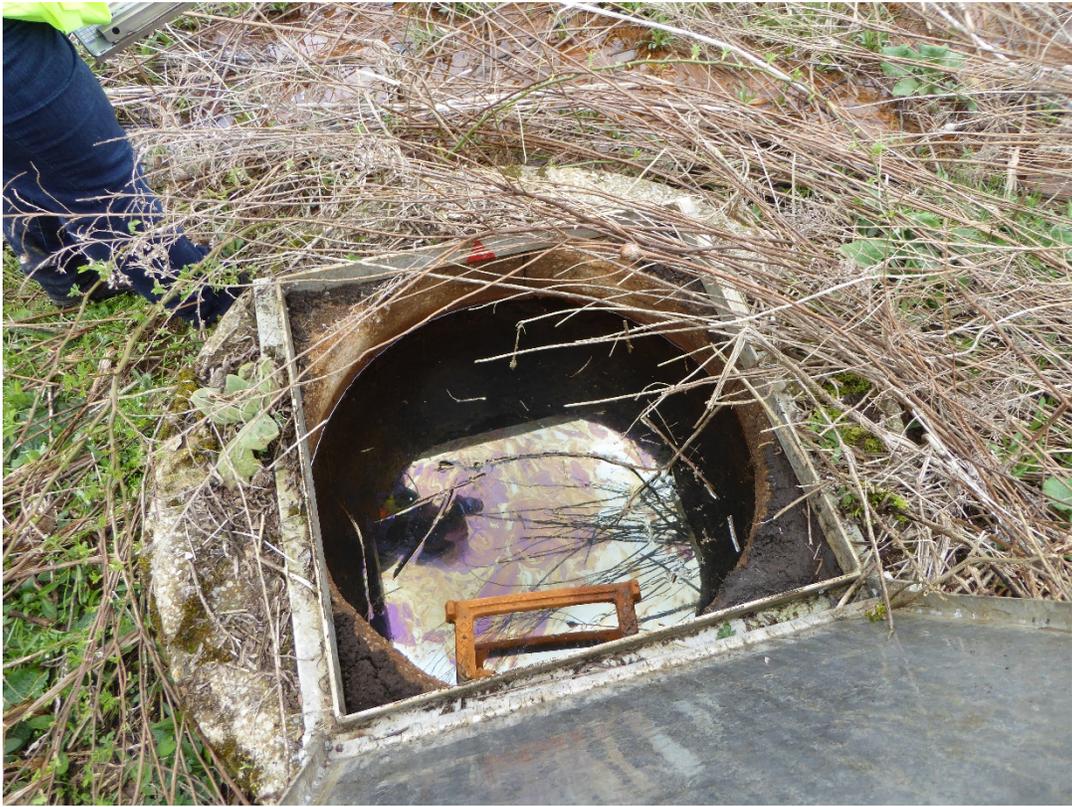
Site inspection participants observed that some leachate manholes are not secured against unauthorized opening, while others cannot be opened due to rusted locks or overgrown vegetation. Monitoring well LH03 was not locked and was recently repaired after being damaged by a mower.

High level of leachate/groundwater in leachate manhole (unlocked)

OU: OU1	<b>Issue Category:</b> Site Access/Security			
	<b>Issue:</b> Some leachate manholes are not secured against unauthorized opening, while others cannot be opened due to rusted locks or overgrown vegetation.			
	<b>Recommendation:</b> Repair and secure all manhole covers.			
<b>Affect Current Protectiveness</b>	<b>Affect Future Protectiveness</b>	<b>Party Responsible</b>	<b>Oversight Party</b>	<b>Milestone Date</b>
No	Yes	PRP	EPA	3/31/2020

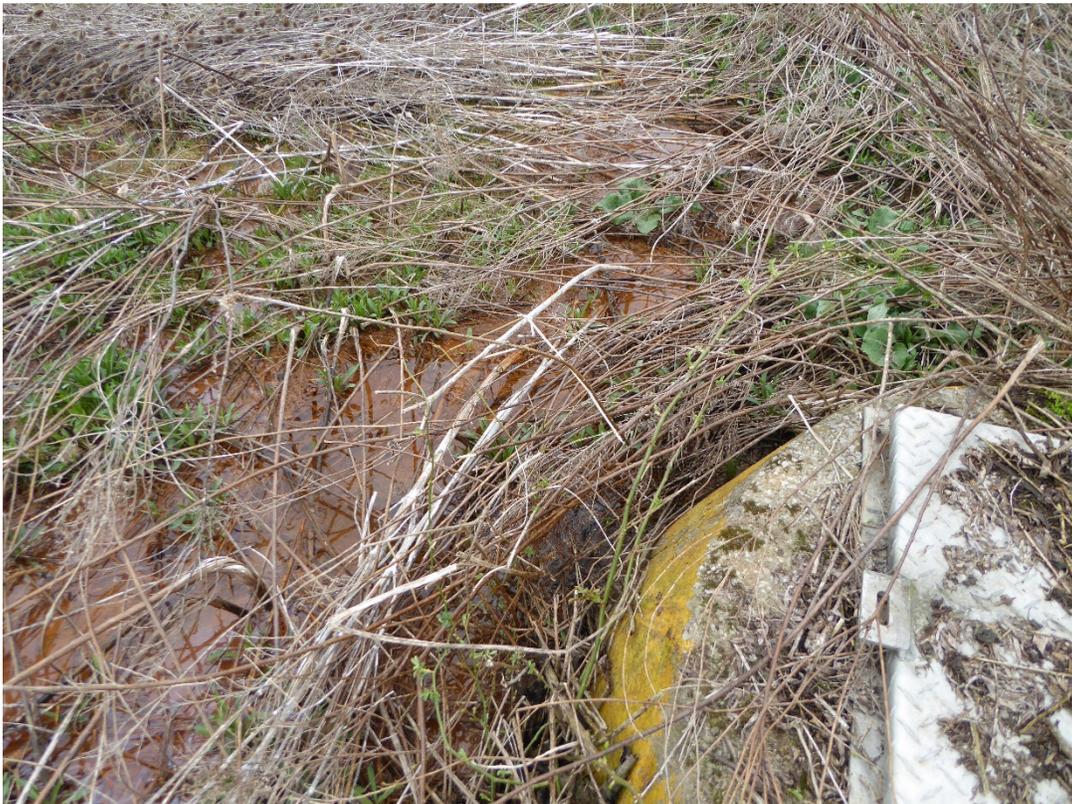
Orange staining adjacent to overflowing leachate manhole

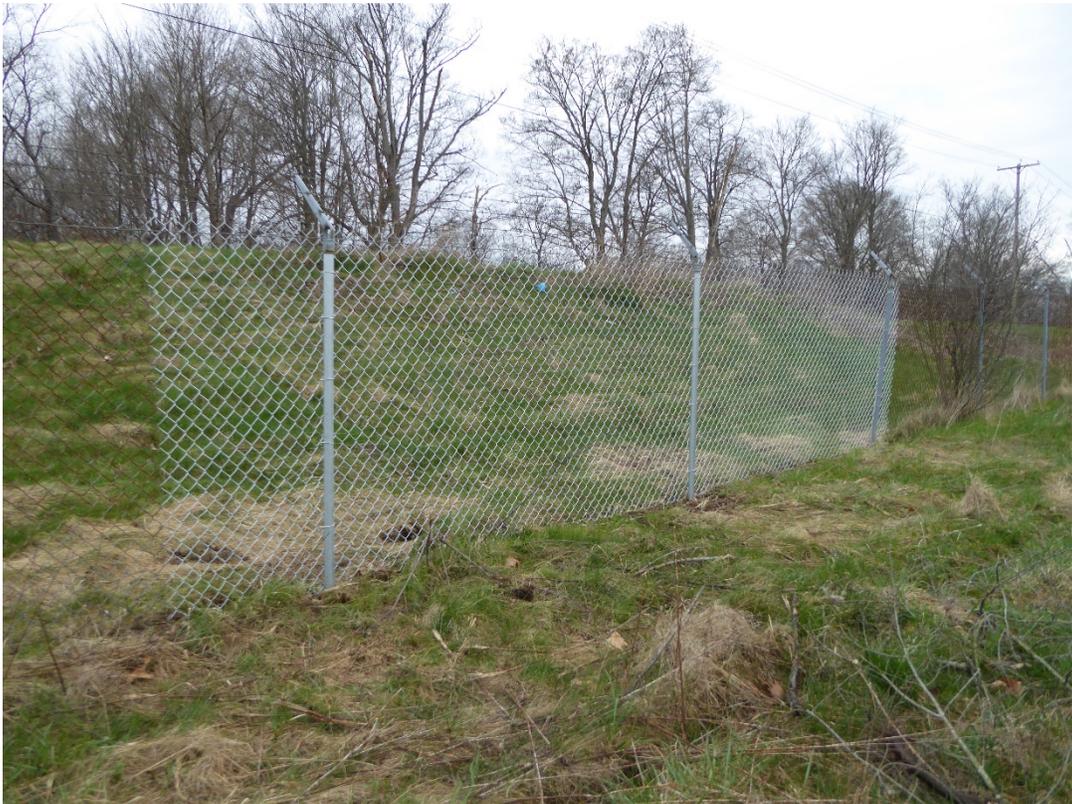
In 2018, a stolen pickup truck was driven through the fence and across the landfill. Site inspection participants observed the abandoned truck stuck in a ditch on the Site. WMPA has repaired the fence in spring 2019. Site inspection participants observed other signs of trespassing, such as a beer can, water bottle, shotgun shell and bullet holes in signs, but no signs of vandalism. Site inspection participants observed one all-terrain vehicle path on the site property but outside the site fence; participants did not see any all-terrain vehicle paths inside the site fence.

Fence repaired after vehicle crashed through it

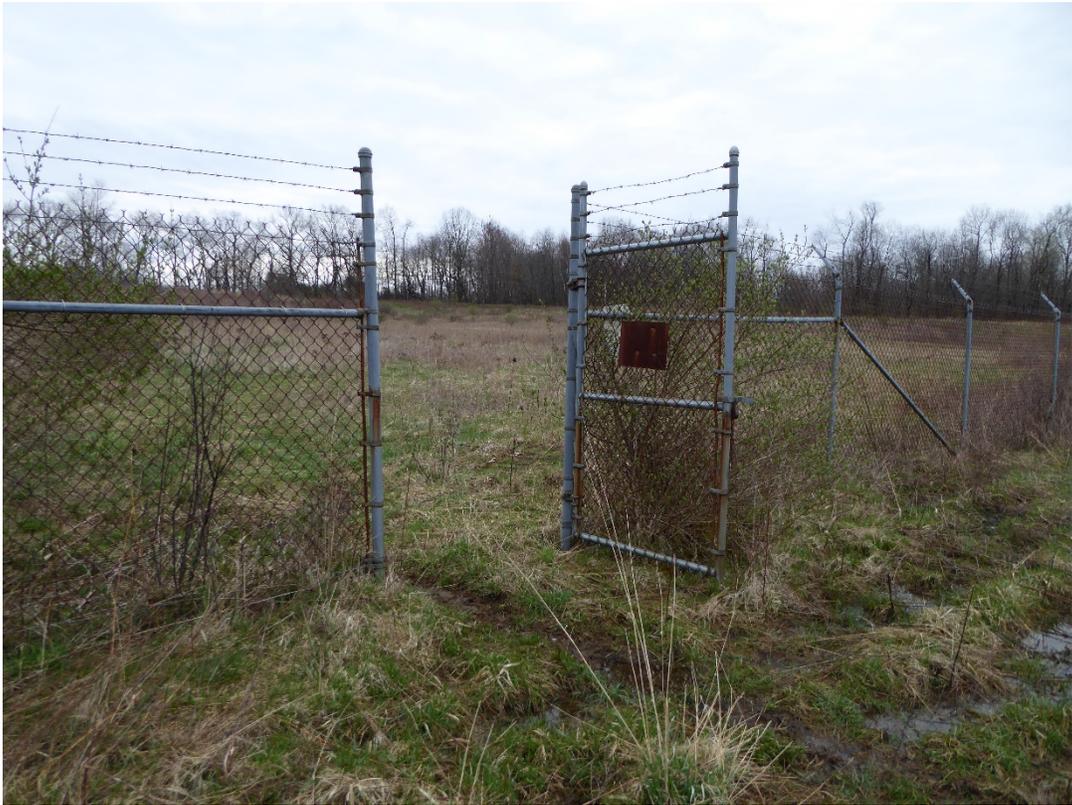
The Site is fenced on all sides, except for the side along the Shenango River. The main access gate is kept locked. Site inspection participants noted that one side gate was not locked and was standing open. The fence has holes

Unlocked side gate

OU: OU1	<b>Issue Category:</b> Site Access/Security			
	<b>Issue:</b> The site fence has several holes, fallen tree limbs, vegetation growing under and through it, an unlocked side gate, and illegible warning signs.			
	<b>Recommendation:</b> Conduct fence maintenance (repair holes, remove down limbs, clear vegetation growing under and through fence, lock gates) and install new signs.			
<b>Affect Current Protectiveness</b>	<b>Affect Future Protectiveness</b>	<b>Party Responsible</b>	<b>Oversight Party</b>	<b>Milestone Date</b>
No	Yes	PRP	EPA	3/31/2020

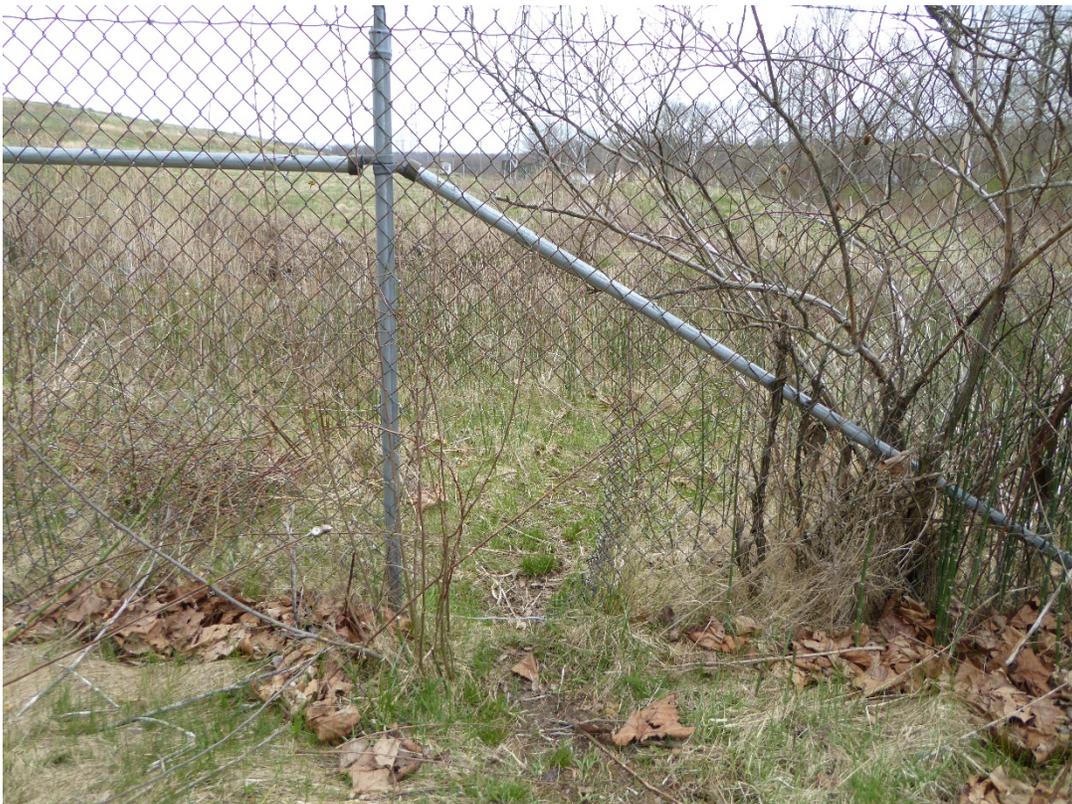
cut in it in various locations. There are also many tree limbs that have fallen onto the fence. Thick vegetation is growing through and adjacent to the fence. Warning signs on the fence are missing or illegible.

One of several holes in fence

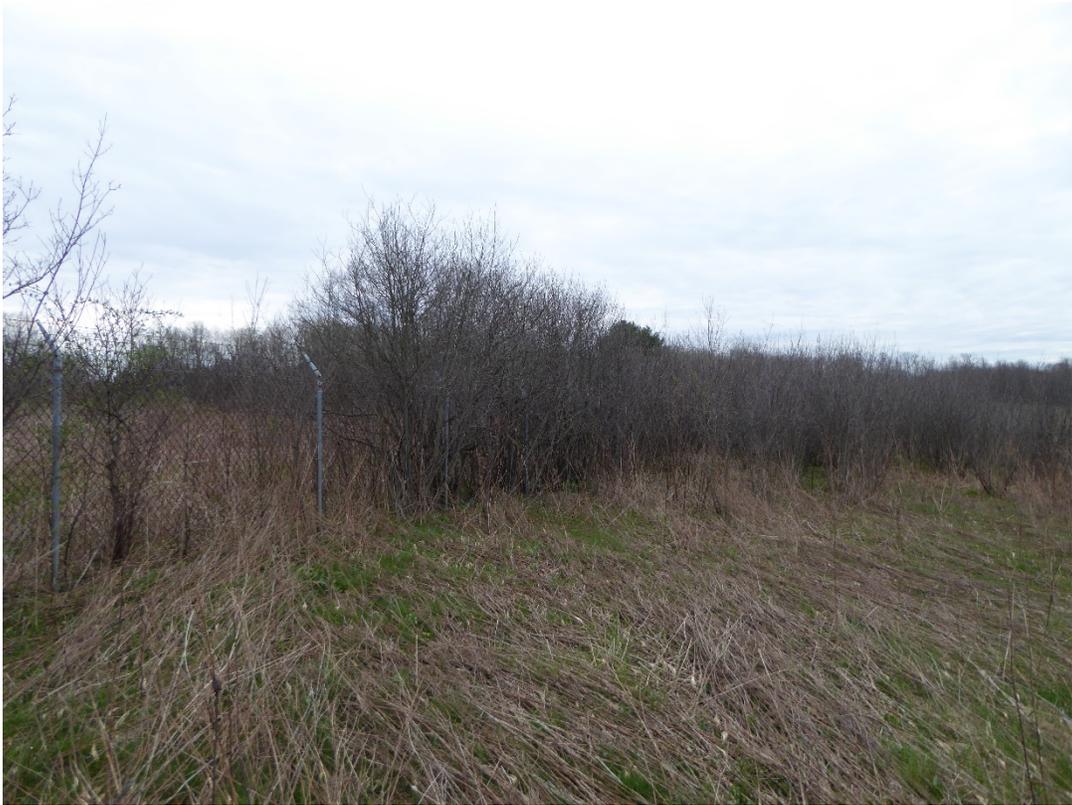
Vegetation growing adjacent and through fence

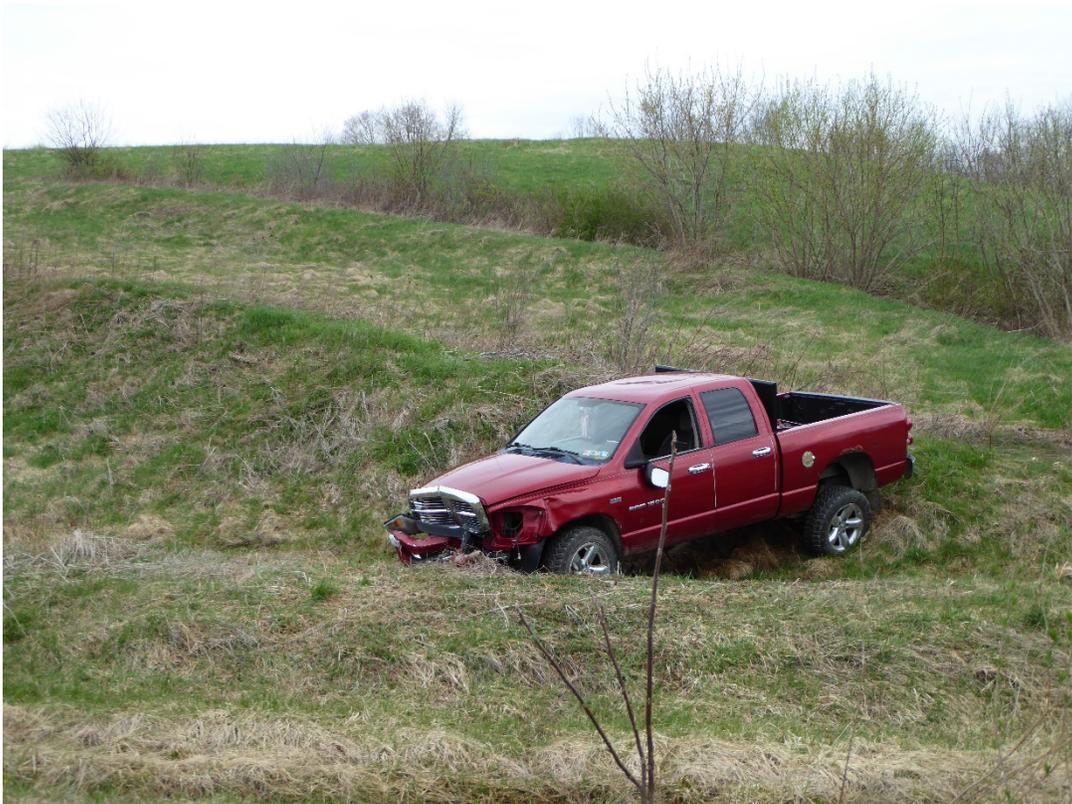
Stolen pickup truck abandoned on site

- WMPA will remove the abandoned pickup truck from the Site.
- In Table 2 of the 2015 Revised Surface Water and Sediment Investigation Work Plan, some of the surface water analytical parameters appear to have missing or incorrect EPA Region 3 BTAG screening levels (e.g., calcium, lead, magnesium, potassium, sodium and pH) or PADEP Chapter 93 Water Quality Standards (e.g., lead, manganese and chloride). EPA recommends that WMPA ensure that correct values are used for future sampling events.

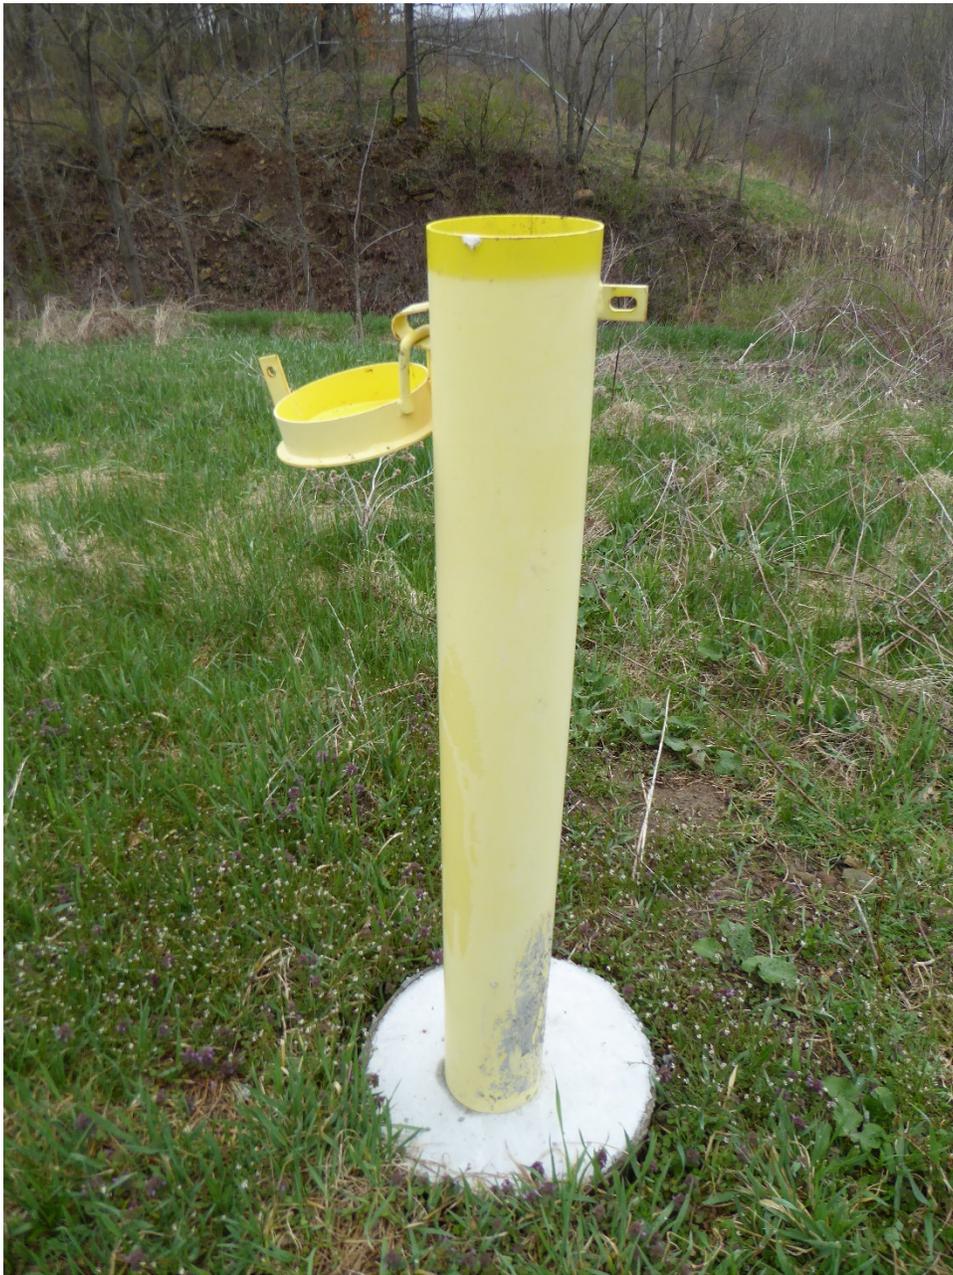
Recently repaired monitoring well LH03 (unlocked)

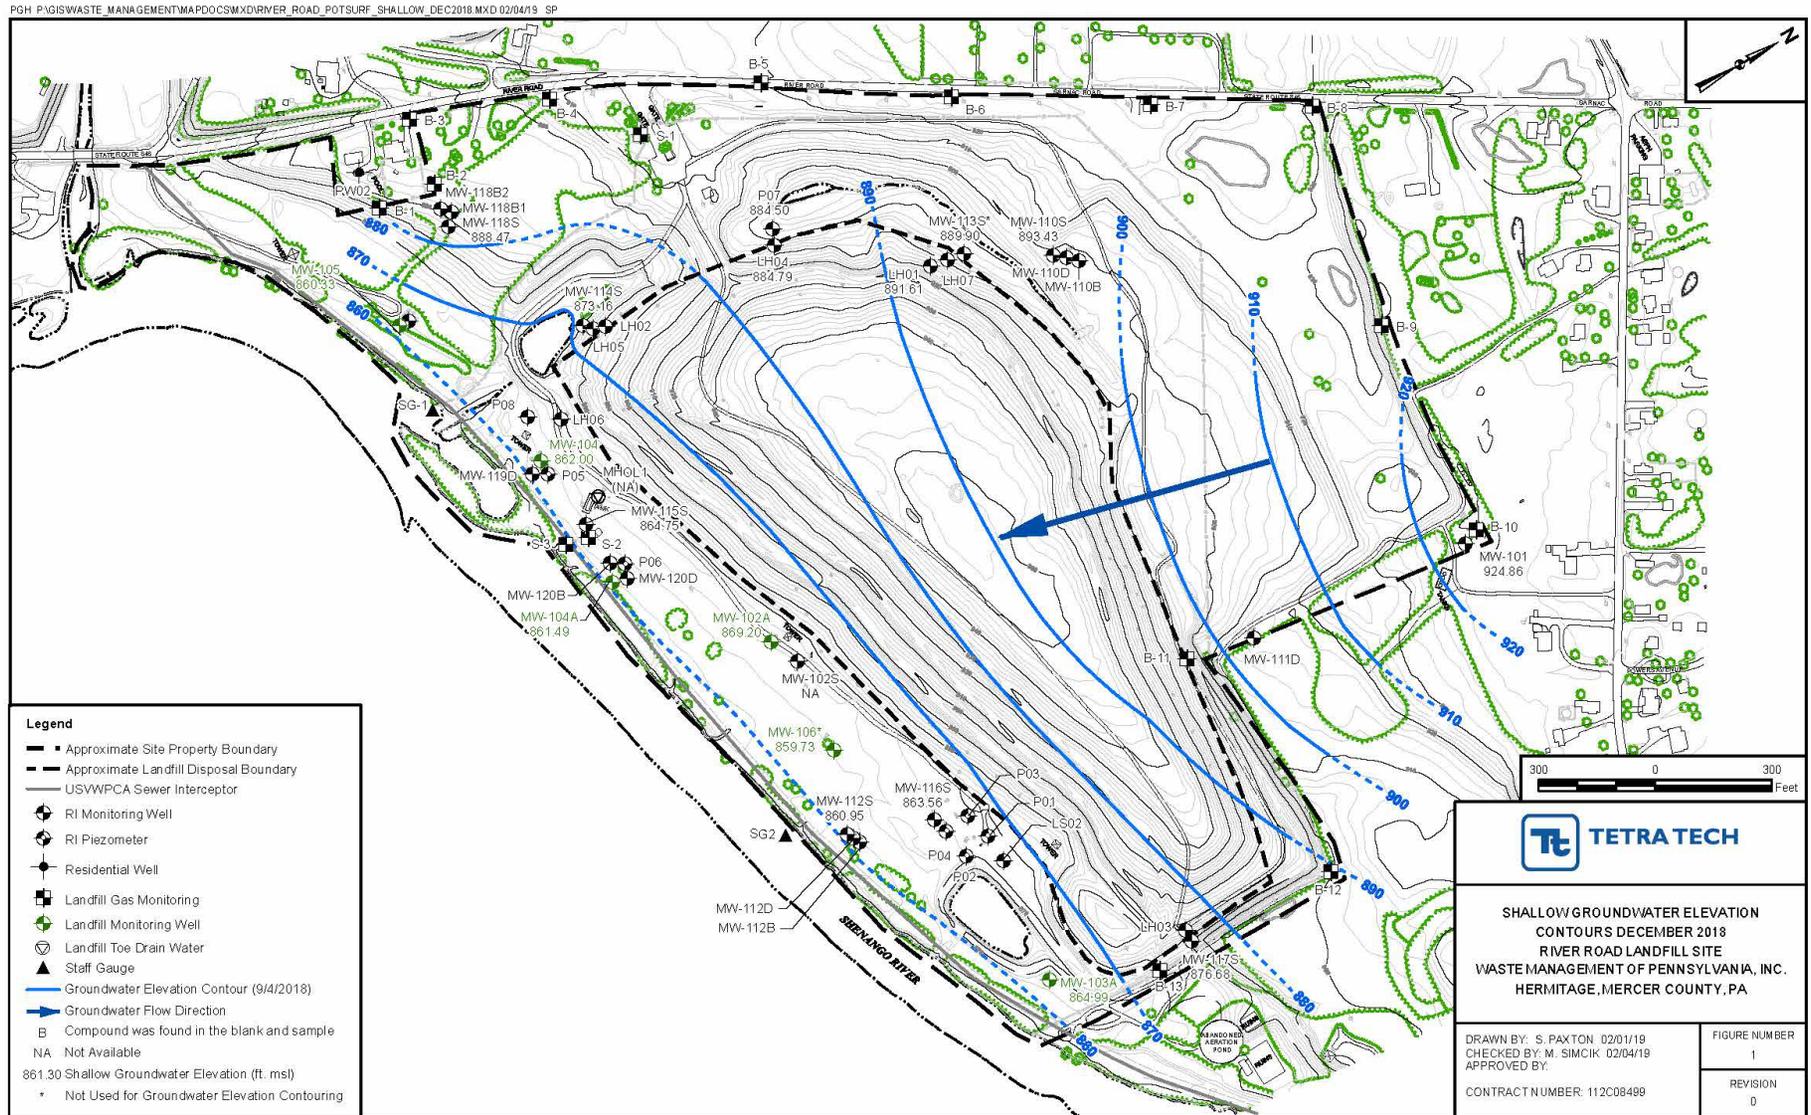
Figure G-1: Shallow Groundwater Elevation Contour Map

Groundwater flow is generally southerly, toward its discharge to the Shenango River (see Figure H-1 in Appendix H for the Site's most recent groundwater contour map). The presence of the leachate collection system causes the formation of a localized flow system. Diversion of shallow groundwater flow into the landfill leachate collection system occurs both upgradient and downgradient of the landfill adjacent to the groundwater dam. Leachate is collected and discharged to the Upper Shenango Valley Water Pollution Control Authority sanitary sewer system and is treated at the City of Sharon's sewage treatment plant.
