**FOURTH FIVE-YEAR REVIEW REPORT FOR
CROSSLEY FARM SUPERFUND SITE
BERKS COUNTY, PENNSYLVANIA**

AUGUST 2019

**U.S. Environmental Protection Agency
Region 3
Philadelphia, Pennsylvania**

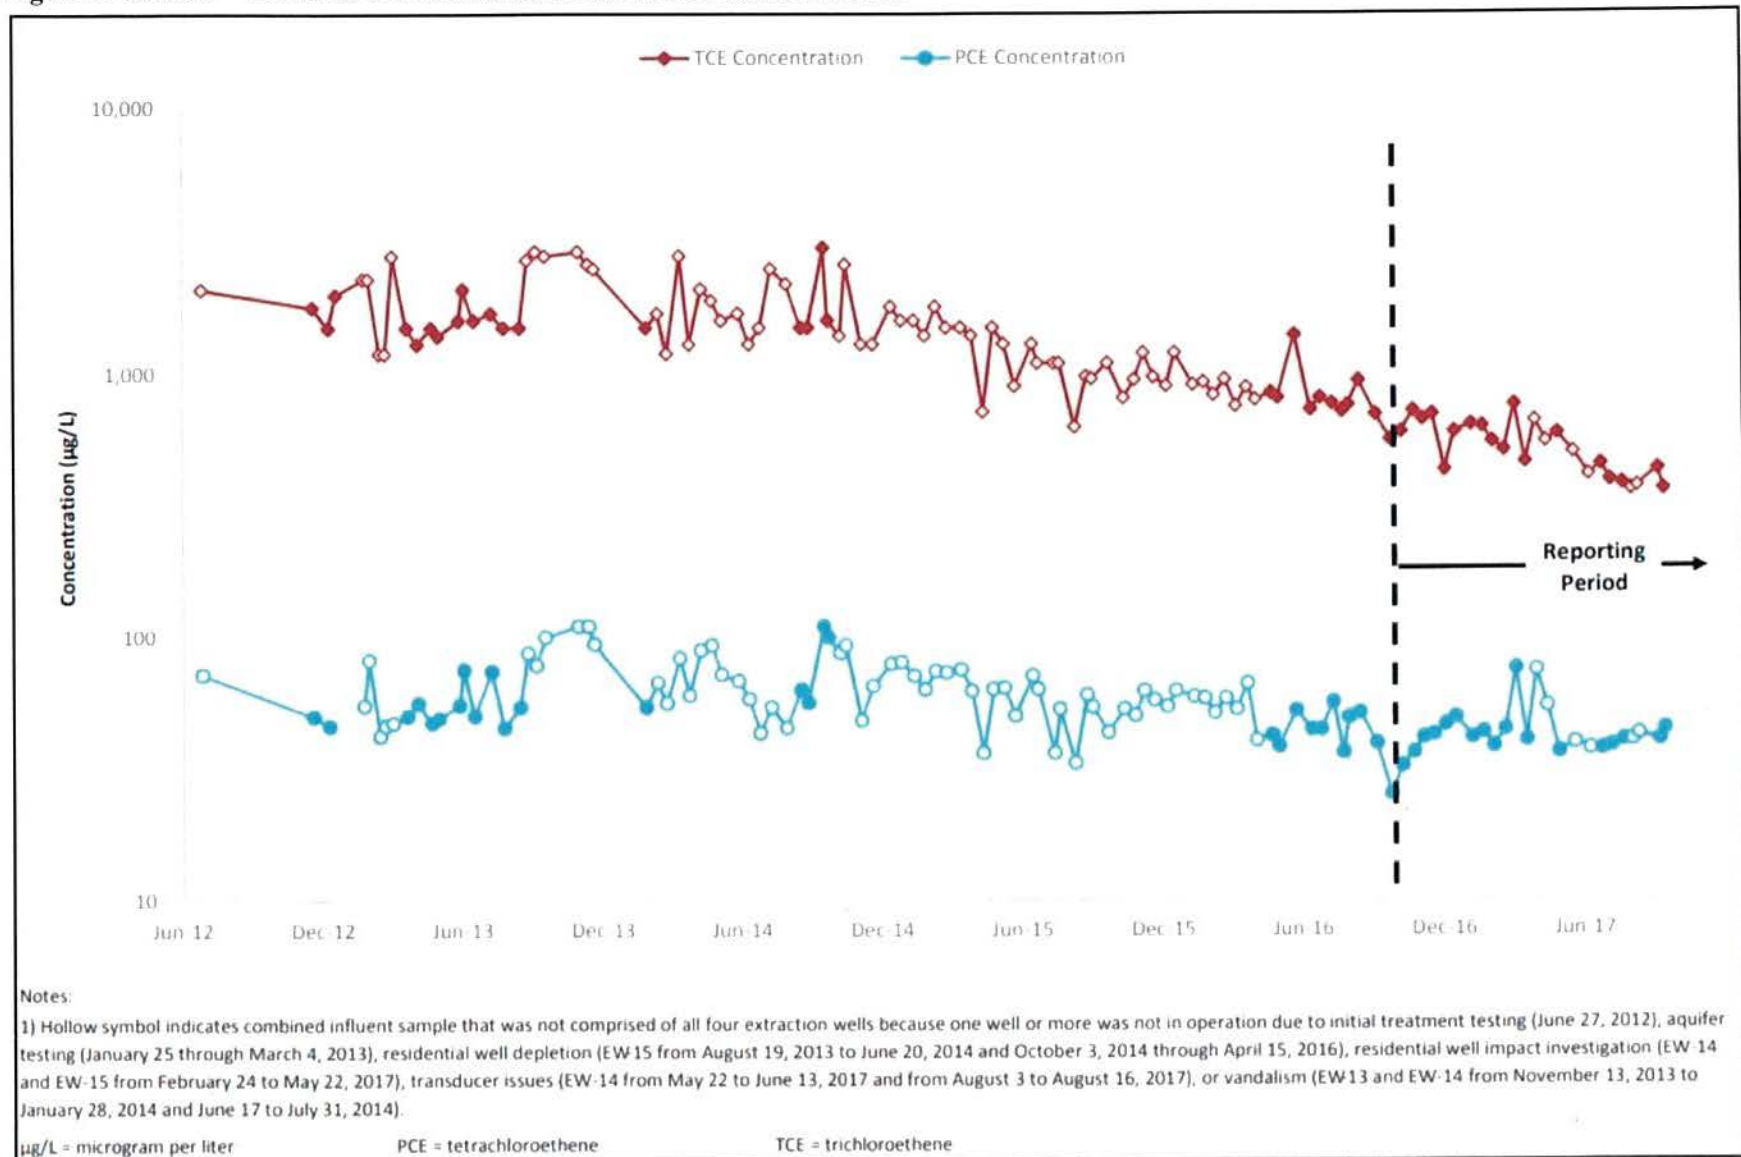
Figure G-3: OU2 – TCE and PCE Concentrations in Combined Influent

TCE and PCE concentrations in the combined influent during FY 2017 ranged from 360 µg/L to 760 µg/L, and an estimated concentration of 32 µg/L to 75 µg/L, respectively, compared to TCE and PCE groundwater cleanup criterion of 5 µg/L. However, cis-1,2-DCE was below its cleanup criterion of 70 µg/L and trichlorofluoromethane (TCFM) was below its current RSL of 520 µg/L (RSL based on a hazard index (HI) of 0.1) in all combined groundwater influent samples during FY 2017. Figure G-3 in Appendix G shows concentrations of TCE and PCE in the combined groundwater influent since October 2012. TCE concentrations in the combined influent have decreased since system startup and PCE concentrations have remained consistent with no considerable increase or decrease in concentration. TCE in the combined influent was measured at 2,100 µg/L at system startup but has decreased to 100 µg/L in October 2018.

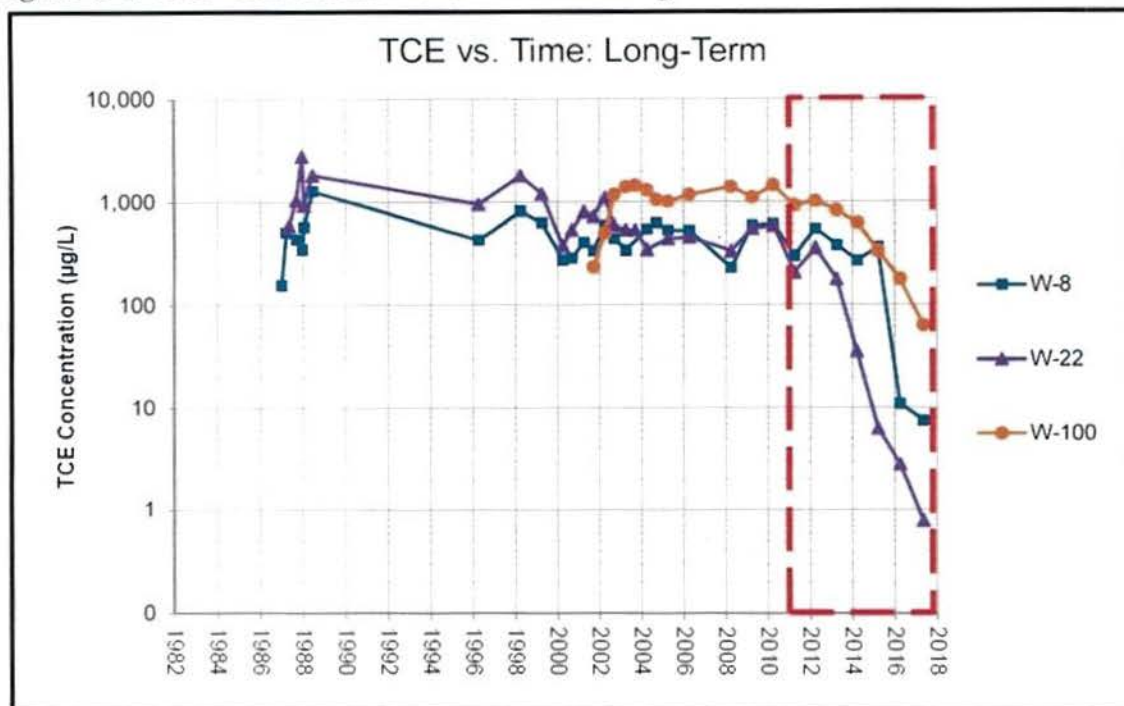
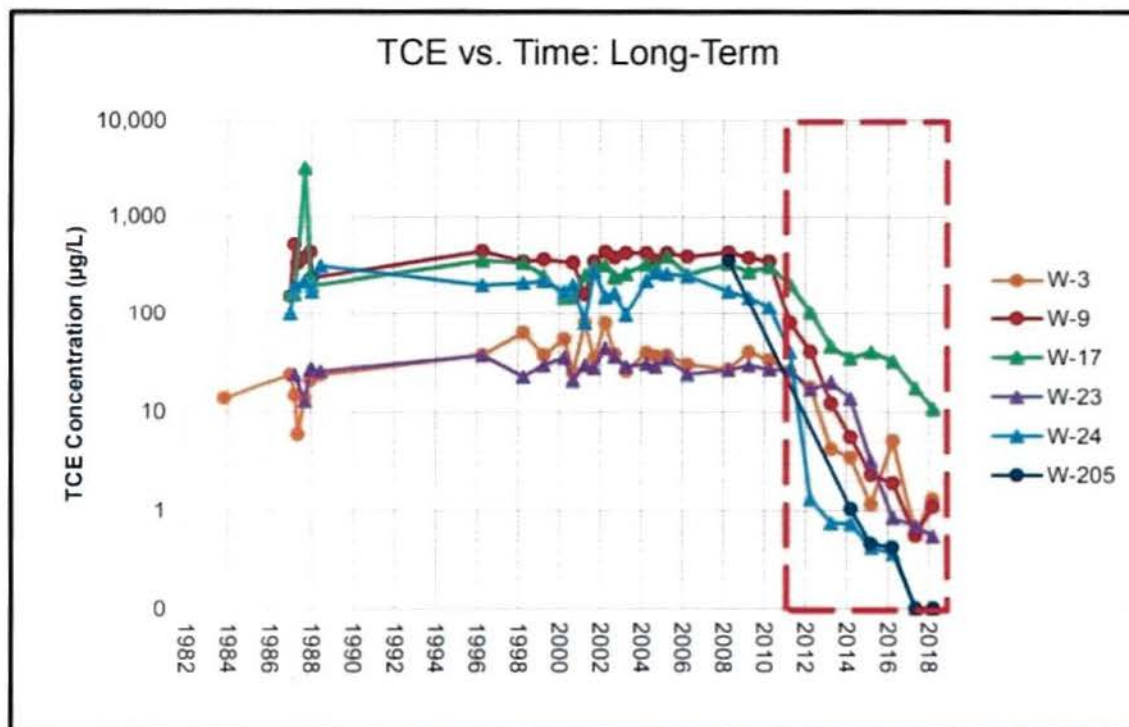
Figure G-7: OU2 – Residential Wells with Decreasing TCE Concentrations

area of the Valley Plume Area extraction wells, have decreased significantly since 2012, as shown in Figure G-7 in Appendix G. Similar decreasing concentration trends were observed for residential wells W-3, W-9, W-17, W-23, W-24 and W-205, located in the southern part of the TCE plume (Figure G-7, Appendix G). Figure G-8 and Figure G-9 in Appendix G show the deep potentiometric surface contours, including the estimated capture of the extraction wells, in October 2016 and March 2017. Additionally, as previously noted, TCE concentrations in the combined influent from all extraction wells has also decreased significantly since the system started (TCE at 2,100 µg/L at system startup decreased to 100 µg/L in October 2018).

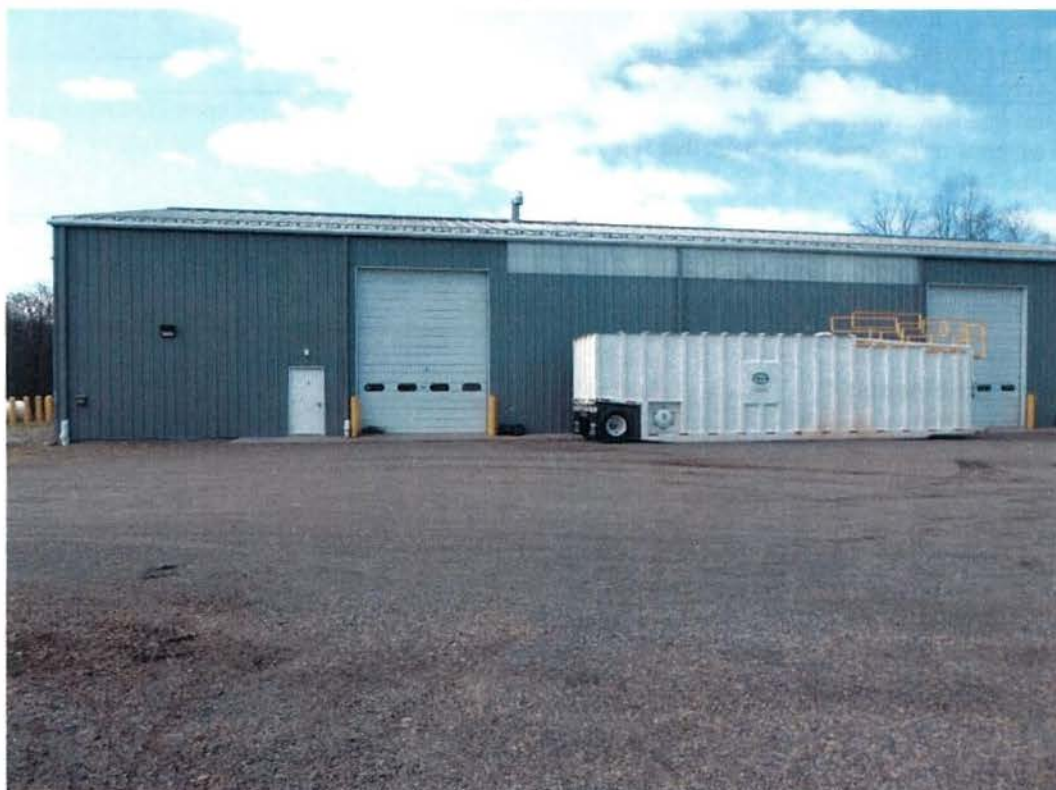
Participants accessed the Site via a gravel road off Huffs Church Road. Site inspection participants began the site inspection at the OU2 groundwater treatment plant. The plant is operating as intended and is in good condition. The plant treats groundwater pumped from four extraction wells along Dale Road. O&M personnel are on site daily to monitor the system. The system can also be monitored remotely. The OU2 contractor indicated that the tank vapor emissions control system was recently modified from a passive system to an active one, to control vapor emissions from the influent tank.

Groundwater treatment building

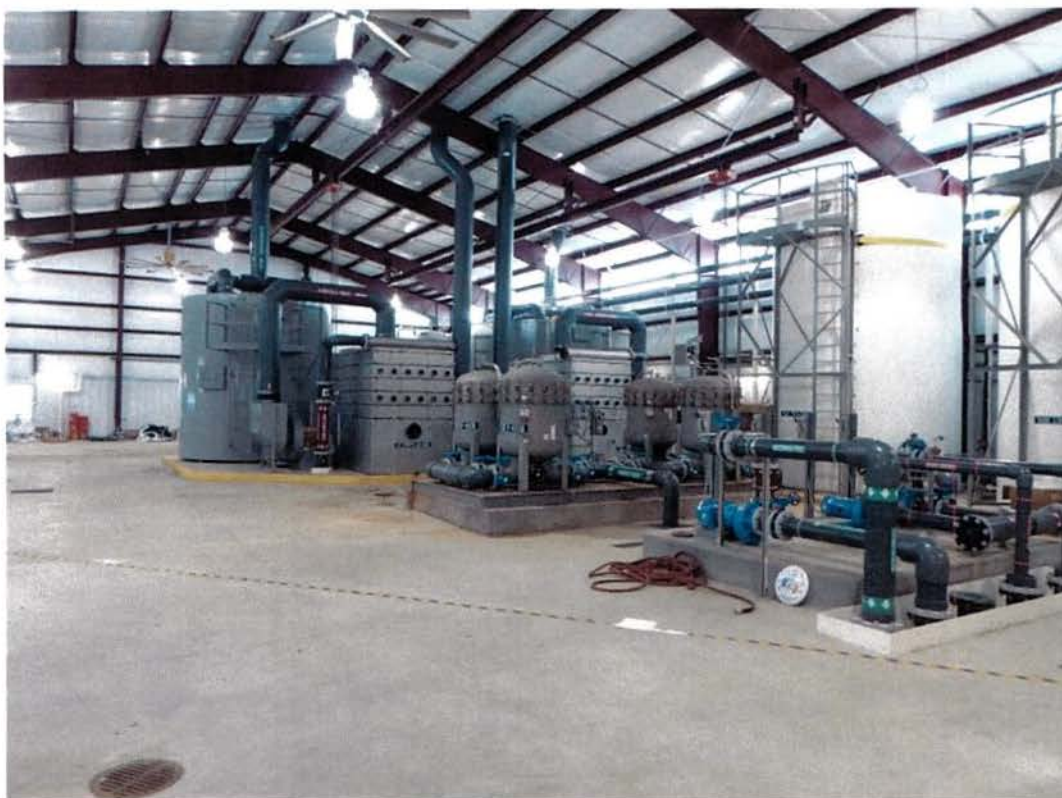
Interior of groundwater treatment building

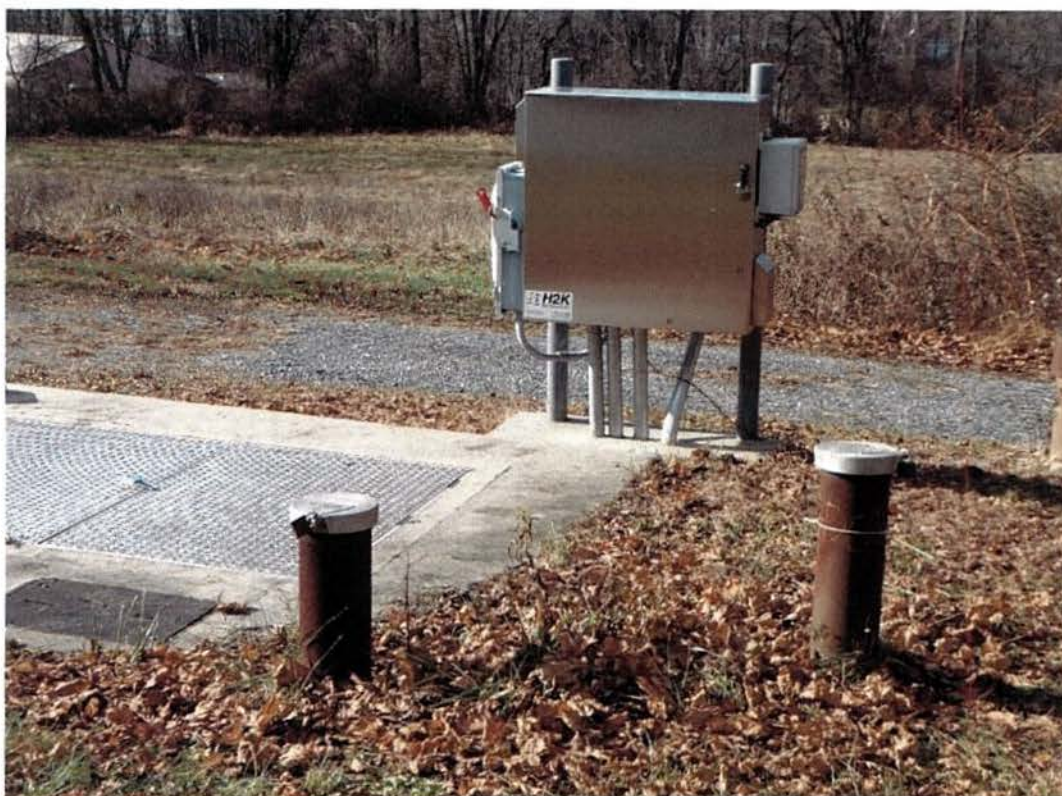
Extraction well

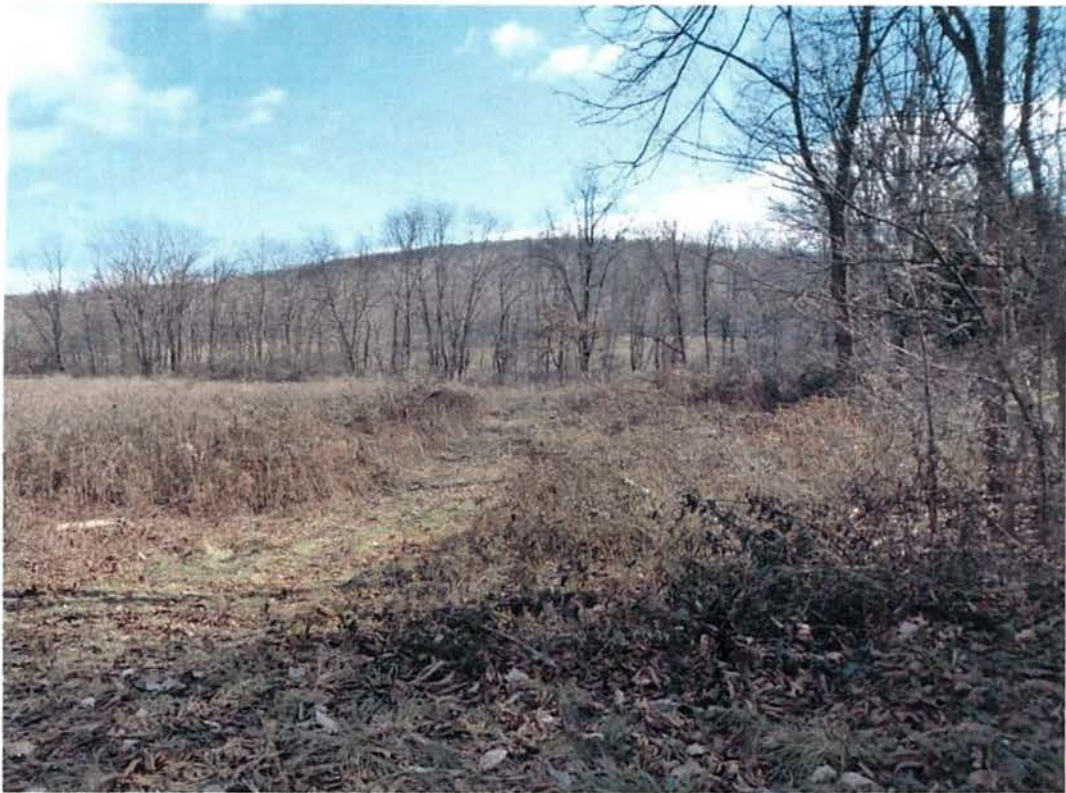
Site inspection participants also drove through the Site and around its perimeter and observed the groundwater Hot Spot Area, Discharge Area 1 located off Dairy Lane and Discharge Area 2 located along Dale Road, as well as extraction wells and monitoring wells across the Site. No issues of concern were noted.

Discharge area 1

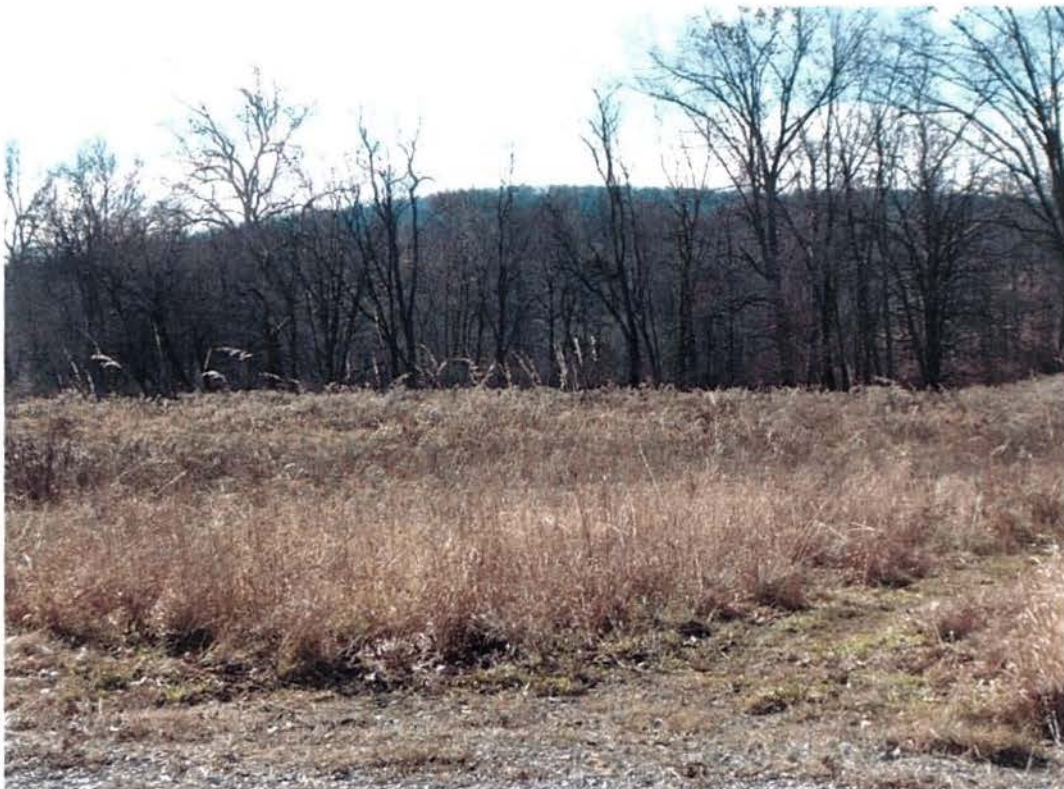
Discharge area 2

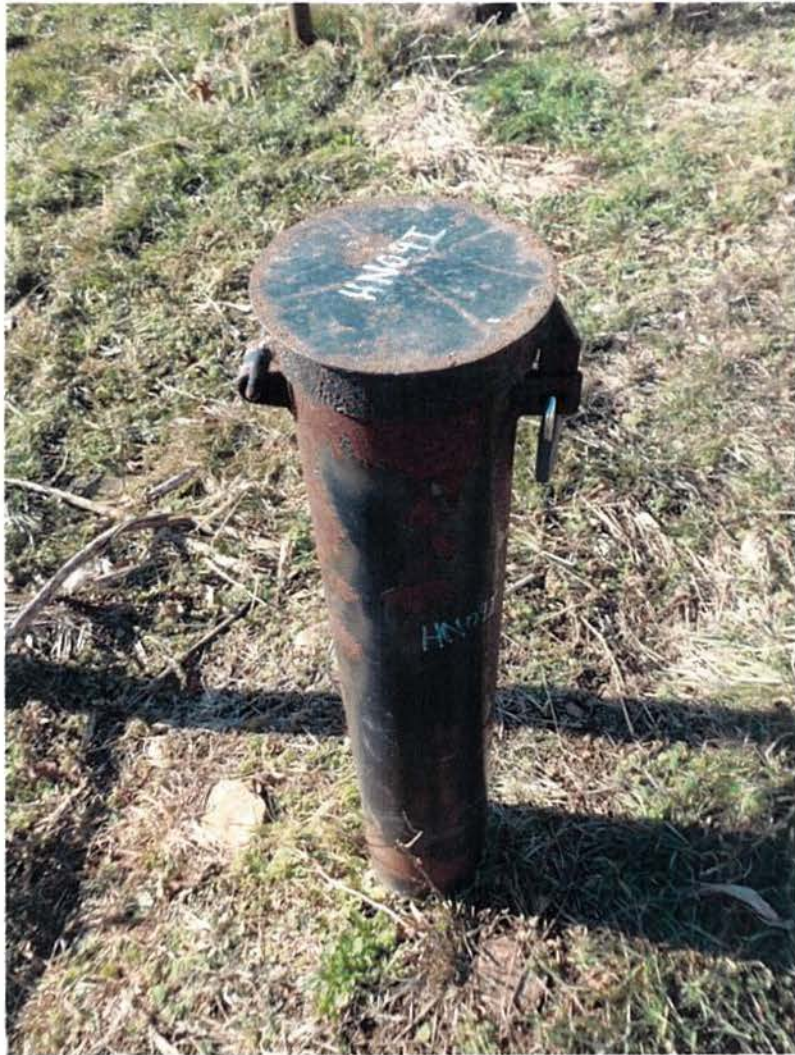
Groundwater monitoring well HN09I
