APPENDIX F

Supplemental Investigation Reports

Peck Property Warehouse, Maintenance and Sheer Building Structural Condition Assessment Portsmouth, Va

Appendix F.2 Asbestos Inspection at Peck Iron Works, 3850 Elm Avenue, Portsmouth, Virginia

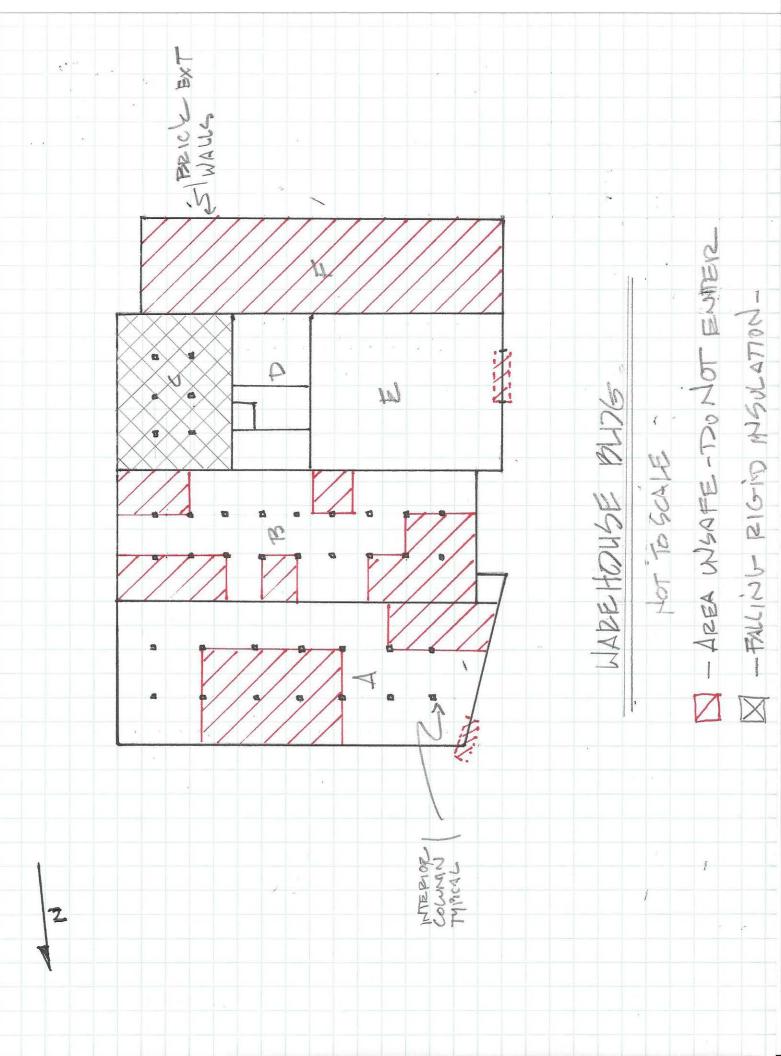
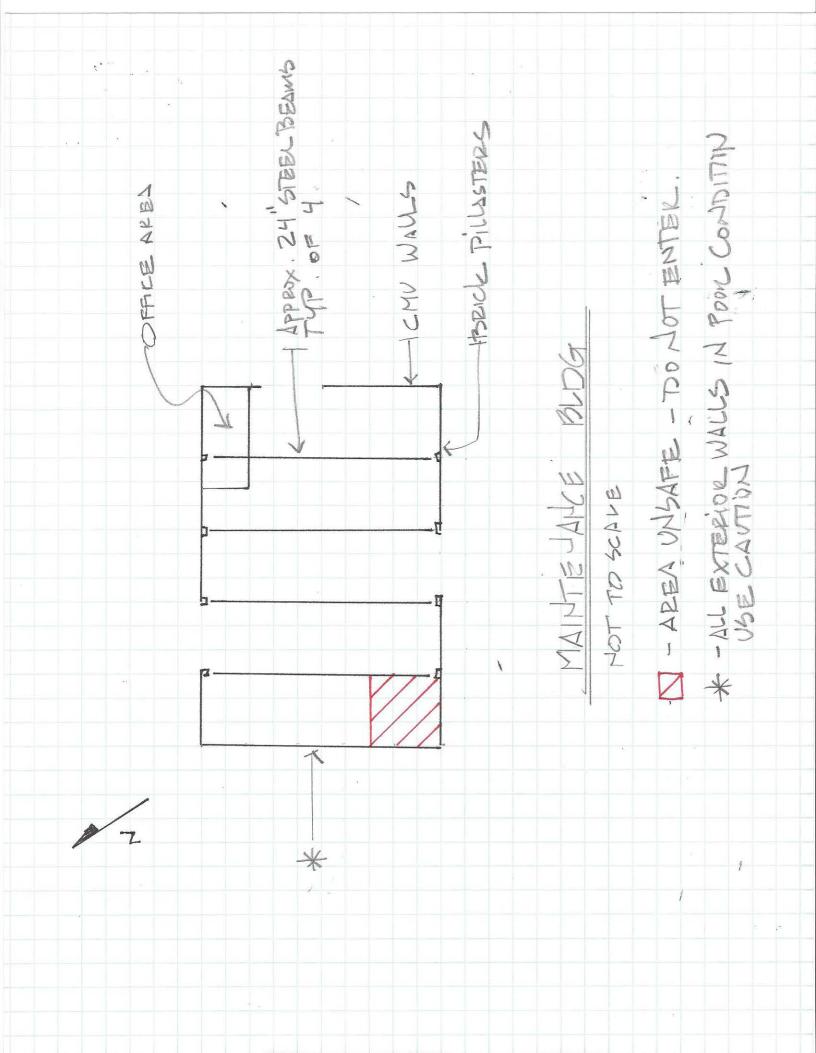
Appendix B - Building Diagrams

The condition varied throughout with some areas already collapsed or ready to collapse with other area in reasonably good condition. In areas A and B the heavy timber framing appeared to have suffered significant termite damage. Approximately 50% of the frame and/or decking had already collapsed or was approaching collapse. The brick on the north-west corner of area A was failing and peeling away from the building. It will collapse shortly which will likely take part of the roof corner with it. The north-west corner of area A should be avoided. Area C appears to be structurally sound, but the plaster and rigid insulation is falling from the roof and beams. Caution should be used while sampling in area C to avoid falling plaster and rigid insulation. Areas D and E appear to be structurally sound for sampling purposes. One note of concern in area E was the large garage door opening. Specifically the opening has been enlarged from its original construction and the lintel has been removed. Consequently the brick above the opening is unsupported. While this area did not appear to be failing, a large section of brick above the opening could collapse at any moment. Personnel should not stand under or near the garage door opening in area E. The heavy timer structure in area F is collapsed or in the process of collapsing. Most of the exterior walls are reasonably sound, though we observed some loose and failing brick. Referring to the building diagram, areas noted in red (single line) cross hatch are off-limits and caution for falling debris should be exercised in area C (noted in gray double-line cross hatch). Please refer to photos at Appendix B for samples of findings.

The exterior walls were in very poor condition. They have significant cracking and some displacement (pushed-in) in several areas, and could easily collapse with little horizontal force. One area of the roof had already started collapsing and other areas are experiencing deterioration. The building is generally sound enough for limited sampling. Due to danger of collapse, the areas hatched in red on the Maintenance Building diagram should be avoided during sampling. Caution should be exercised when standing/sampling near an exterior wall. Referring to the building diagram, areas noted in red (single line) cross hatch are off-limits. Please refer to photos at Appendix B below for samples of findings.

The building is sound enough for limited sampling. As noted above, we did not inspect the roof. The roof appeared sound, as observed from the underside of the roof deck, but even though the roof is readily accessible, we recommend not going on the roof for sampling. There are no areas inside the building or in close proximity to the outside of the building that need to be avoided during sampling. Please refer to photos at Appendix B below for samples of findings.

- 1. Avoid do not enter all areas noted in red (single line) cross hatch on building diagrams.
- 2. Beware of falling material in all areas but particularly in Warehouse Building area C, also noted with gray (double line) cross-hatching.
- 3. Any sampling should also be conducted by a two person team, with one person sampling while the second provides safety oversight.
- 4. Wear proper PPE during any sampling.
- 5. Do not conduct sampling during periods of high wind or storm.

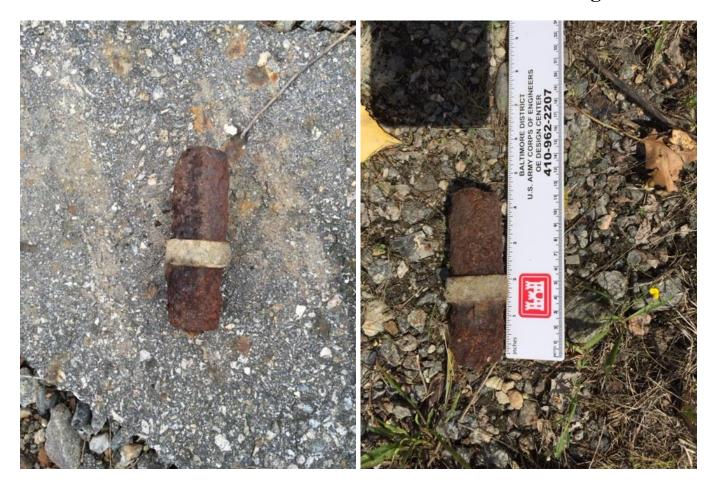
Item Description	/Justi	fication/C	omments:					
One unfired anti-aircraft 40mm projectile, no fuze, interior visible to show no filler.								
Anomaly type categories (Check Appropriate Box)								
☐ MEC	□ A	bandoned	⊠ Scrap ☐ Prac	tice Ordna	ance	☐ Inert Ordnan	се	☐ Metal Waste
Other		lo Find	☐ No Dig ☐ Rus	t Layer				
Was photo taker	າ?	⊠ Yes	□ No	File Name: MD 05June15				
Ordnance Positi	ve Ide	entification	n (If Known, Record E	Below and	d record	fuze condition	on and dis	sposition):
Quantity: 1	Ordna Unkn	ance Mark/N own	Mod: N	lose Fuze	Mark/Mod	d: Tail F	uze Mark/N	lod:
Ordnance Filler:	N/A	☐ Explos	ive Propellant	☐ Pyro	technic	⊠ No Filler	N.E.W.	0
Ordnance Categ	ory:	Munition	s Debris					
Bomb			Guided Missile	□Мо	ortars		☐ Pyrotech	nics and Flares
☐ Cluster/Dispense	er		Land Mine	⊠ Pro	ojectiles		☐ Small Arı	ms
☐ Grenade ☐ Misc. Explosive Device			☐ Ro	ckets		Underwa	ter Ordnance	
Fuzing Types: N	o Fuz	е

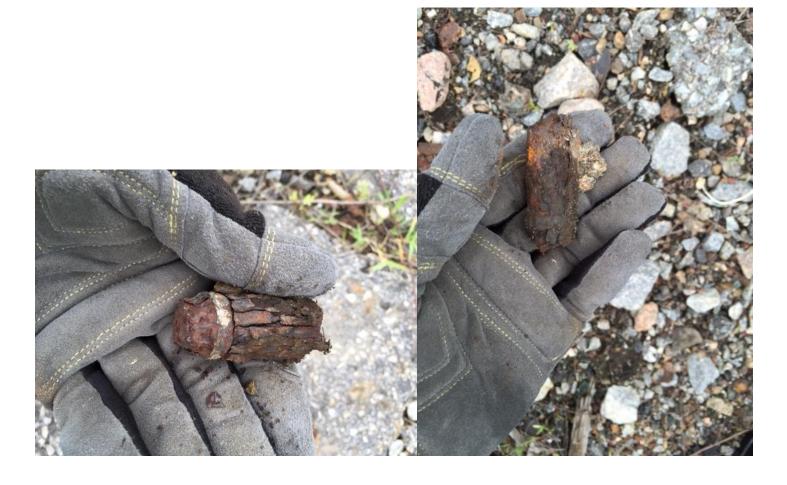
Item Description/Ju	stification/0	Comments:						
Two unfired 20mm projectiles, no filler, interior exposed, no fuzing.								
Anomaly type categ	ories (Ched	k Appropriate Box)						
☐ MEC ☐] Abandoned	⊠ Scrap ☐ Prac	ctice Ordna	ance 🗌 I	nert Ordnance	[Metal Waste	
	No Find	☐ No Dig ☐ Rus						
Was photo taken?	⊠ Yes		File Name: MD 05June15					
Ordnance Positive I	dentificatio	n (If Known, Record E	Below and	d record fuz	ze condition	and dis	position):	
	lnance Mark/ known	Mod: N	lose Fuze	Mark/Mod:	Tail Fuz	e Mark/M	od:	
Ordnance Filler: N/	A ☐ Explo	sive Propellant	☐ Pyrc	technic 🛚	No Filler N.	. E.W.)	
Ordnance Category	: Munitio	ns Debris						
Bomb		Guided Missile		ortars		•	nics and Flares	
☐ Cluster/Dispenser		Land Mine		ojectiles		Small Arn		
☐ Grenade ☐ Misc. Explosive Device			Ro	ckets		Underwat	er Ordnance	
Fuzing Types: No F	uze							
☐ All-ways Acting ☐ Base Detonating ☐			□Influenc	е	□Electric		□Impact

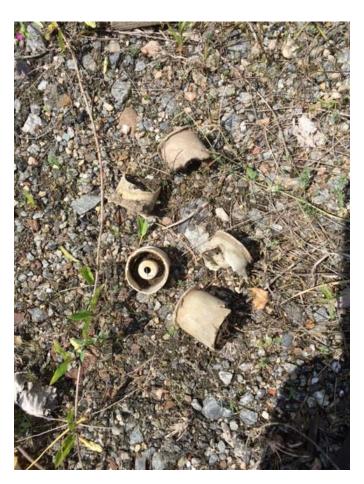
Item Description/Jus	stification/C	Comments:	•				
Six fired 40mm projectile casings, no filler, interior exposed.							
Anomaly type categories (Check Appropriate Box)							
	Abandoned	_ · _	tice Ordna			☐ Metal Waste	
	No Find	☐ No Dig ☐ Rust		☐ Dig Aban	doned	☐ Target >4 ft	
Was photo taken?	⊠ Yes		File Name				
Ordnance Positive Id	dentificatio	n (If Known, Record B	selow and	d record fuze cond	lition and dis	sposition):	
	nance Mark/l k nown	Mod: N	lose Fuze I	Mark/Mod: Ta	ail Fuze Mark/N	Mod:	
Ordnance Filler: N/A	∟ □ Explo	sive	☐ Pyro	technic 🛛 No Fille	er N.E.W.	0	
Ordnance Category:	Munition	ns Debris					
Bomb		Guided Missile		ortars	•	nics and Flares	
☐ Cluster/Dispenser		Land Mine		ojectiles	☐ Small Ar		
☐ Grenade ☐ Misc. Explosive Device				ockets	Underwa	ter Ordnance	
Fuzing Types: No Fu	Fuzing Types: No Fuze						
☐ All-ways Acting ☐ Base Detonating ☐			□Influence	_	lectric	☐Impact	
☐Mechanical Time ☐Mechanical long delay [☐MT Supe	-	iezoelectric	☐Point Detonating (PD)
