**FOURTH FIVE-YEAR REVIEW REPORT FOR  
MODERN SANITATION LANDFILL SUPERFUND SITE  
WINDSOR AND LOWER WINDSOR TOWNSHIPS  
YORK COUNTY, PENNSYLVANIA**

**FEBRUARY 2020**

**U.S. Environmental Protection Agency  
Region 3  
Philadelphia, Pennsylvania**

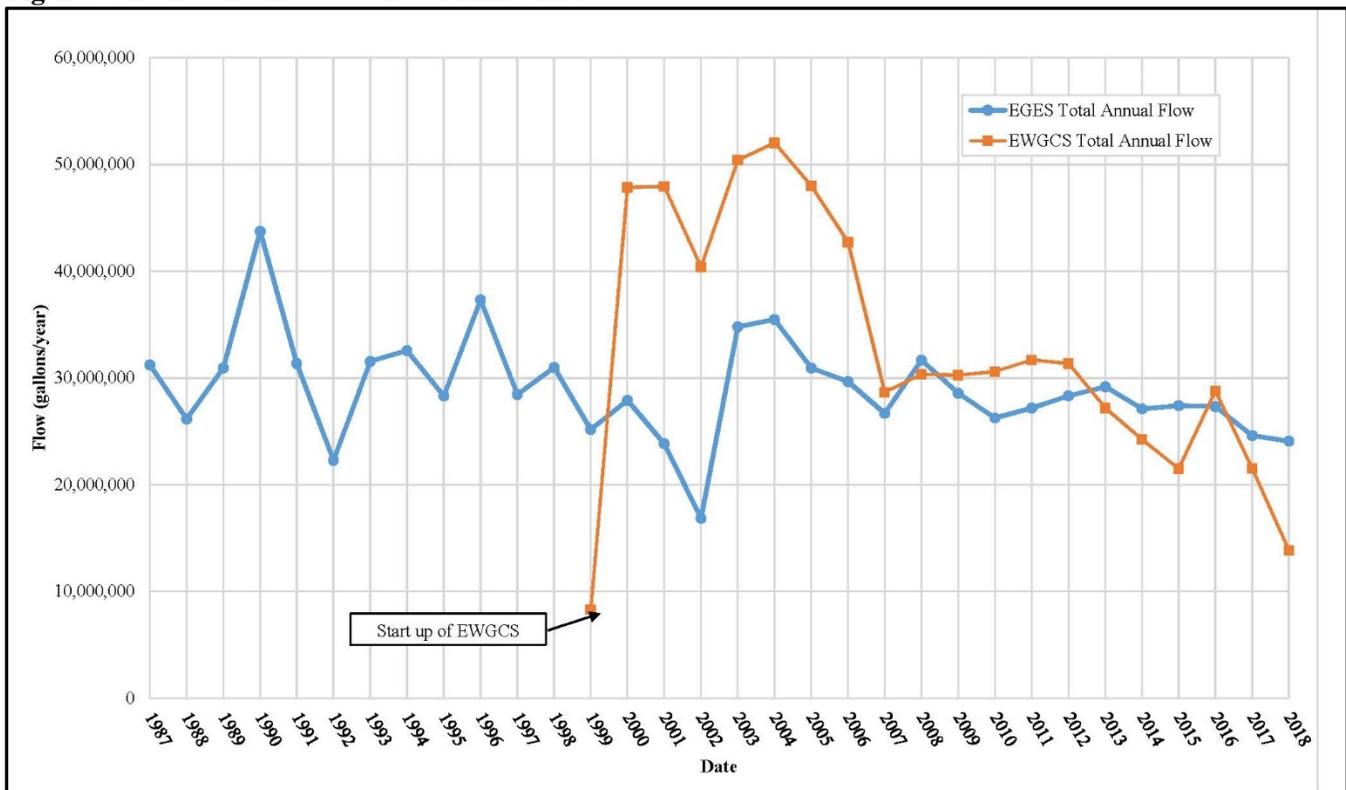
**Figure 4: EGES and EWGCS Total Annual Flow**

Figures 4 and 5 present graphs of the annual flow volumes from the extraction wells. Figure 4 depicts the flows from the EGES system since its start up in 1987 as well as the flows from the four new EWGCS wells since their startup in 1999. Figure 5 depicts total flow volumes from the combined two systems and shows a decline in flow since 2004. As depicted on Figure 4, most of the decline in flow volume is associated with the EWGCS. Reduced flow from the EWGCS is largely attributed to the development of the lined disposal cells over top of the western groundwater collection area that has resulted in the elimination of surface recharge to the capture area of the western system.

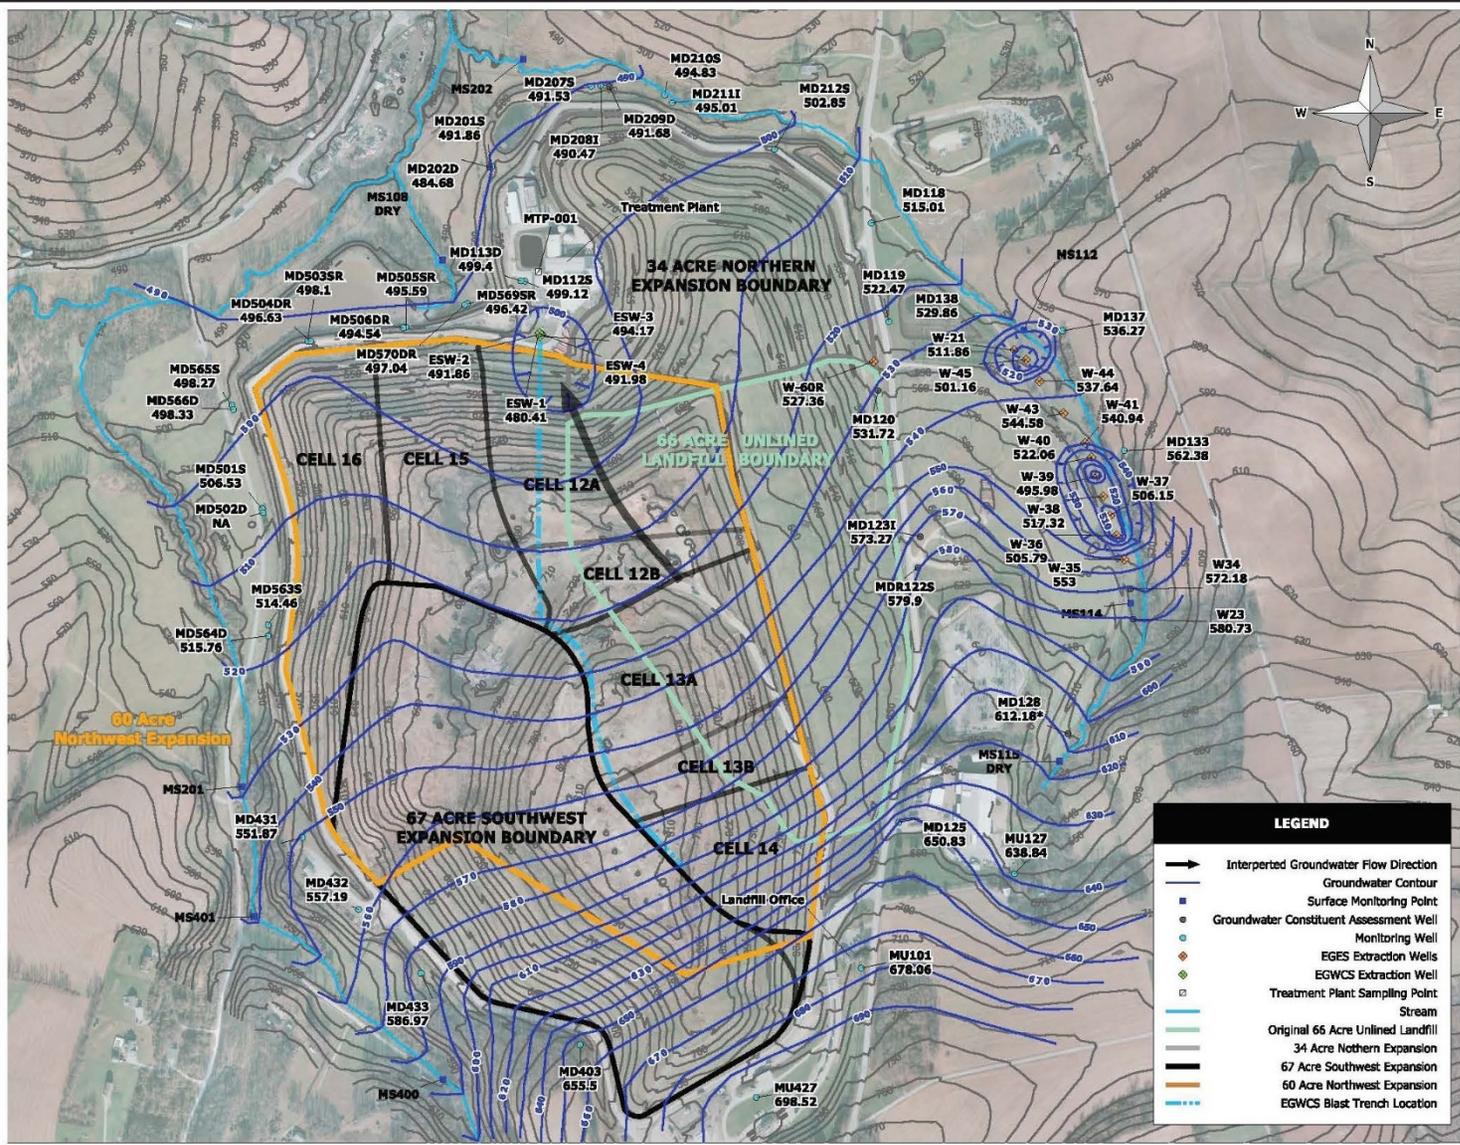
Figure 6: Groundwater Contour Map -2018

The groundwater level and flow pattern at Modern Landfill demonstrates that groundwater is effectively intercepted by the EGES and the EWGES. The interpreted groundwater contour map for August 2018 is presented on Figure 6. There is little change in the groundwater contours from the September 2013 groundwater contour map (previous FYR Report) to the August 2018 map.

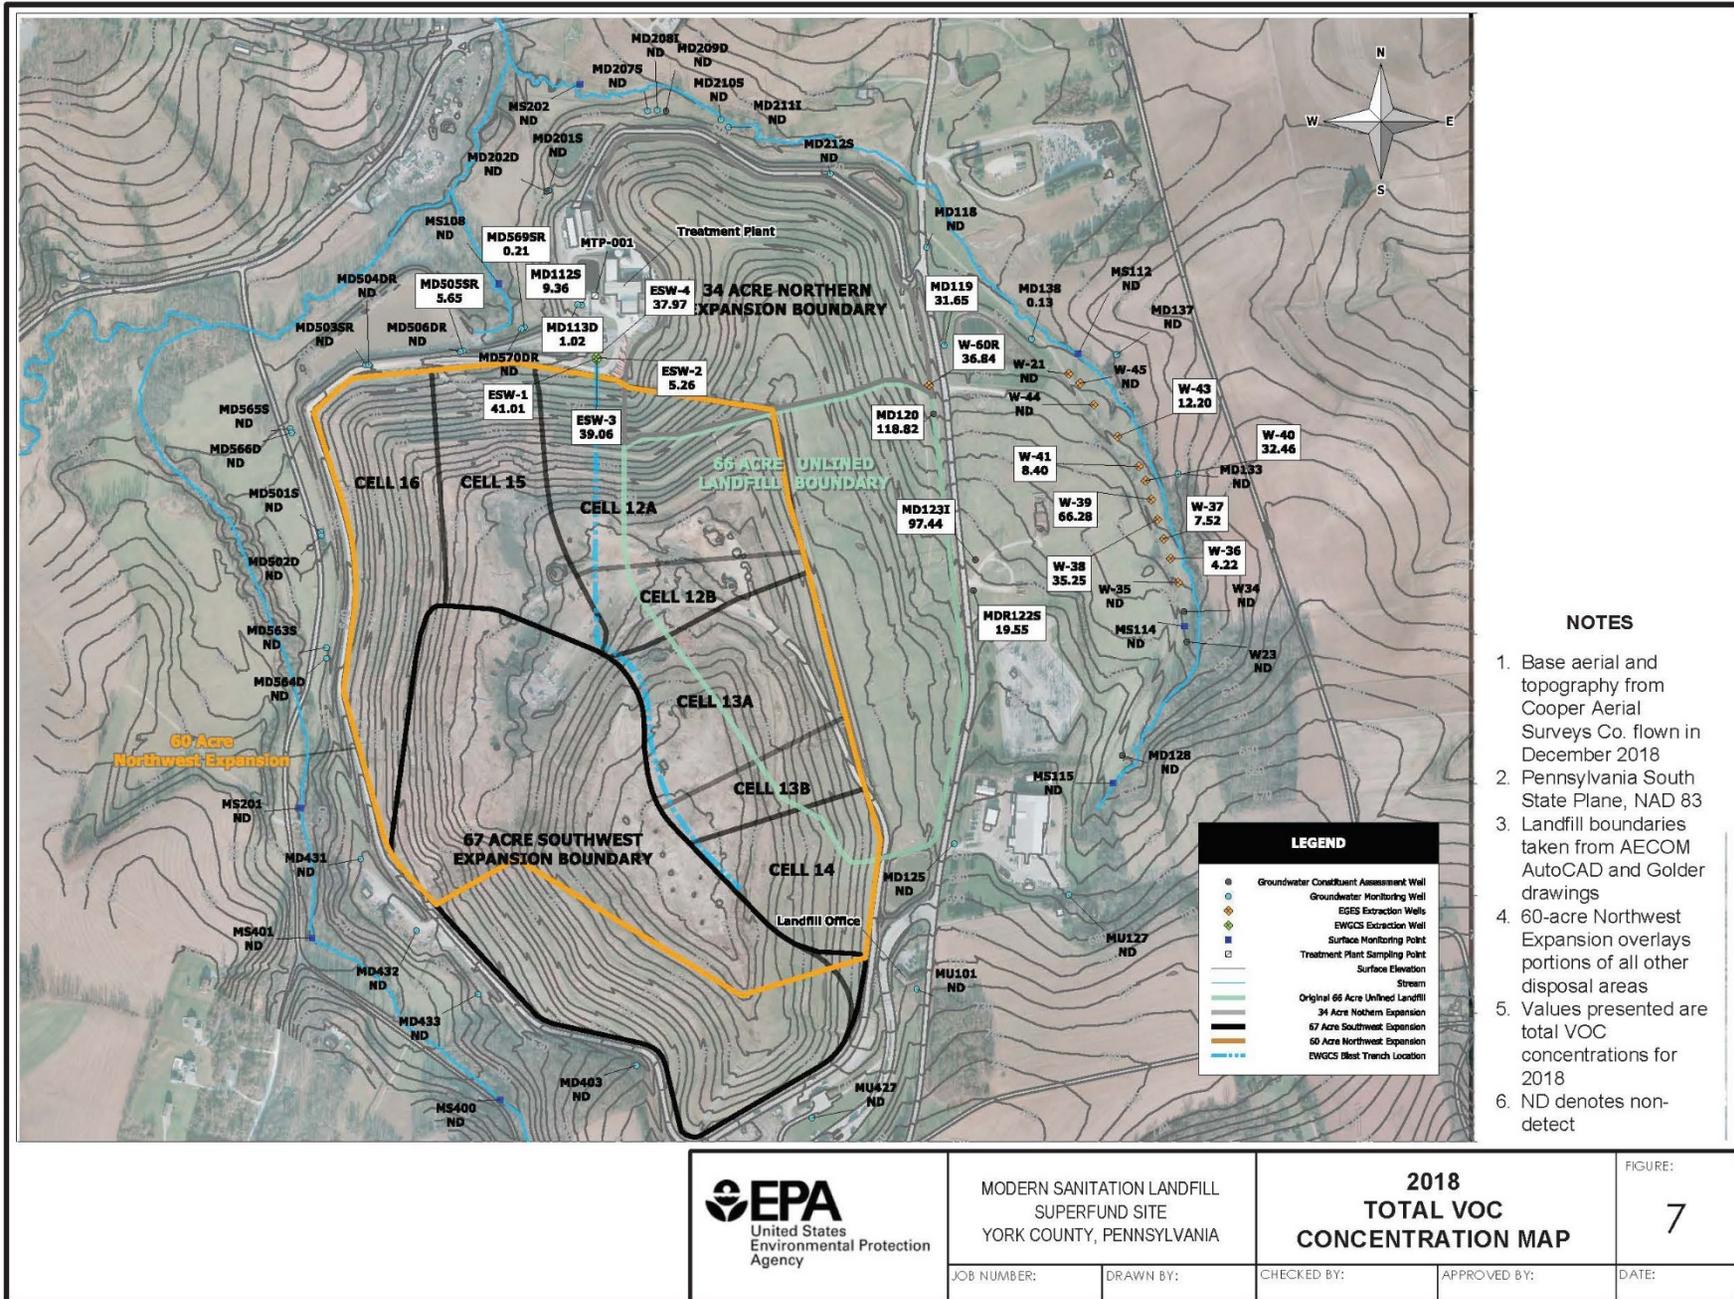
Figure 7: Total VOC Concentration Map – 2018

Low concentrations of VOCs have been detected in four wells near the EWGCS (MD-112S, MD113D, MD505SR and MD569SR). The concentrations of VOCs detected in these wells are below the groundwater remediation goals with no increasing trend. These four wells are located near the EWGCS extraction wells and are within the area of pumping influence. Continuous pumping from the EWGCS limits potential migration of VOCs downgradient and is evident as monitoring wells located further downgradient have had no detectable concentrations of VOCs.

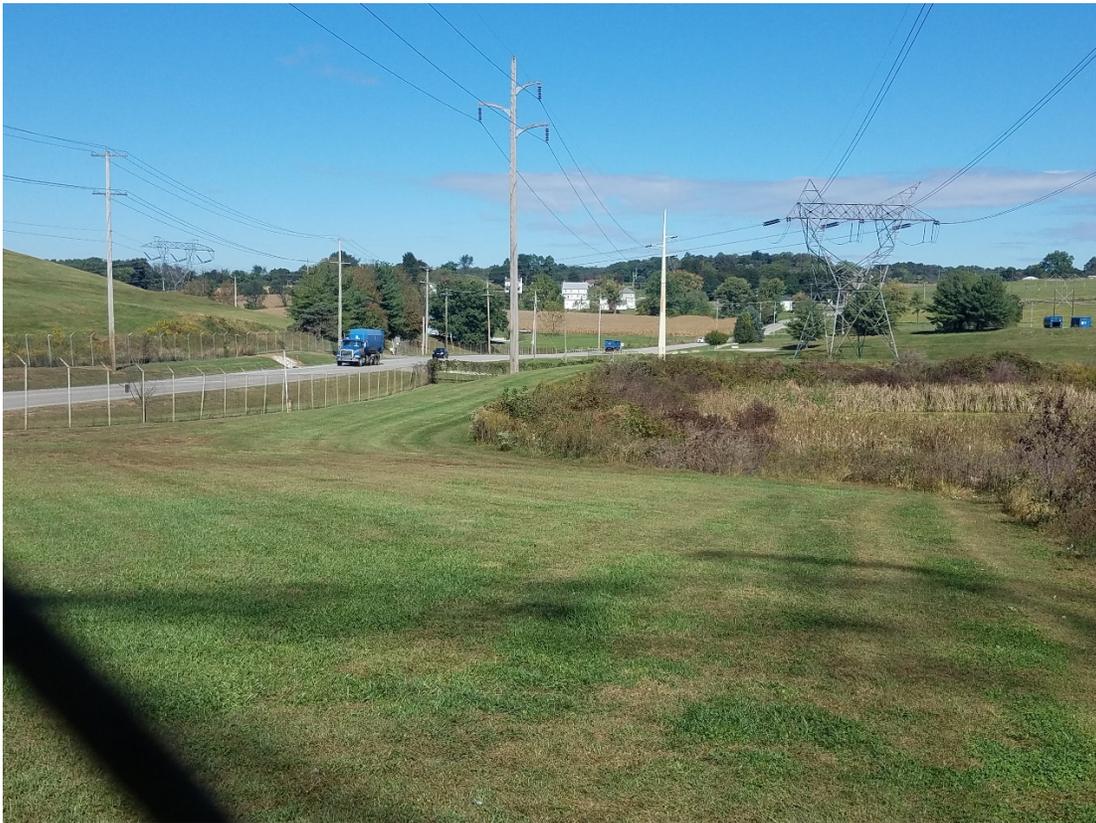
Looking north along Mt. Pisgah Road towards monitoring well MD119

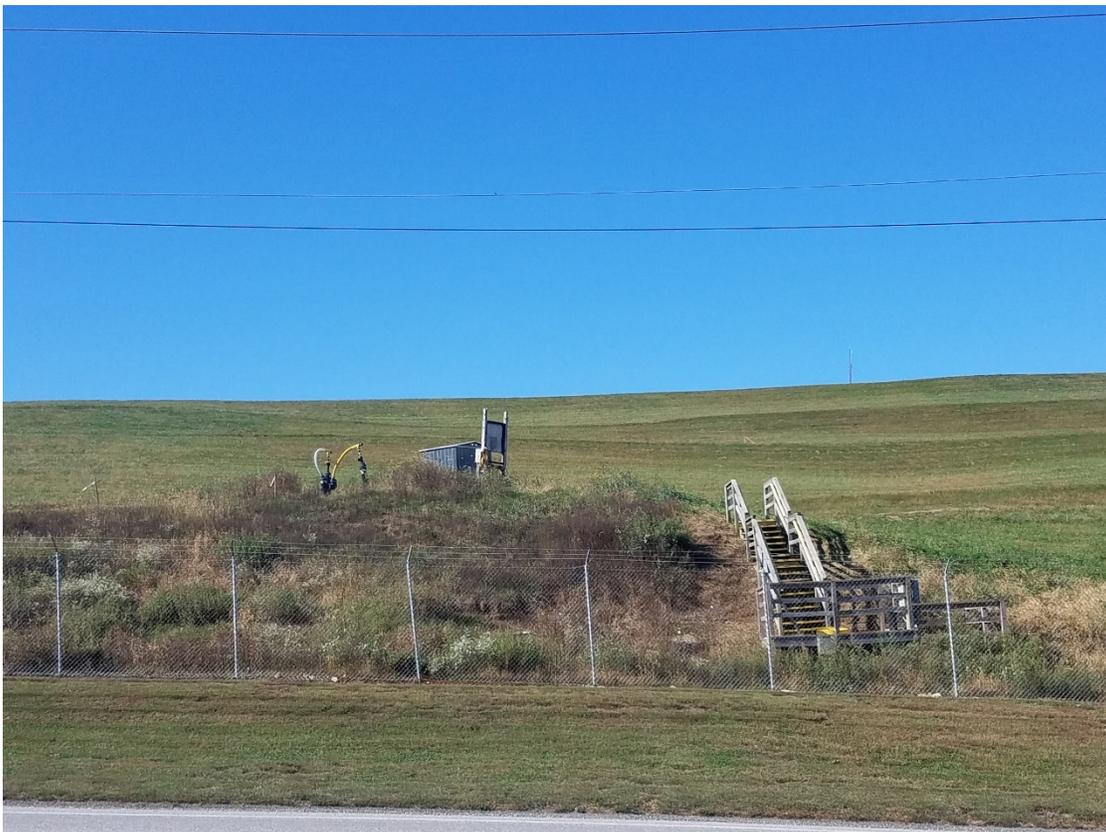
The remainder of the Site was capped by various expansions of the operating landfill. The groundwater monitoring wells were in good condition as they are sampled quarterly. It was noted that extraction well W-60 had become clogged in 2017 and a replacement extraction well, W-60R, was installed that same year. Extraction well W-60R was operating until September 2019 when it was taken off-line due to iron fouling. A new replacement well was installed in late October 2019. No significant issues were noted during the Site Inspection. These systems are operated and maintained by Republic Services, Inc. and their contractors. Photographs from the Site inspection are included in Appendix H.

Replacement extraction well W-60R

Well W60R replaced well W-60 in December 2015

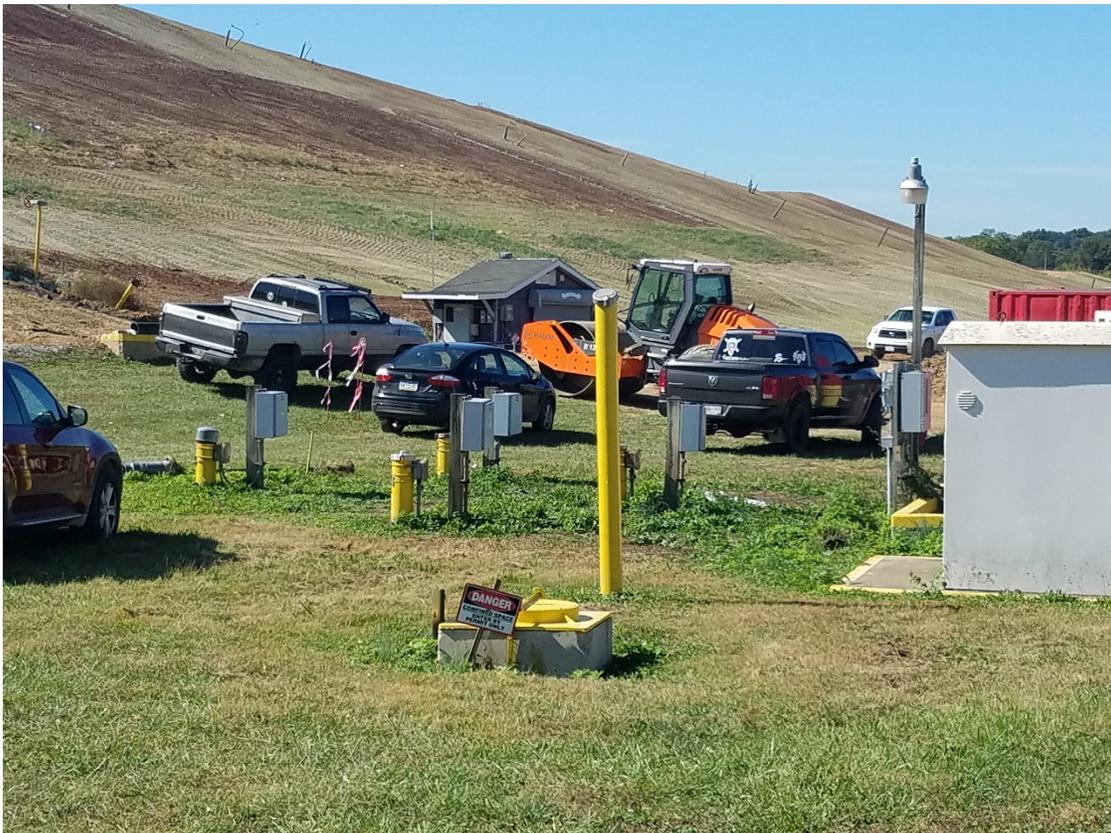
The EWGCS was constructed in 1999 and replaced the original western perimeter groundwater collection system. The EWGCS is comprised of a 2,825 ft long subsurface blast trench with four extraction wells (ESW-1, ESW-2, ESW-3, and ESW-4) placed at the downgradient end (northern end) of the trench. Extraction Well ESW-4 came online in August 1999, and the remaining three wells (ESW-1, 2, and 3) became operational in March 2000. The EWGCS is oriented parallel to the direction of groundwater flow and passively collects groundwater due to the natural horizontal and induced upward vertical gradient. The EWGCS collects impacted groundwater and provides a preferential pathway for groundwater flow (Golder, 2000).

EWGCS extraction wells ESW-1, ESW-2, ESW-3, and ESW-4

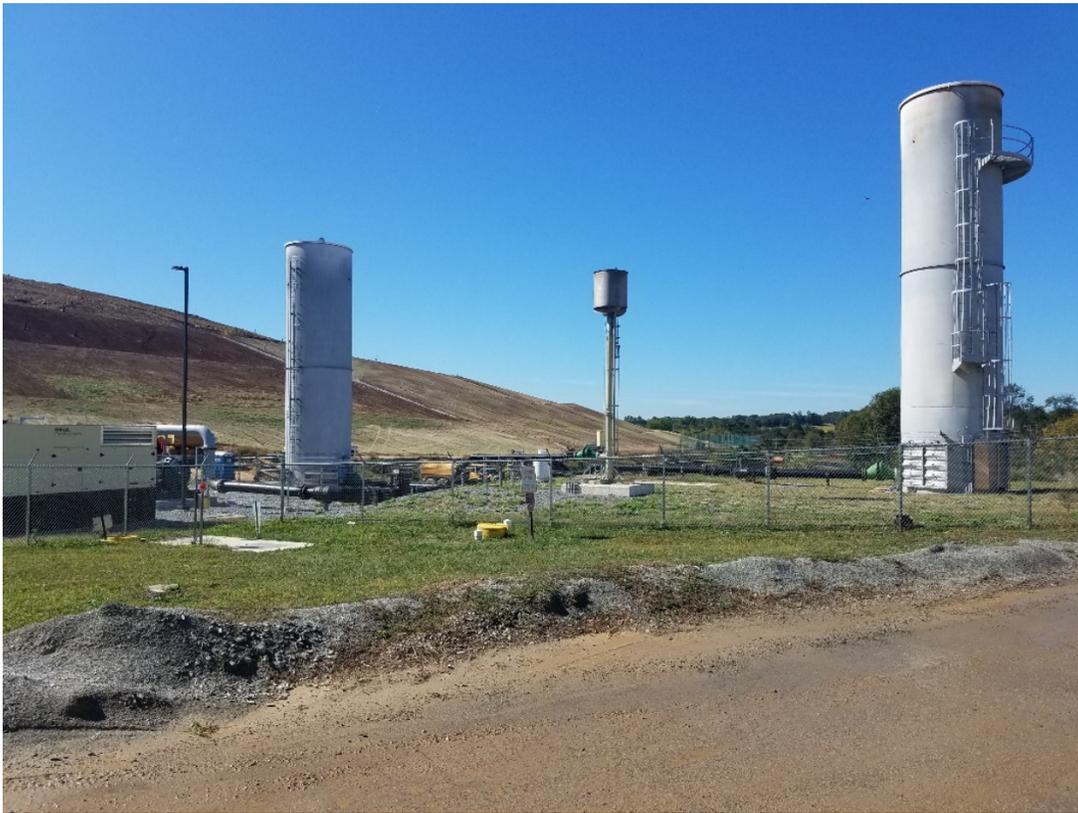
Enclosed flares and a candle flare outside treatment plant

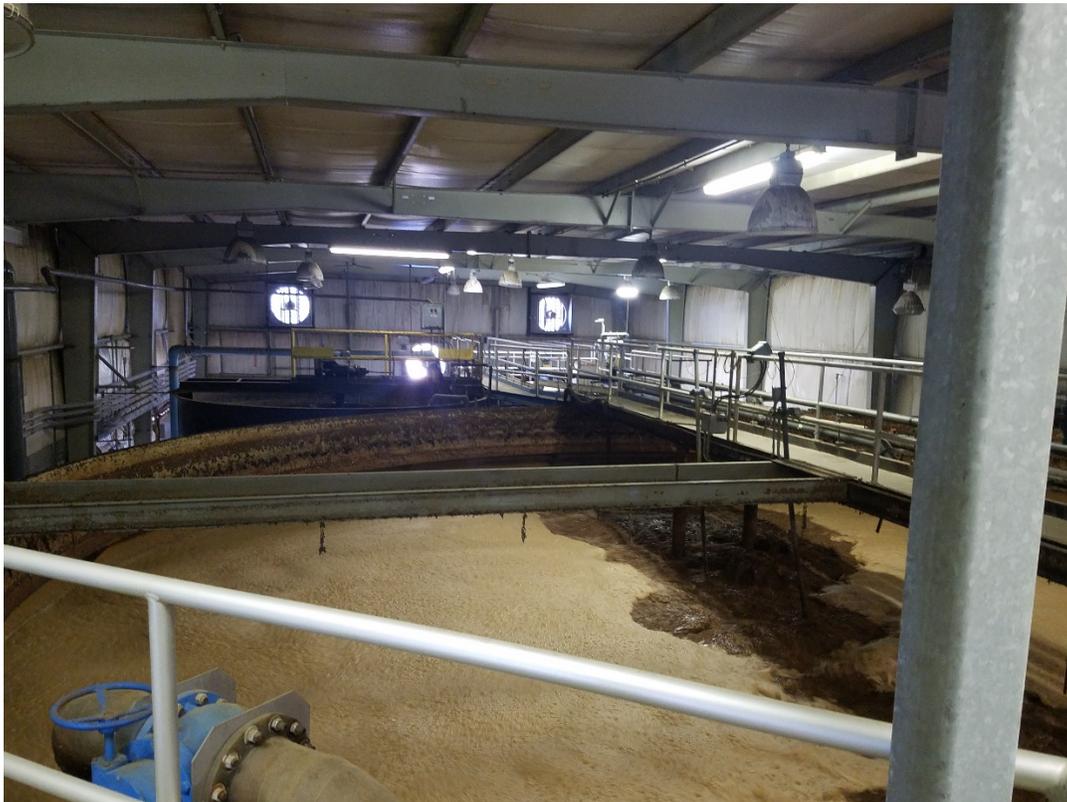
Biological reactor tanks inside treatment plant building
