**FOURTH FIVE-YEAR REVIEW REPORT FOR
ORDNANCE WORKS DISPOSAL AREAS SUPERFUND SITE
MONONGAHELA COUNTY, WEST VIRGINIA**

SEPTEMBER 2021

**U.S. Environmental Protection Agency
Region III
Philadelphia, Pennsylvania**

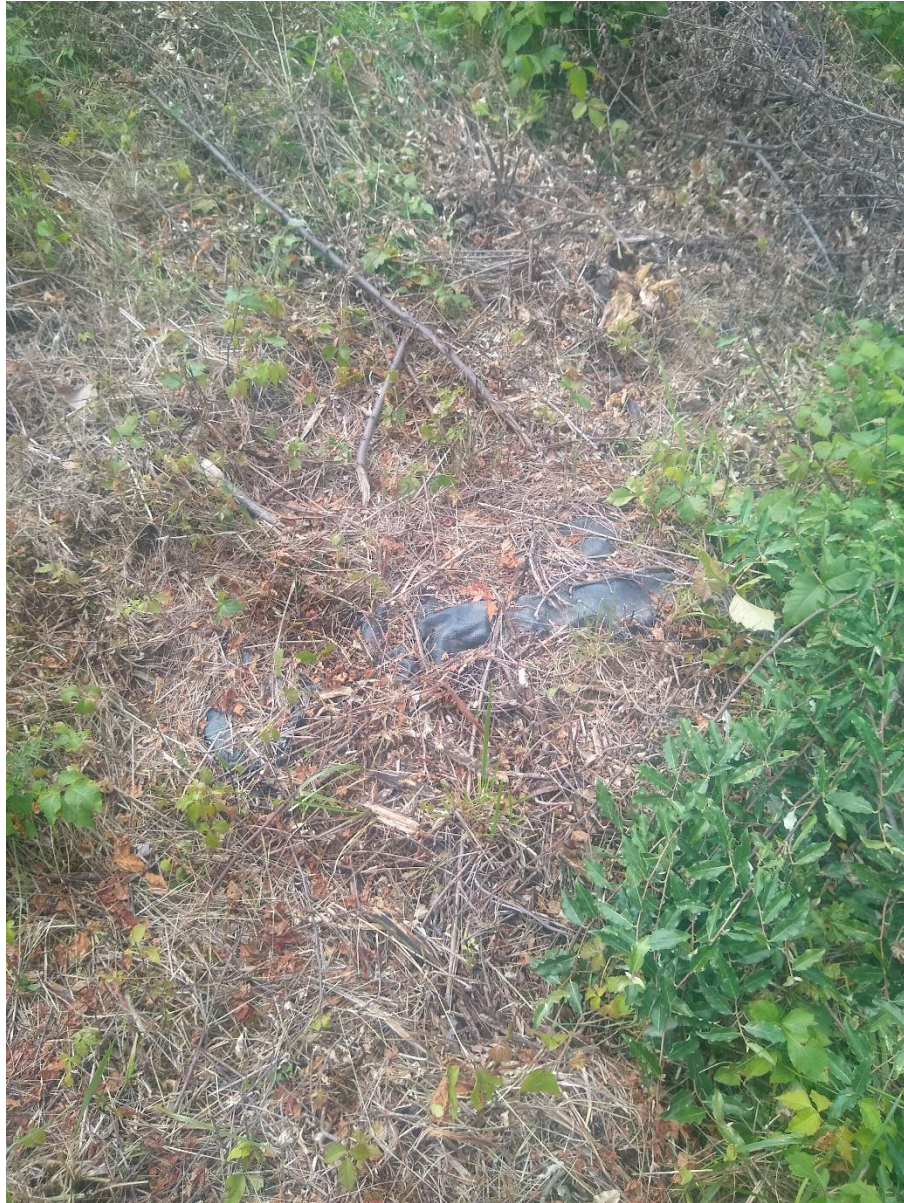
The landfill cap was generally in good condition and covered in topsoil. Participants noticed one location halfway down the northeast flank of the landfill cap where landscaping fabric was exposed, and the soil was slightly eroded. Some invasive species were observed, including Autumn Olive (*Elaeagnus umbellata*) and Multiflora Rose (*Rosa multiflora*), but the landfill cap was generally well vegetated with mostly native vegetation including flowers and small shrubs.

Areal extent _____ About 20 sq feet _____
Depth _____ 6 inches _____
Remarks _____ Minor erosion and exposed landscaping fabric noted halfway down the landfill cap toward the treatment ponds. Could be covered with topsoil and re-seeded. _____ | <input type="checkbox"/> Location shown on site map
<input type="checkbox"/> Erosion not evident |

Minor erosion and exposed landscaping fabric

- Site contacts should be updated on the sign at the site entrance gate.
- One location of minor soil erosion along with some invasive species and some larger woody vegation was observed at the landfill cap. Cap maintenance to address these issues should be performed during the planned maintenance by the PRPs in fall 2021. Maintenance fell behind schedule due to Covid-19.

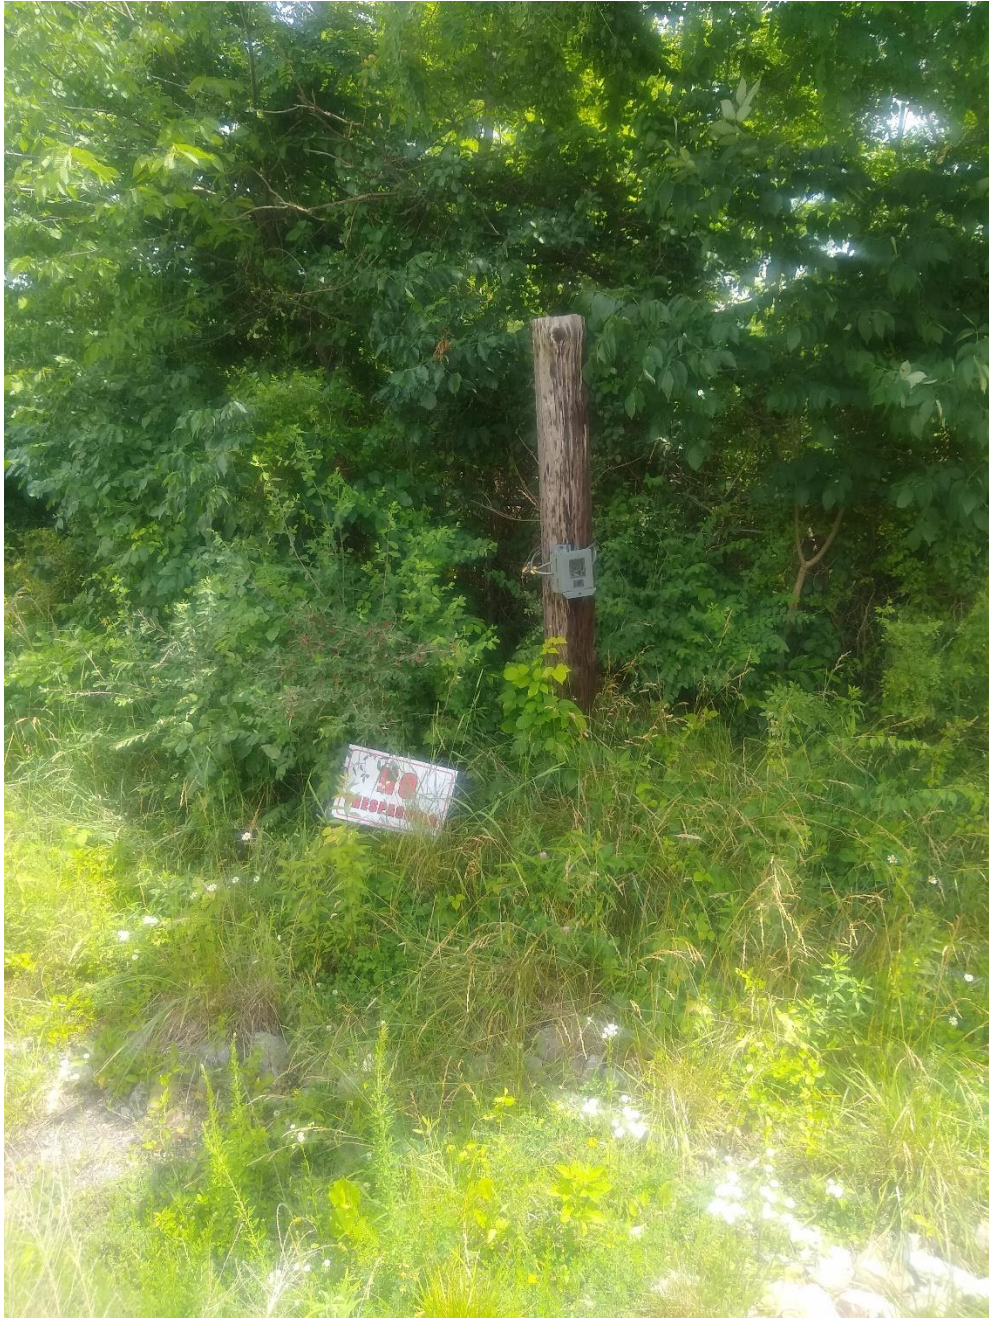
No trespassing signage

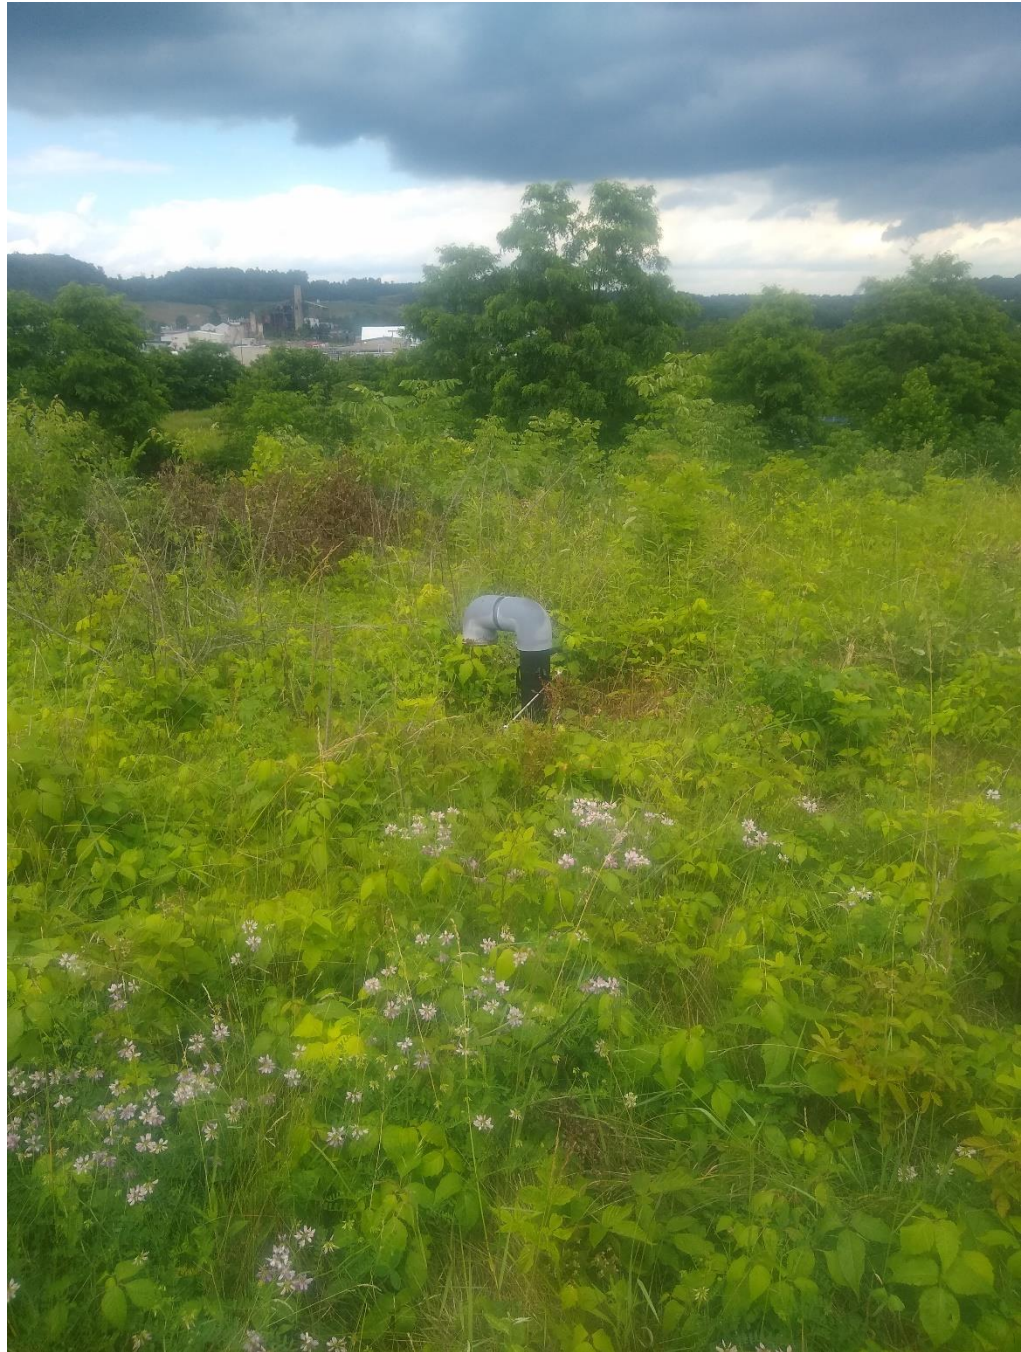
Some larger woody vegetation was observed around the edges of the landfill cap. This should be addressed through routine maintenance by the PRPs.

5.	Vegetative Cover <input type="checkbox"/> Trees/Shrubs (indicate size and locations on a diagram) Remarks _____ Small area of bare ground as noted above under erosion section. Otherwise well-vegetated, but care should be taken to remove invasives and woody vegetation _____	<input type="checkbox"/> Grass <input checked="" type="checkbox"/> Cover properly established	<input checked="" type="checkbox"/> No signs of stress

Condition of vegetation of landfill cap

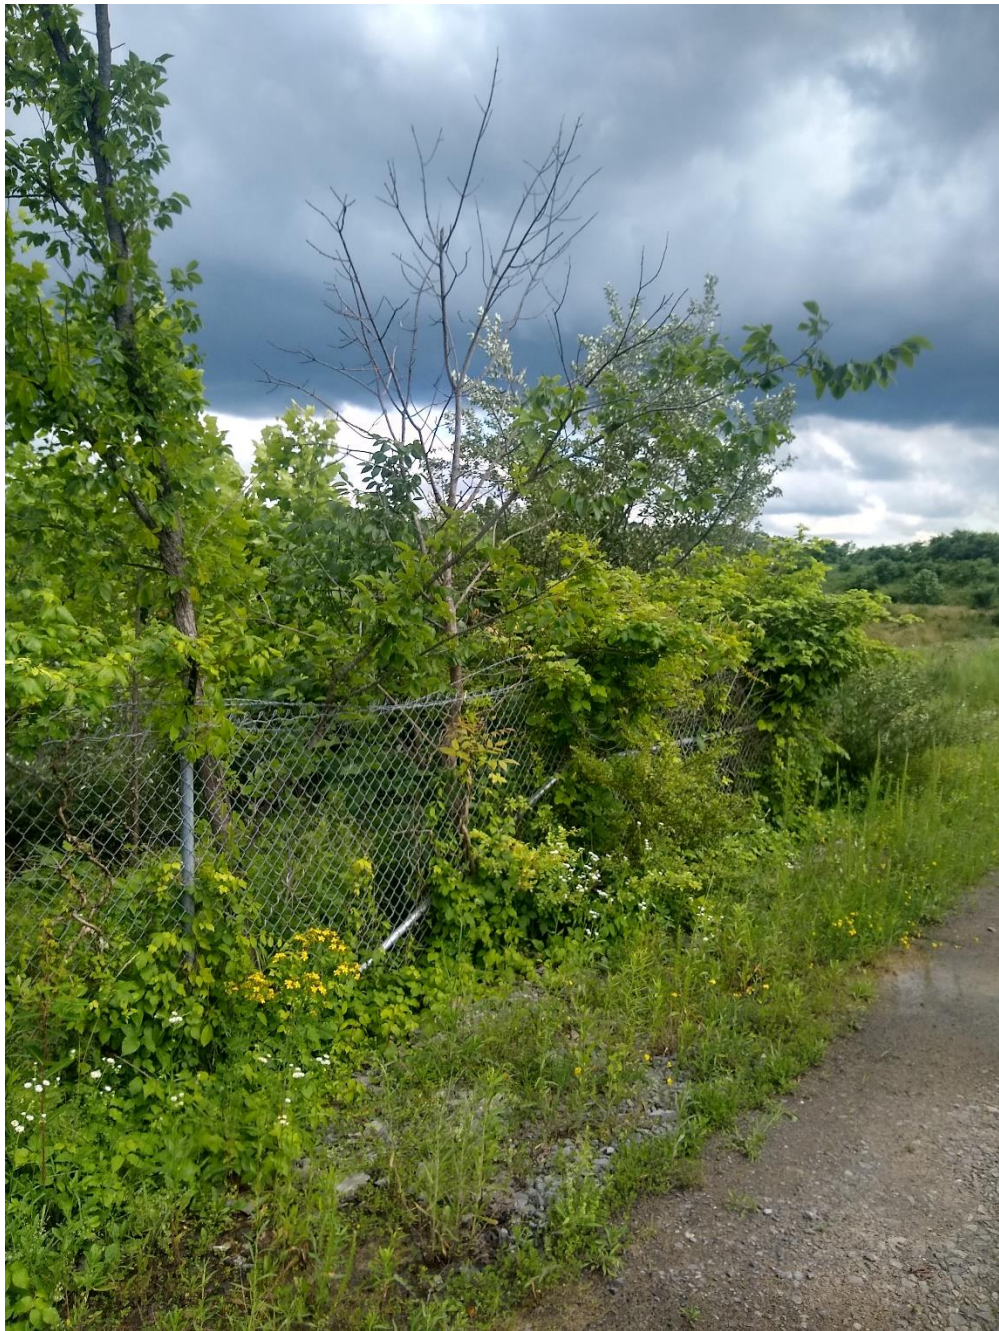
1.	Fencing damaged <input type="checkbox"/> Location shown on site map <input type="checkbox"/> Gates secured <input type="checkbox"/> N/A Remarks ____Gates are secured and signed. Fencing was grown over in vines and shrubs in places. Barbed wire topping the fence just right of the entrance gate (at the top of the landfill cap) was damaged by fallen woody vegetation. _____ _____
----	---

Damage to perimeter fence from fallen woody vegetation

- During the site inspection, it was noted that some of the fences were overgrown by shrubs and vines, and in one location fallen vegetation has damaged the barbed wire. The vegetation should be removed, and the barbed wire should be repaired.
