**FIRST FIVE-YEAR REVIEW REPORT FOR  
BORIT ASBESTOS SUPERFUND SITE  
MONTGOMERY COUNTY, PENNSYLVANIA**

**AUGUST 2022**

**U.S. Environmental Protection Agency  
Region 3  
Philadelphia, Pennsylvania**

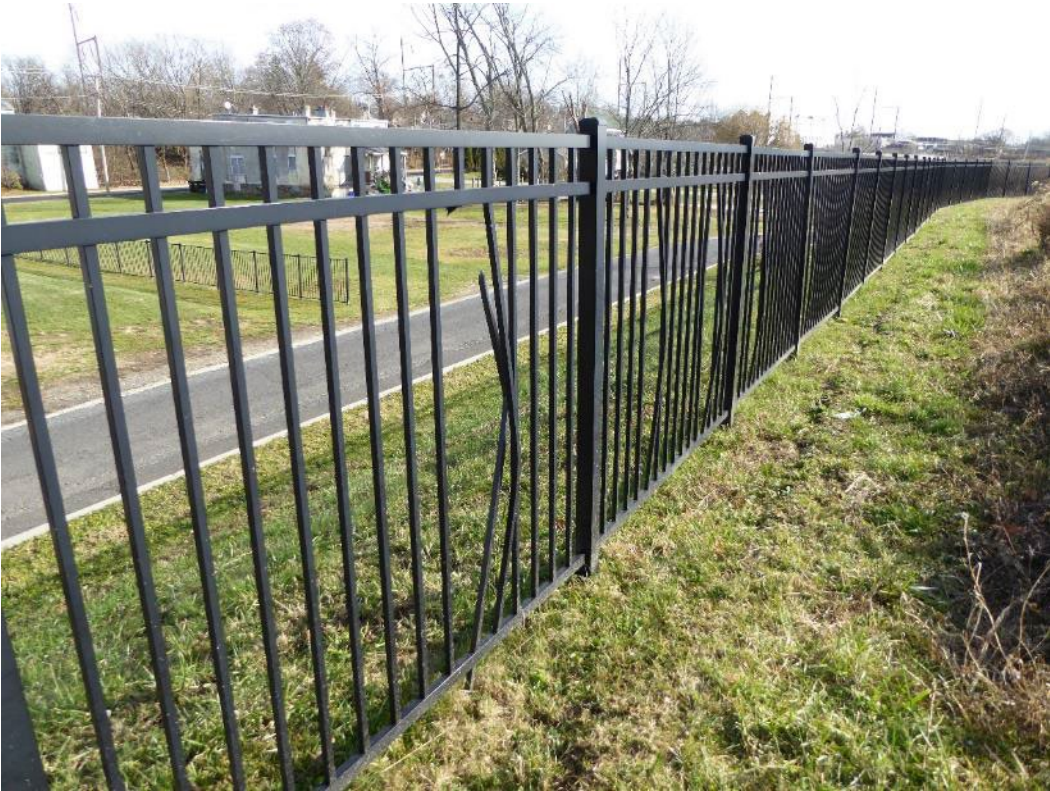
Access to the Site is restricted by a fence on all sides except along Wissahickon Creek. There was some damage to the Park Parcel fence along the road; some of the vertical members were bent or broken.<sup>13</sup> Site inspection participants did not observe any evidence of trespassing or vandalism.

Damaged fence at Park Parcel

<sup>13</sup> The fence was installed by EPA to prevent access while the cleanup was being completed, but the fence is not required as part of the Site's remedy. Any cap disturbance and all subsequent repairs required as a result of the removal of any fencing, signage or site security measures by the property owners (either direct such as earth disturbance, or indirect such as trespassing) will be the sole responsibility of the property owners.

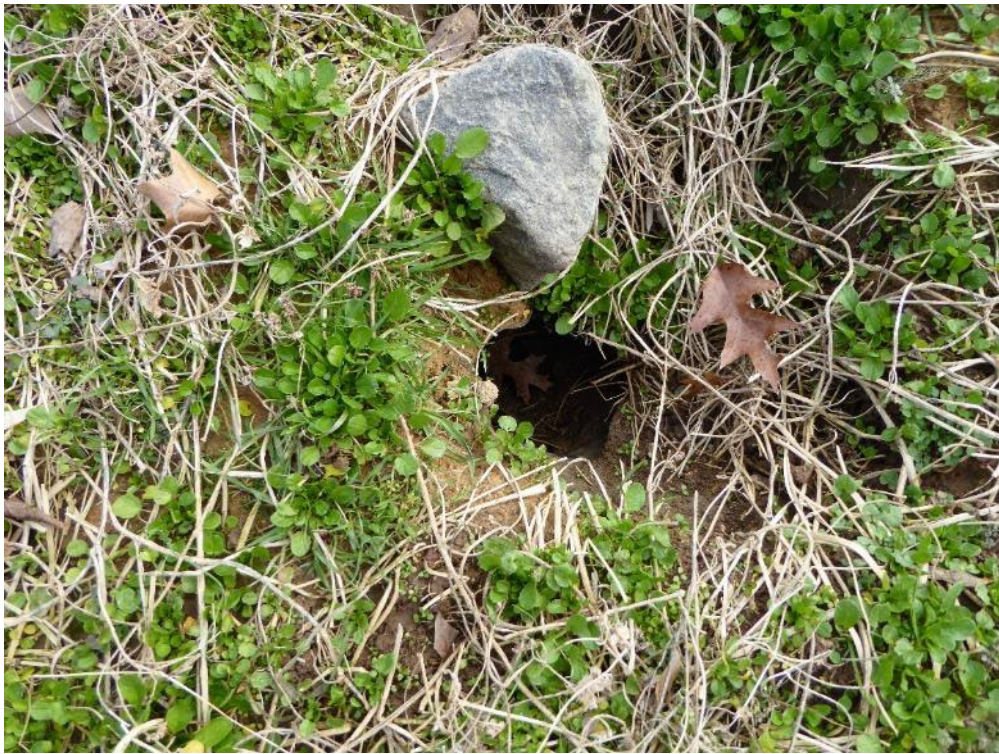
The December 2021 FYR Site inspection found about a dozen groundhog burrows on the Park Parcel, mainly on the slope facing Wissahickon Creek along with a few burrows next to the gravel entrance road. At some of the burrows, chunks of ACM had been unearthed and were present on the ground surface. On March 4, 2022, PADEP collected the unearthed ACM and Whitpain Township filled the burrows. PADEP removed any ACM coming out of the burrows and placed it in a plastic-lined drum for future disposal off-Site. More than a dozen groundhog burrows were filled. Bentonite was placed in the bottom of the burrows and they were topped off with topsoil and hand tamped.

Site inspection participants walked around the perimeter of the Site, including all three parcels. The cap appeared to be in good condition except for some groundhog burrows observed on the Park Parcel. About a dozen burrows were spotted, mainly on the slope facing Wissahickon Creek along with a few next to the gravel entrance road. At some of the burrows, chunks of asbestos-containing material had been unearthed and were present on the ground surface.

Animal burrow on Park Parcel slope facing Wissahickon Creek

PADEP and Whitpain Township are conducting O&M, generally in accordance with the July 2020 O&M Plan. The December 2021 FYR Site inspection found about a dozen groundhog burrows on the Park Parcel, mainly on the slope facing Wissahickon Creek along with a few burrows next to the gravel entrance road. At some of the burrows, chunks of ACM had been unearthed and were present on the ground surface. On March 4, 2022, PADEP and Whitpain Township collected the unearthed ACM and filled the burrows. PADEP removed any ACM coming out of the burrows and placed it in a plastic-lined drum for future disposal off-Site. More than a dozen groundhog holes were filled. Bentonite was placed in the bottom of the holes and they were topped off with topsoil and hand tamped. Whitpain Township, as the entity responsible for inspections and minor cap repairs at the Park Parcel, should regularly look for and fill groundhog burrows at the Park Parcel. PADEP is conducting O&M for the Asbestos Pile Parcel.

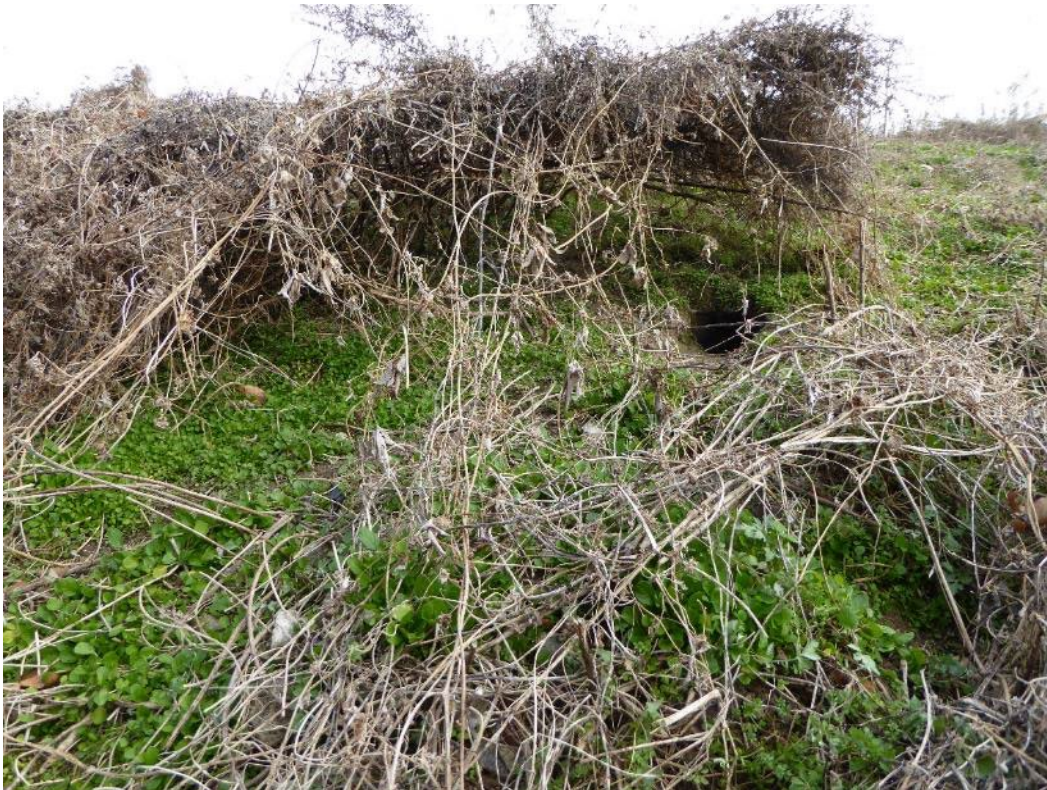
Animal burrow on Park Parcel slope facing Wissahickon Creek

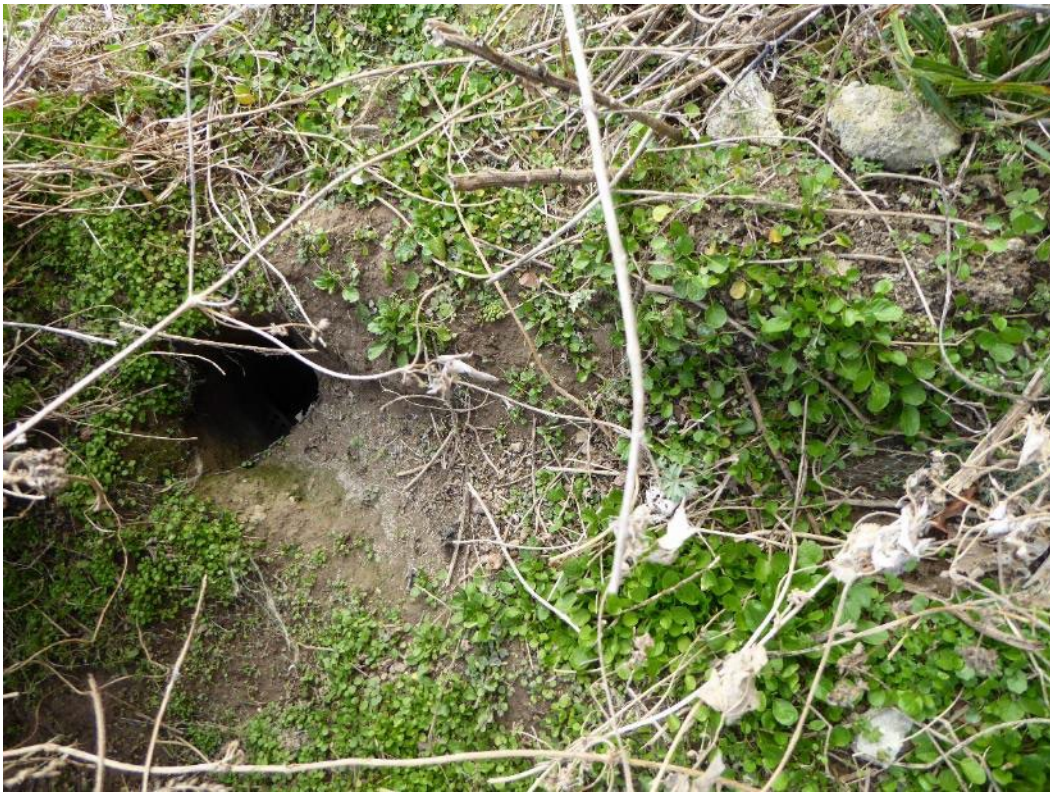
Animal burrow on Park Parcel slope facing Wissahickon Creek

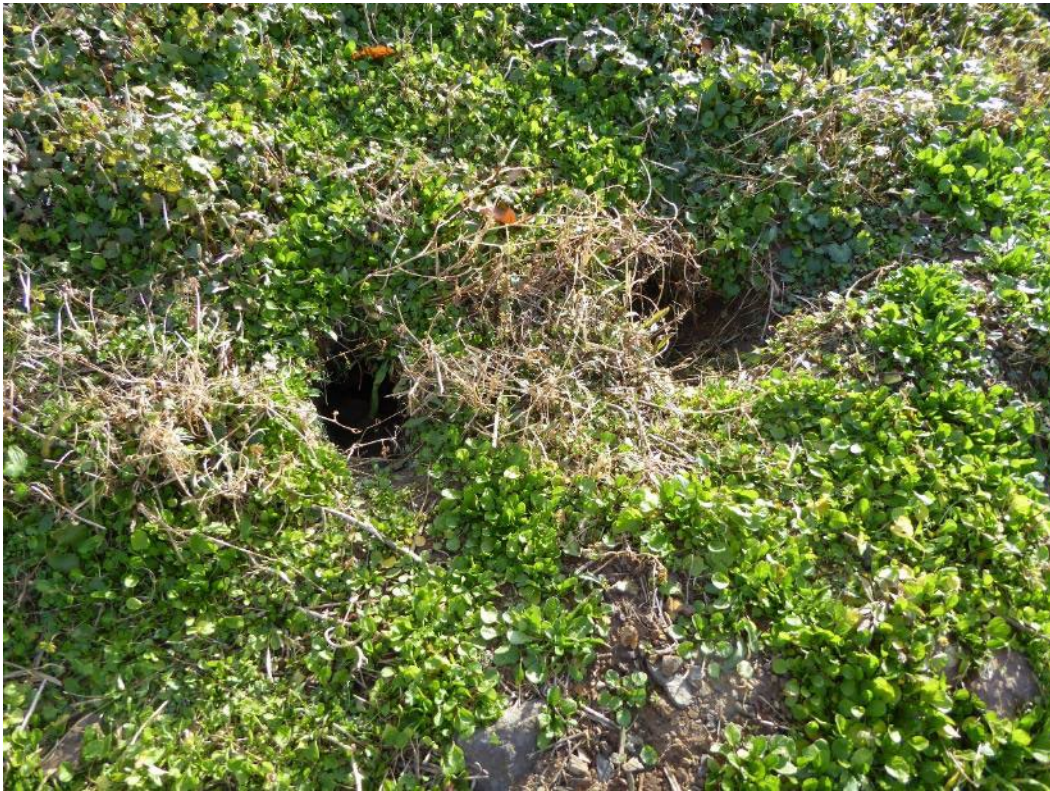
Animal burrows on Park Parcel next to access road

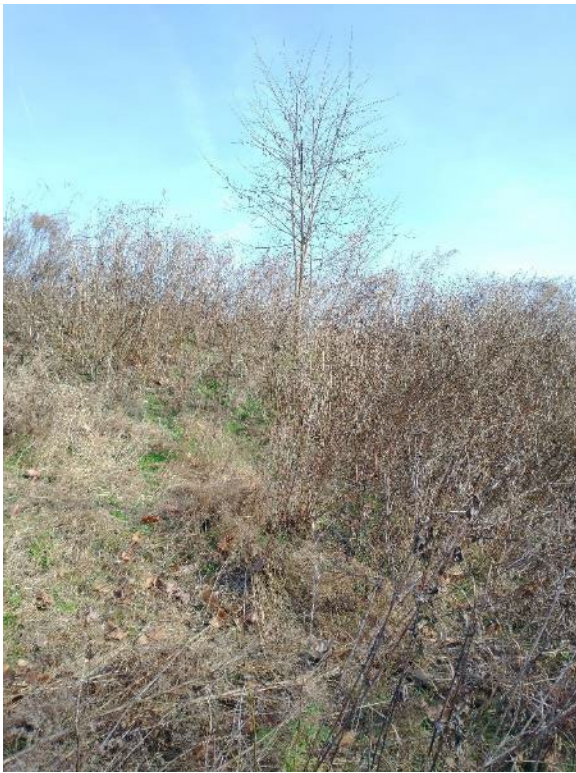
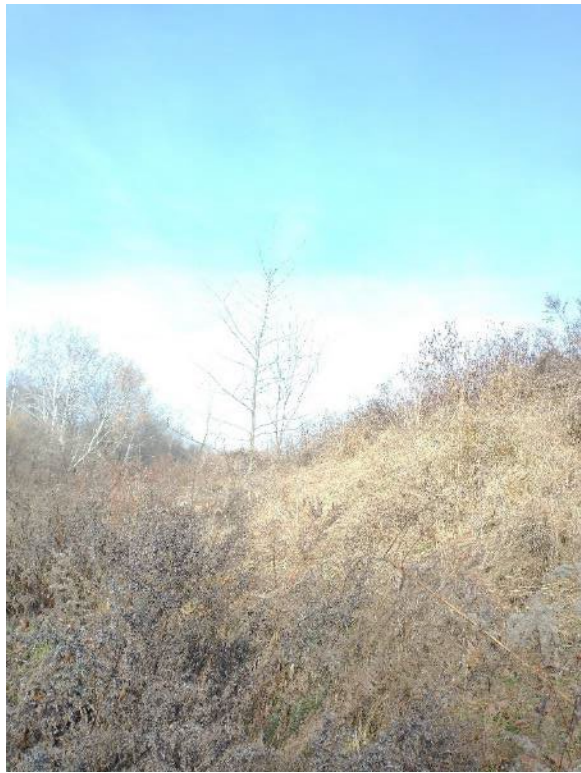
About five small trees (3 to 6 inches in diameter) were observed growing on the Reservoir Parcel slope facing Wissahickon Creek. These trees should be removed in accordance with the O&M Plan because trees are prohibited along the berm of the Reservoir Parcel adjacent to Wissahickon Creek.

Trees on Reservoir Parcel slope facing Wissahickon Creek

The December 2021 FYR Site inspection also found several small trees growing on the Reservoir Parcel slope facing Wissahickon Creek. PADEP will remove these trees as prescribed in the O&M Plan. The December 2021 FYR Site inspection also found a few small trees on the slope of the Park Parcel near Rose Valley Creek where it enters the Site. These trees should be removed if they are growing where cable concrete mats are present.

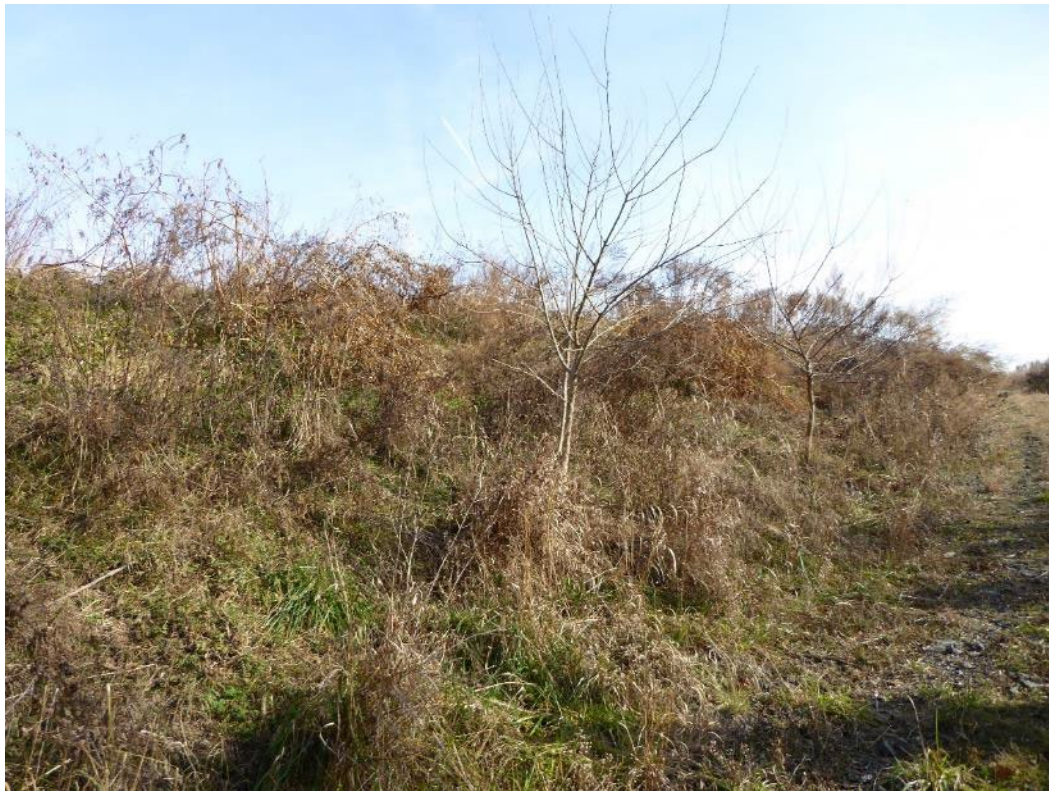
Trees on Reservoir Parcel slope facing Wissahickon Creek

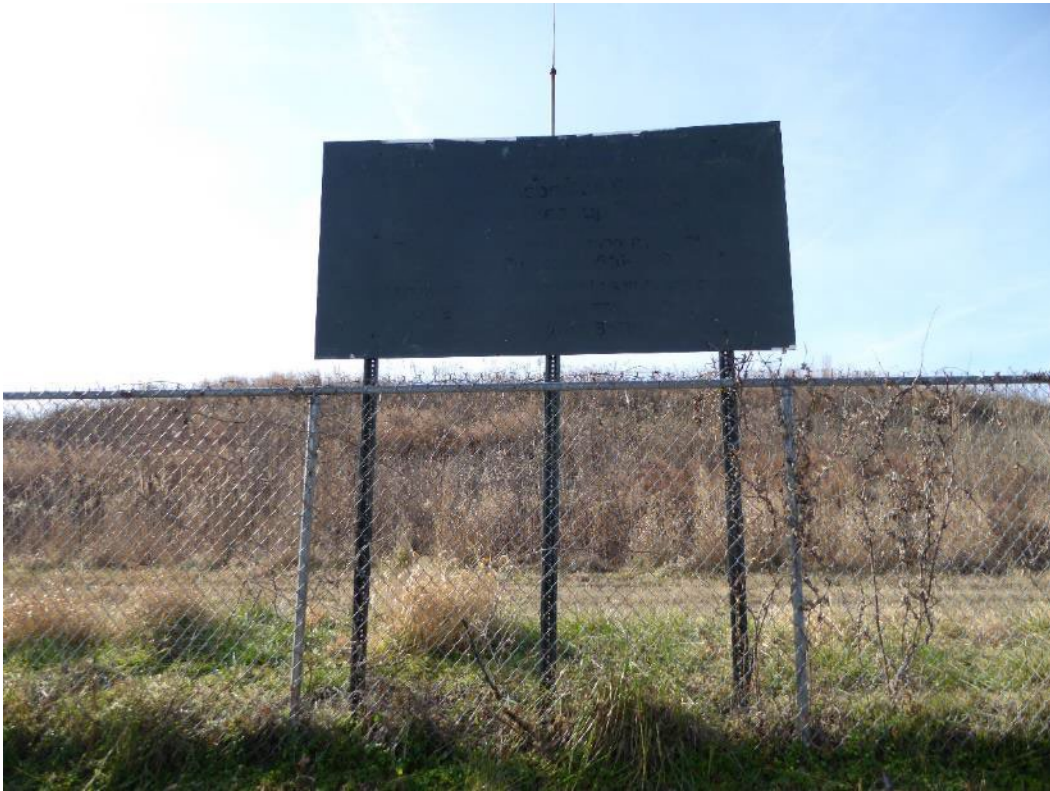
There are signs along Wissahickon Creek telling people not to dig due to buried asbestos and providing contact information for EPA. Participants at the December 2021 Site inspection noted that the large Site sign along the road was no longer legible; a new sign was installed in January 2022.

Site sign along road, no longer legible

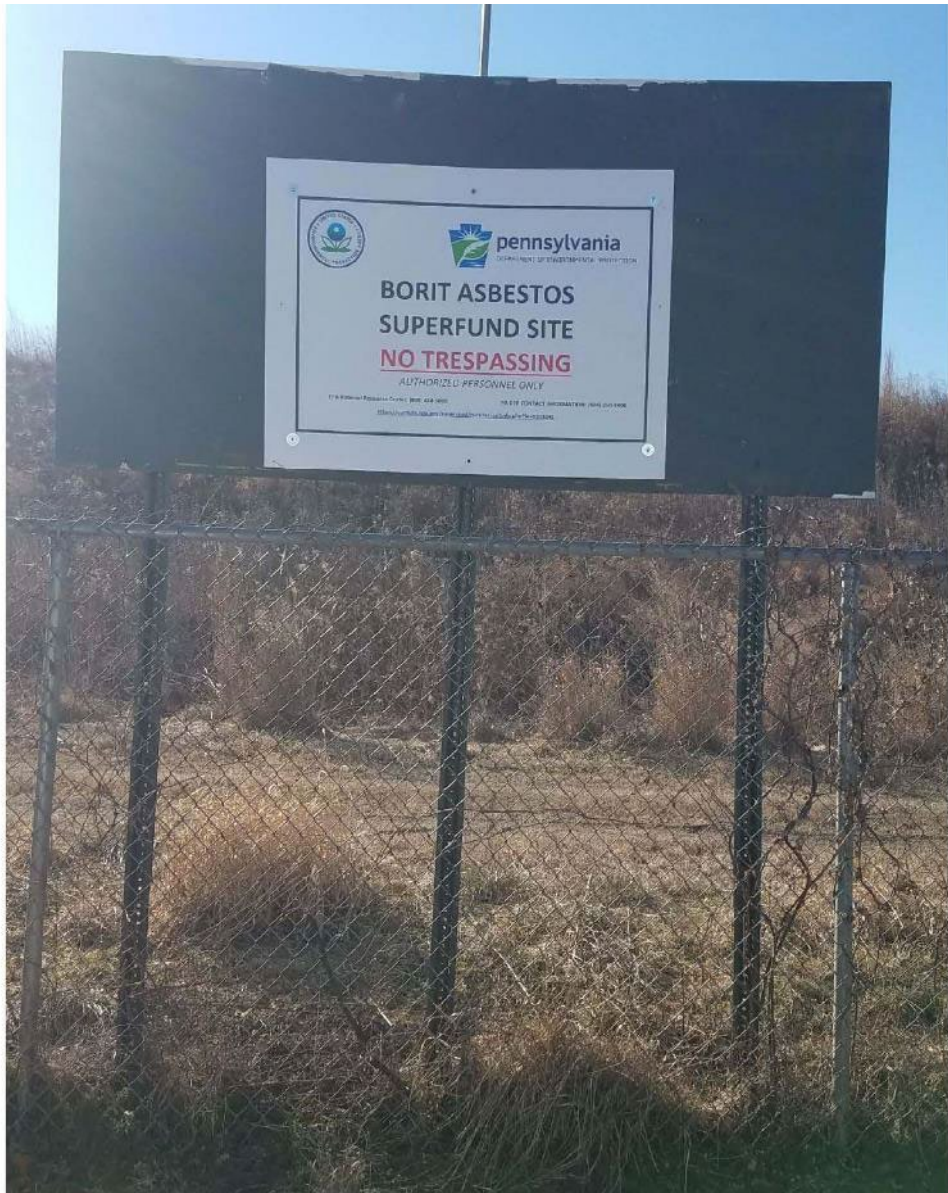
New site sign (installed January 2022)
