FIFTH FIVE-YEAR REVIEW REPORT FOR
RENTOKIL, INC. (VIRGINIA WOOD PRESERVING DIVISION) SUPERFUND SITE
HENRICO COUNTY, VIRGINIA

June 2023

U.S. Environmental Protection Agency
Region 3
Philadelphia, Pennsylvania

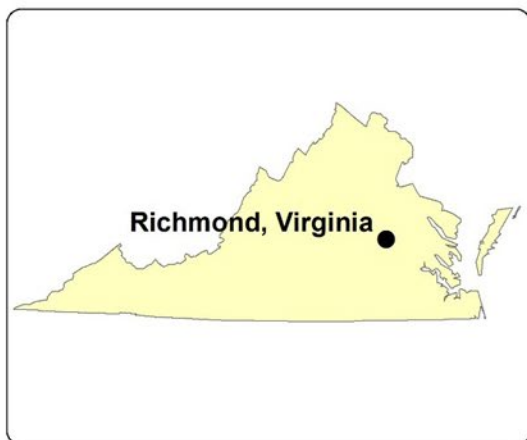
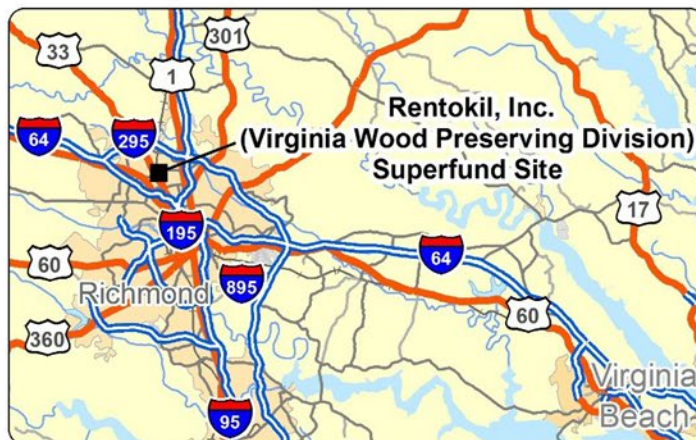
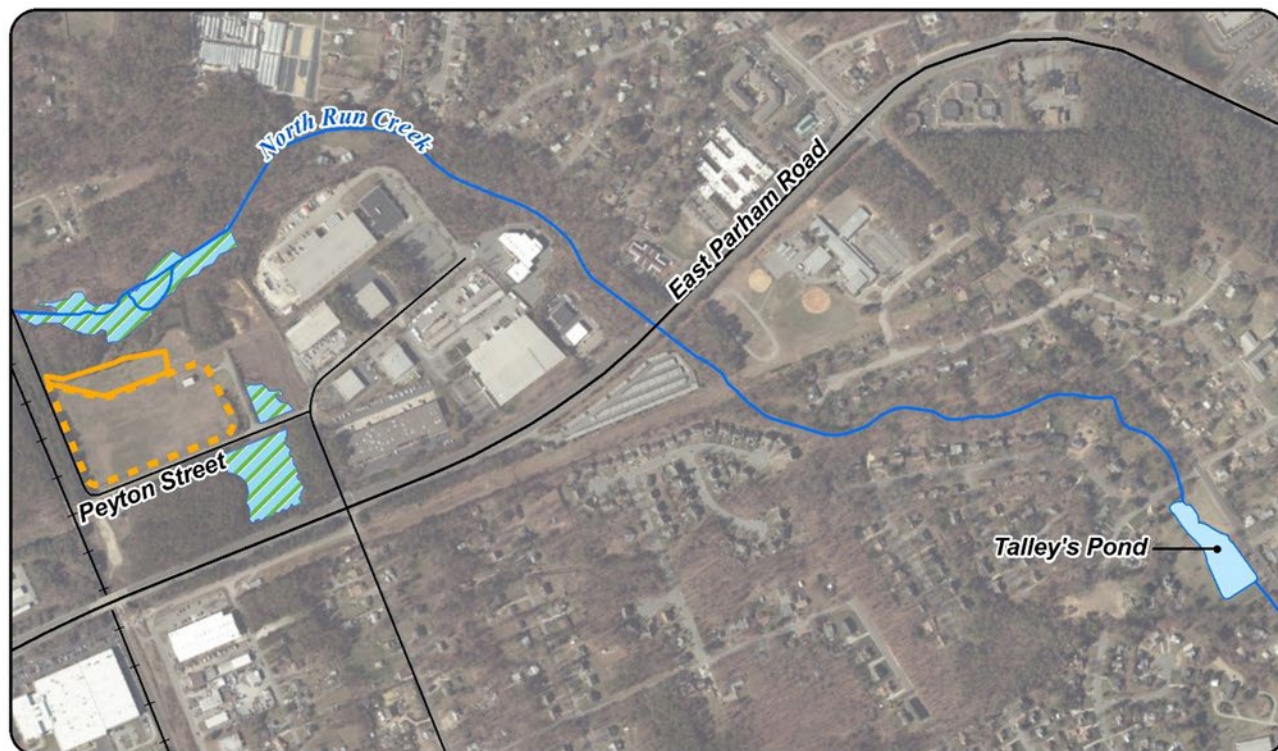
Figure 1: Site Vicinity Map

The Site is located on and around Peyton Street and Oakview Avenue, about 10 miles north-northwest of Richmond, Virginia, in Henrico County (Figure 1).³ A former wood-treating facility operated at the Site from 1957 until January 1990 (“the facility”). As described in the 1993 Record of Decision (ROD), the Site is comprised of the land occupied by the former facility, as well as wetland areas contiguous to the northcentral boundary and the southeastern corner of the facility where hazardous substances from the former facility came to be located (Figure 2). Chemicals used during wood-treatment operations included chromium zinc arsenate (CZA), chromated copper arsenate (CCA), pentachlorophenol (PCP), fuel oil no. 2, creosote, xylene, and fire retardants. Site operations resulted in the contamination of soil, sediment, and groundwater with hazardous substances.

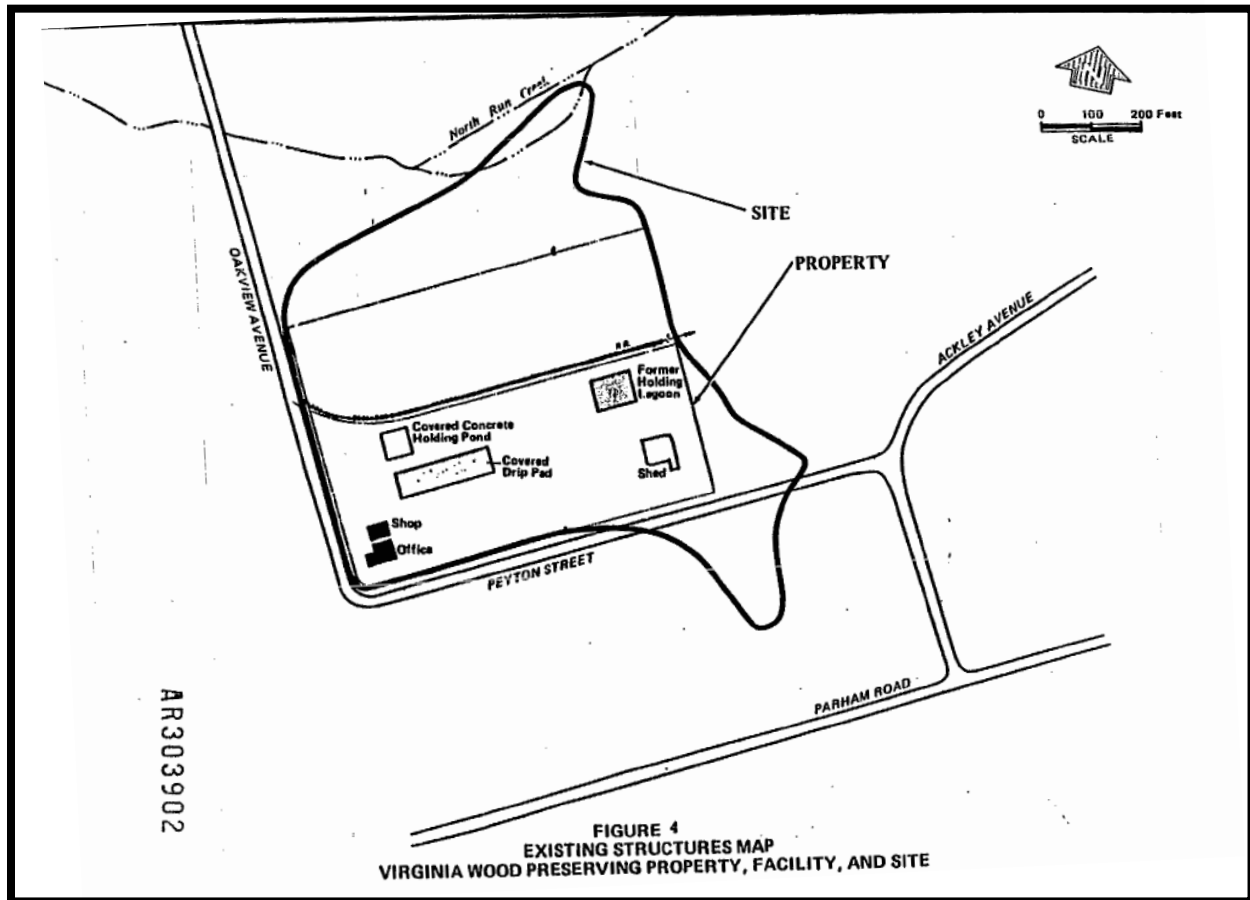
Figure 2: 3; ; 5'Site Boundary

Note: Figure 2 above is Figure 4 from the Site's 1993 ROD.

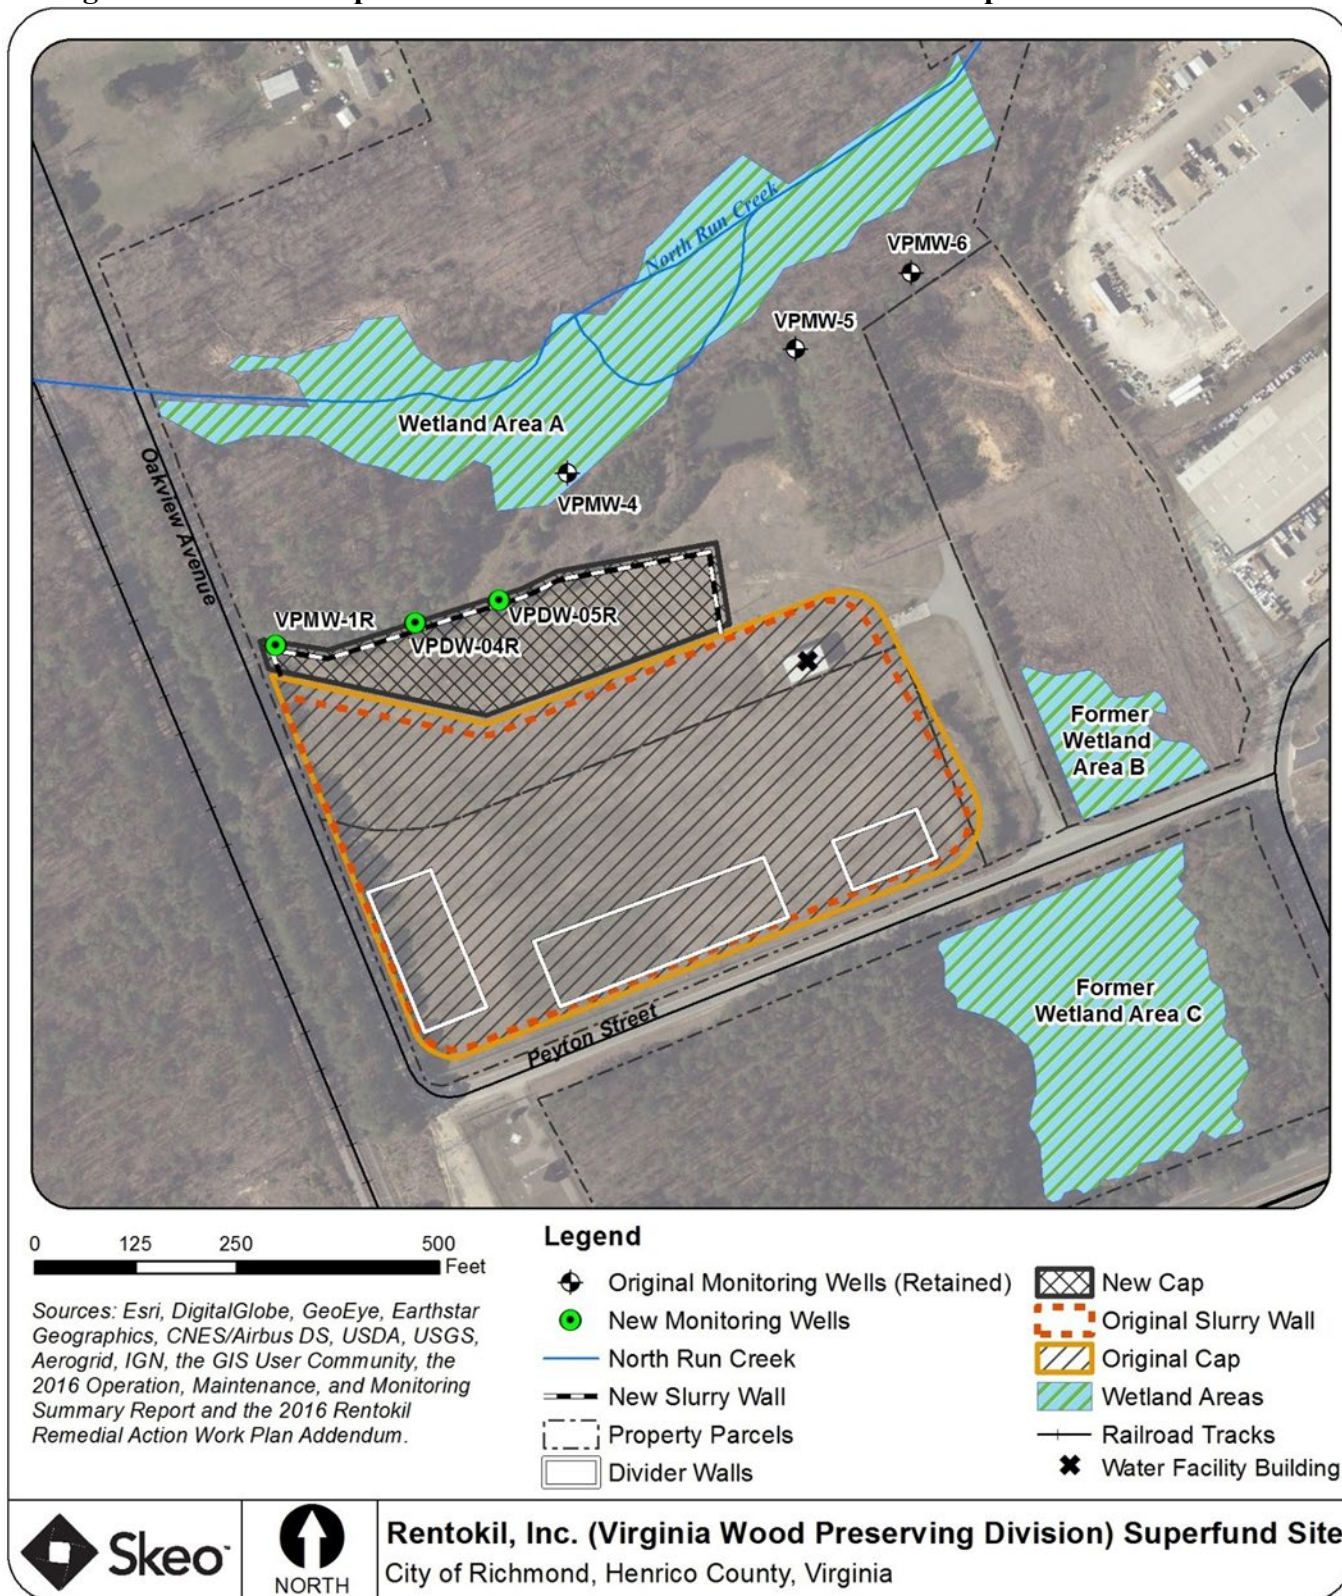
Figure 3: Detailed Map of Current Site Features and Remedial Components

VPI extended the cap (Cap Area 2) and slurry wall in December 2016 to contain the residual PCP-contaminated soil and prevent the infiltration of water. The slurry wall extension is 18 inches wide and installed to a depth of 15-26 feet below ground surface. The total length of the slurry wall is approximately 770 feet. The new cap components include a non-woven geotextile, geomembrane, geocomposite drainage layer, 18 inches of protective cover soil, and 6 inches of vegetated topsoil. The new cap overlaps the original cap by a minimum of 12 inches.

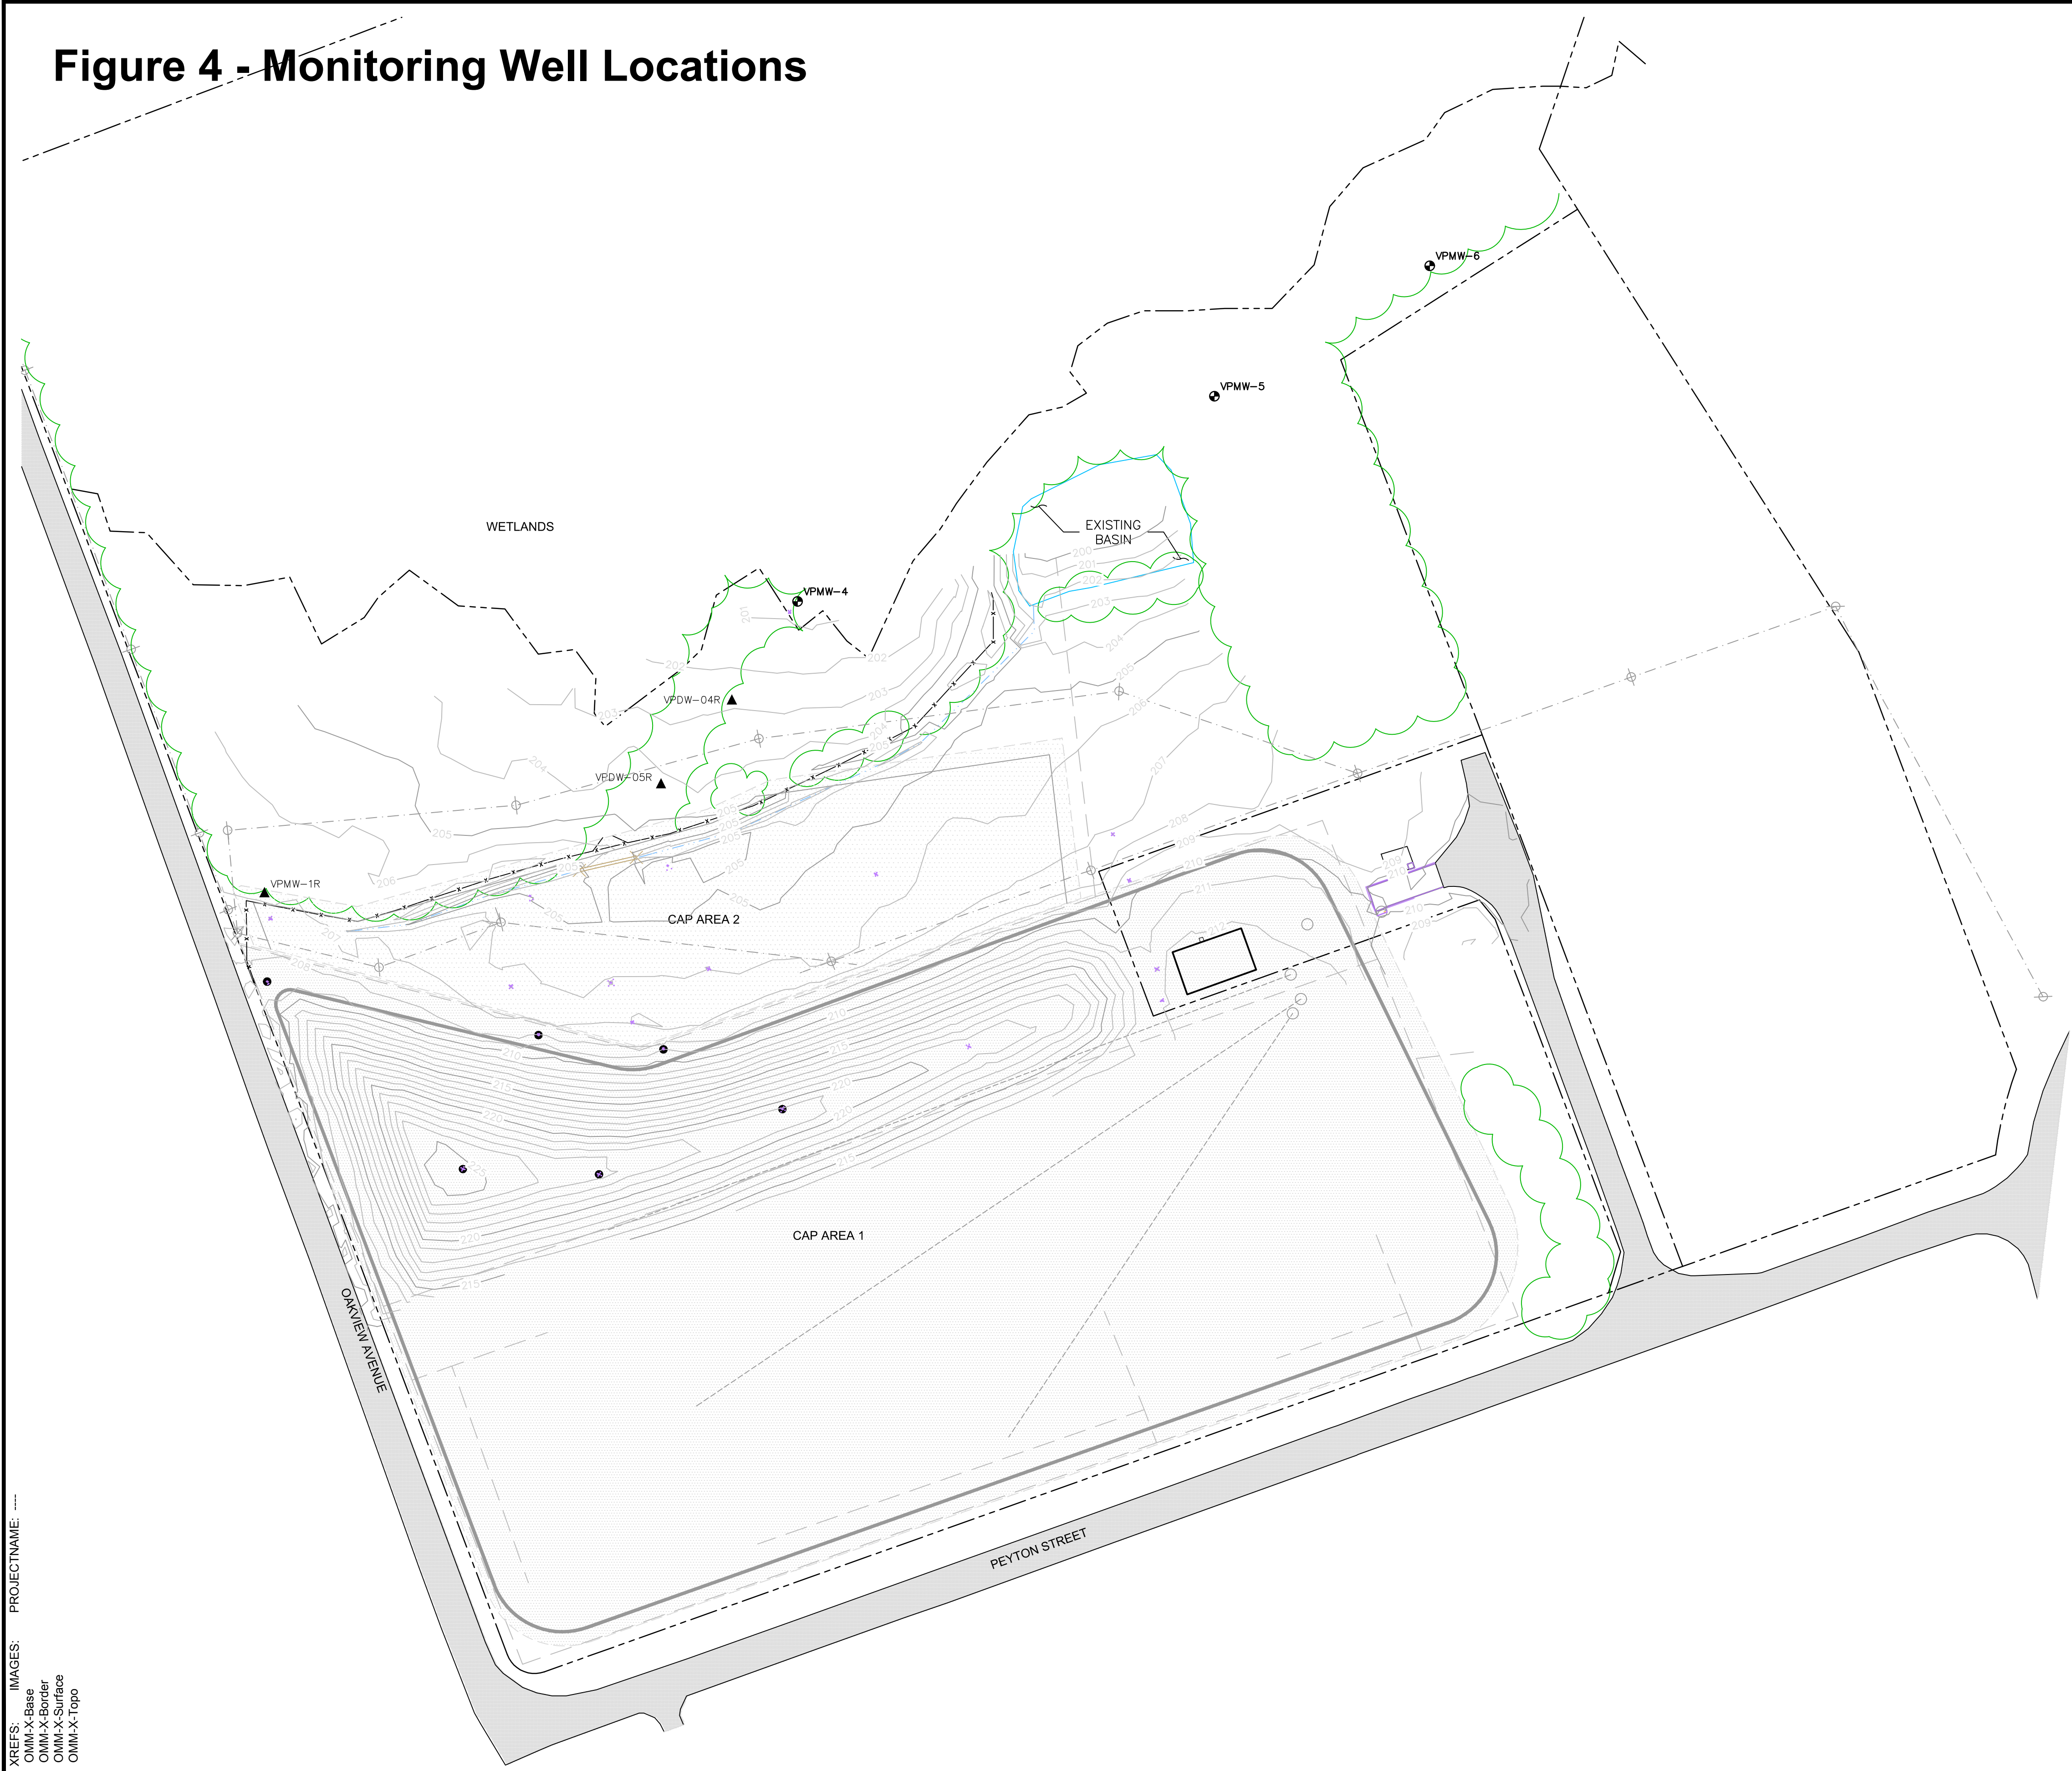
Figure 4 - Monitoring Well Locations

**EXISTING SITE CONDITIONS AND
MONITORING WELLS LOCATIONS**

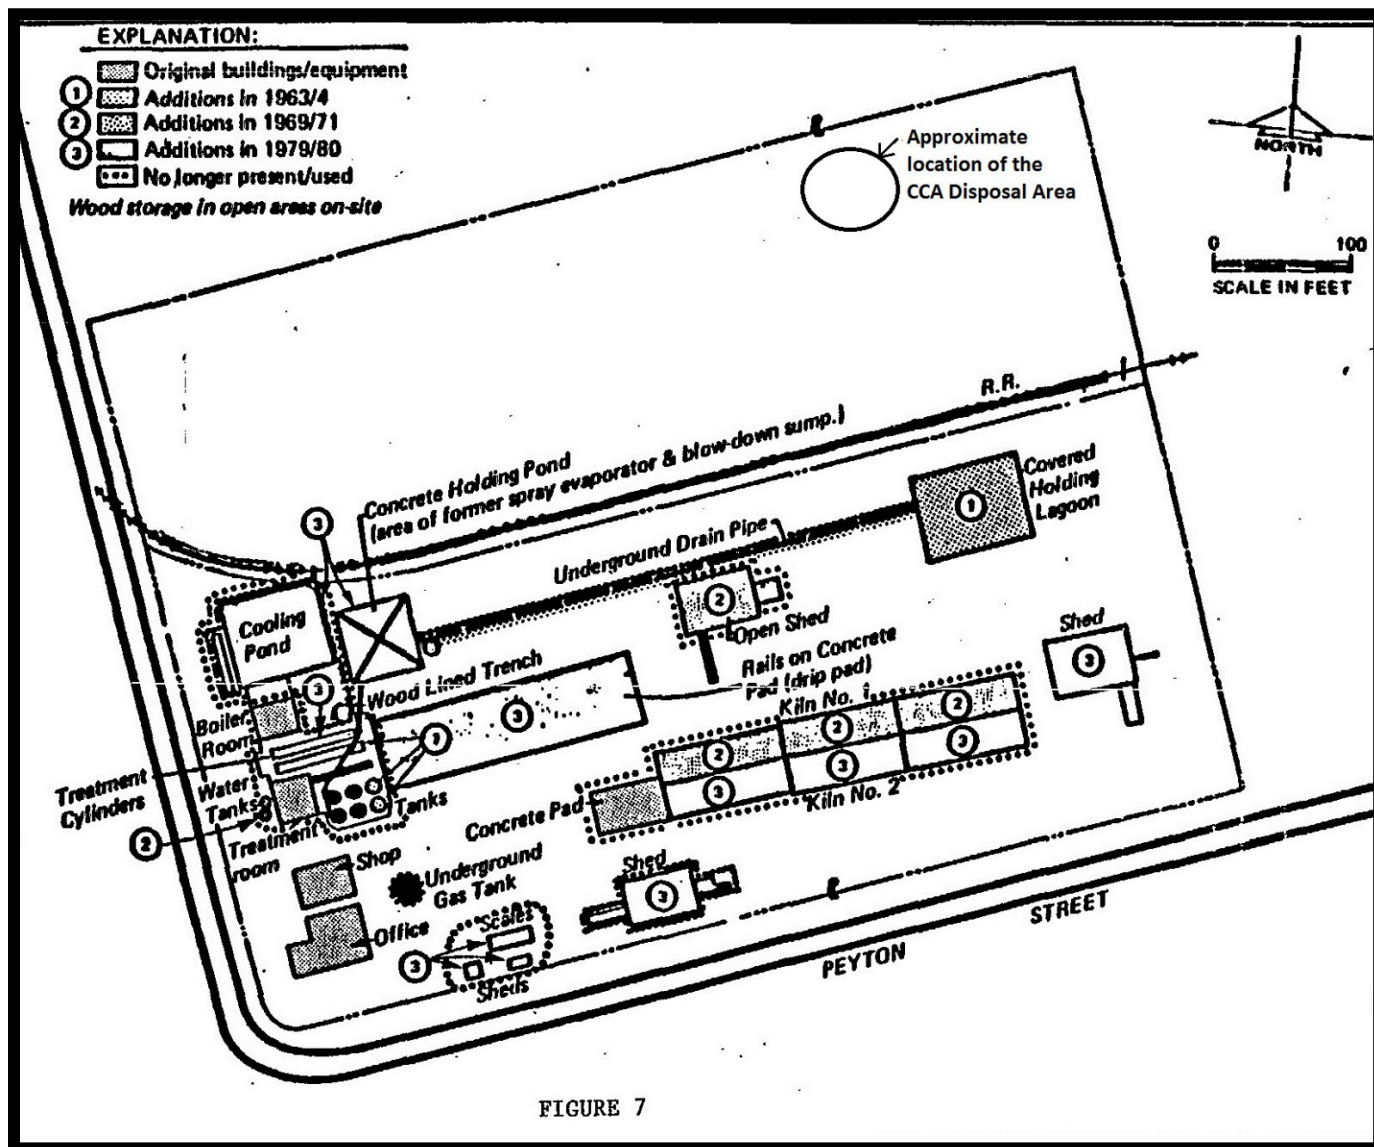
Figure 5: Historic Site Features

Following fish kills in Talley's Pond in 1962, under the direction of the Virginia State Water Control Board, the Site owner cleared, cleaned and replaced the facility's blowdown sump with a concrete holding pond and constructed a covered, unlined pond in 1963. An underground pipe connected the concrete holding pond to the covered unlined pond. In 1987, Rentokil removed the contents of the unlined pond and disposed of the waste off-site (Figure 5). Because the unlined pond was not backfilled, the excavation filled with rainwater and groundwater. The sludge at the bottom of the former unlined pond was considered a listed hazardous waste. In 1989, the owners of Talley's Pond (the off-property pond) dredged the pond sediment, placed the sediment around Talley's Pond and seeded the area. EPA added the Site to the Superfund program's National Priorities List (NPL) in March 1989.

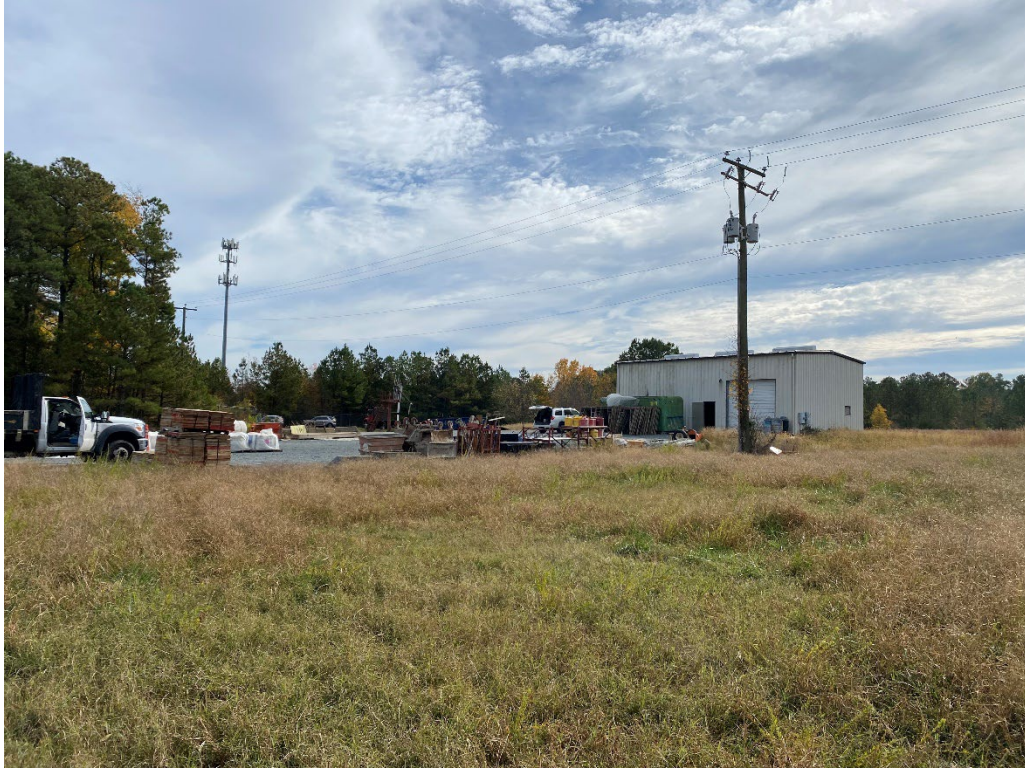
2.	Land Use Changes On Site <input type="checkbox"/> N/A		
Remarks: <u>New owner using non-capped area for storage of contractor equipment.</u>			
3.	Land Use Changes Off Site <input checked="" type="checkbox"/> N/A		
Remarks: _____			
VI. GENERAL SITE CONDITIONS

Contractor Storage Area and Water Facility Building

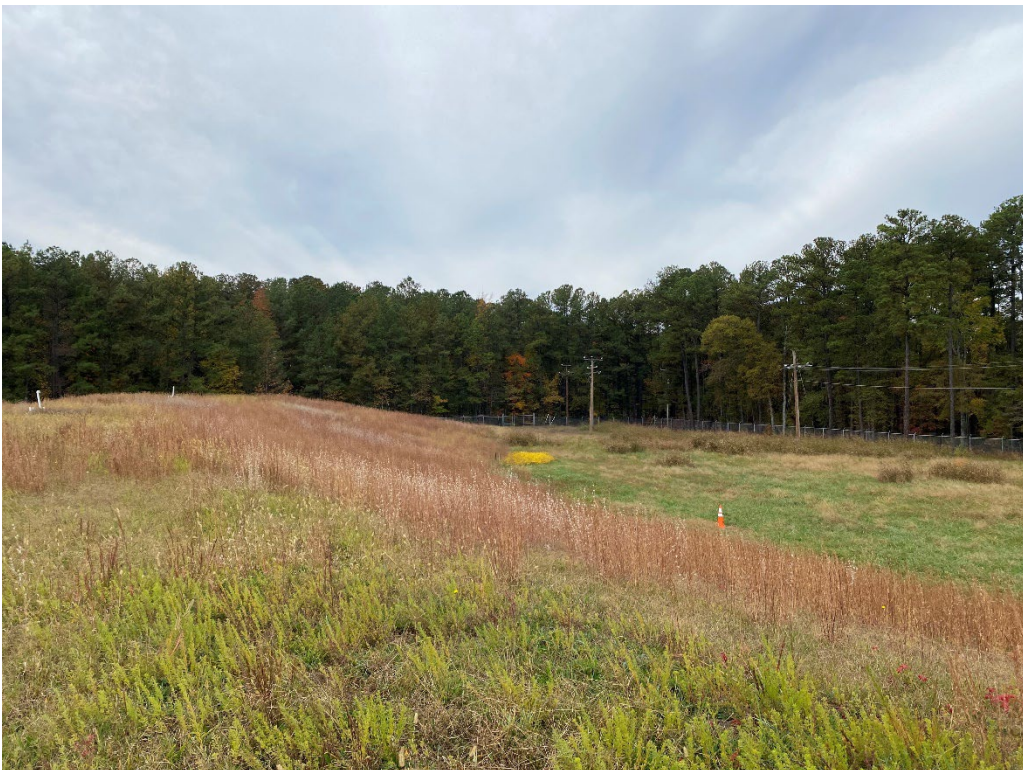
Site inspection participants returned to inspect the fenced cap and slurry-wall area. The four cap vents were also inspected. No damaged fencing was noted. The original and extended caps were in good condition and vegetation was well established. No erosion was evident. No issues were noted in these areas.

Capped Area, Facing West

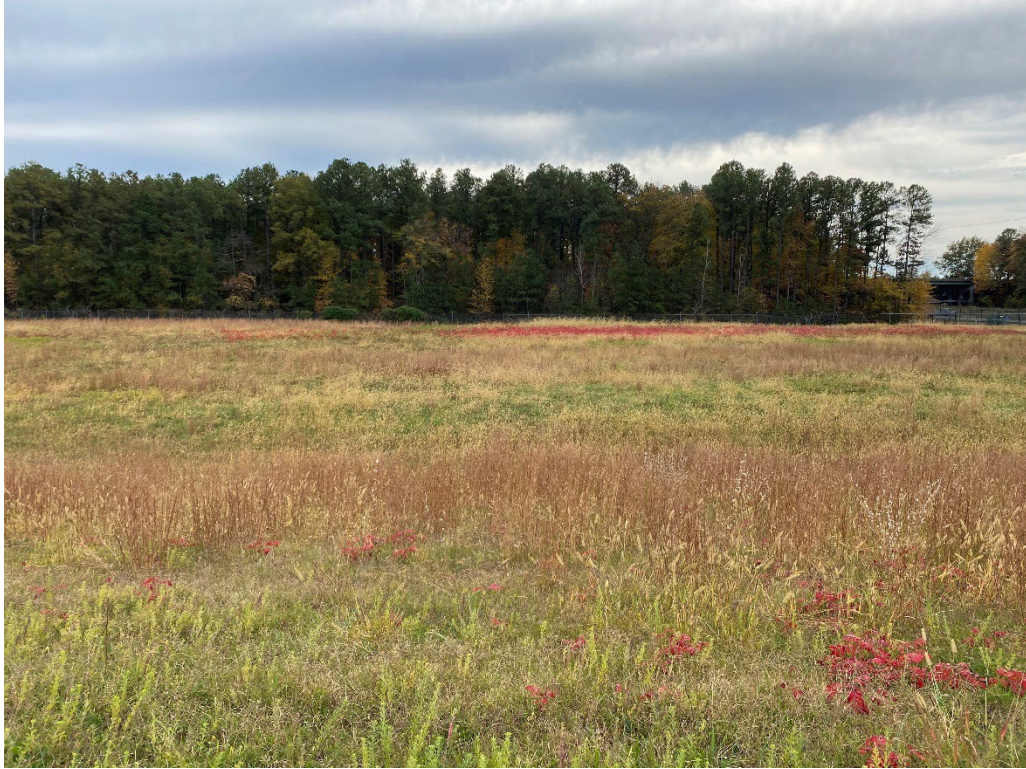
Capped Area, Facing South

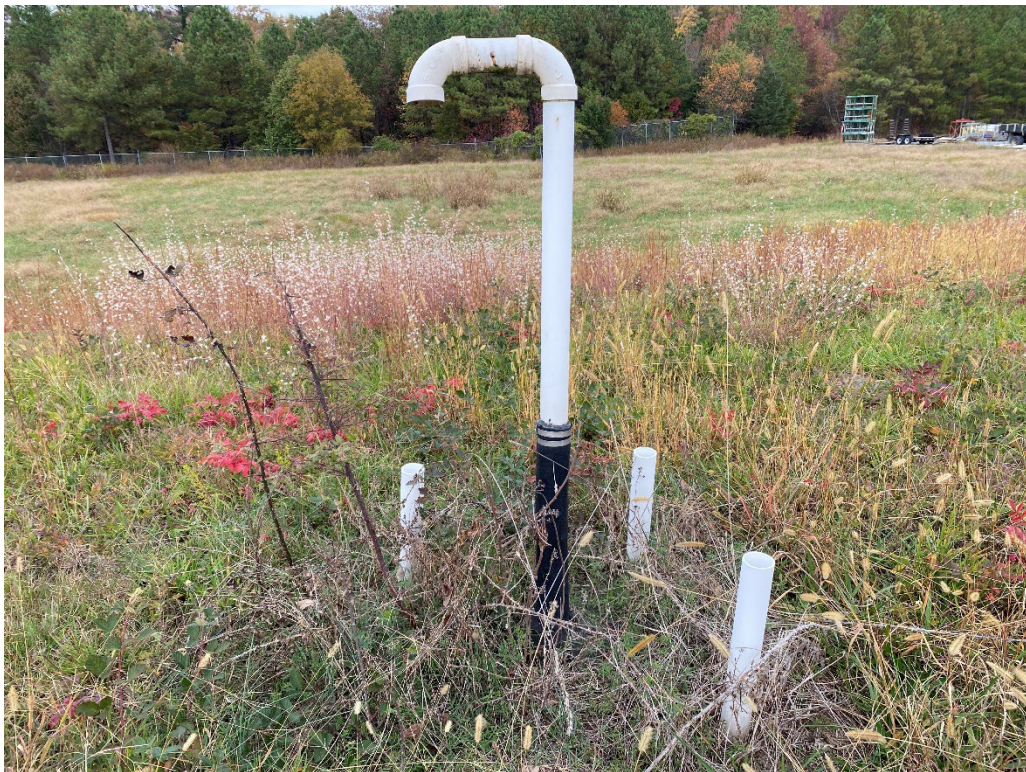
D. Cover Penetrations <input checked="" type="checkbox"/> Applicable <input type="checkbox"/> N/A			
1.	Gas Vents	<input type="checkbox"/> Active	<input checked="" type="checkbox"/> Passive
<input checked="" type="checkbox"/> Properly secured/locked		<input checked="" type="checkbox"/> Functioning	<input type="checkbox"/> Routinely sampled
<input type="checkbox"/> Evidence of leakage at penetration		<input type="checkbox"/> Needs maintenance	<input type="checkbox"/> N/A
<input checked="" type="checkbox"/> Good condition

Vent on Original Capped Area

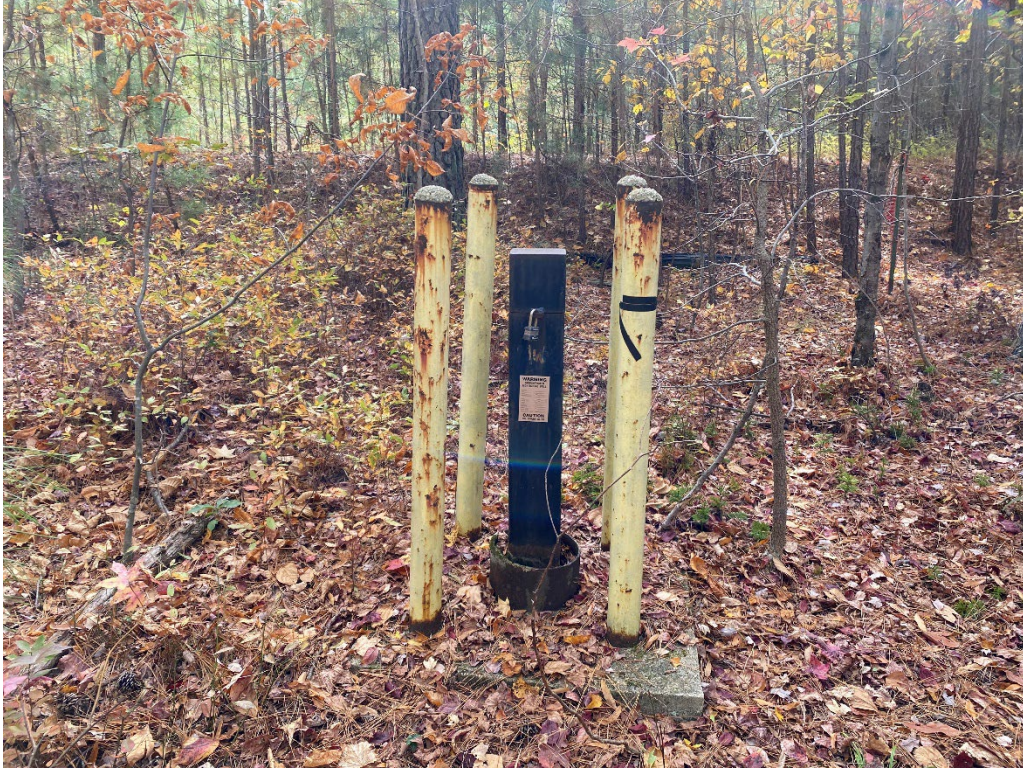
E. Monitored Natural Attenuation	
1.	Monitoring Wells (natural attenuation remedy) <input checked="" type="checkbox"/> Properly secured/locked <input checked="" type="checkbox"/> Functioning <input checked="" type="checkbox"/> Routinely sampled <input checked="" type="checkbox"/> Good condition <input checked="" type="checkbox"/> All required wells located <input type="checkbox"/> Needs maintenance <input type="checkbox"/> N/A Remarks: <u>Monitoring wells on site are used to assess the performance of the slurry wall and cap (not natural attenuation). All monitoring wells are secured with locks.</u>

Monitoring Well

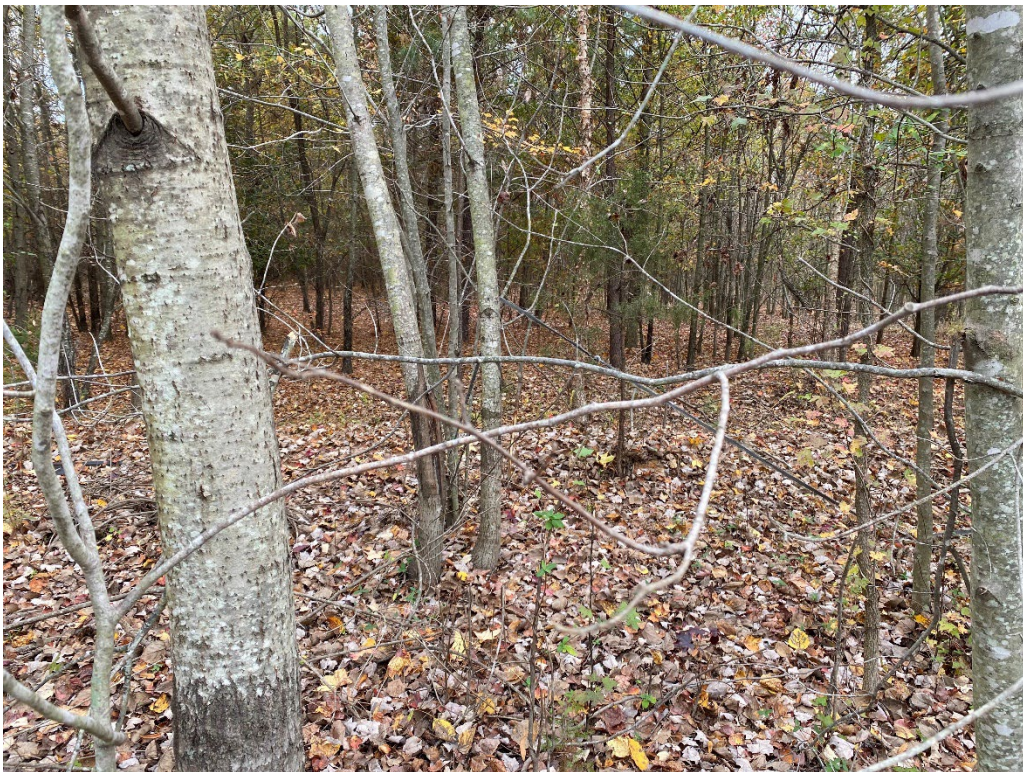
Next, the participants toured the inside of the water facility building. The owner is currently using the building for storage of contractor equipment. Site inspection participants left the water facility building and observed former Wetland Area B, which is fenced and supports well-established vegetation.

Former Wetland Area B
