**Five-Year Review Report**  
**Third Five-Year Review Report**  
**for**  
**Koppers Co., Inc. (Charleston Plant)**  
SCD980310239

**Charleston**  
**Charleston County, South Carolina**

June 2013

United States Environmental Protection Agency  
Region 4  
Atlanta, Georgia

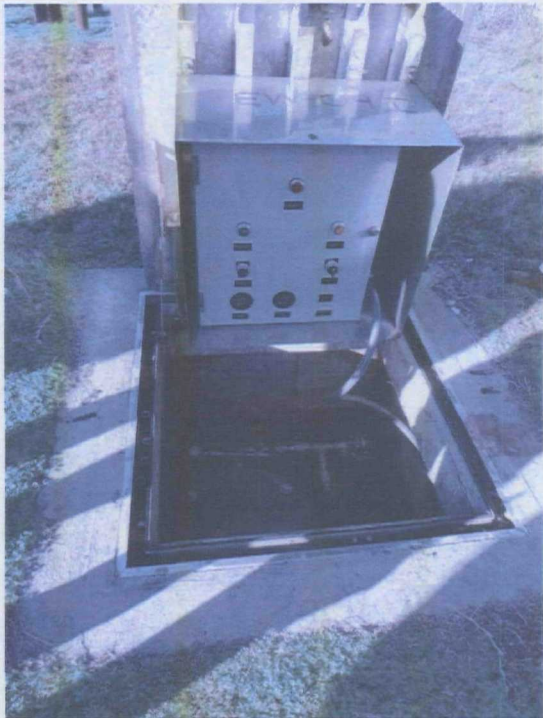
Extraction well

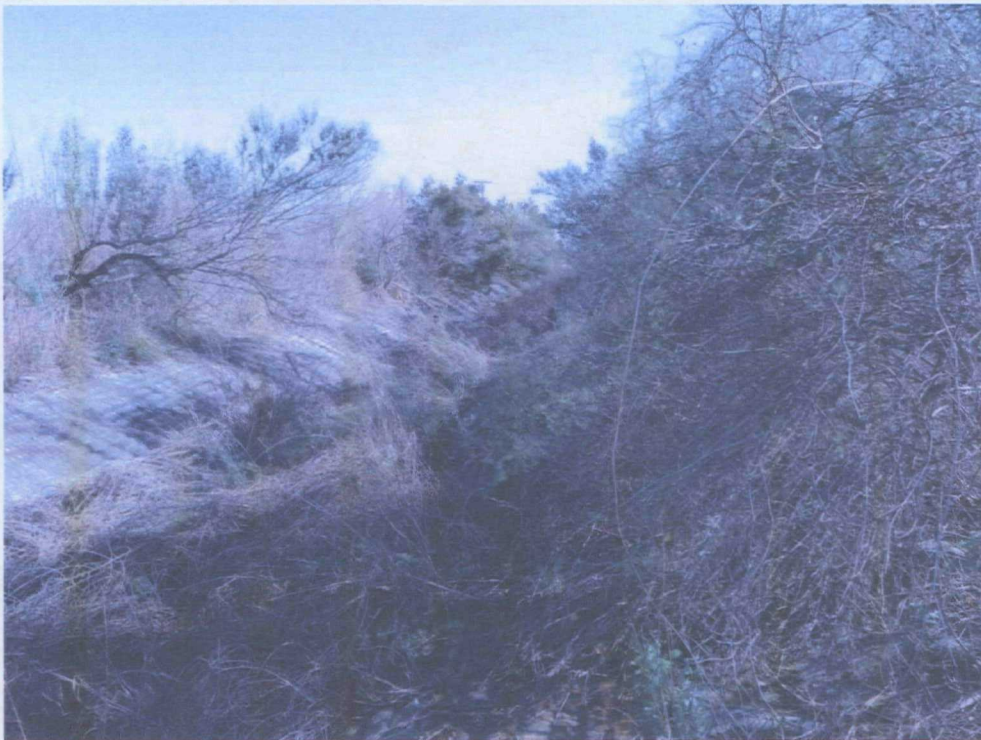
Site inspection attendees noted no deficiencies in the Site's engineered soil cover. Site inspection attendees noted that the Milford Street drainage ditch contained sediment and shrubs, and that the Hagood Avenue ditch contained sediment, trees and shrubs. Following the site inspection, EnviroSmart cleaned out the Milford Street ditch in January 2013. Section 9 of this FYR report recommends that the City of Charleston clean out the Hagood Avenue ditch in order to allow proper drainage.

Milford Street drainage ditch

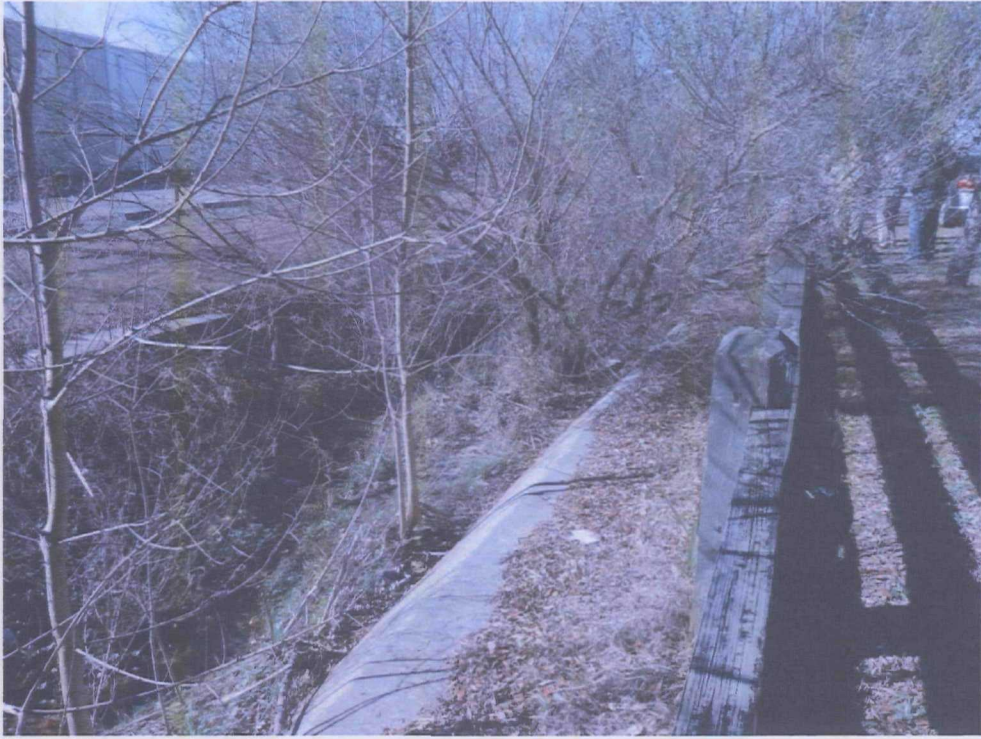
Based on the condition of the Hagood Avenue drainage ditch at the January 2013 FYR site inspection, it does not appear that the ditch was cleaned out as recommended in the 2008 FYR report. Section 9 of this FYR report recommends that the City of Charleston clean out the ditch in order to allow proper drainage.

Hagood Avenue drainage ditch

- The Hagood Avenue drainage ditch contains sediment, trees and shrubs. The EPA recommends that the City of Charleston clean out the ditch to promote proper drainage.
- The EPA recommends that Beazer ensure that all monitoring wells are properly locked.
- The Site's local document repository is not up to date. The EPA will update the document repository after this FYR report is finalized.
