Five-Year Review Report
Fifth Five-Year Review Report
for
A.L. Taylor (Valley of Drums)
KYD980500961

September 2013

The United States Environmental Protection Agency
Region 4
Atlanta, Georgia

**Fifth Five-Year Review Report
for
A.L. Taylor (Valley of Drums)
State Hwy 1020
Brooks
Bullitt County, Kentucky**

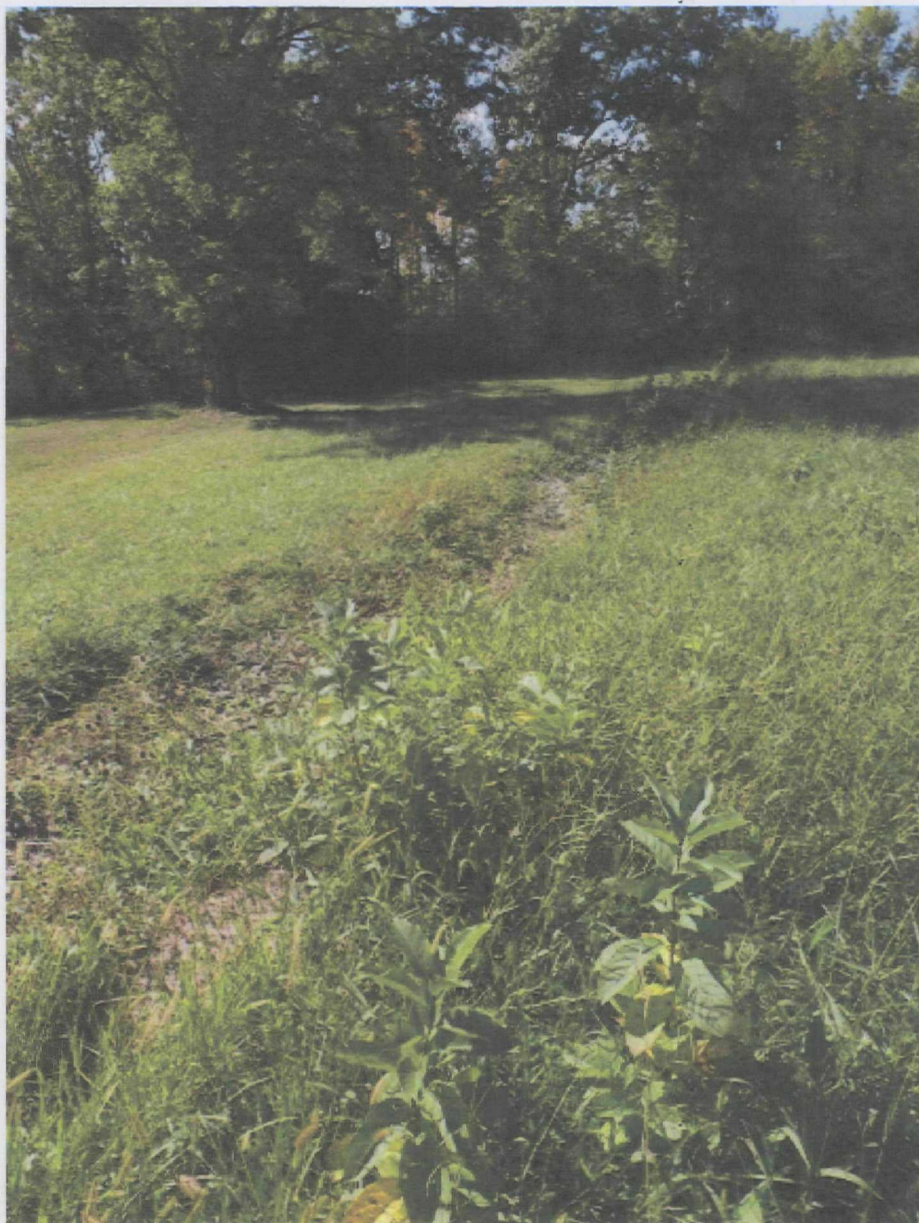
Perimeter ditch outside of fenced area on the southern portion of the Site near MW 6.

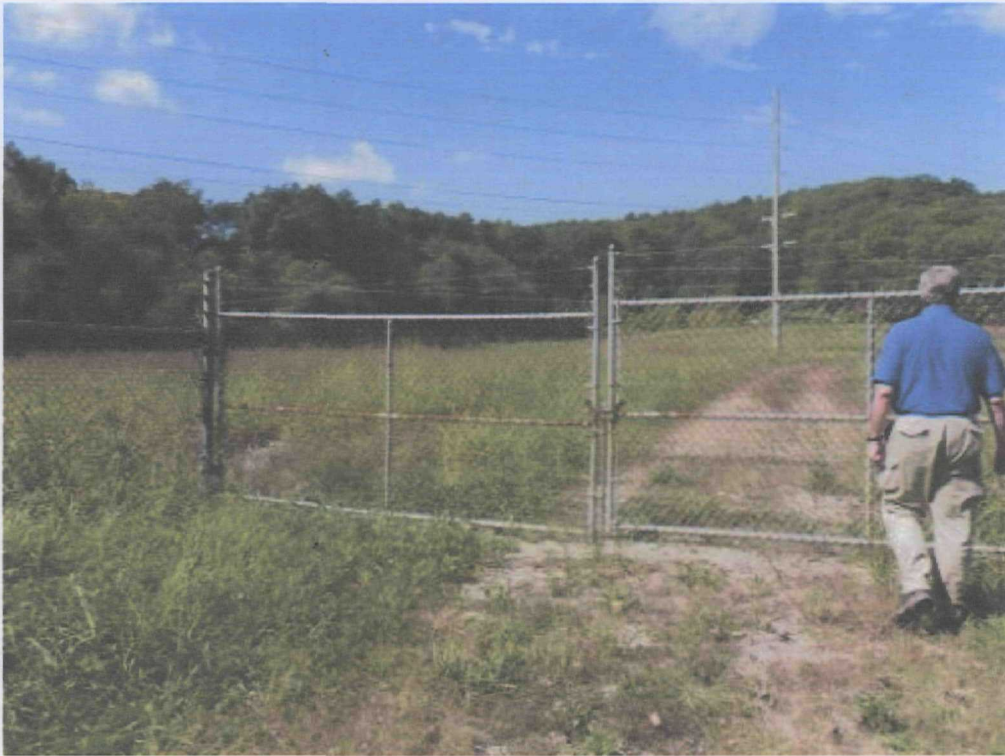
Locked and secured gate on the southern portion of the Site.

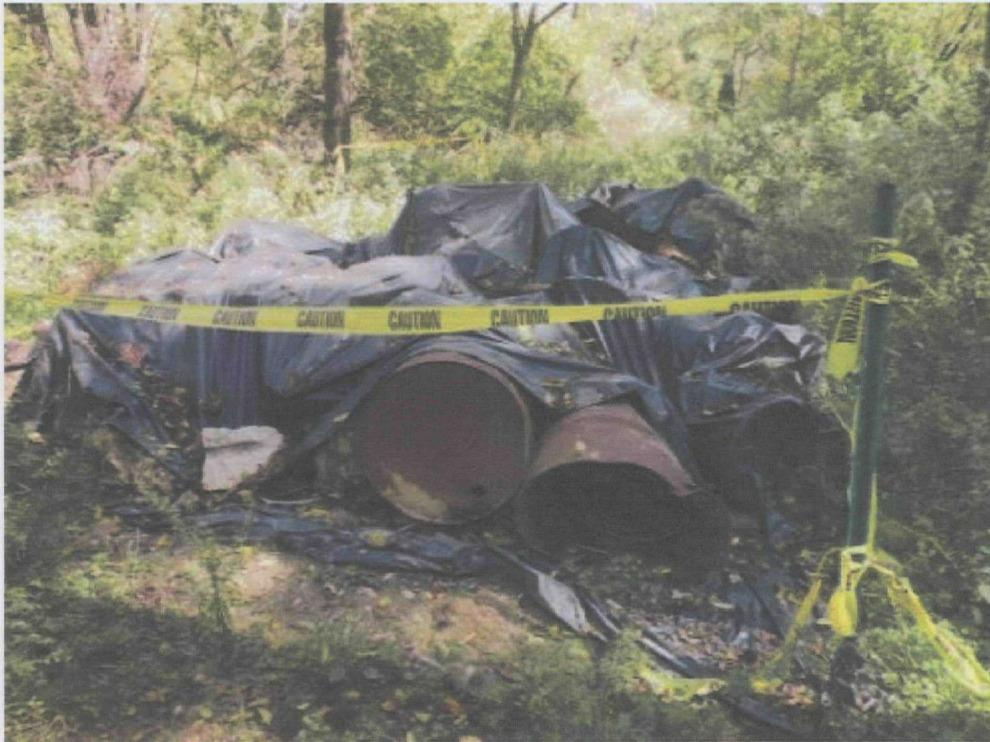
Site inspection participants also viewed the Jefferson Memorial site, located north of the Site. Excavated drum carcasses and temporary monitoring wells were observed. KDEP is working with relevant parties to conduct cleanup activities.

Excavated drums from the adjacent Jefferson Memorial site, located north of the Site.

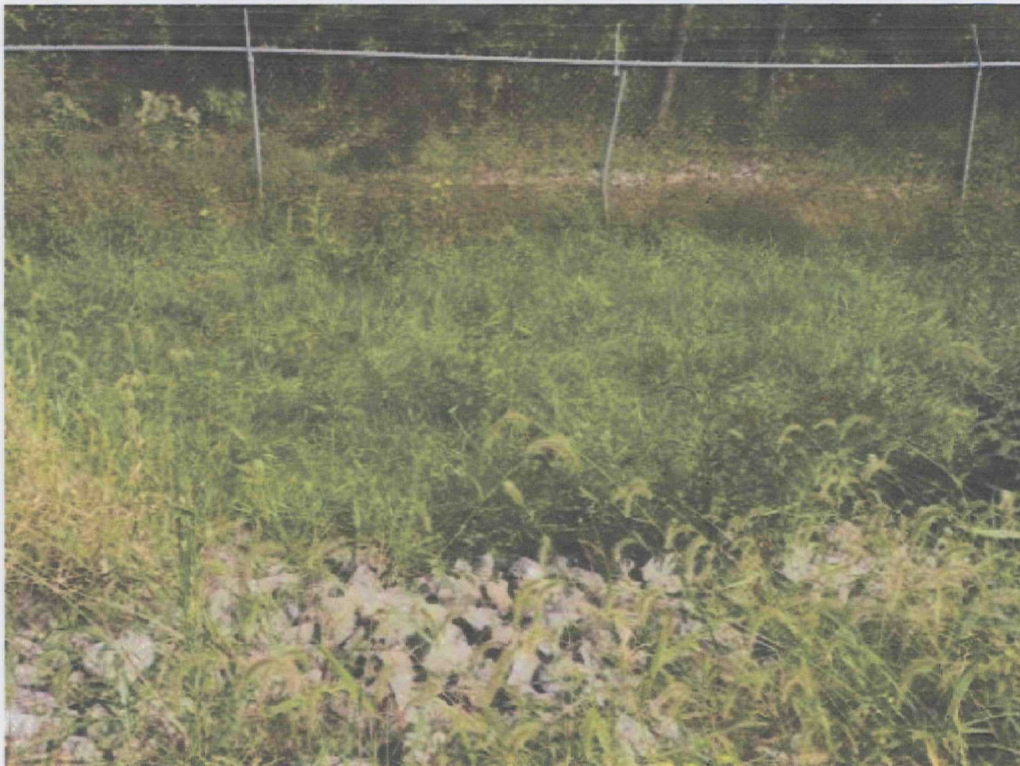
KDEP awarded a contract to the O&M contractor in 2008 for mowing, cap maintenance and vegetation control activities at the Site. KDEP's O&M contractor began semiannual O&M activities at the Site in 2009. Although O&M activities have taken place on a regular basis, site inspection participants observed overgrowth of vegetation on the cap within the fenced area of the Site during the October 2012 site inspection. Overgrowth of vegetation may impede the letdown channels on the cap from functioning properly.

Overgrown letdown channel along the eastern fence line of the Site.

- Remove any vegetation causing the drainage ditch to function improperly.

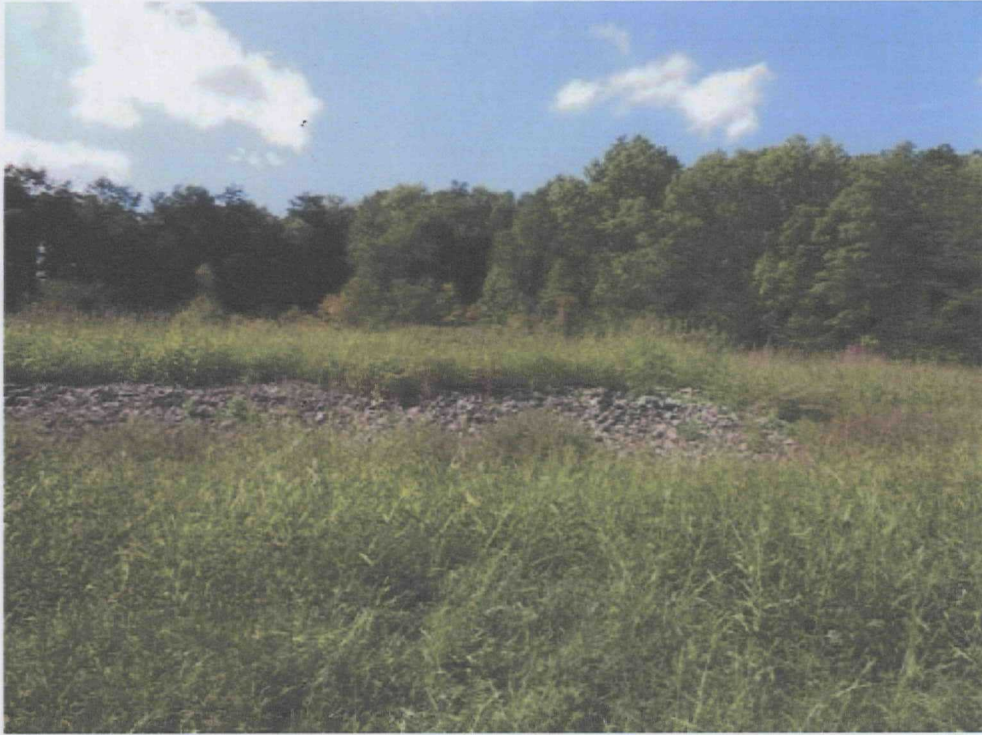
Letdown channel in the northwestern portion of the fenced site area.

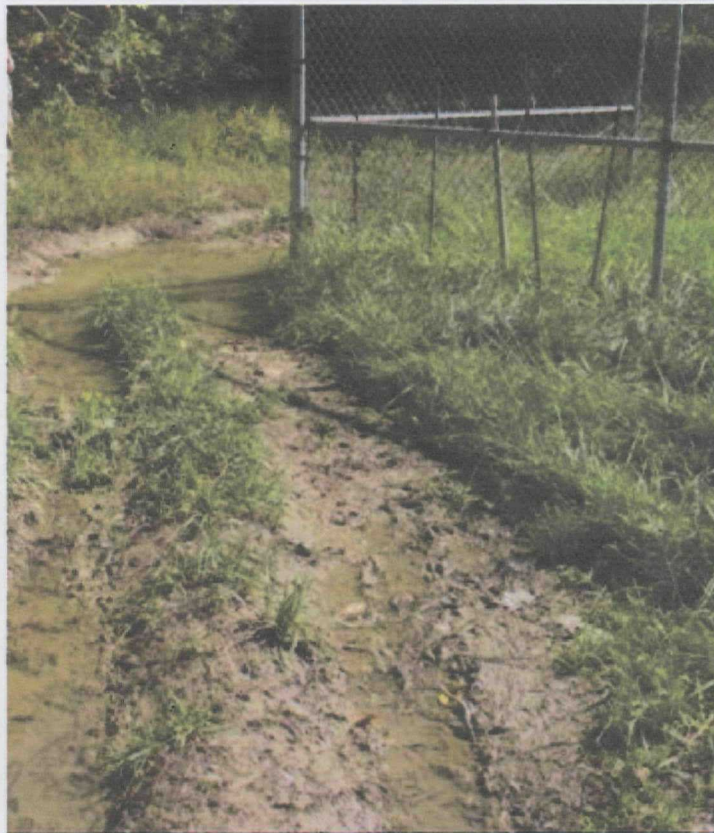
Investigations of the ponding on the southeast side of the Site's fenced area are ongoing. During the October 2012 site inspection, participants observed the grass on the east side of the Site pushed down in the direction of the area where water historically ponds on the Site. There appears to be overgrowth of vegetation in the letdown channels on the cap, which may impede water moving off the cap and therefore be contributing to the ponding of water near the fence line on the southeast side of the Site.

Ponding water and raised/missing fence on the eastern portion of the Site.

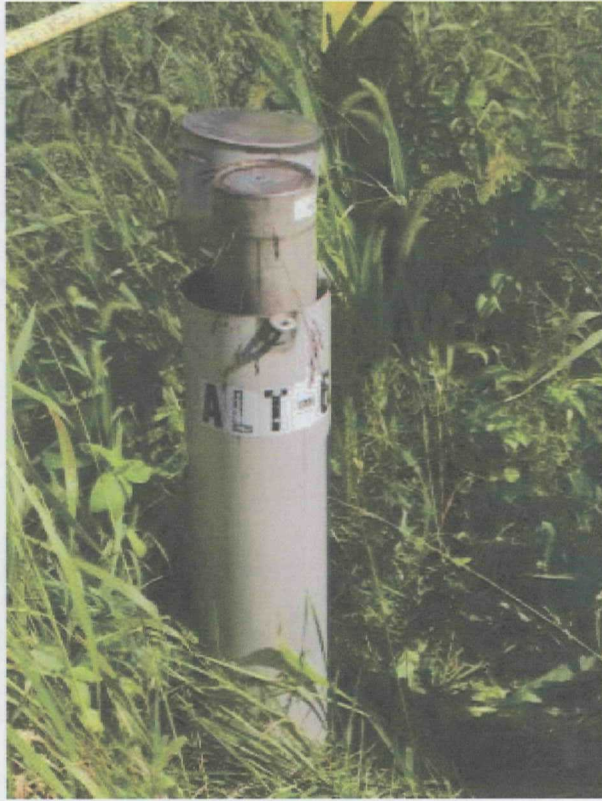
MW 6.

During the October 3, 2012 site inspection, participants observed that each of the twelve ground water monitoring wells at the Site had been cleaned. KDEP conducted annual ground water sampling in 2010 and 2011.

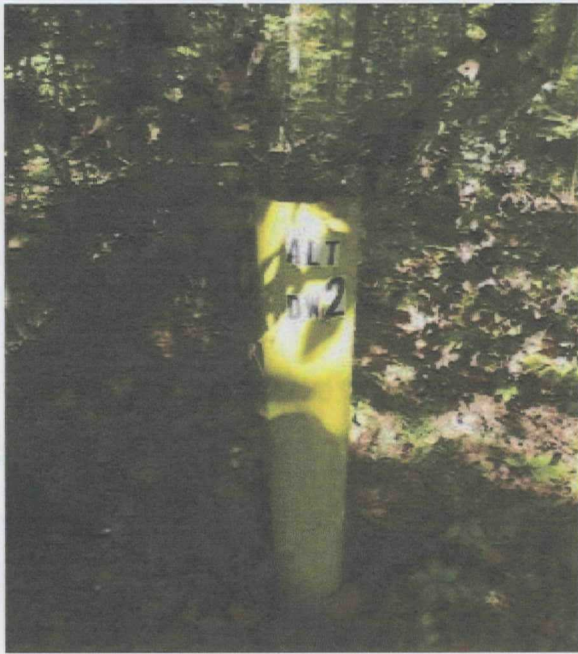
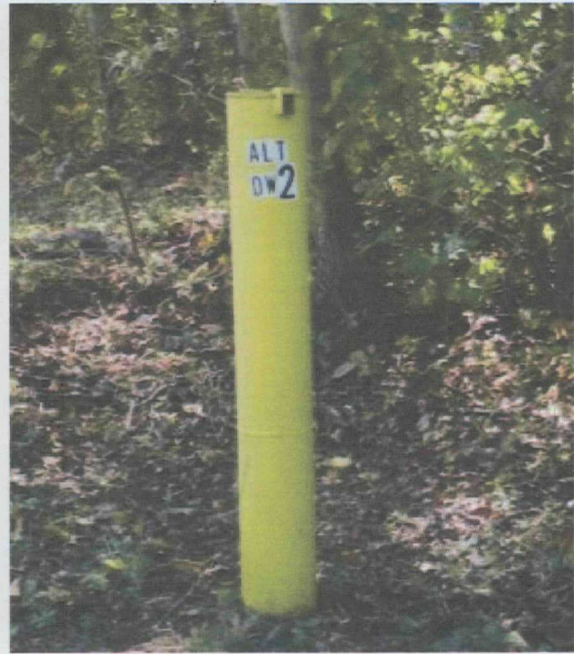
- An unmarked pipe remains just outside of the cap near MW 10.
- Site inspection participants found two undocumented wells, both of which were labeled MW DW2. Participants observed these wells to be in good condition but unlocked.
- The EPA should provide the Bullitt County Public Records Office with public water supply data collected for properties surrounding the Site so that Bullitt County can update its property record information cards as necessary.

Undocumented wells, both marked ALT DW2, near MW 6 and MW 11.

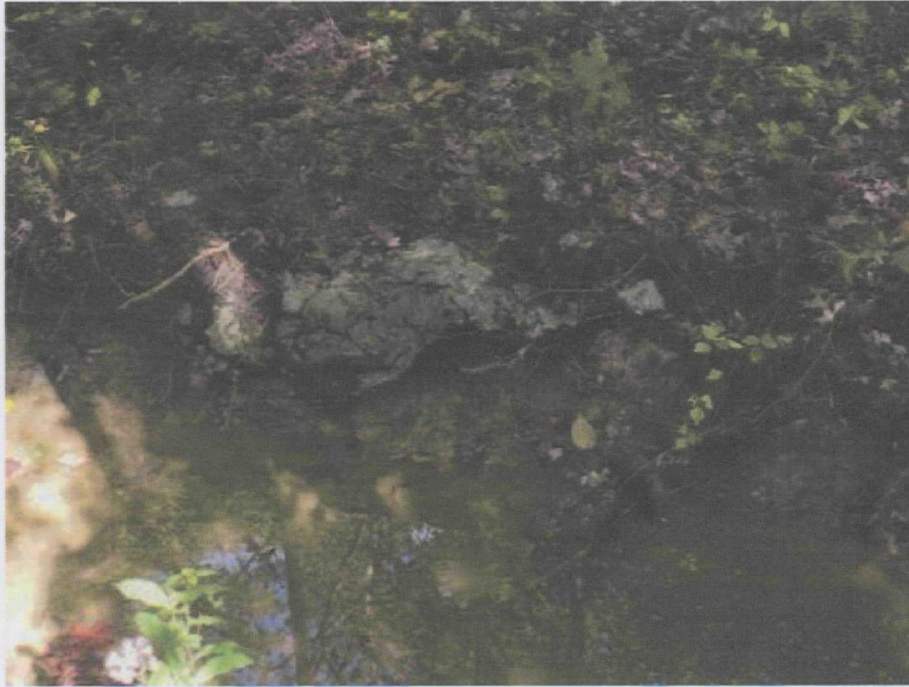
Waste disposal and drum storage operations at the Site resulted in contamination of ground water, surface water, soil and sediment. Contaminated materials, including ponded sediments, sludge and waste materials excavated outside the capped area, are located beneath the capped landfill. Site investigations found hardened sludge and drum carcasses in Wilson Creek as recently as 2011.

Paint sludge in Wilson Creek.
