**THIRD FIVE-YEAR REVIEW REPORT FOR  
SANGAMO WESTON, INC./TWELVEMILE CREEK/LAKE HARTWELL PCB  
CONTAMINATION SUPERFUND SITE  
PICKENS COUNTY, SC**

**U.S. Environmental Protection Agency**

**Region 4 Superfund Division**

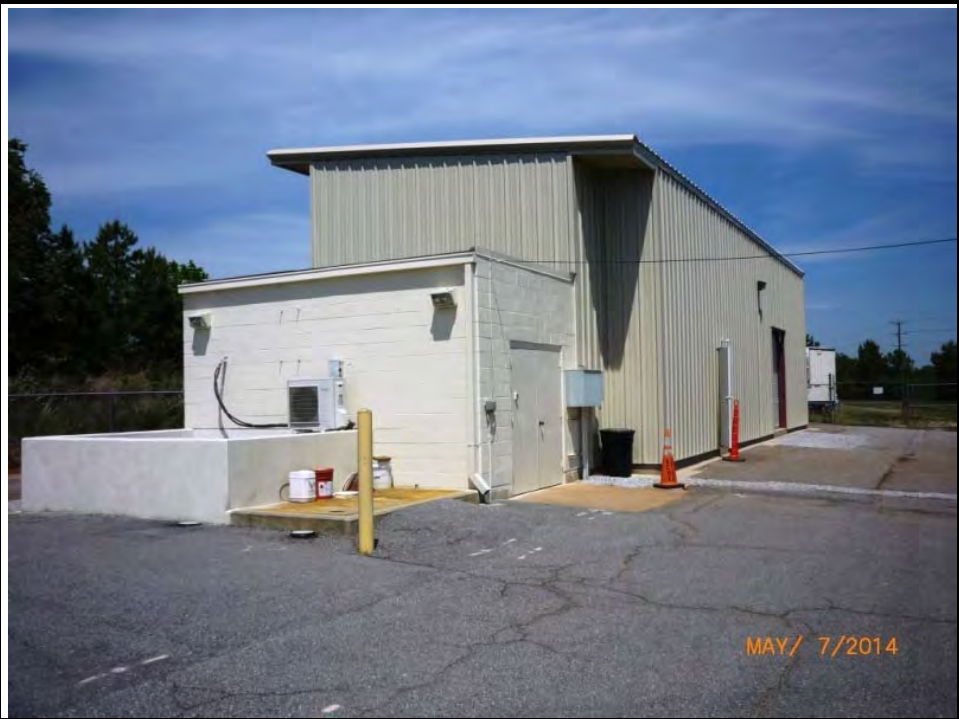
**Description**  
*Plant Site*  
 Wastewater Treatment Plant (WWTP) Building

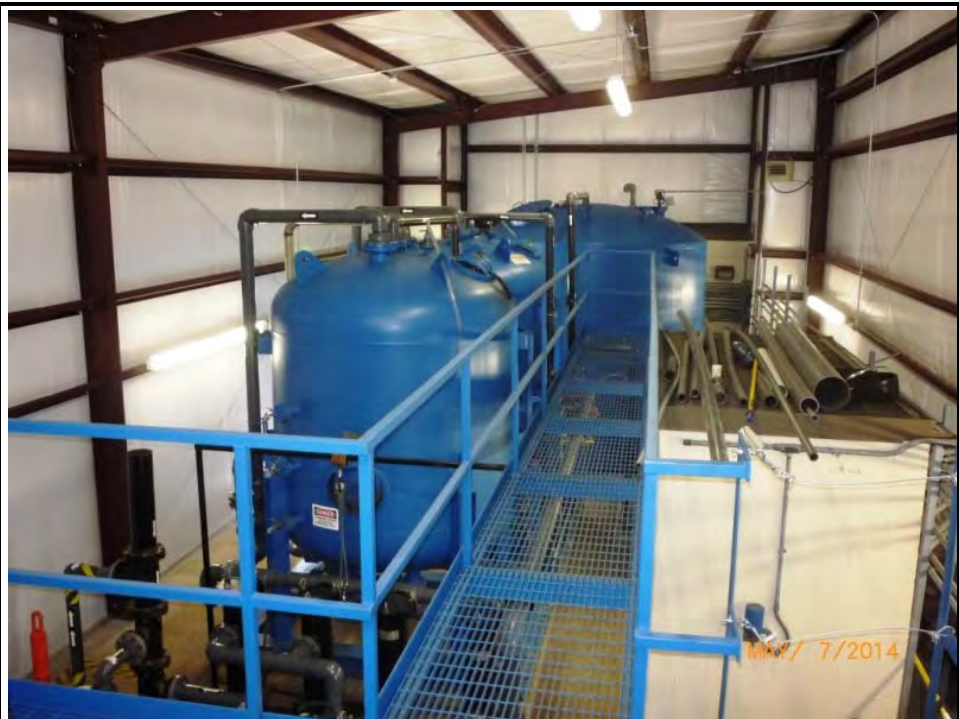
<b>Photo No.</b>	<b>Date</b>
2	5-7-2014

**Description**  
*Plant Site*  
 WWTP Interior

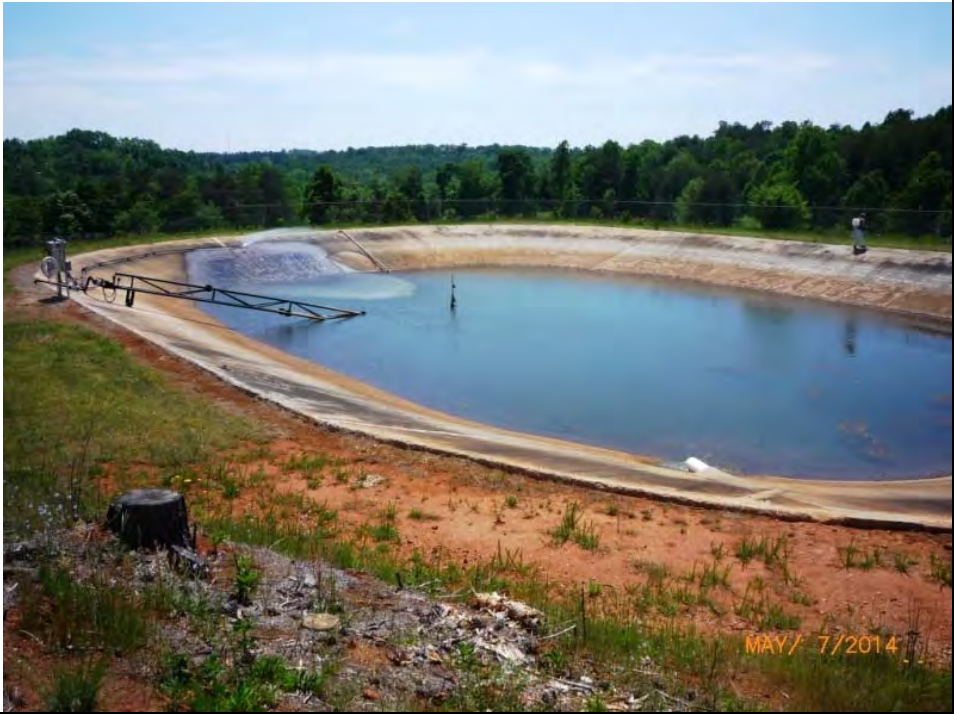
<b>Client Name:</b> Schlumberger Technology Corporation		<b>Site Location:</b> Operable Unit One (OU1)
<b>Photo No.</b> 3	<b>Date</b> 5-7-2014

<b>Description</b> <i>Plant Site</i> WWTP Equalization Basin

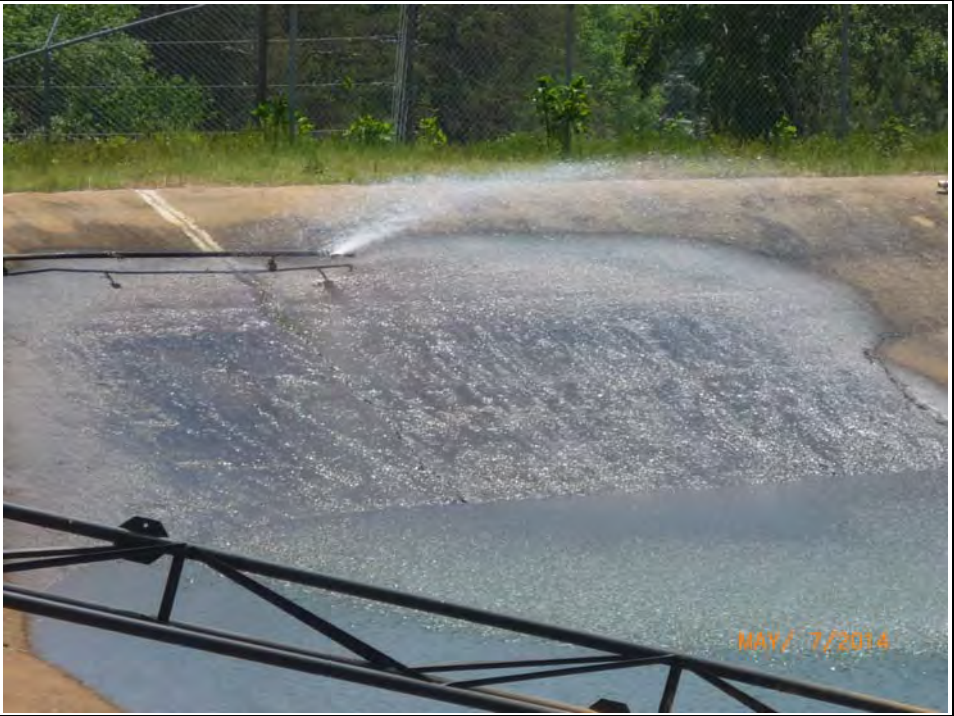
<b>Photo No.</b> 4	<b>Date</b> 5-7-2014

<b>Description</b> <i>Plant Site</i> Equalization Basin Aeration System

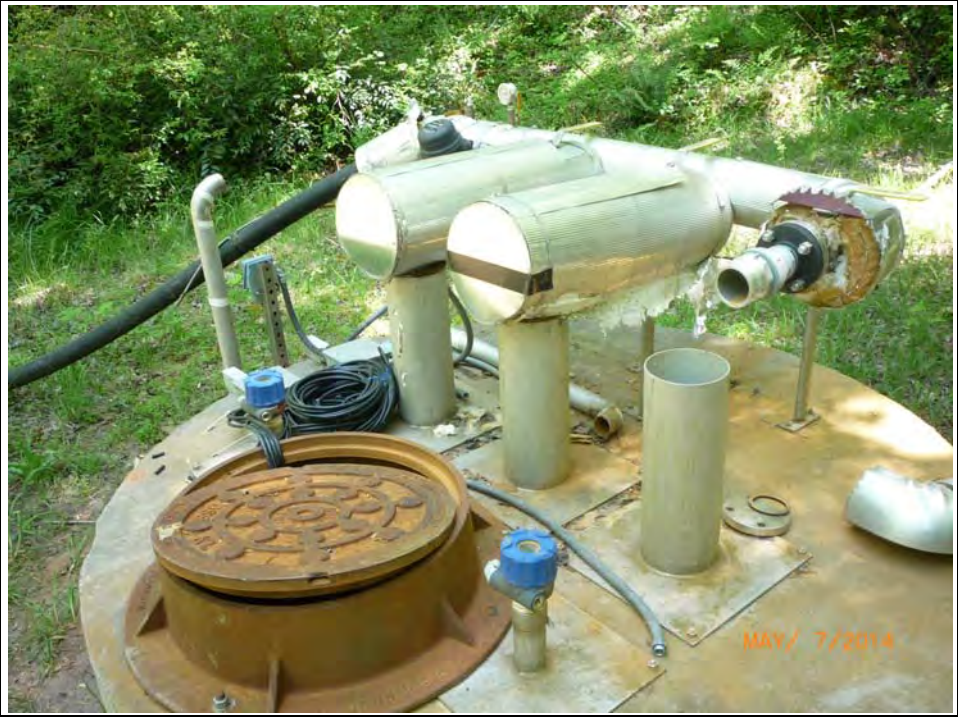
<b>Photo No.</b>	<b>Date</b>
7	5-7-2014

**Description**  
*Plant Site*  
 Area 2 – Sump

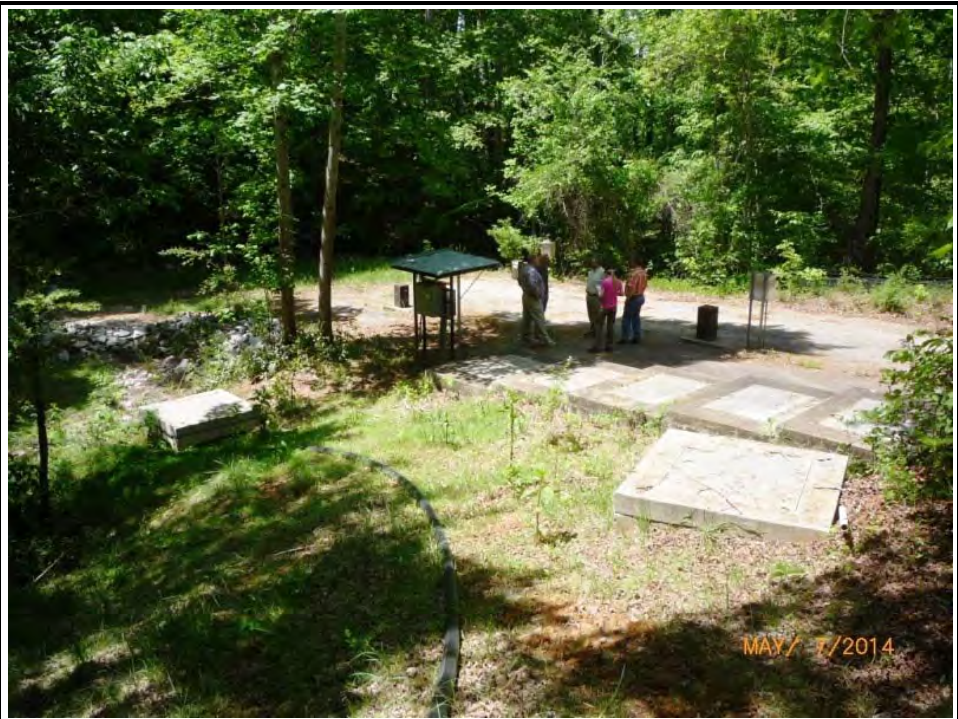
**Description**  
*Plant Site*  
 Area 2 Groundwater Seep Collection System

- During the Stormwater Control system repair, a 30-inch groundwater collection sump with a sump pump controlled by a float switch was installed below the Stormwater Control system to collect transition zone water at bedrock. The new sump system has been operating since installation, producing an estimated average 6 gpm during dry periods of non-precipitation and up to 20 gpm after storm events.

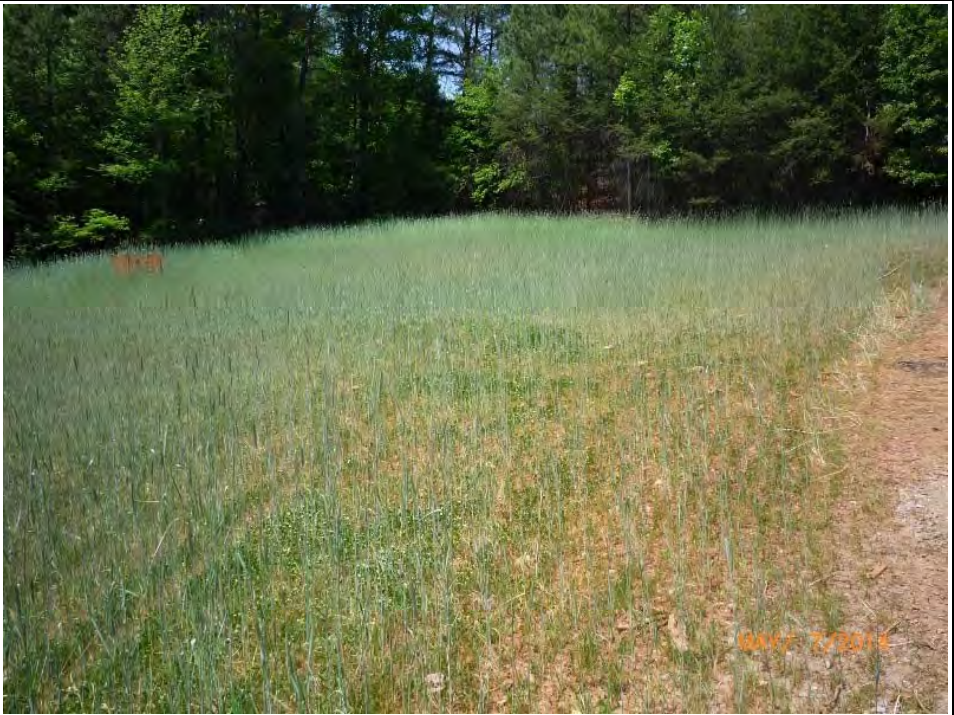
9	5-7-2014	
<b>Description</b>

<i>Plant Site</i> Area H – Post Excavation and Infiltration Gallery		
<b>Description</b>

In November 2012, STC completed an excavation of hot spot soils and installation of an infiltration gallery for further ISCO treatments. The work was conducted in accordance with the work plan approved by SC DHEC (Geosyntec Consultants 2012) and associated underground injection control permits. During the work, STC excavated approximately 561 tons of VOC-impacted soil and transported the waste offsite for disposal at the Upstate Regional Municipal Solid Waste Landfill in Enoree, Union County, South Carolina. STC backfilled the excavation with approximately 365 tons of clean #57 stone and subsurface piping to create the infiltration gallery.

In December 2012, STC tested the infiltration gallery with about 200 gallons of potable water, and then placed approximately 9,000 gallons of ISCO solution averaging 1.1 percent sodium permanganate into the gallery. The rate of injection (14 gallons per minute [gpm]) was sufficiently slow that minimal groundwater mounding and displacement were measured in downgradient monitoring wells.

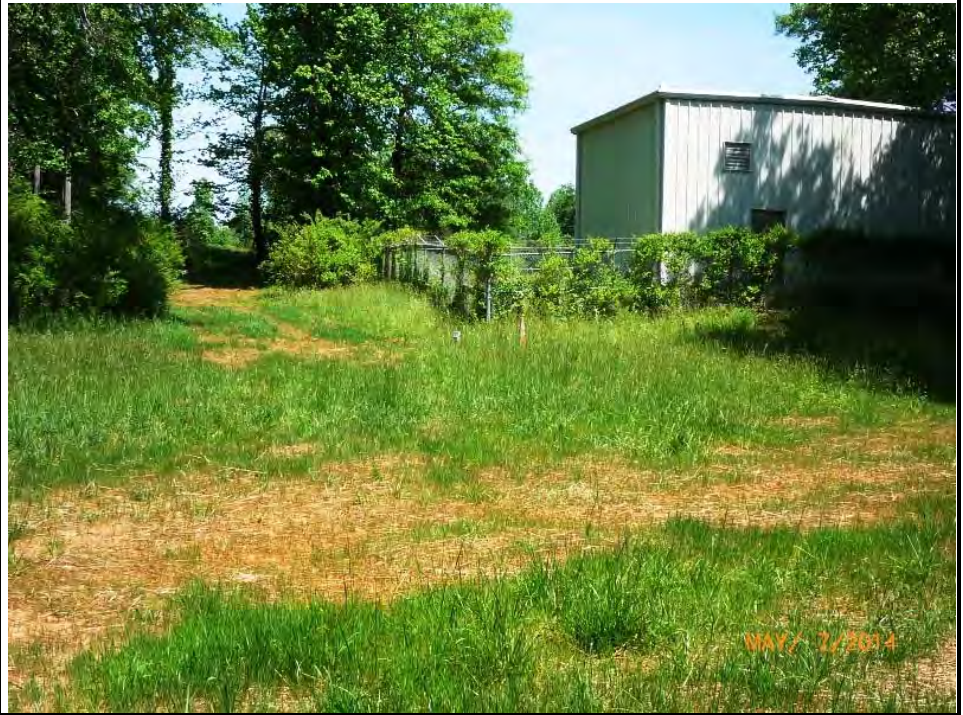
**Description**  
*Breazeale Site*  
 Exterior of Decommissioned  
 WWTP Building

- In early 2013 the National Pollutant Discharge Elimination System (NPDES) permit for Breazeale was rescinded and the wastewater treatment plant (WWTP) and associated wells were abandoned in the last half of 2013 and the beginning of 2014.
- Groundwater monitoring will continue to be conducted annually.
- Additional groundwater investigation in the September 2014 to refine the location of elevated groundwater concentration
- In December 2014, ISCO injections were completed in a number of borings targeted within the elevated groundwater concentration areas.

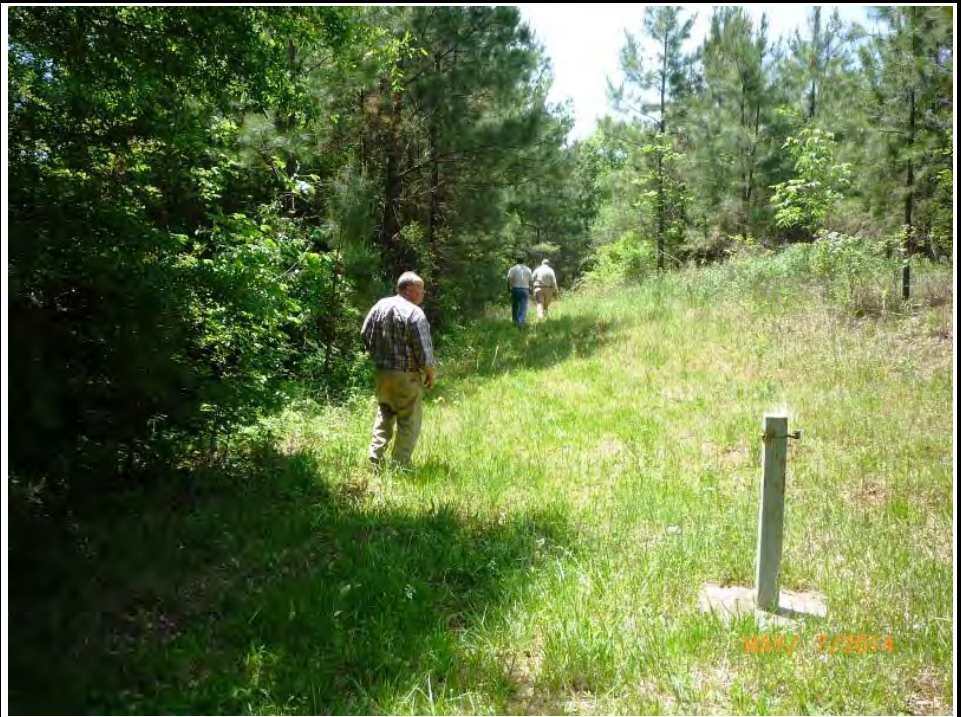
<b>Photo No.</b>	<b>Date</b>
14	5-7-2014

**Description**  
*Secure Landfill*  
 Monitoring Well

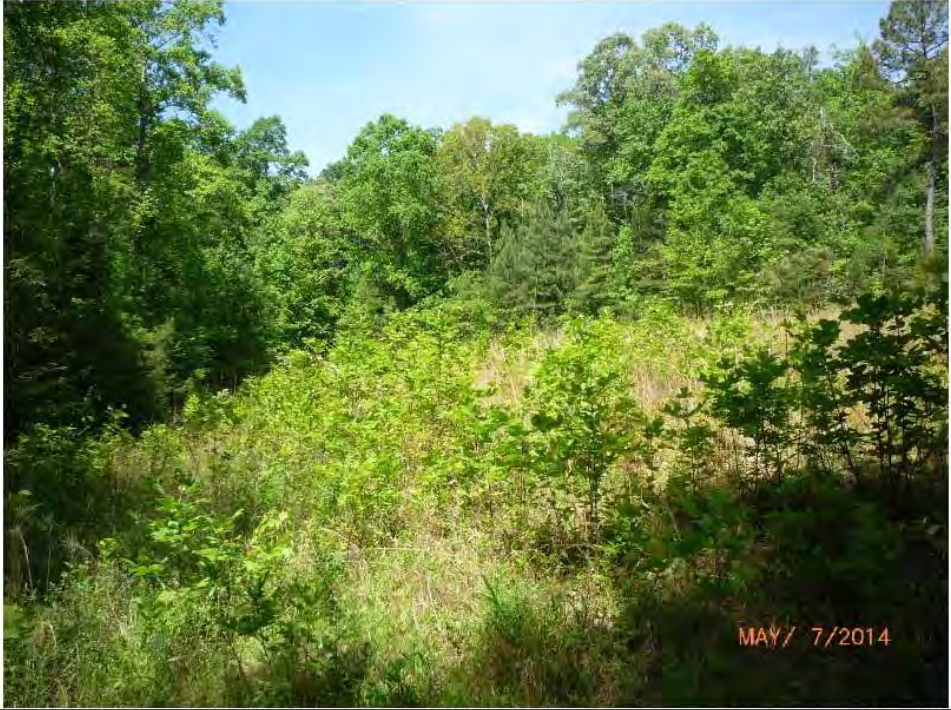
<b>Client Name:</b> Schlumberger Technology Corporation		<b>Site Location:</b> Operable Unit One (OU1)
<b>Photo No.</b> 15	<b>Date</b> 5-7-2014

<b>Description</b> <i>Cross Roads Site</i> View of Site

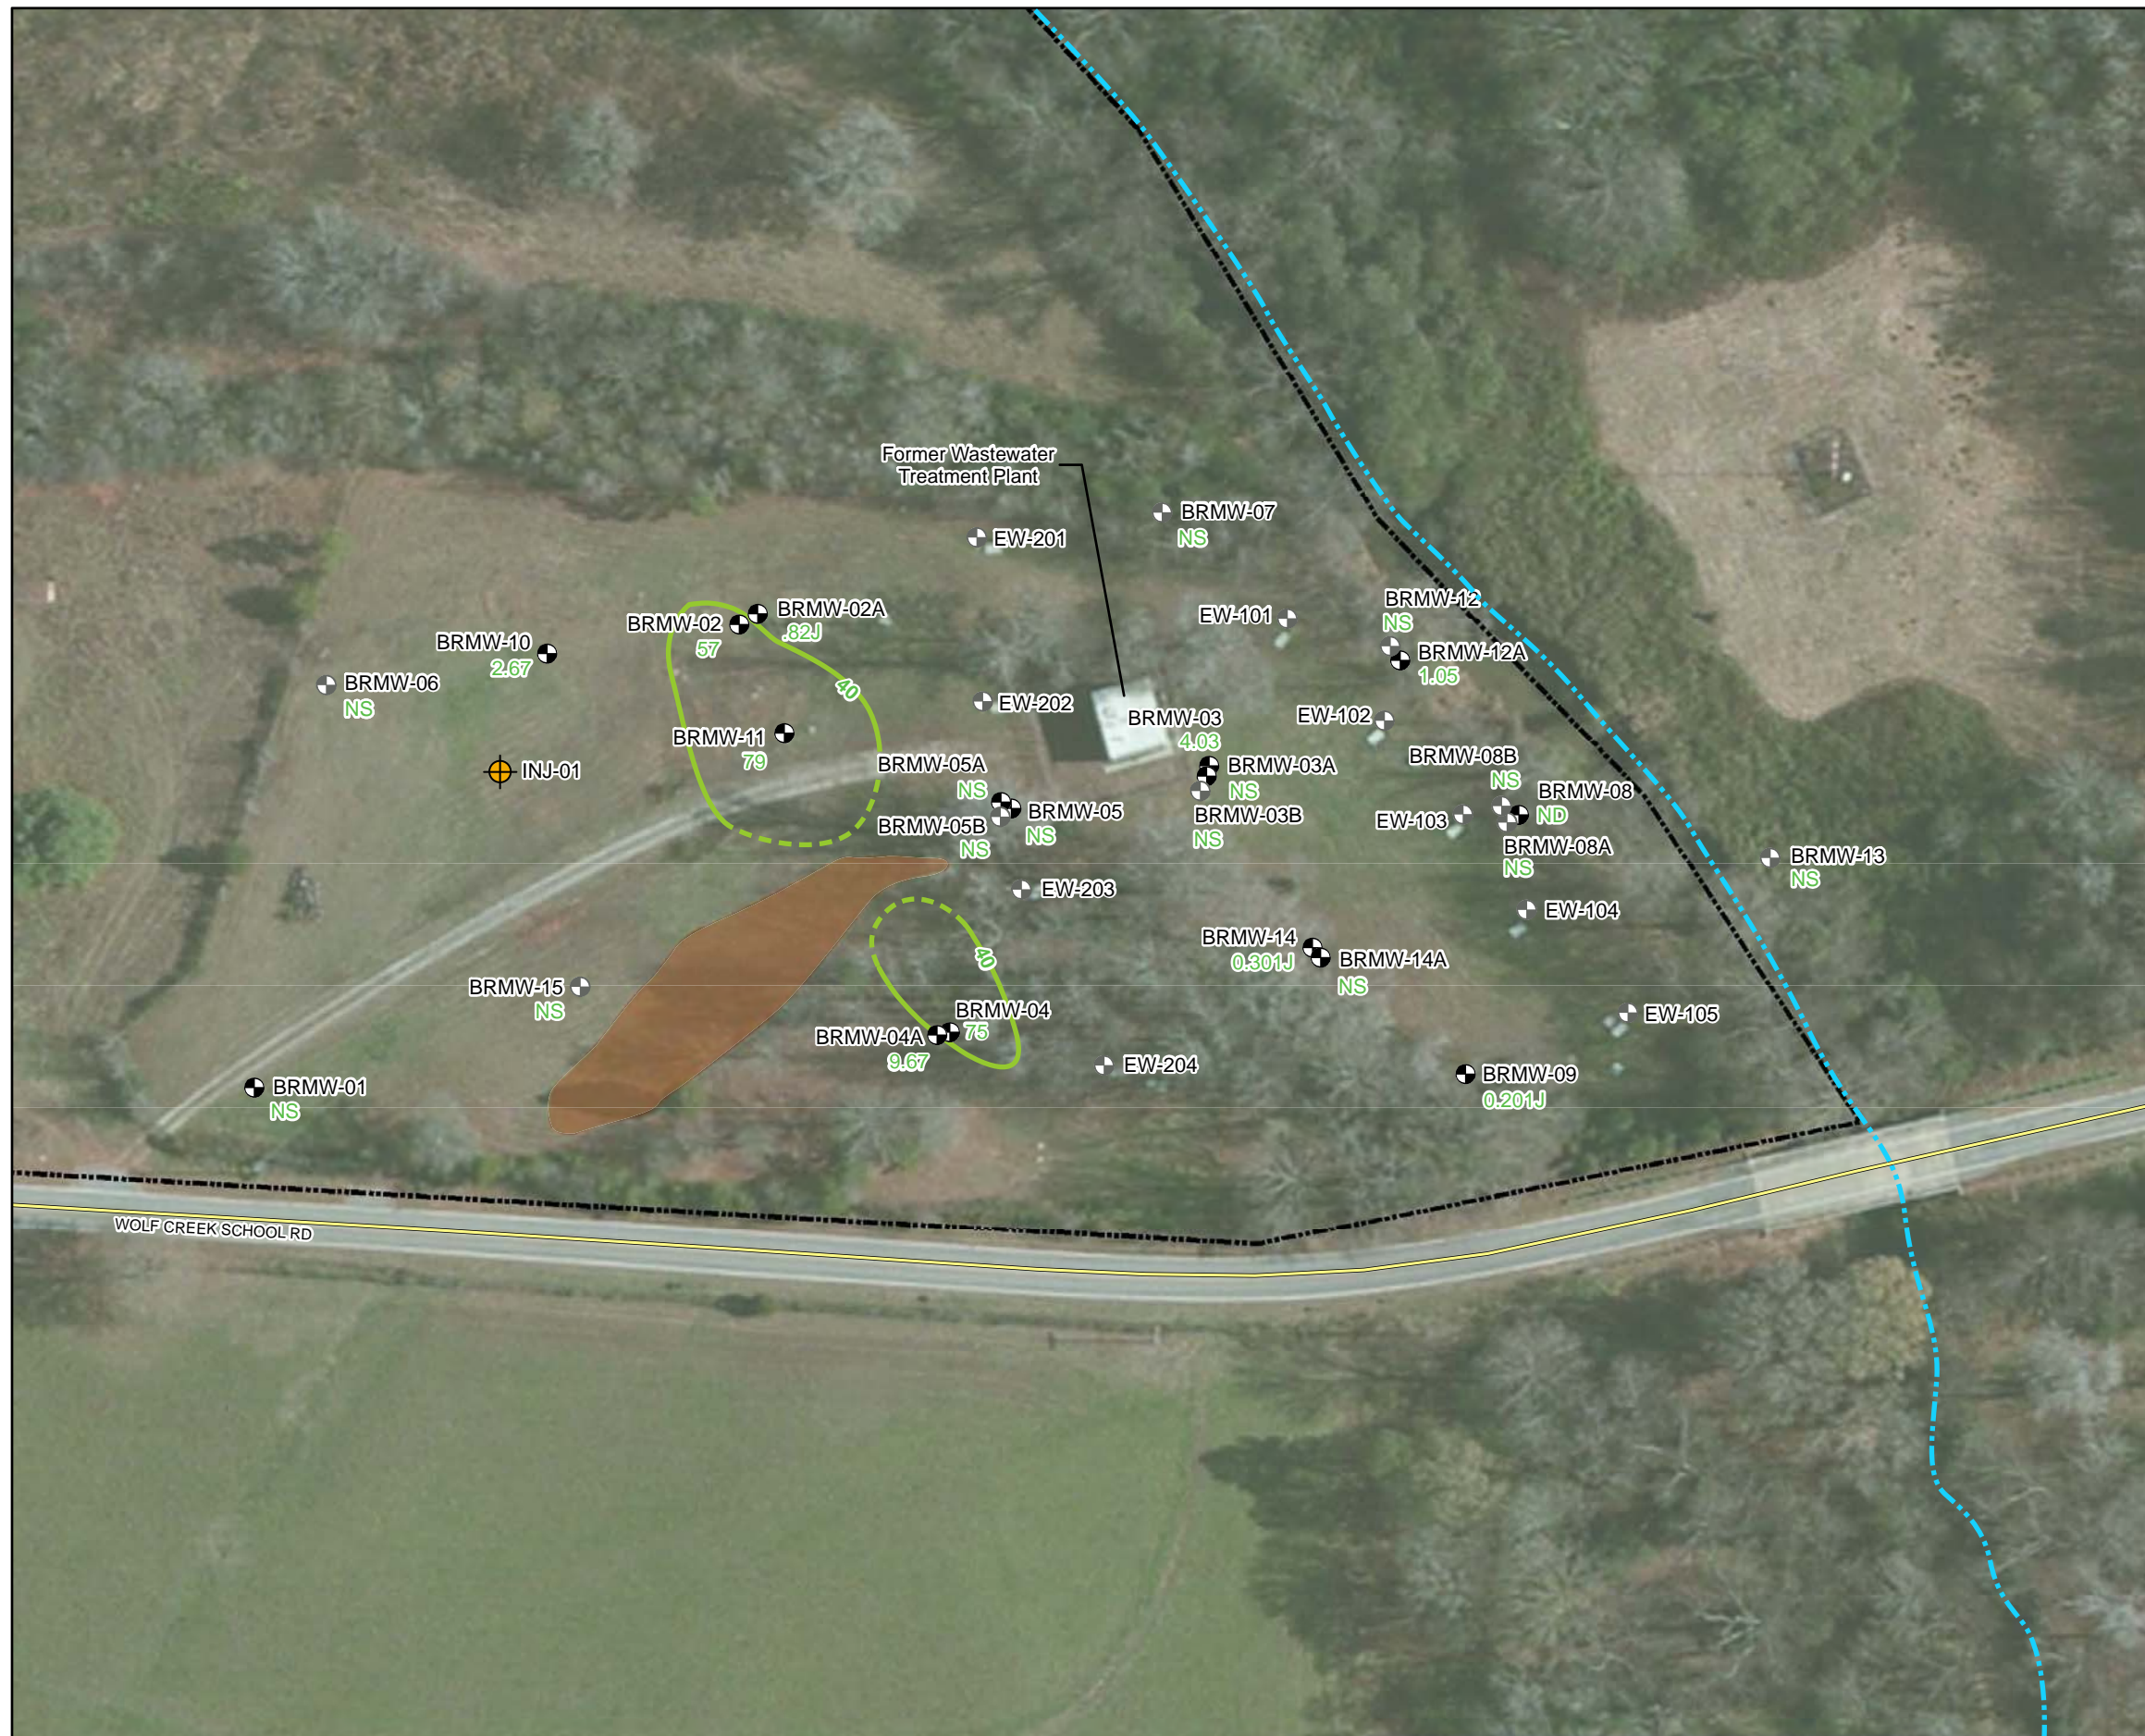
**FIGURE 7**  
**Plant Site PCB Concentrations in Groundwater**  
**March 2014**  
**Third Five-Year Review Report**  
**Sangamo Weston Site, Pickens, South Carolina**

Aroclor 1242 was the only PCB detected and was above the Performance Standard in 4 of the 17 wells analyzed for PCBs. As shown on Figure 7 (Appendix B), only concentrations above the Performance Standard of 0.5 µg/L were plotted with isocontours. Source Areas D and B contained exceedances indicating a plume at Area B migrating toward the southeast.

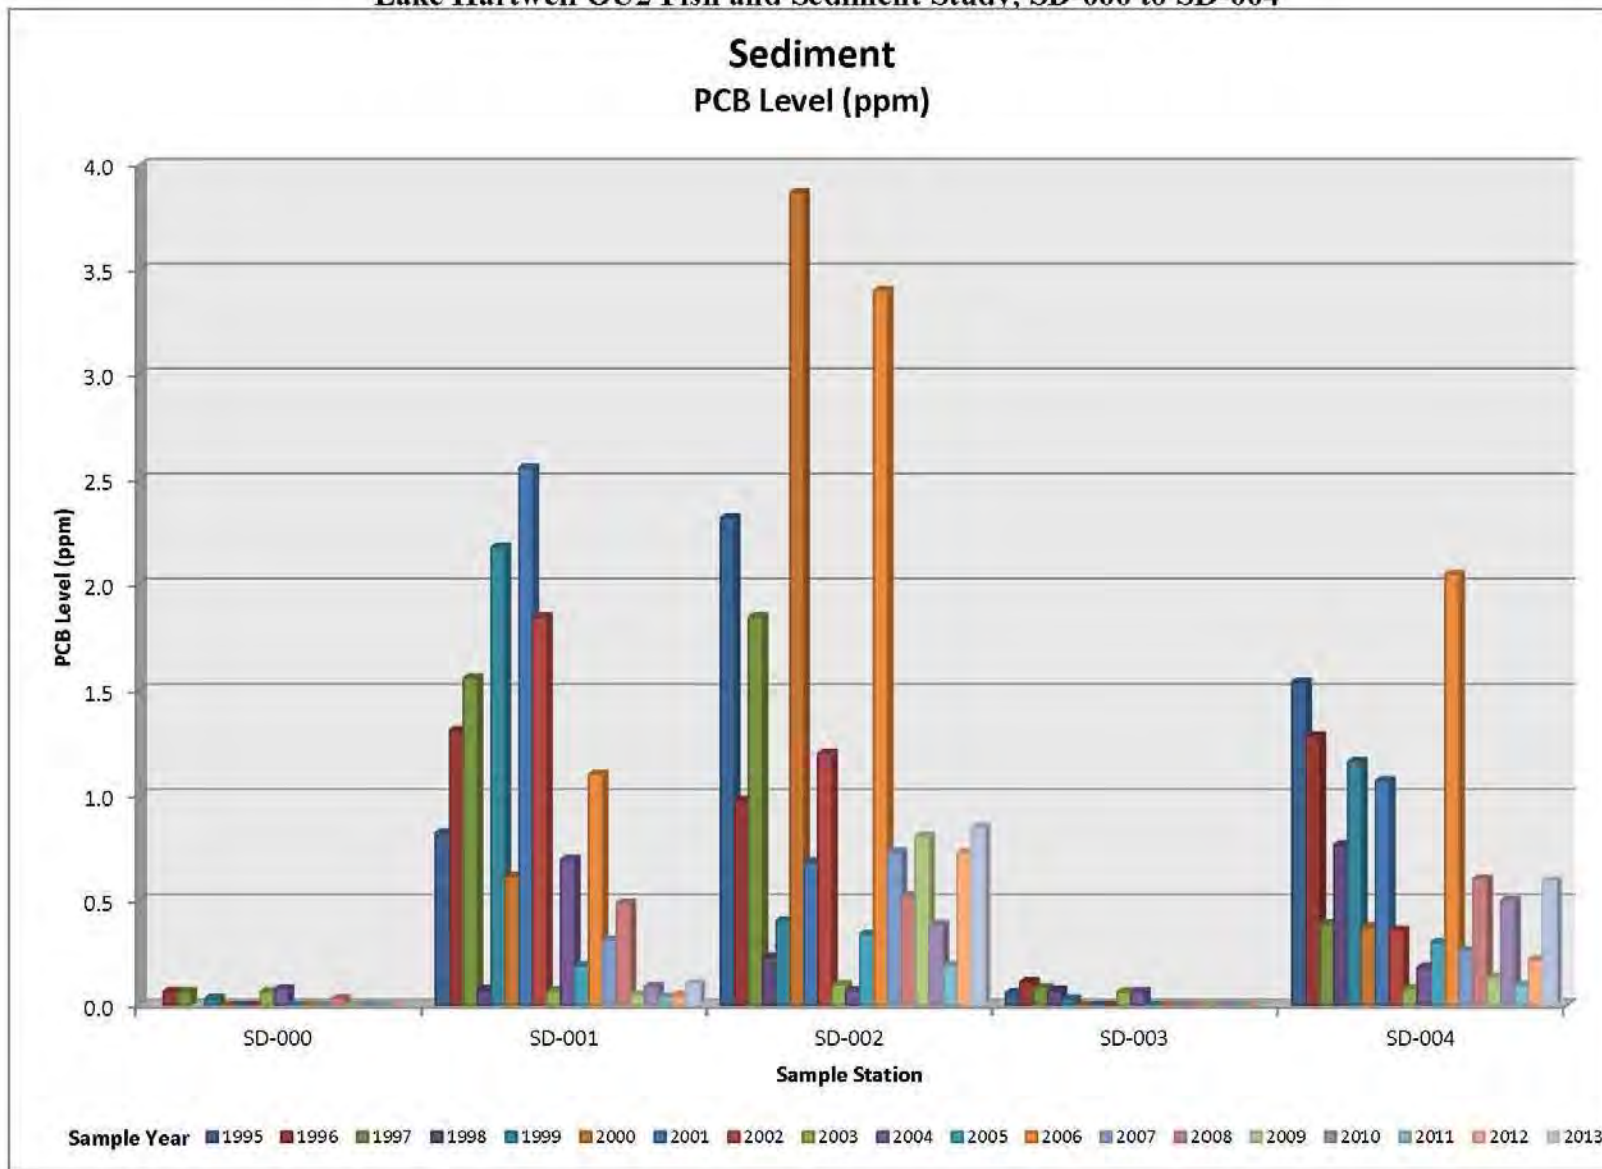
**Figure 3.1. PCB Levels in Sediment Samples (1995-2013),  
Lake Hartwell OU2 Fish and Sediment Study, SD-000 to SD-004**

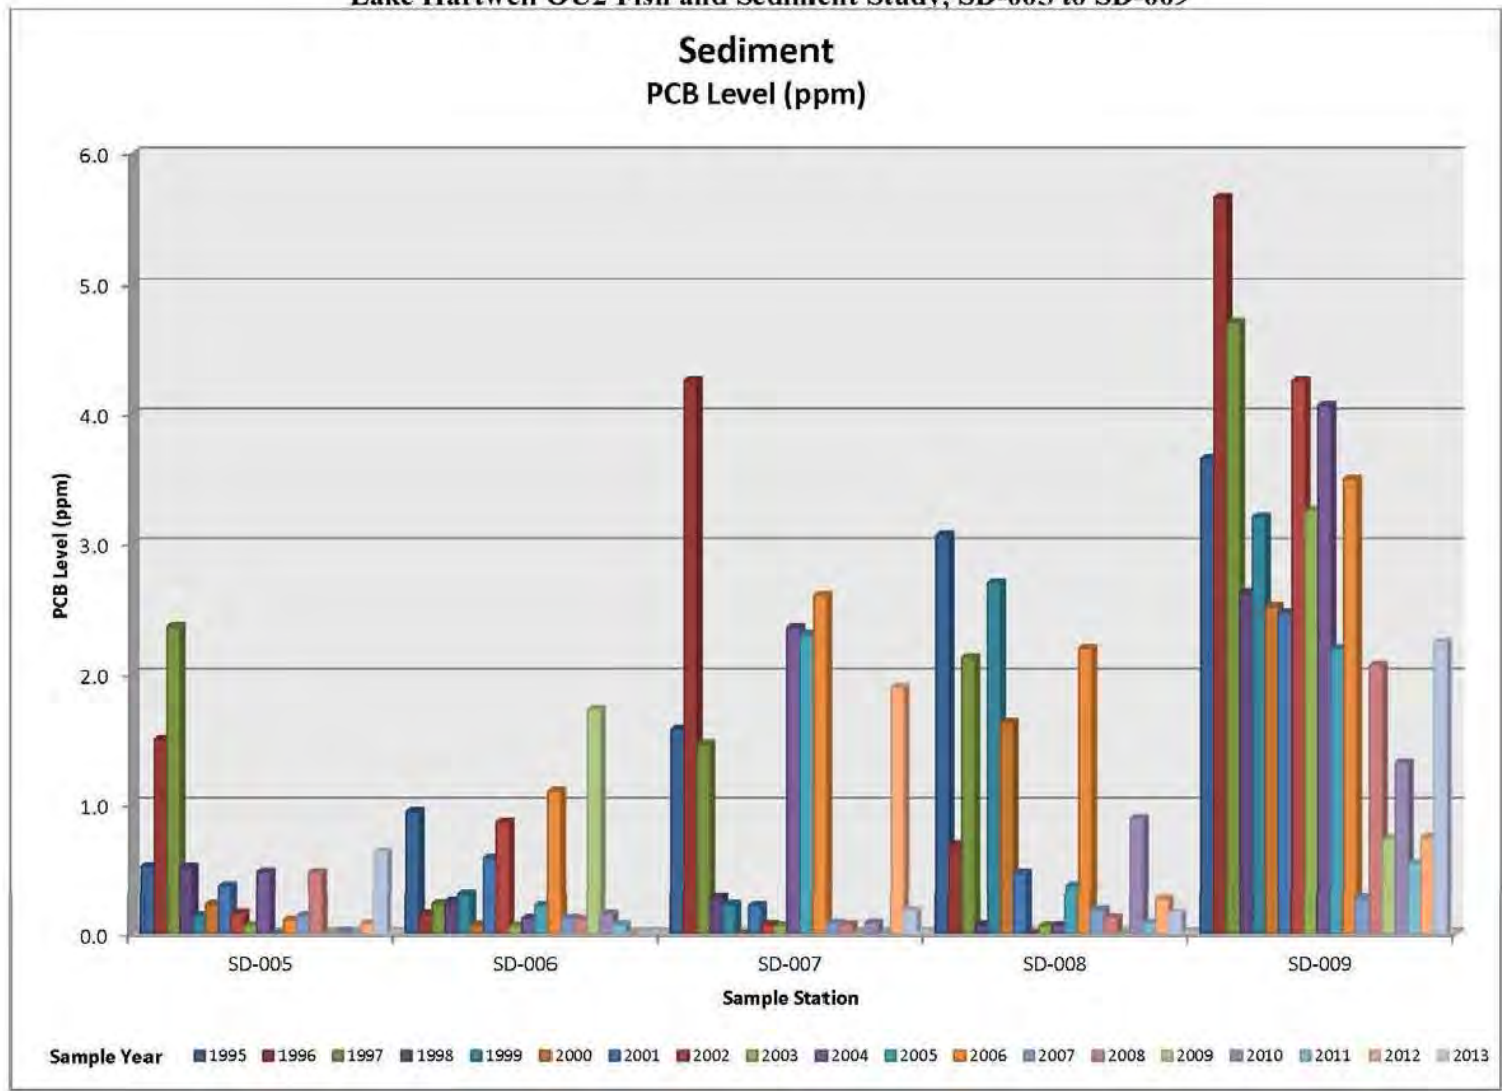
Figure 3.2. PCB Levels in Sediment Samples (1995-2013),  
Lake Hartwell OU2 Fish and Sediment Study, SD-005 to SD-009

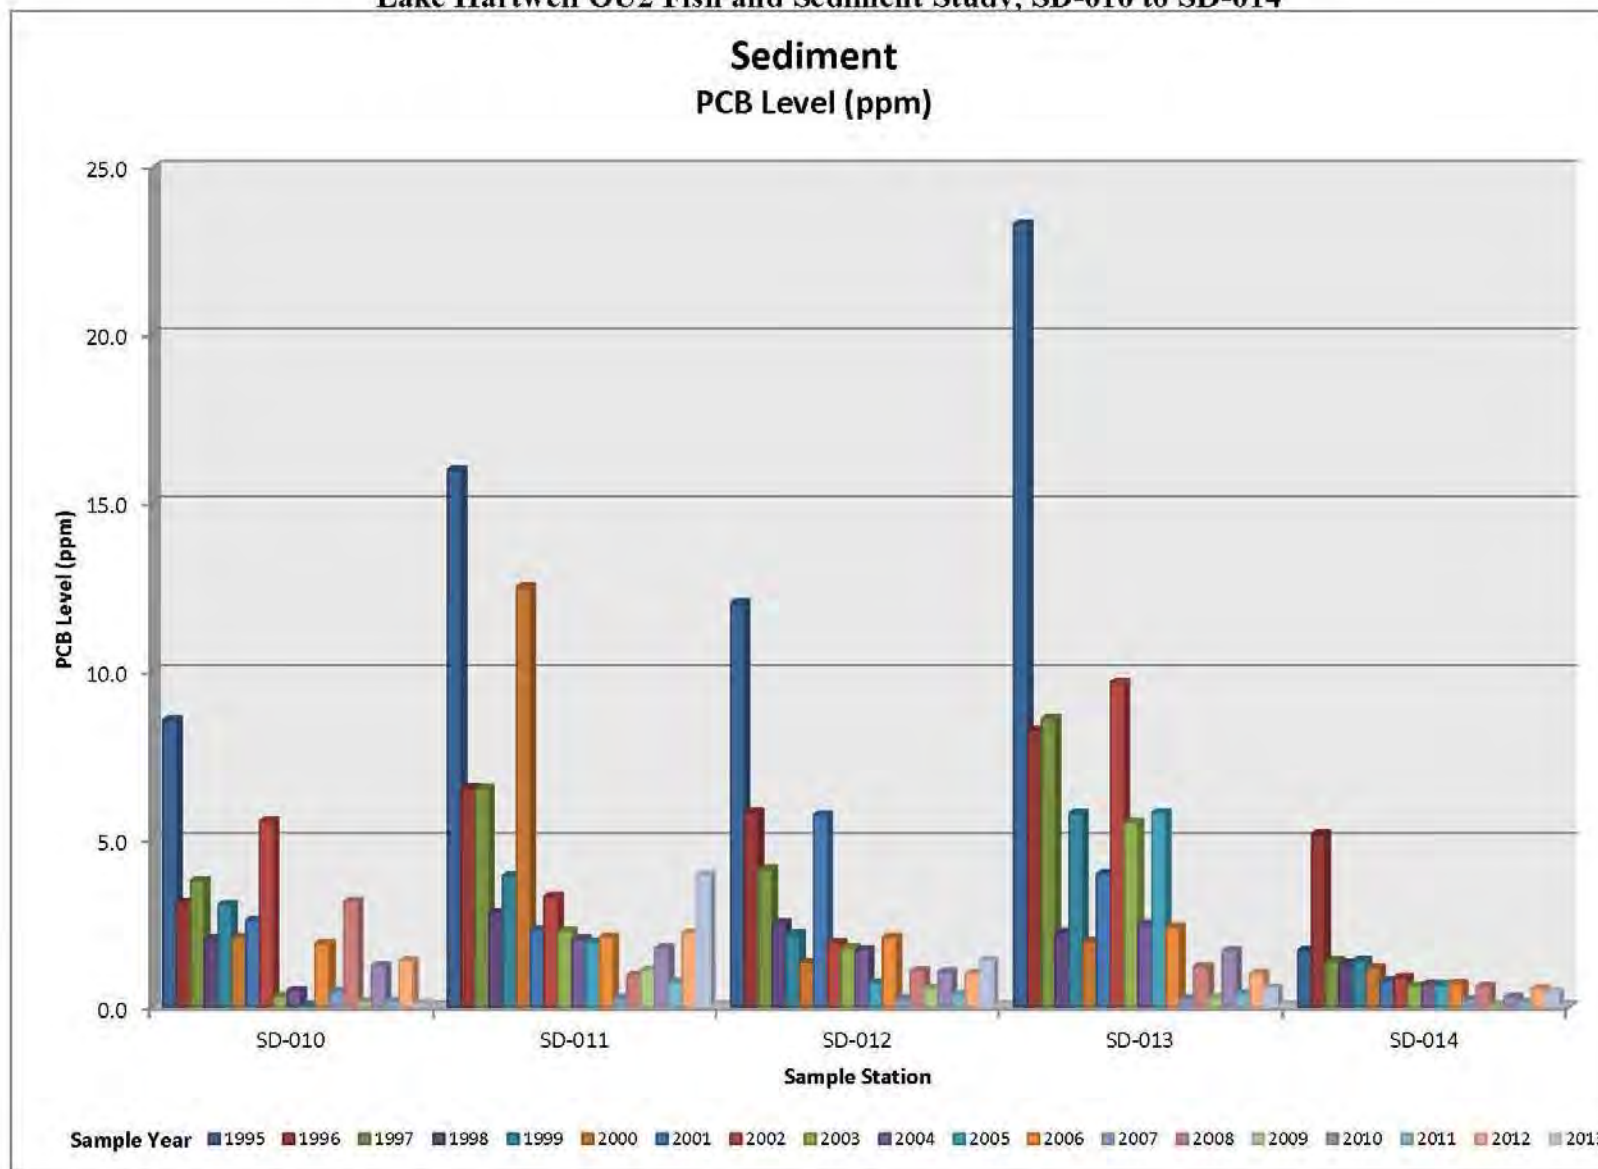
**Figure 3.3. PCB Levels in Sediment Samples (1995-2013),  
Lake Hartwell OU2 Fish and Sediment Study, SD-010 to SD-014**

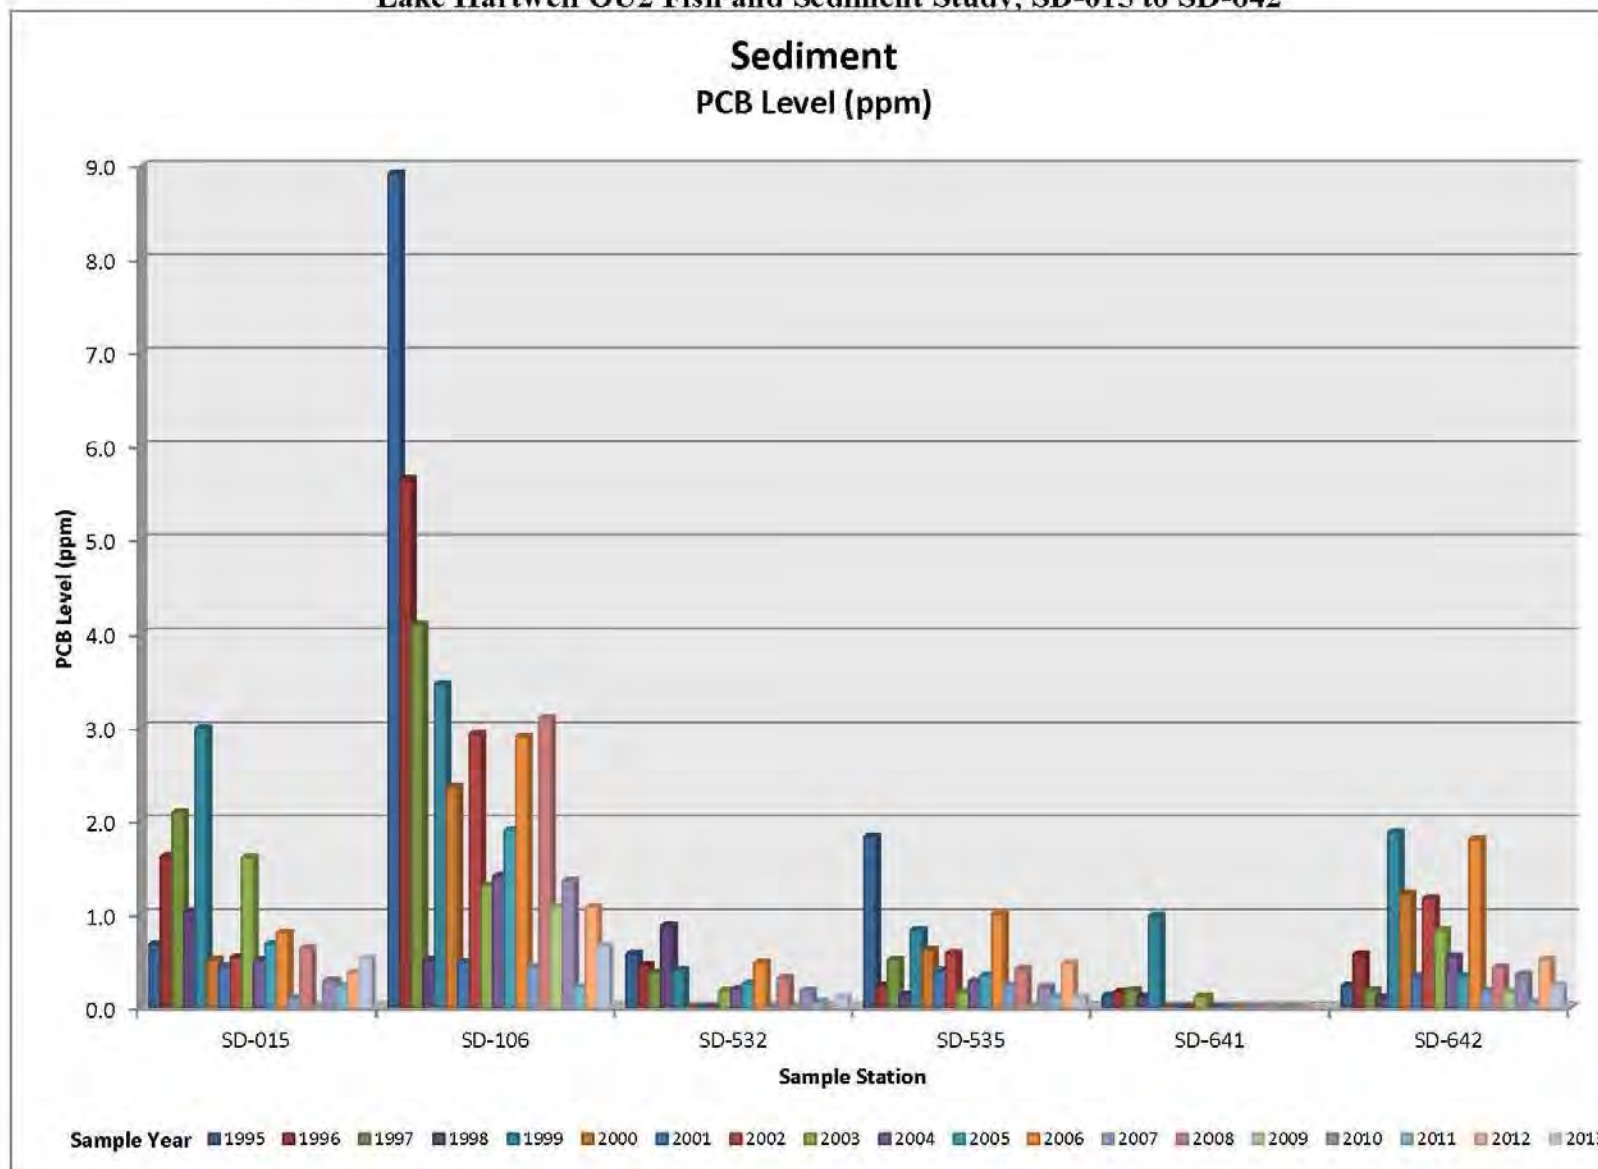
**Figure 3.4. PCB Levels in Sediment Samples (1995-2013),  
Lake Hartwell OU2 Fish and Sediment Study, SD-015 to SD-642**

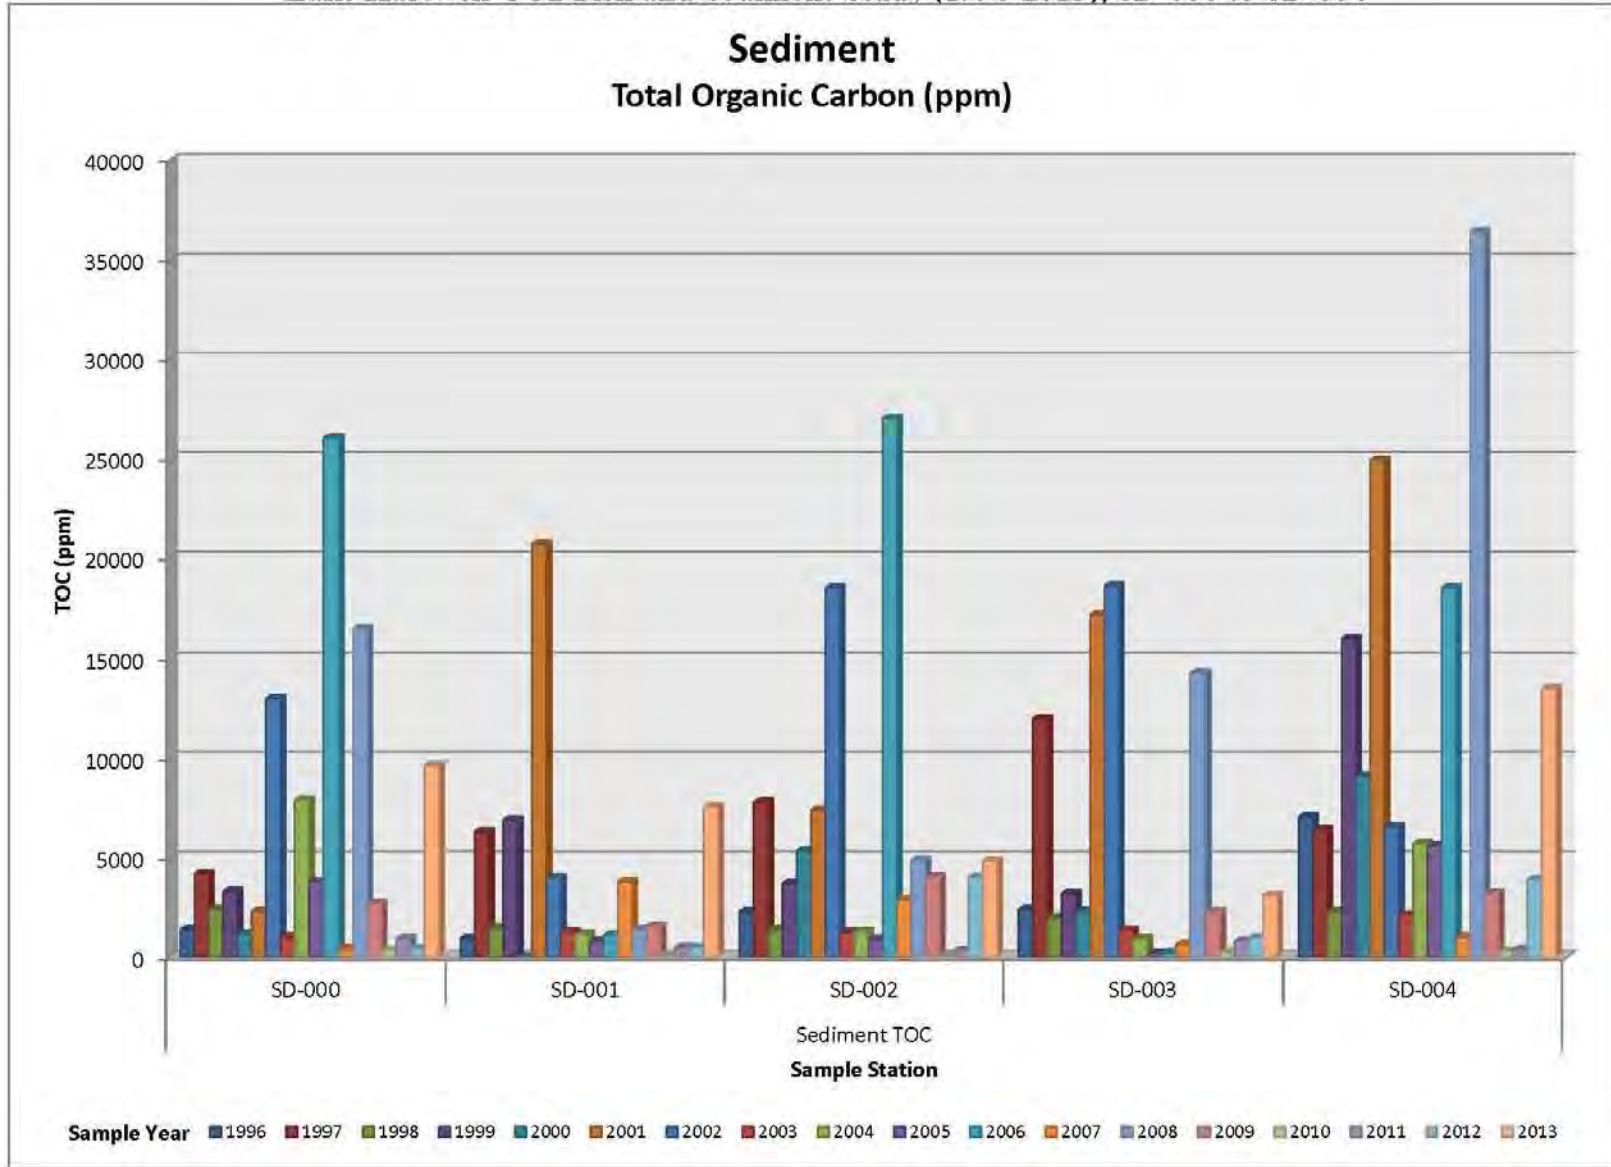
**Figure 4.1. TOC Levels in Sediment Samples  
Lake Hartwell OU2 Fish and Sediment Study (1996-2013), SD-000 to SD-004**

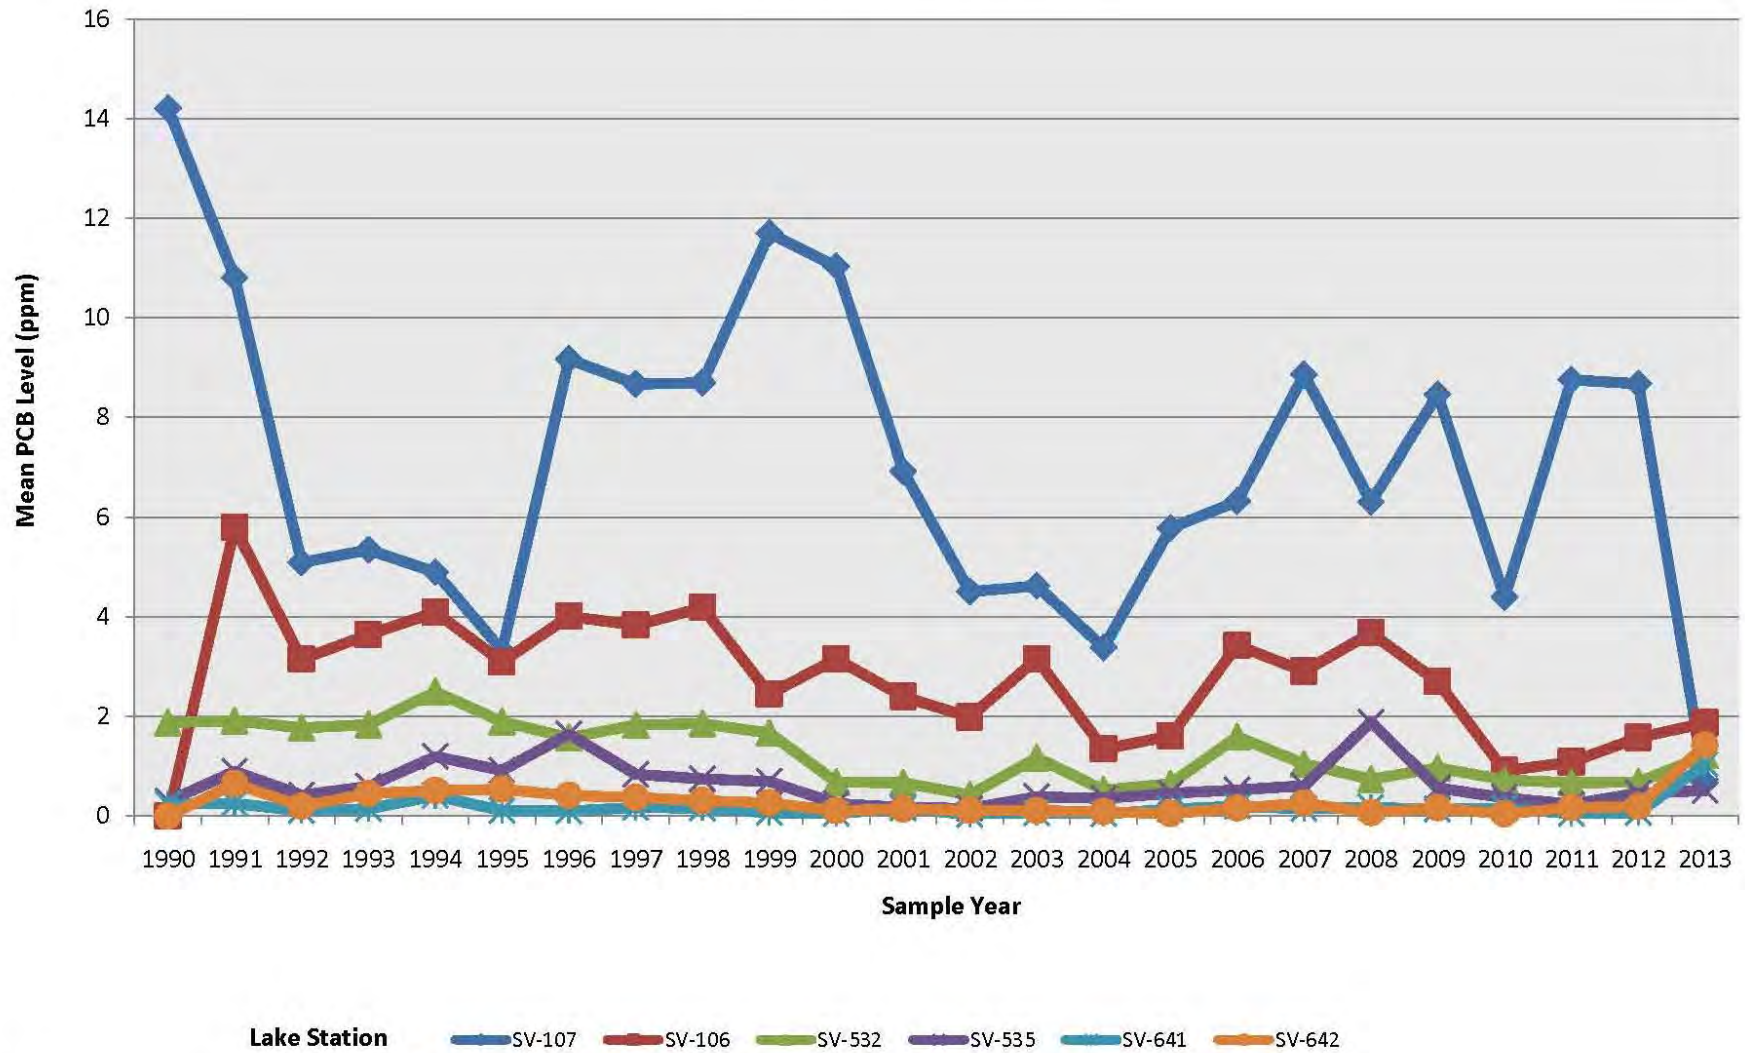
Figure 8. PCB Levels in Largemouth Bass (*Micropterus salmoides*) Fillet Samples  
 Lake Hartwell OU2 Fish Study (1990-2013)
