**THIRD FIVE-YEAR REVIEW REPORT FOR  
SANGAMO WESTON, INC./TWELVEMILE CREEK/LAKE HARTWELL PCB  
CONTAMINATION SUPERFUND SITE  
PICKENS COUNTY, SC**

**U.S. Environmental Protection Agency**

**Region 4 Superfund Division**

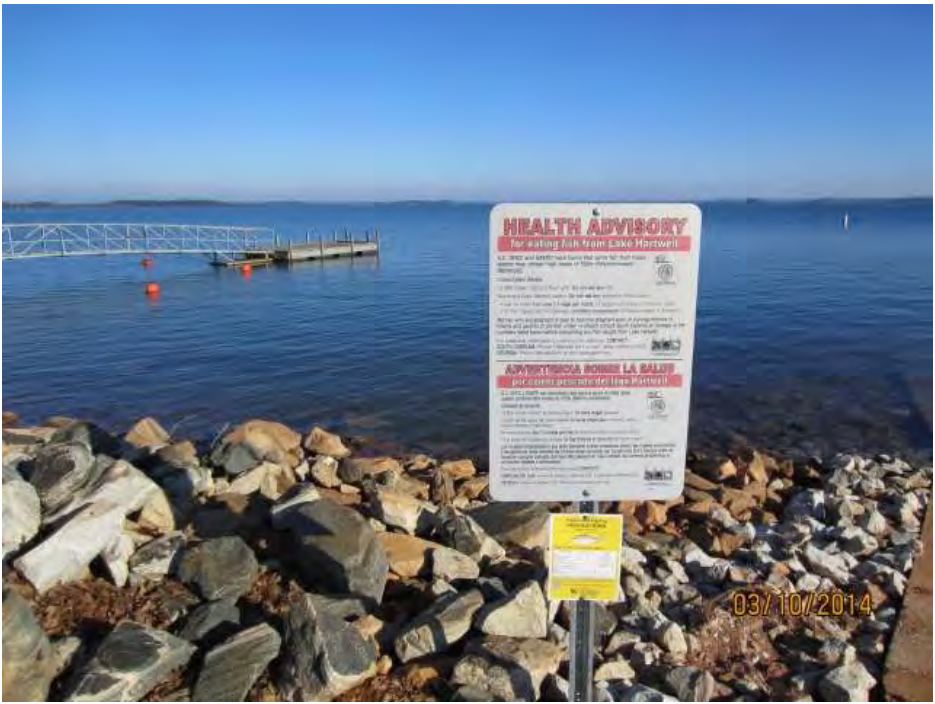
<b>Client Name:</b> Sangamo Weston		<b>Site Location:</b> Lake Hartwell, South Carolina/Georgia	<b>Project No.:</b> 208503.0000.0000
<b>Photo No.</b> 3	<b>Date</b> 03/10/14

<b>Description</b> COE 41 Big Oaks (Former COE 44); sign in good condition.

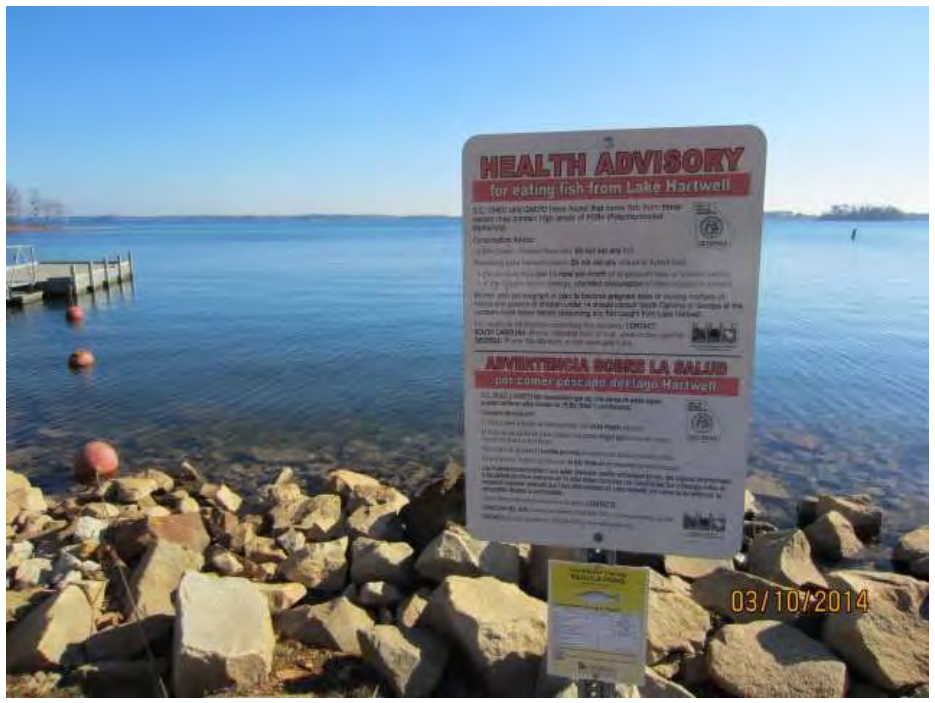
<b>Photo No.</b> 4	<b>Date</b> 03/10/14

<b>Description</b> COE 49 Watsadler (Former COE 52); sign in good condition. Sign has a few dings and is slightly faded.

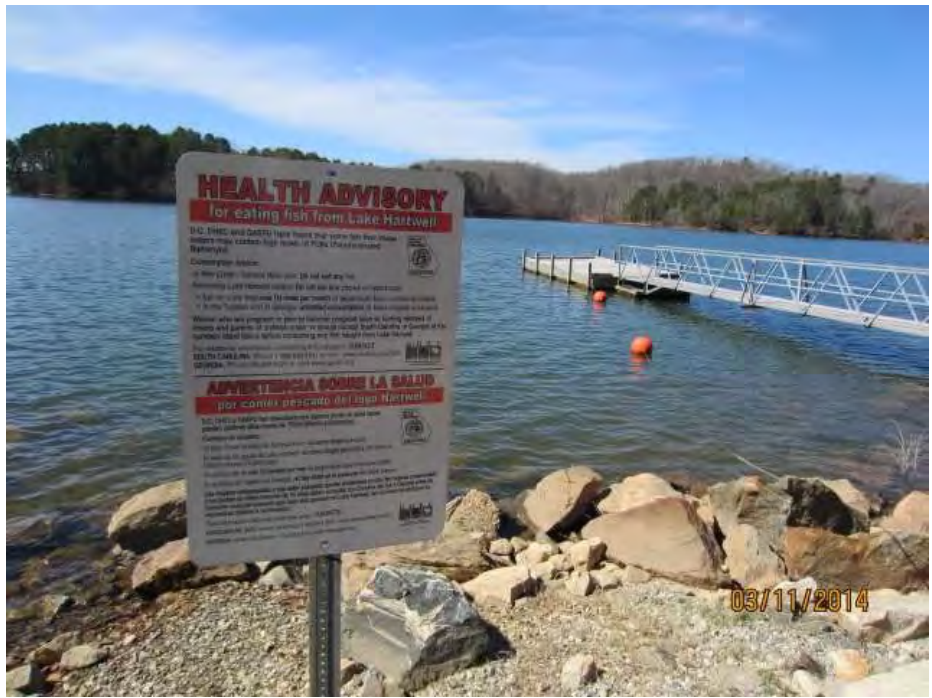
<b>Client Name:</b> Sangamo Weston		<b>Site Location:</b> Lake Hartwell, South Carolina/Georgia	<b>Project No.:</b> 208503.0000.0000
<b>Photo No.</b> 31	<b>Date</b> 03/11/14

<b>Description</b> COE 20 Glenn Ferry (Former COE 21); sign in good condition.

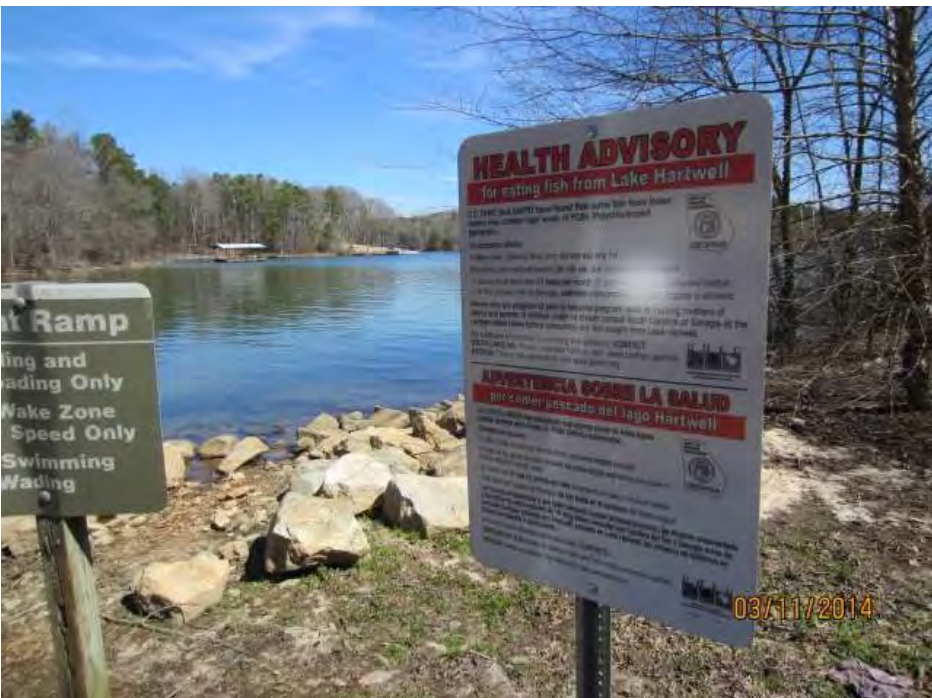
<b>Client Name:</b> Sangamo Weston		<b>Site Location:</b> Lake Hartwell, South Carolina/Georgia	<b>Project No.:</b> 208503.0000.0000
<b>Photo No.</b> 32	<b>Date</b> 03/11/14

<b>Description</b> COE 21 Durham (Former COE 22); sign in good condition.

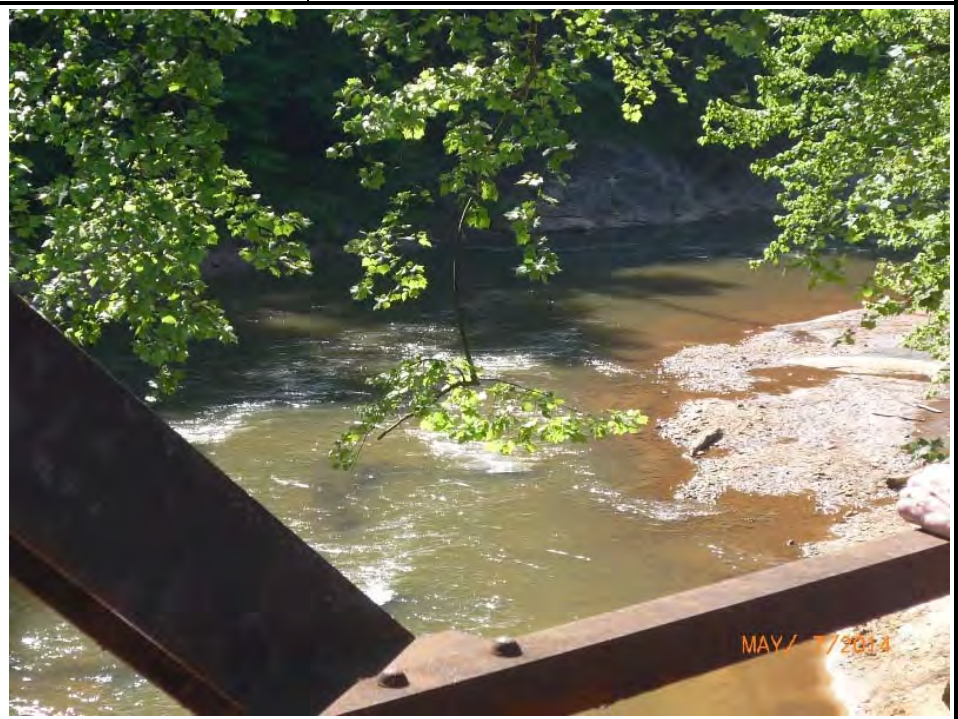
**Description**  
*Twelve Mile Creek (OU2)*  
Lay Bridge Overpass looking downstream

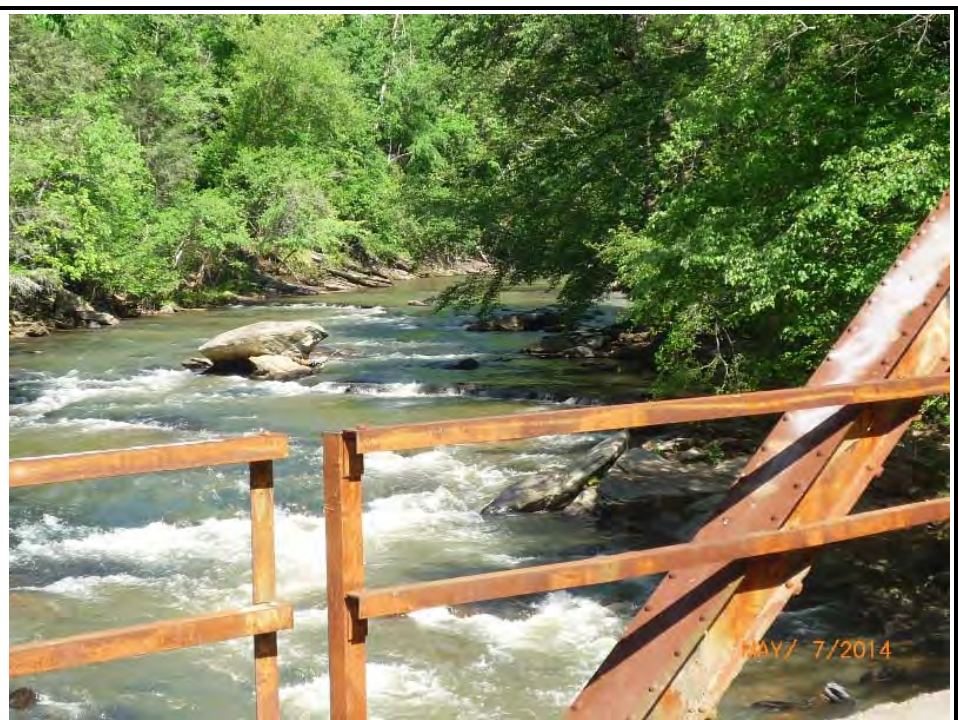
<b>Photo No.</b> 4	<b>Date</b> 5-7-2014
-----------------------	-------------------------

**Description**  
*Twelve Mile Creek (OU2)*  
Lay Bridge Overpass looking upstream

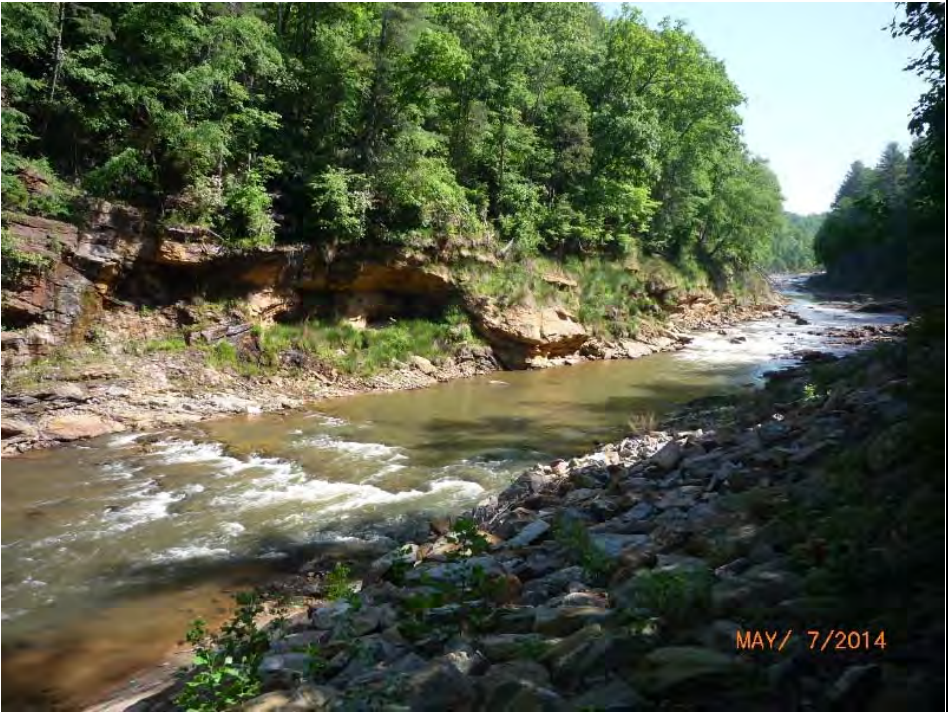
<b>Client Name:</b> Schlumberger Technology Corporation		<b>Site Location:</b> Operable Unit One (OU2)
<b>Photo No.</b> 8	<b>Date</b> 5-7-2014

<b>Description</b> Historic location of Woodside II Dam

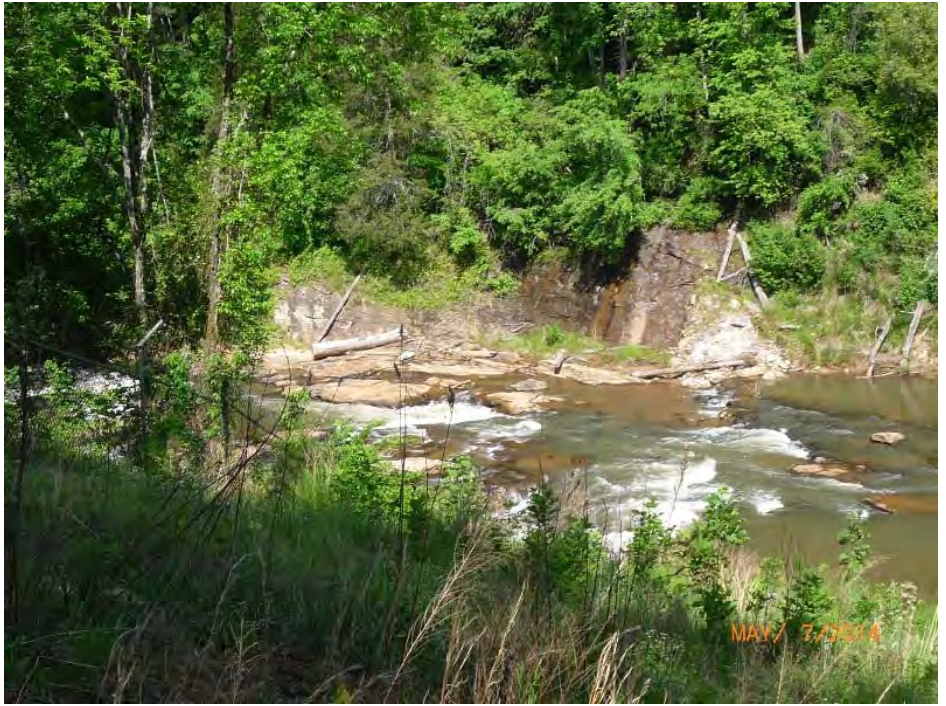
<b>Photo No.</b> 11	<b>Date</b> 5-7-2014

<b>Description</b> Historic location of Woodside 1 Dam
