**Third Five-Year Review Report
for
JFD Electronics/Channel Master
EPA ID NCD122263825**

**Oxford
Granville County, North Carolina**

September 2015

United States Environmental Protection Agency
Region 4
Atlanta, Georgia

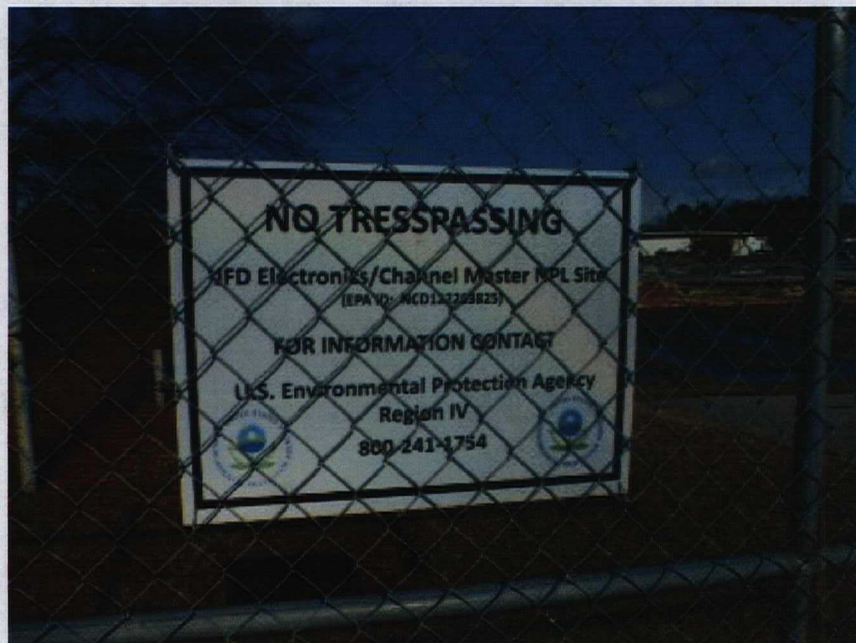
Signage at locked entrance gate.

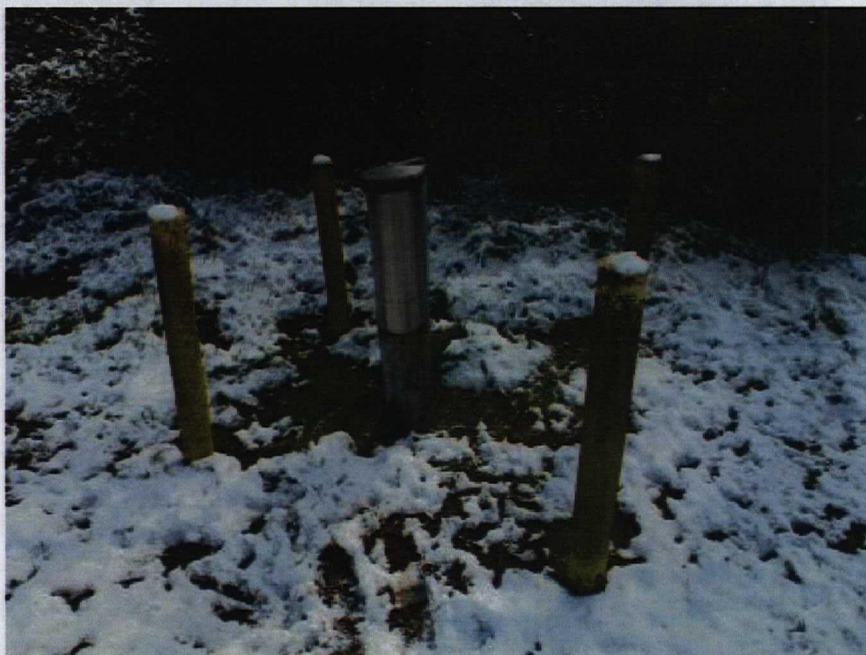
Recently installed monitoring well.

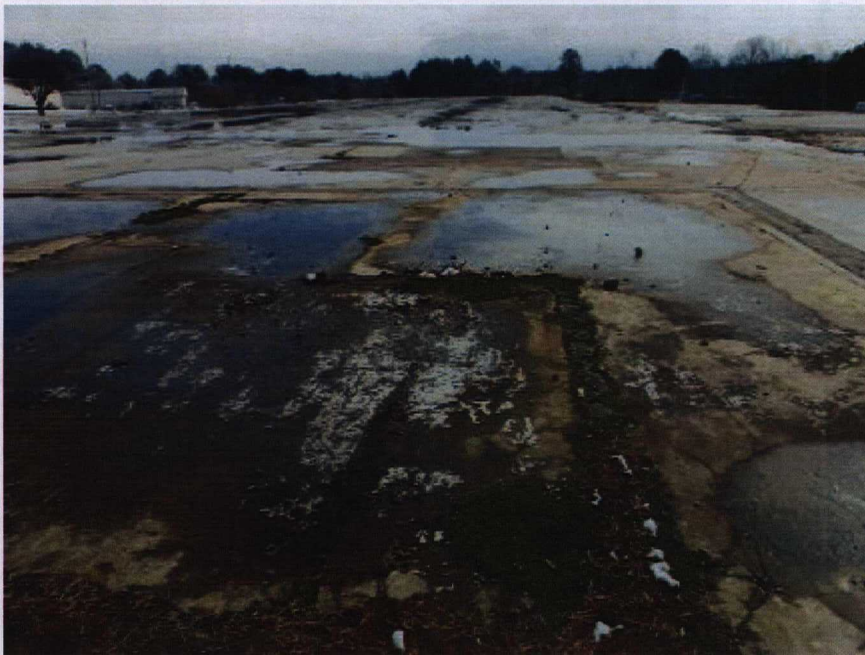
On-site building slab.

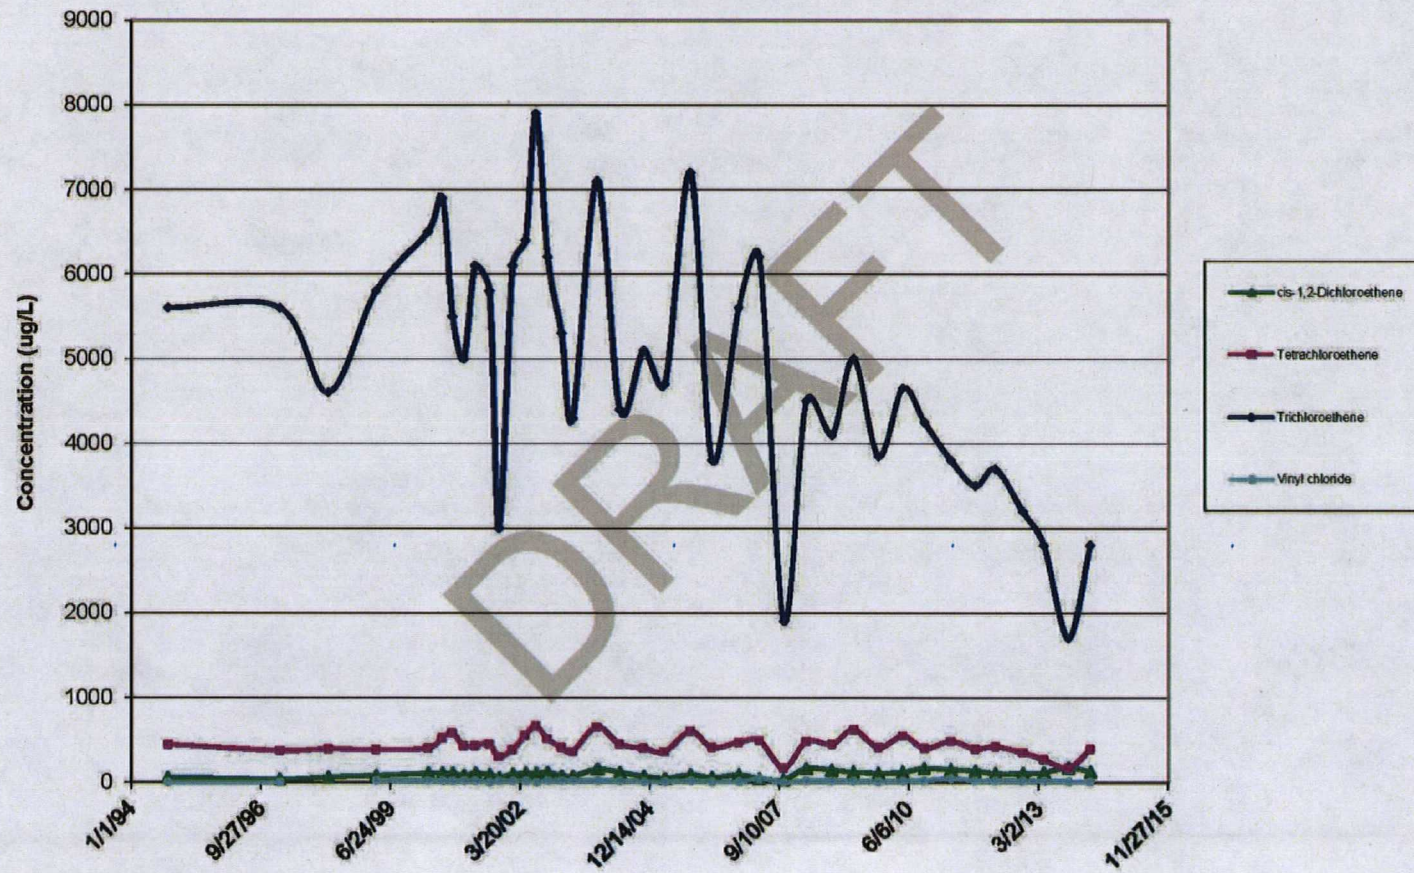
**Key VOCs in Well CMMW04
JFD Electronics/Channel Master Site**

Notes:
Concentrations below analytical MDLs/RLs are plotted at half the RL.
Total 1,2-Dichloroethene data used to plot 10/94 cis-1,2-Dichloroethene

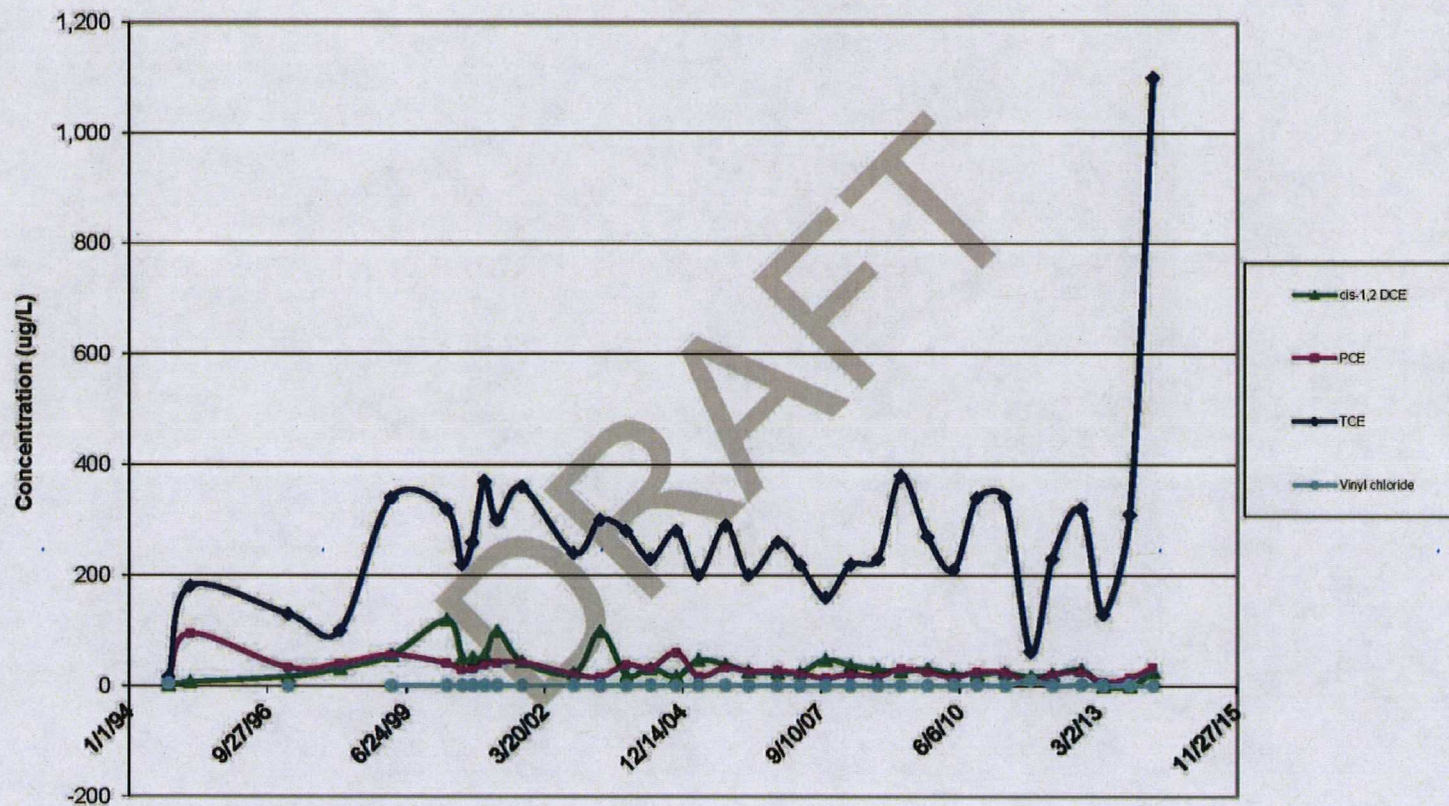
**Key VOCs in Well CMMW07
JFD Electronics/Channel Master Site**

Concentrations below analytical MDLs/RLs are plotted at half the RL.
Total 1,2-Dichloroethene data used to plot 10/94 cis-1,2-Dichloroethene concentration.

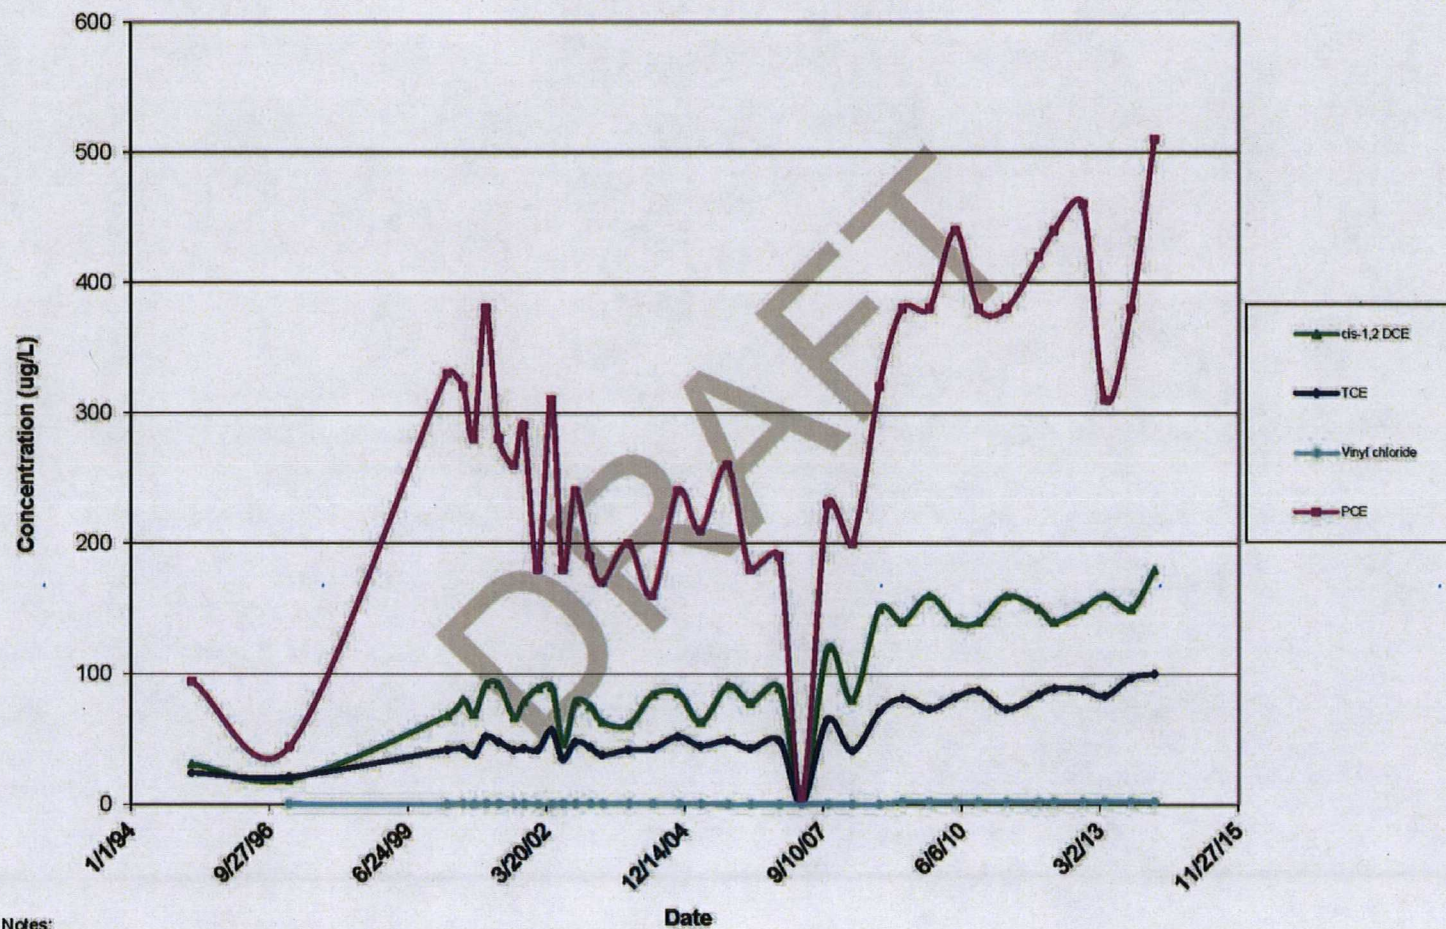
**Key VOCs in Well CMMW23
JFD Electronics/Channel Master Site**

Notes:
Concentrations below analytical MDLs/RLs are plotted at half the RL.

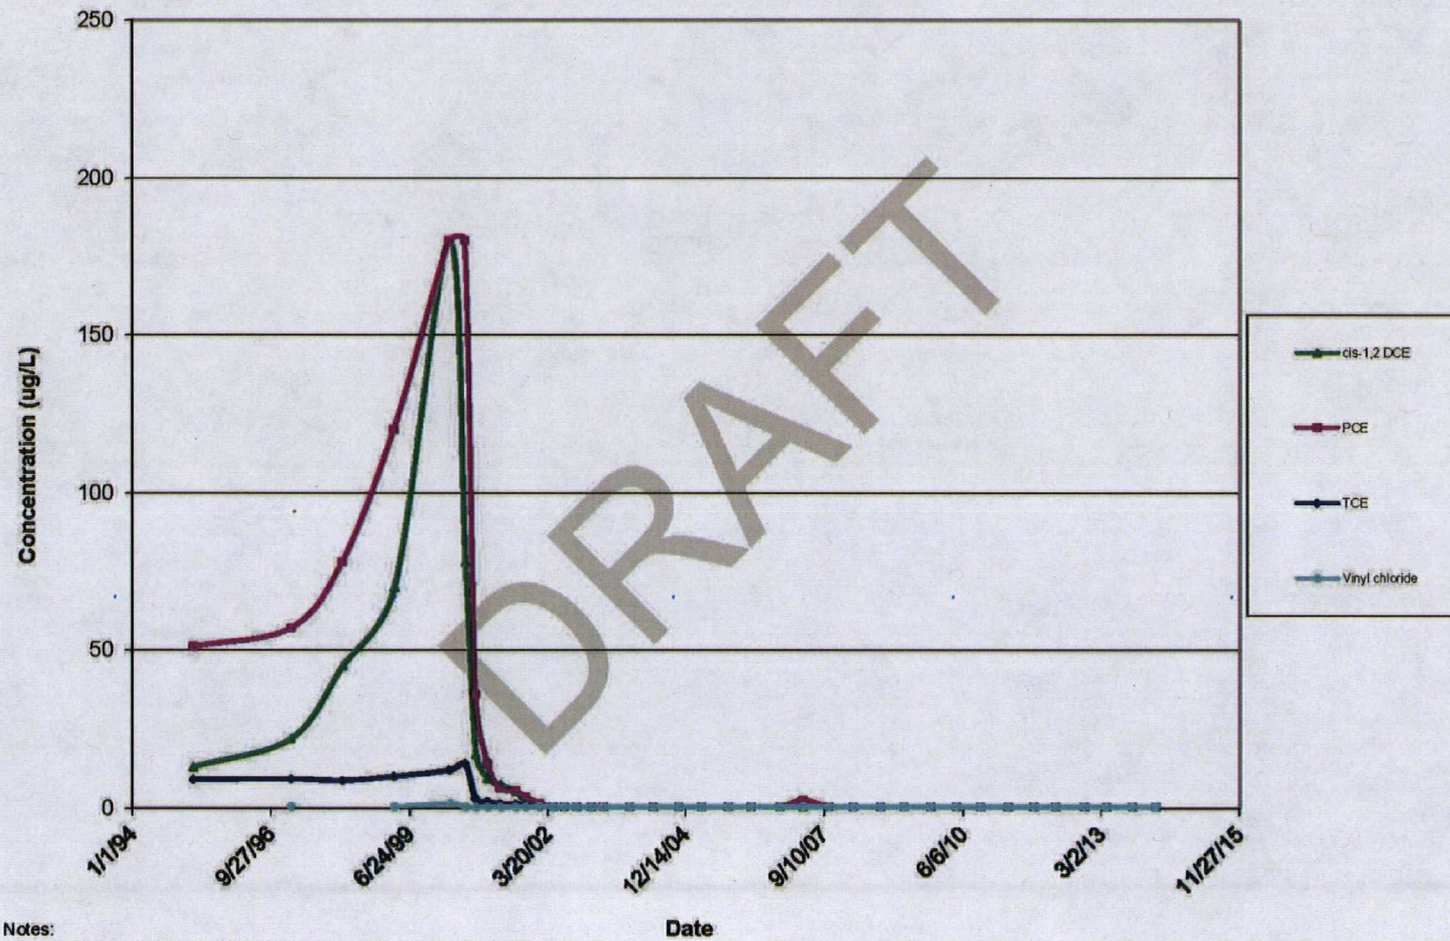
Key VOCs in Well CMMW26
JFD Electronics/Channel Master Site

Notes:
Concentrations below analytical MDLs/RLs are plotted at half the RL.
