Conceptual Site Model

Lee's Lane Landfill Site
Louisville, Kentucky

Report Prepared by Lee's Lane Landfill Group and The
Louisville and Jefferson County Metropolitan Sewer
District

089257 | Report No 3

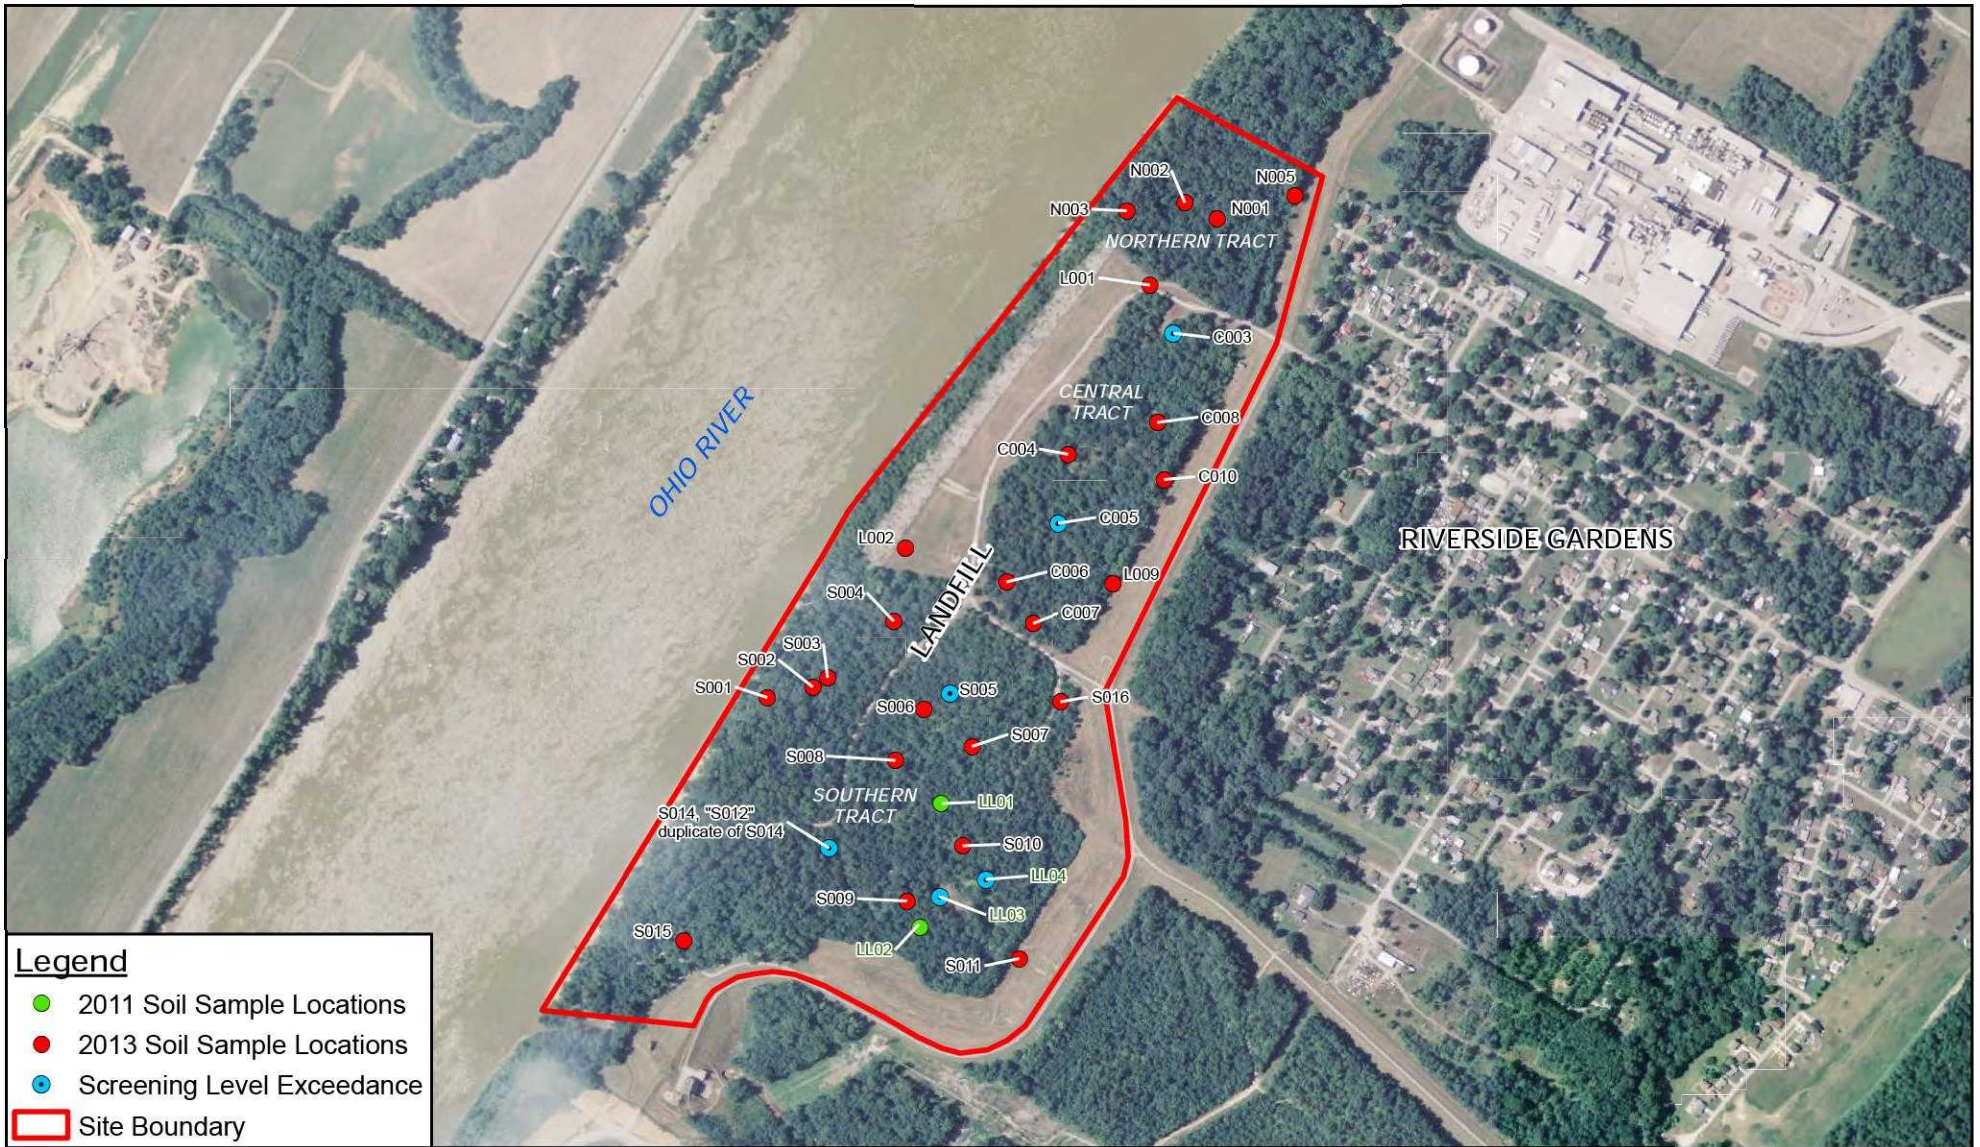
MAP OF SAMPLE LOCATIONS
NEAR EXPOSED WASTE BASED ON
2011 AND 2013 SAMPLE ROUNDS **FIGURE 3.2**

reports which have noted that the Site has been used by ATVs and pickup trucks, which leave ruts in the cap that may expose waste (see Section 9.0 on security). Also trash has been observed to be brought on and dumped at various locations by ATVs and pickup trucks. Figure 3.2 presents the locations of exposed waste and shows the location of the Southern, Central and Northern Tracts. Exposed waste was mostly noted in the Southern Tract. The areas of exposed waste have not been delineated but are believed to represent a small portion of the overall landfill footprint based on limited Site inspections.

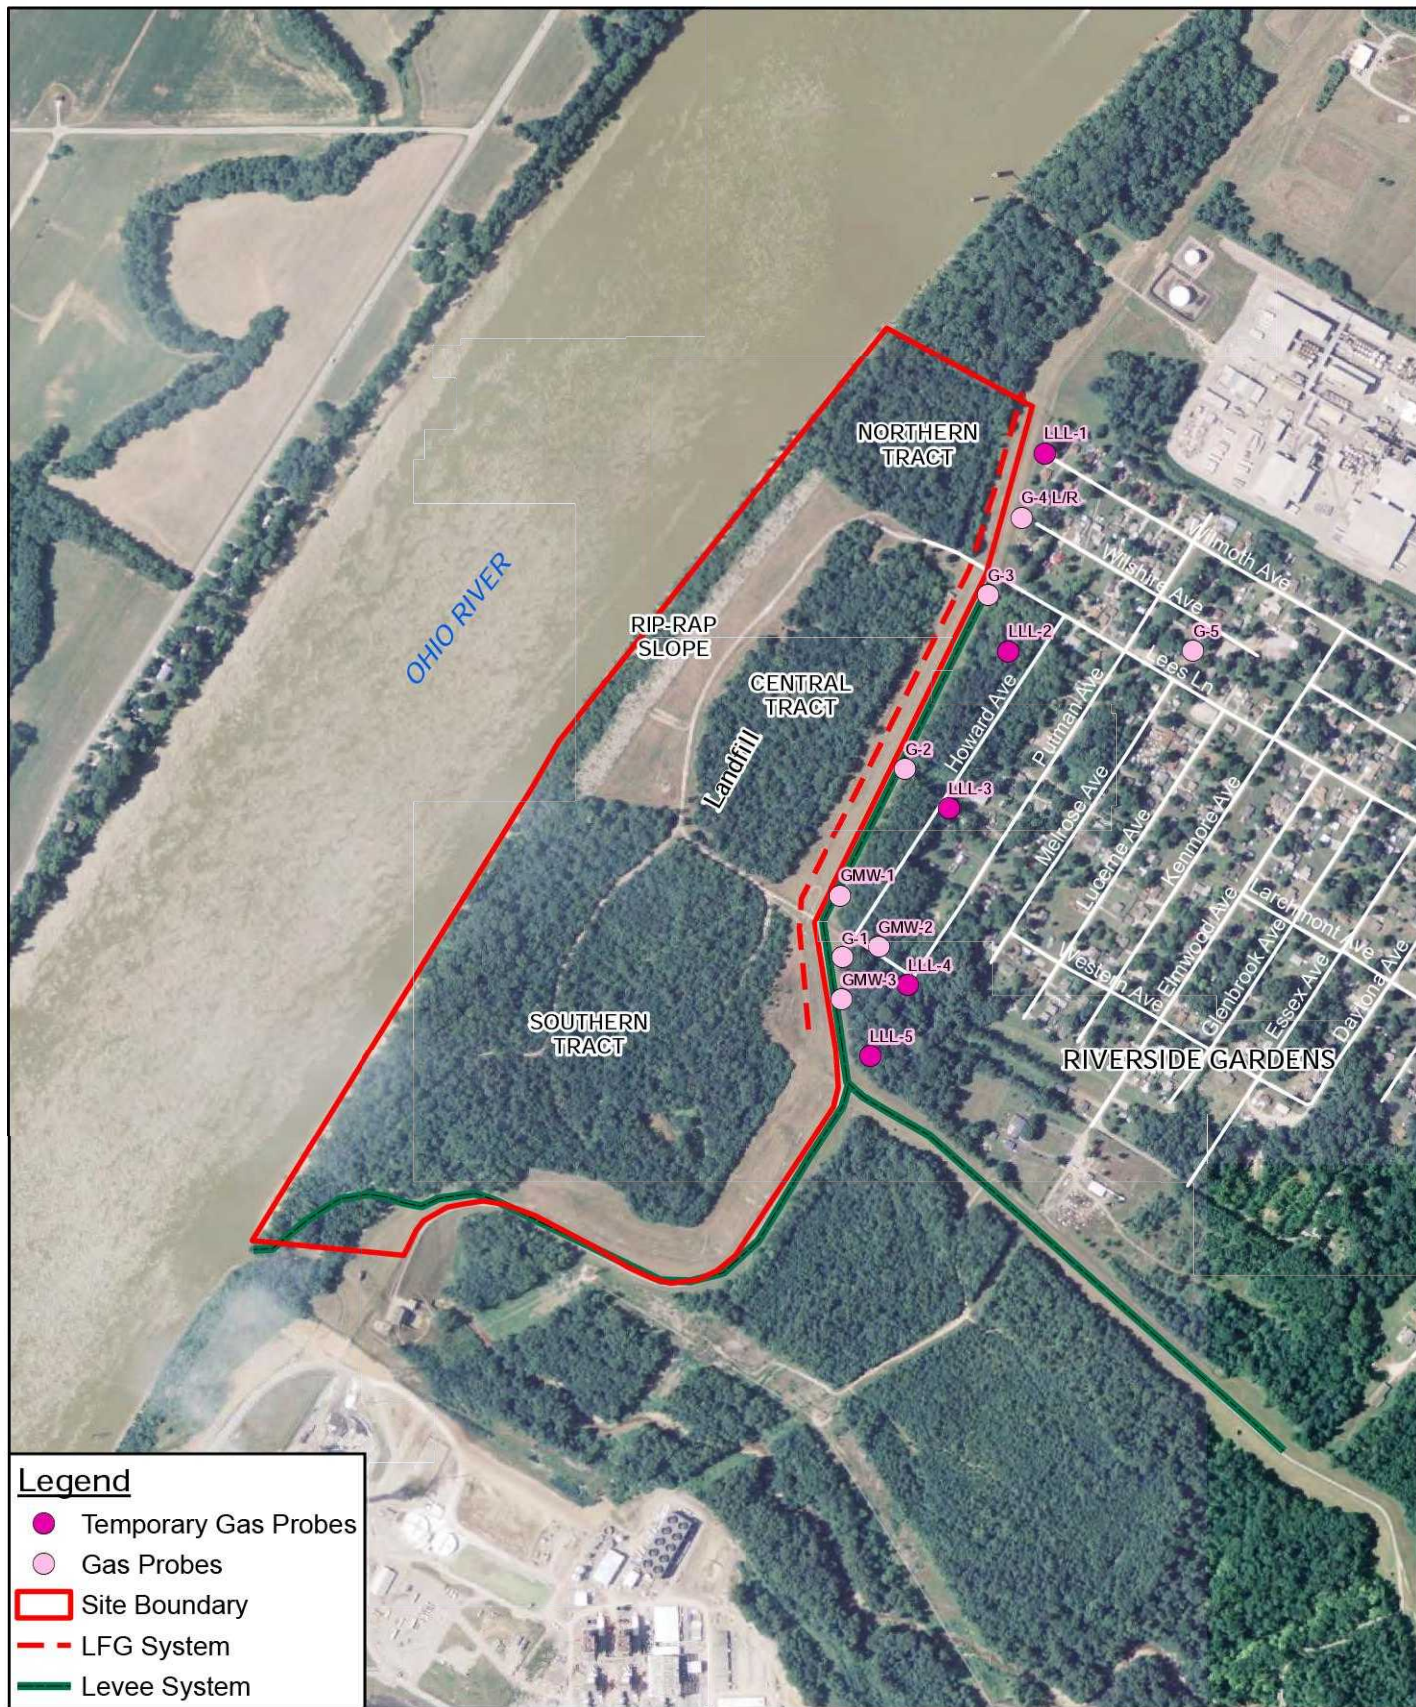
FIGURE 4.1

In response to a routine inspection which found a leachate seep and exposed waste, EPA and MSD conducted sampling in 2011. Four areas were targeted based on the presence of surface accumulation of various types of debris, including crushed drums, wiring, insulators, plastic, different types of metal, and material from a fire at a local neoprene plant. The samples were analyzed for VOCs, SVOCs, pesticides, PCBs and metals. The results for both the EPA and the MSD sampling events are summarized on Table 4.1, and Figure 4.1 presents the sampling locations.

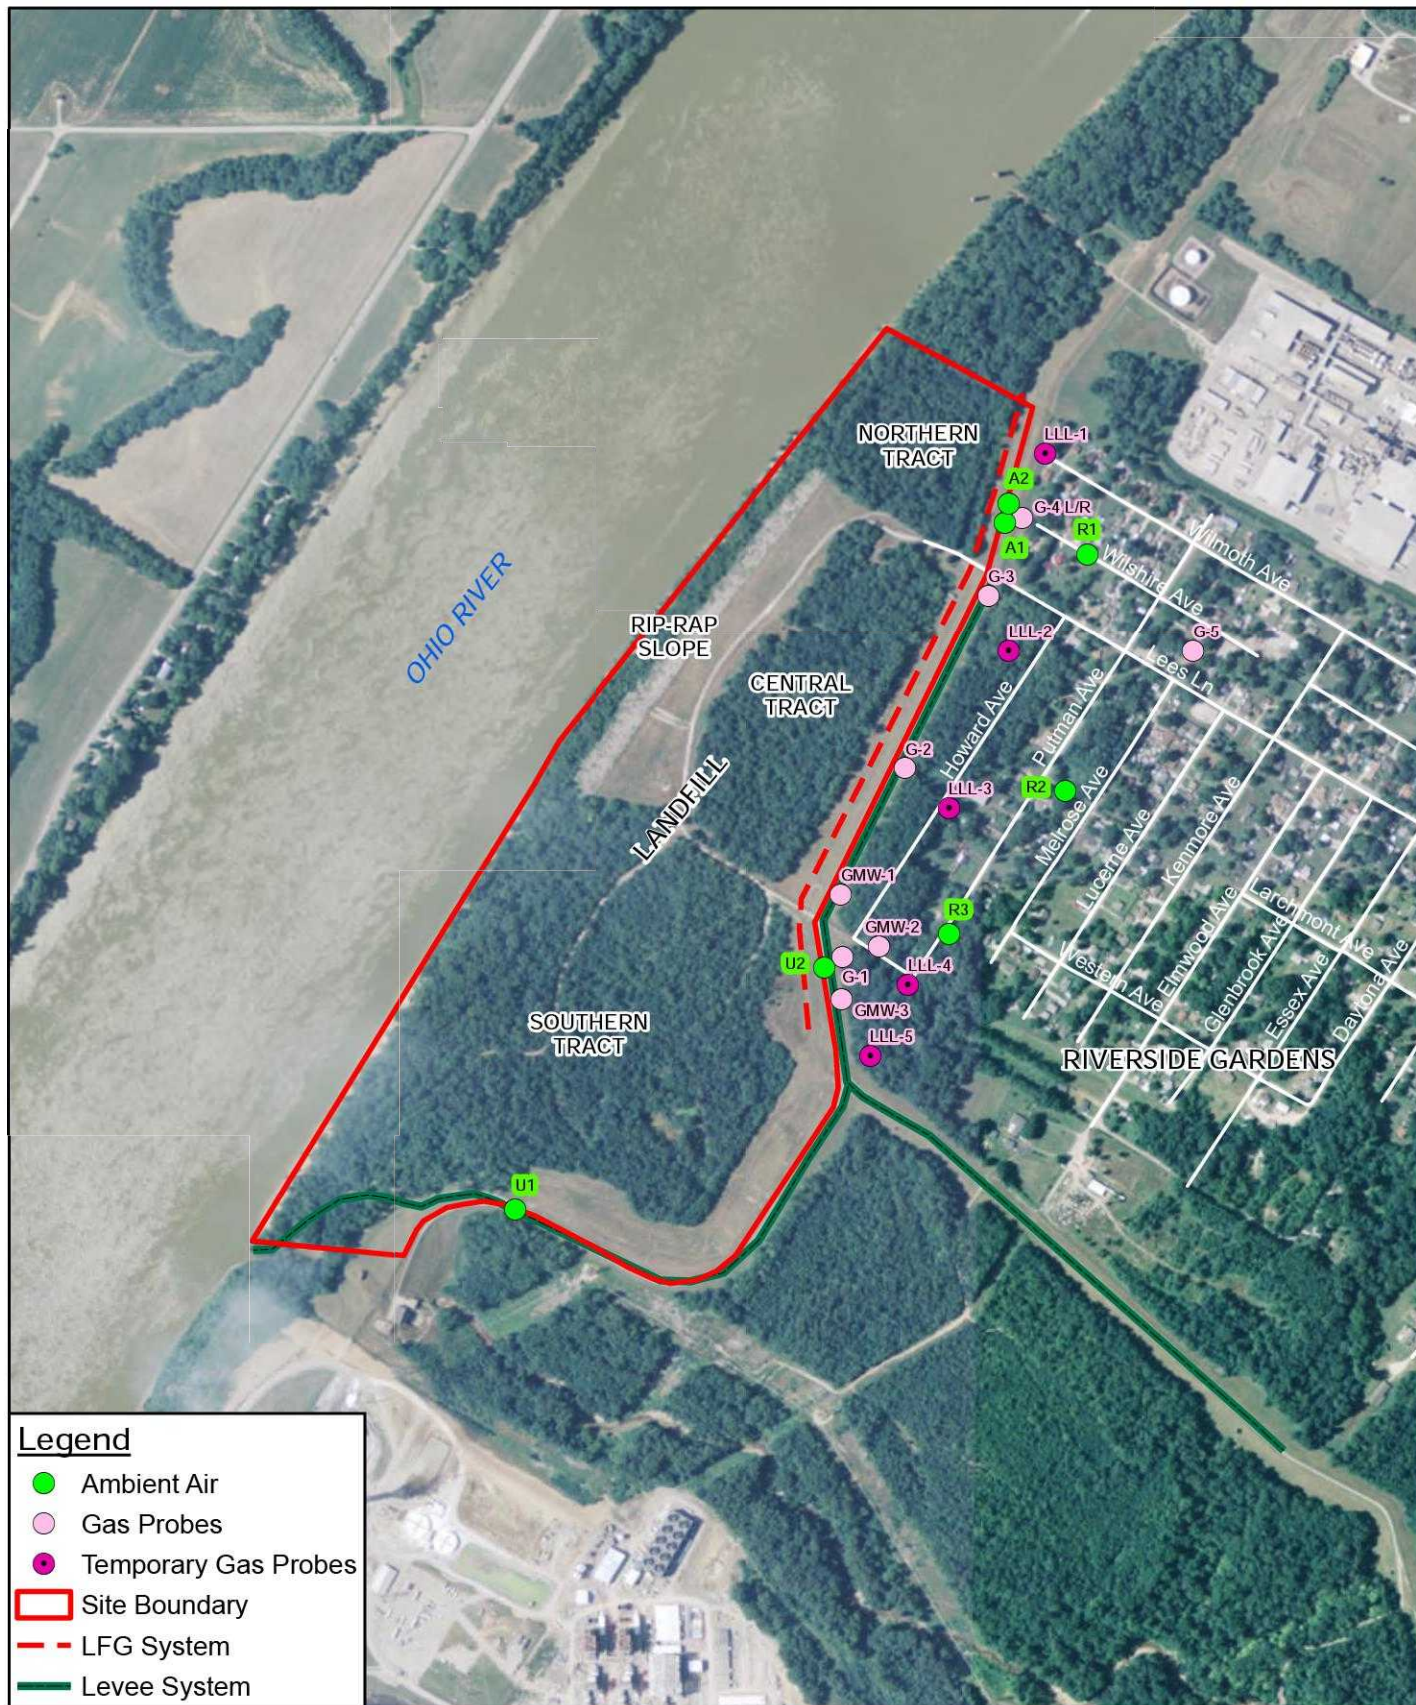
FIGURE 6.1

Figure 6.1 provides a schematic cross section showing the various sampling locations of the VI evaluation.

In 2013, a soil gas study was completed using both permanent (G-series probes) and temporary gas probes (LLL-series probes) (EPA, 2013c). Figure 6.1 shows the soil gas probe locations on a typical cross section and Figure 6.2 shows the sampling locations. The G-series soil gas probes

Figure 6.1 shows a schematic cross section of sampling locations and Figure 6.6 shows the locations of the eight residences selected for the detailed VI evaluation and one location that was selected for soil gas only without indoor or crawl space sampling (Unit 034).

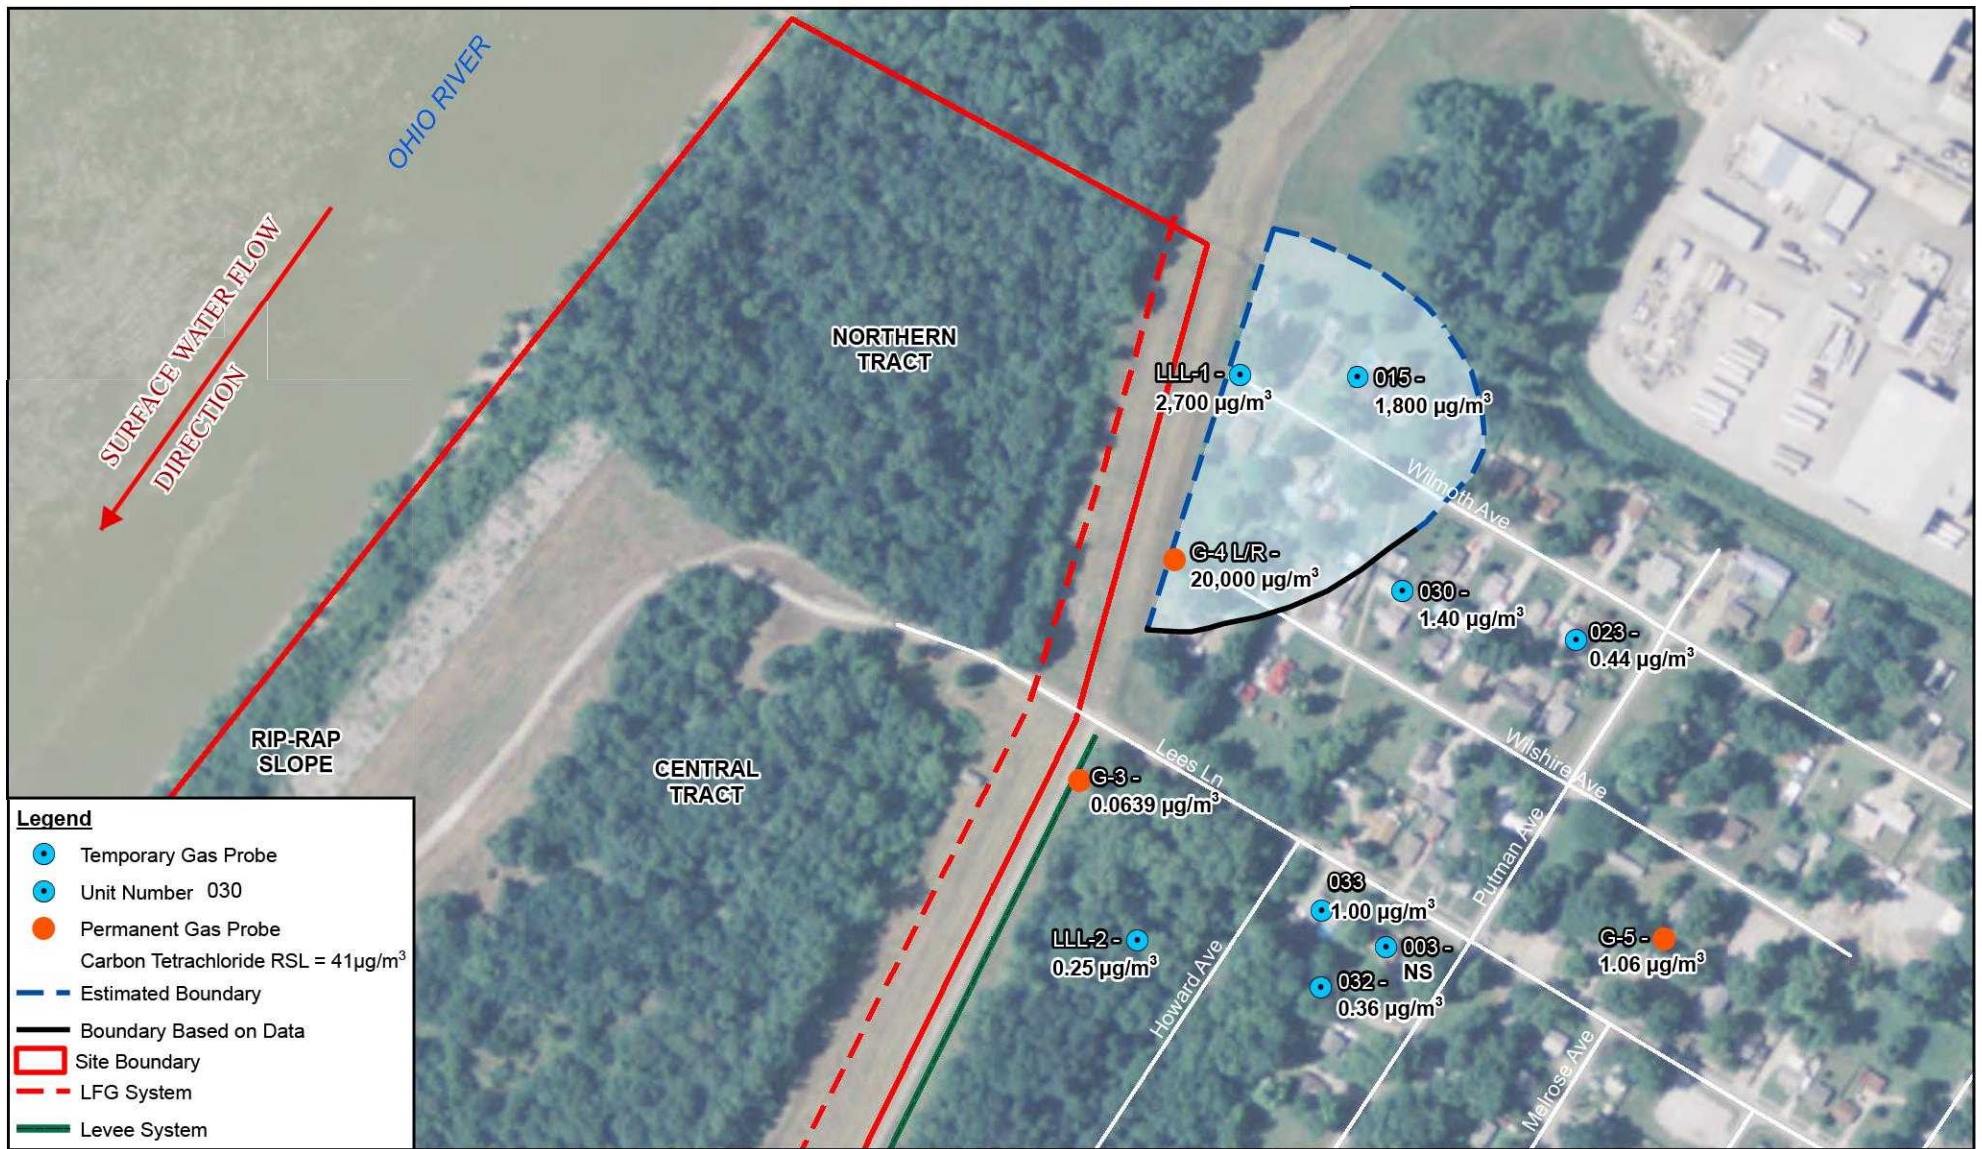
FIGURE 6.2

As part of the monitoring activities by MSD, ambient air was monitored for VOCs on a semi-annual basis. Figure 6.2 shows the ambient air monitoring locations, while Table 6.3 provides the results of ambient air monitoring from 2012 to 2015. As shown, there are VOCs detected in ambient air including the upwind, background samples. Similar to the subsurface gas sample results, the ambient air data are reported in ppbv rather than $\mu\text{g}/\text{m}^3$. Hence, the screening levels are converted to ppbv for Table 6.3. As shown, only chloroform exceeded its RSL at A1, A2, U1, U2 and R1 in September 2013. Figure 6.2 shows these locations. While most VOCs in ambient air were below RSLs, it is important to note that when VOCs are present in ambient air, these VOCs contribute to VOCs present in indoor air samples. There are many potential sources of VOCs in ambient air (e.g., industrial, vehicles, combustion), thus making source evaluation an essential component to every VI evaluation.
