**FIRST FIVE-YEAR REVIEW REPORT FOR
ILLINOIS CENTRAL RAILROAD COMPANY'S JOHNSTON YARD SITE
SHELBY COUNTY, TENNESSEE**

JULY 2017

**U.S. Environmental Protection Agency
Region 4
Atlanta, Georgia**

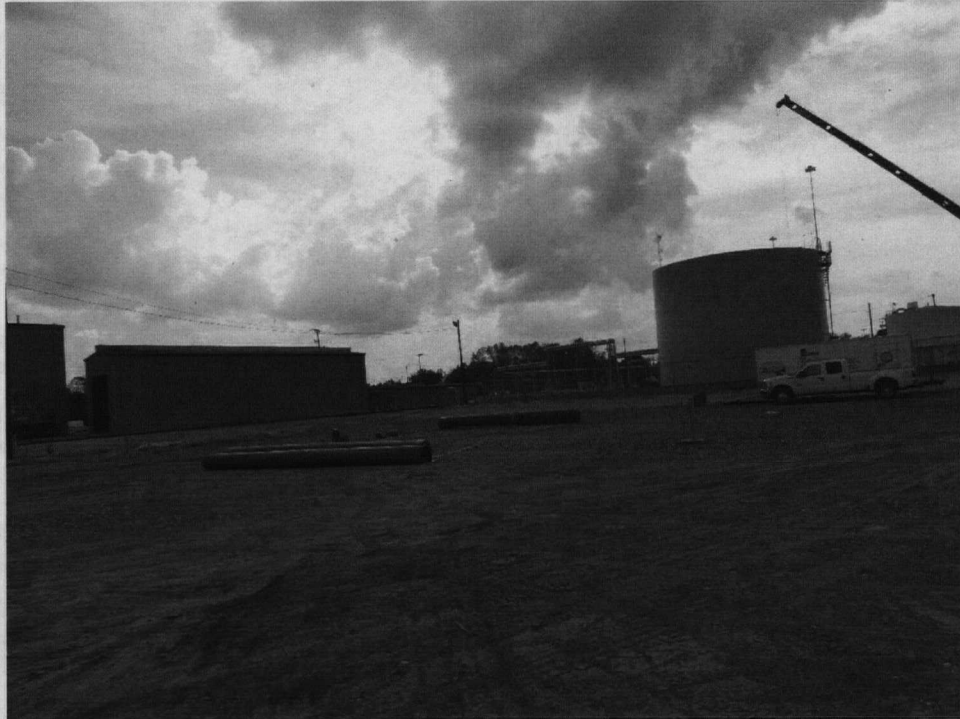
Fuel tank in area of old fuel spill plume with locomotive laundry on left.

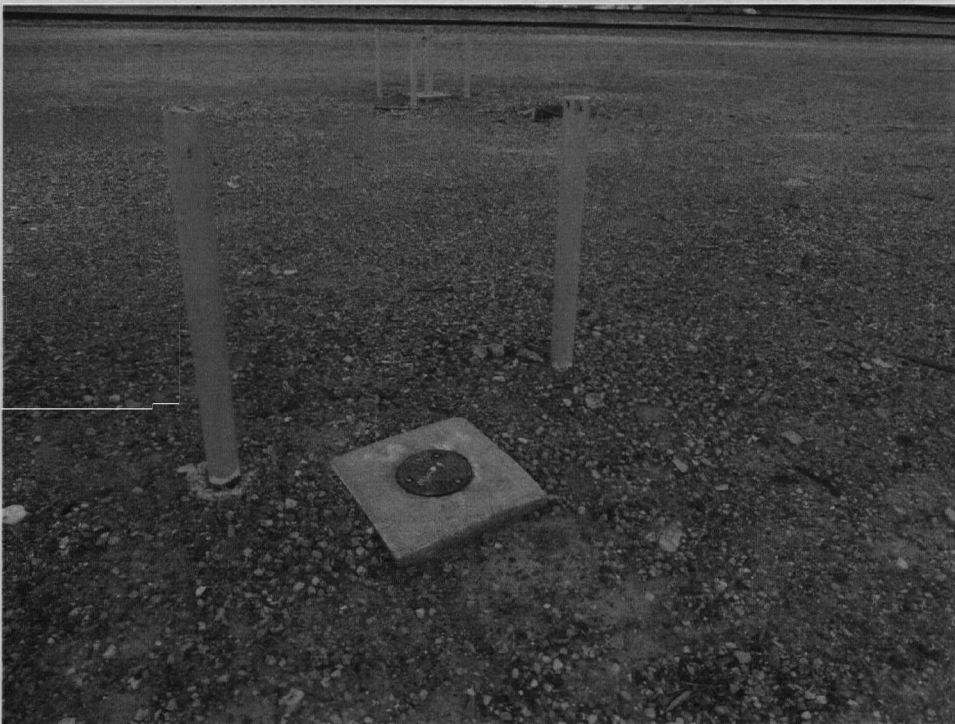
Flush mounted wells with bollards in free product plume area.

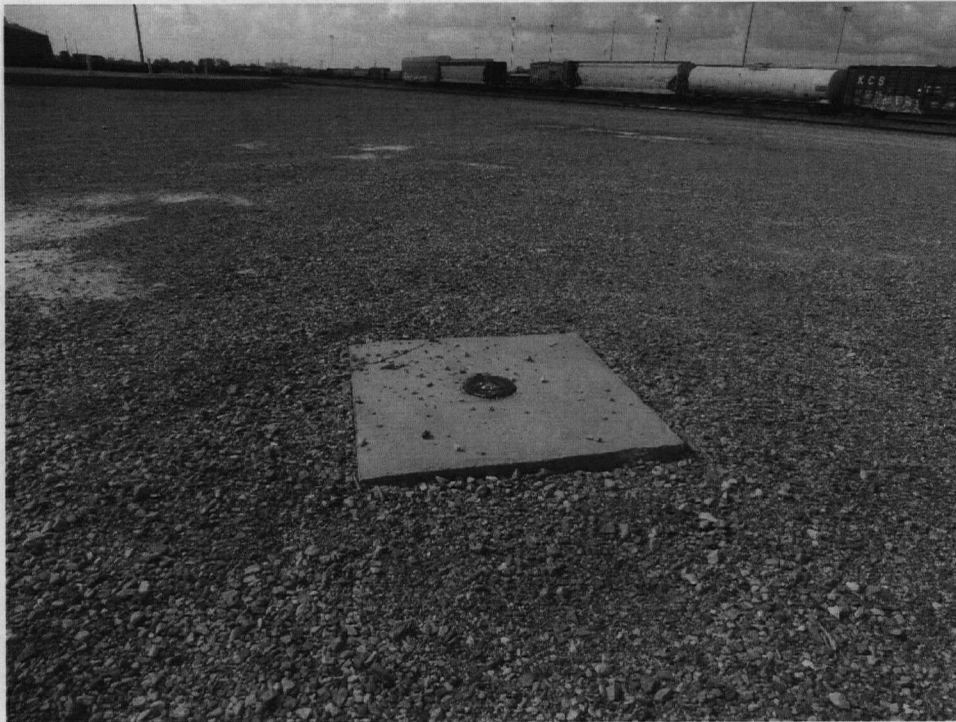
Flush mounted well with trains in background.

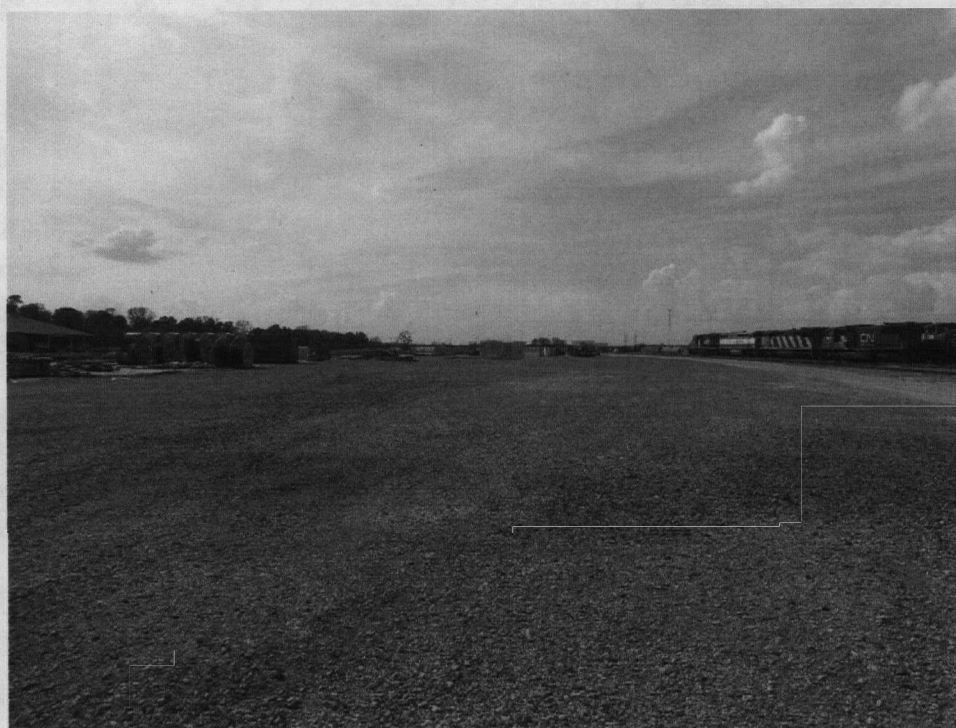
Vicinity of smaller plume area behind locomotive repair center.

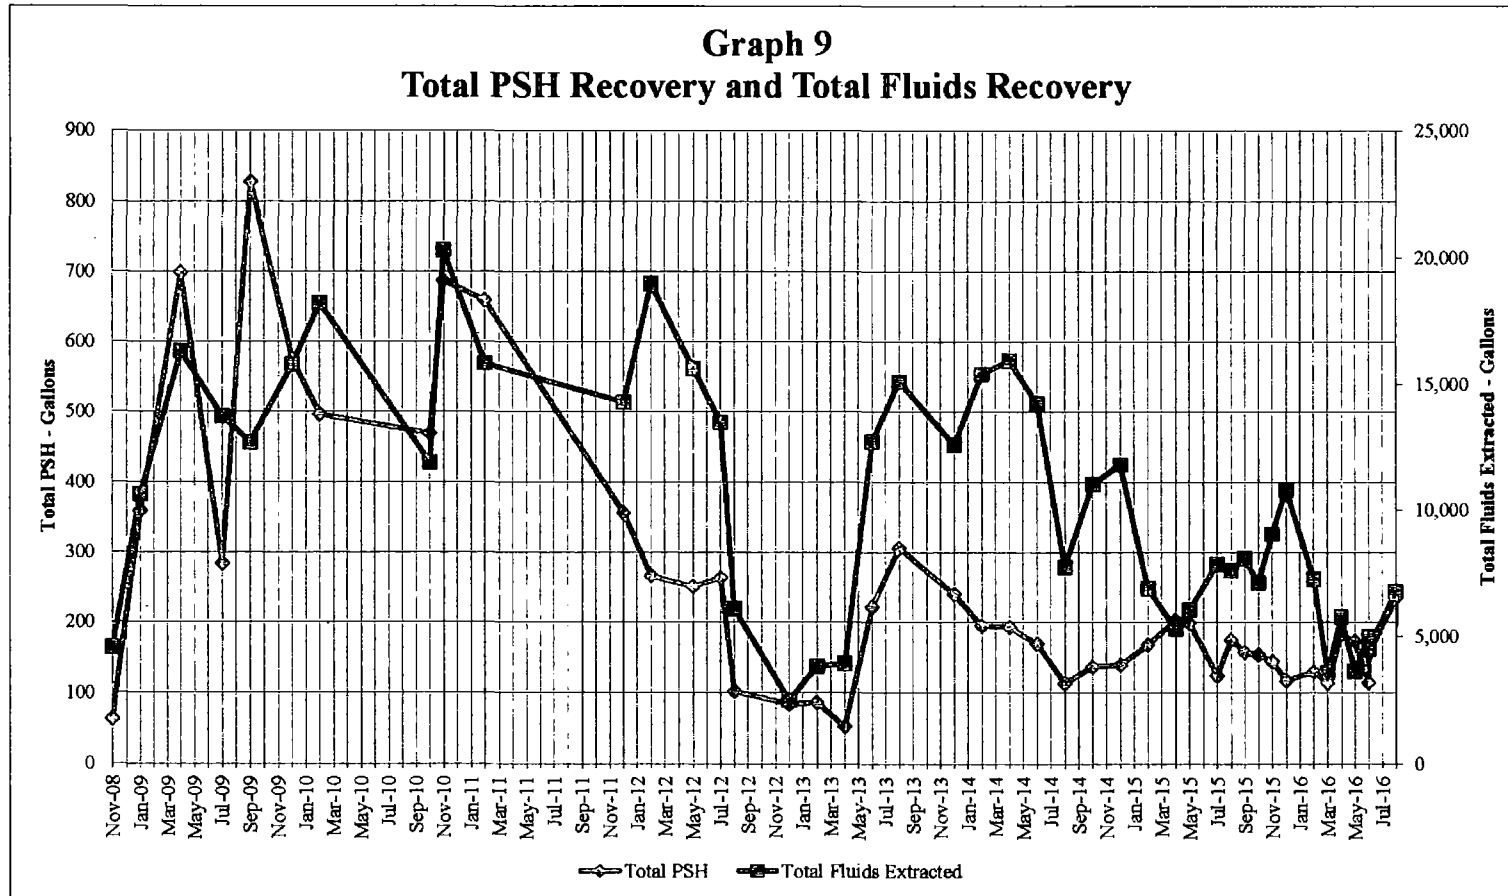
Figure I-1: Total PSH Recovery and Total Fluids Recovery, 2008-2016

The ROD estimated a total volume of PSH of approximately 14,000 gallons. The ROD also noted the uncertainty associated with the total volume that could be recovered and used an estimate of 50% recovery (7,000 gallons) of PSH as a basis for the active alternatives. The selected remedy assumed that 7,200 gallons of PSH could be recovered in two years. In practice, the PRP has recovered PSH through the periodic MEME events since 2008 and have recovered a total of 10,475 gallons.

Yes, the remedy is generally functioning as intended by the decision documents. The MEME technology is reducing the amount of free product in subsurface. The ROD estimated a total volume of PSH of approximately 14,000 gallons. The ROD also noted the uncertainty associated with the total volume that could be recovered and used an estimate of 50% recovery (7,000 gallons) of PSH as a basis for comparison of the remedial alternatives. The selected remedy assumed that 7,200 gallons of PSH could be recovered in two years. In practice, the PRP has recovered PSH through the periodic MEME events since 2008 and have recovered a total of 10,475 gallons, with 100 or more gallons of free product typically removed per event. The volume of PSH recovered per event has varied since 2008, but indicates a generally declining overall trend between 2008 to 2016.

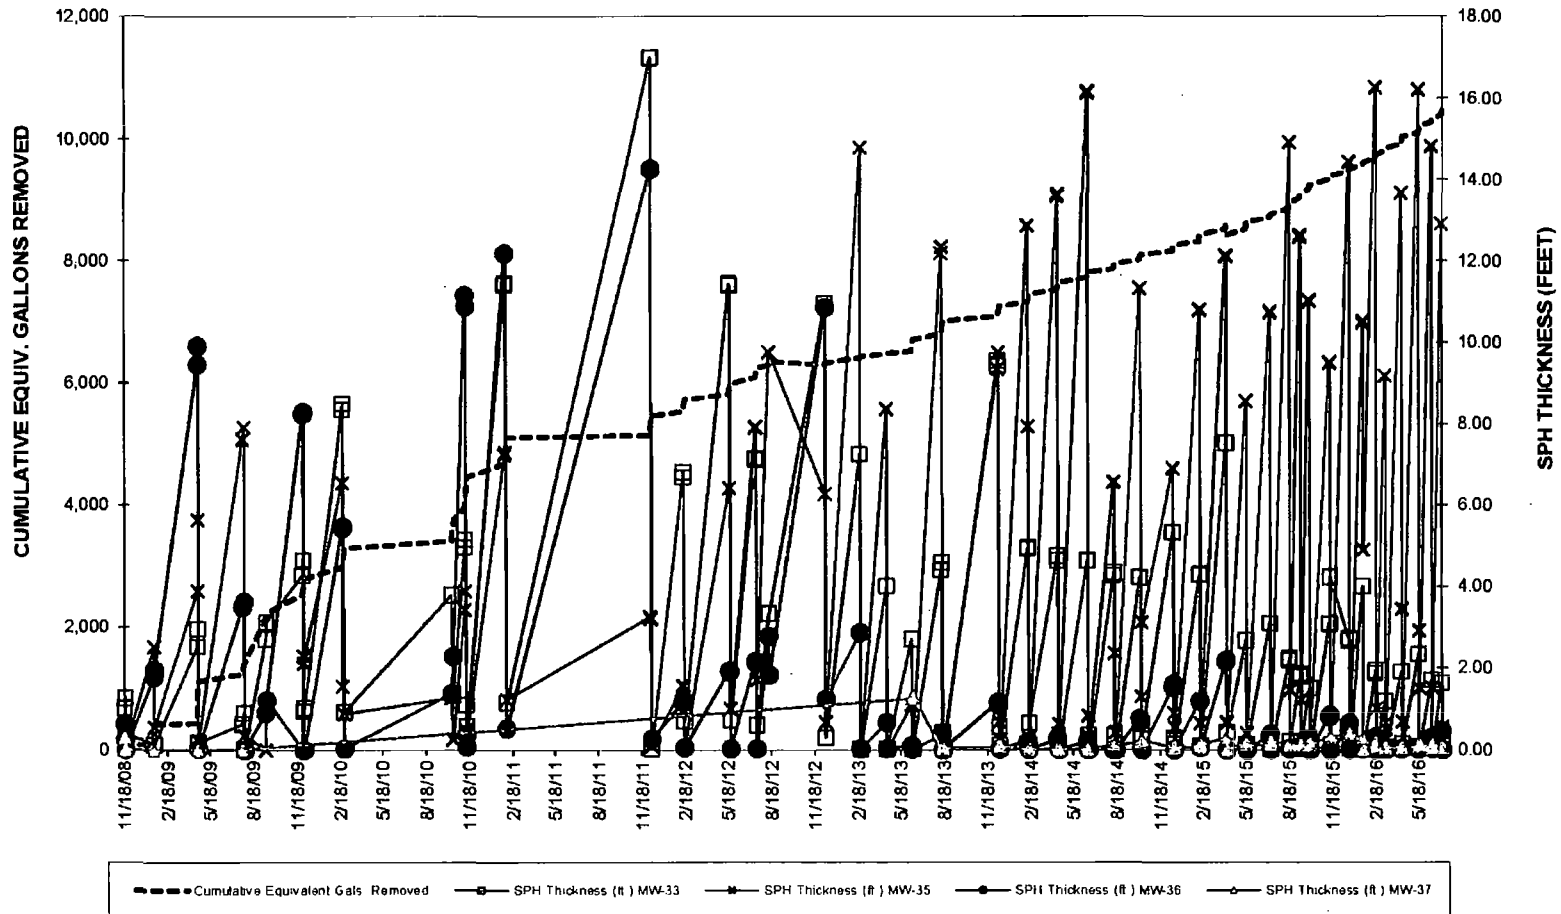
Figure I-2: Cumulative PSH (referred to as SPH in figure) Thickness Measurements for Wells MW-33, MW-35, MW-36 and MW-37 in the Fluvial Aquifer, 2008-2016

**CUMULATIVE EFR® GRAPH
FLUVIAL AQUIFER**
CN Harrison Yard
2921 Horn Lake Road
Memphis, Tennessee

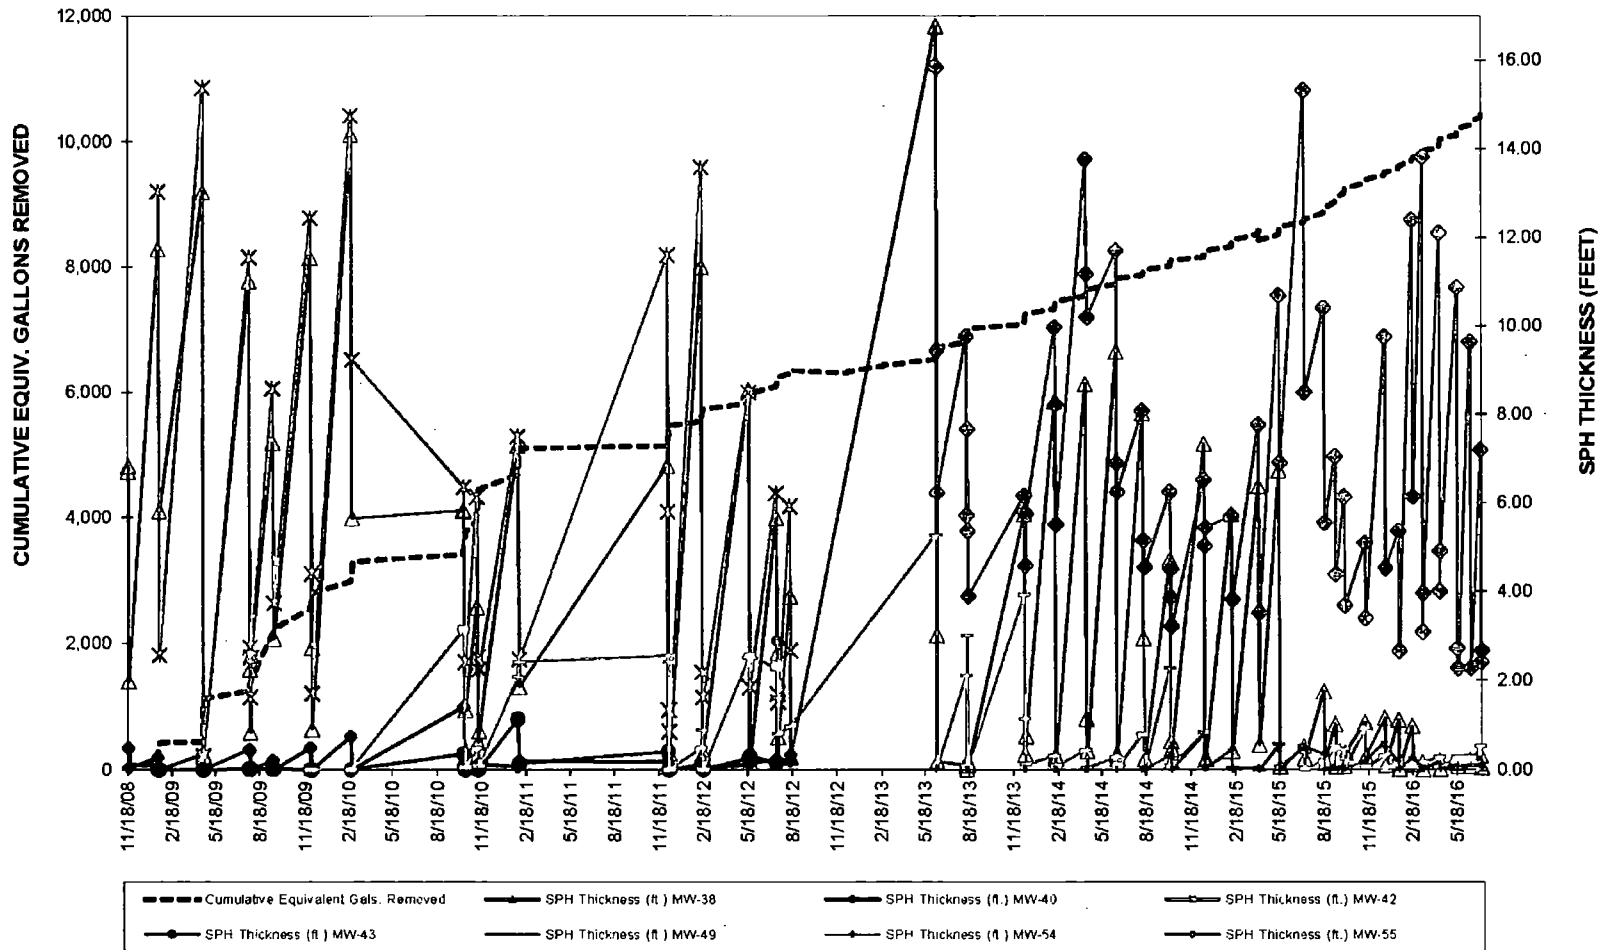
Figure I-3: Cumulative PSH (referred to as SPH in figure) Thickness Measurements for Wells MW-38, MW-40, MW-42, MW-43, MW-49, MW-54 and MW-55 in the Fluvial Aquifer, 2008-2016

**CUMULATIVE EFR® GRAPH
FLUVIAL AQUIFER**
